# National Transportation Safety Board

ERA23FA174

## COMPUTED TOMOGRAPHY

Specialist's Factual Report

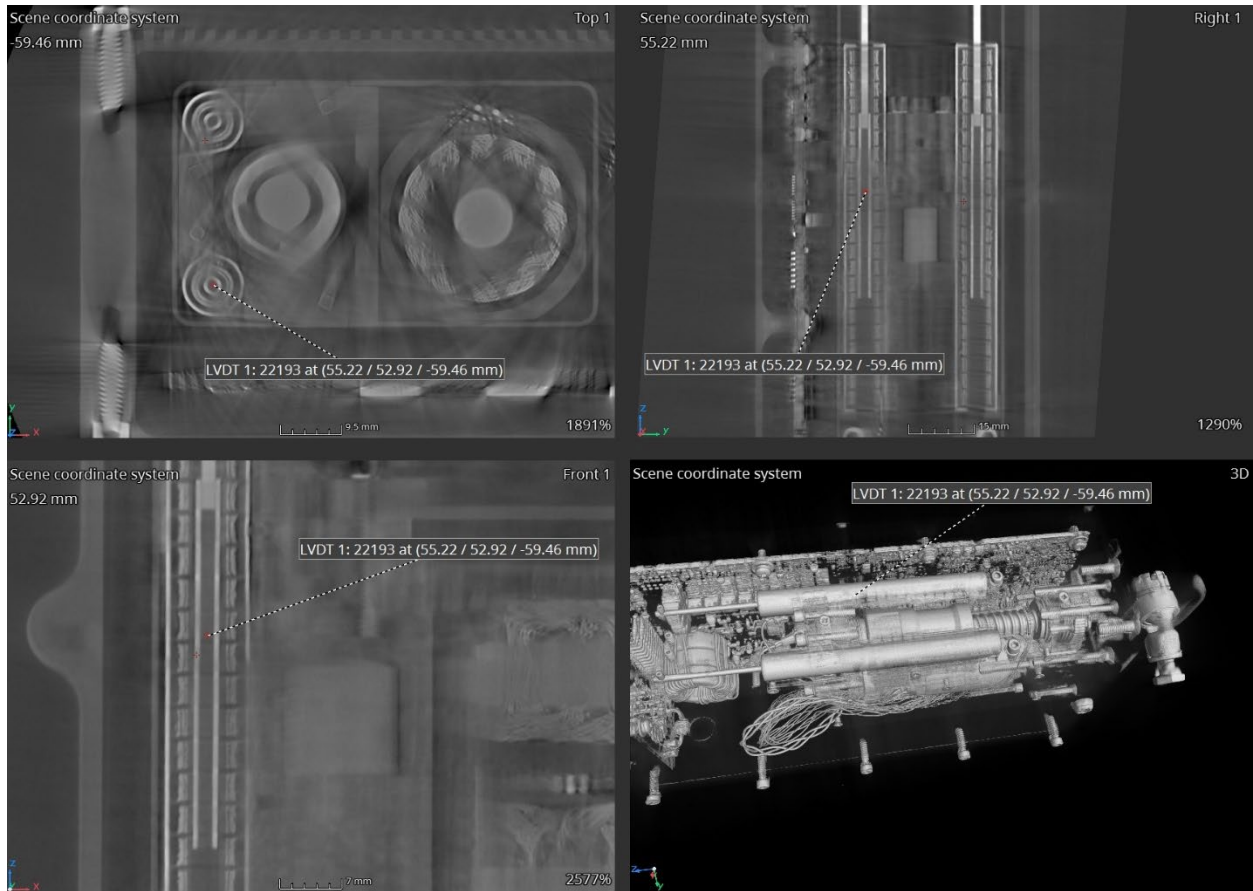
**Figure 27.** Left TACS control unit - LVDT 1.

The CT results for the left TCU are shown in Figures 1 through 44. Review of the images indicated that, when the scans were conducted, there were no indications of missing or broken components. The Linear Variable Differential Transformers (LVDTs) 1 and 2 had some wire anomalies. The LVDT anomalies are being noted as points of interest, but it is not definitive from the scan results alone whether the noted anomalies are due to physical abnormalities or image resolution effects.
