## **NATIONAL TRANSPORTATION SAFETY BOARD**

### **Attachment 1. Accidents with Lower Strength Restraint Failures**

## **SURVIVAL FACTORS**

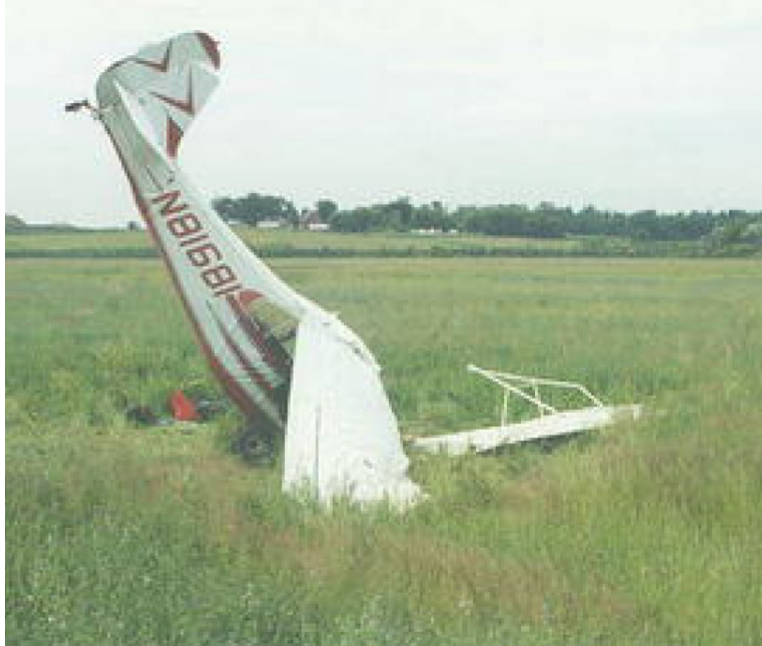
On June 23, 2000, about 2030 central daylight time, an Aeronca 7AC, N81681, sustained substantial damage on impact with terrain west of the approach end of runway 12 (4,098 feet by 75 feet, dry asphalt) at Airlake Airport (LVN), near Lakeville, Minnesota (see figure 2). The commercial rated front seat pilot was fatally injured and the commercial rated rear seat occupant was seriously injured.

**Figure 2.** Aeronca 7AC, N81681 at the accident site in Lakeville, MN.

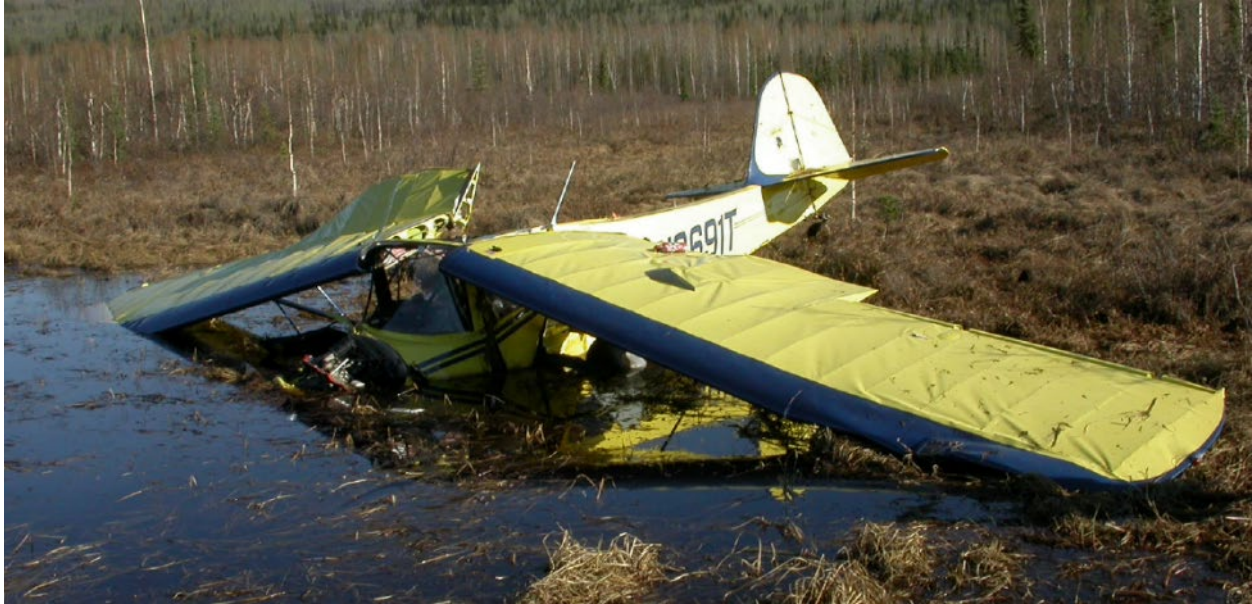
Marina Airpark, Fairbanks, Alaska (see figure 4). The commercial certificated pilot was fatally injured which was attributed to multiple blunt force trauma according to the autopsy, including left rib fracture, laceration of the aorta, inferior vena cava, and pericardium. The sole, pilot-rated passenger, received serious injuries.

**Figure 4.** Taylorcraft F-19, N3691T, at the accident site in Fairbanks, AK.

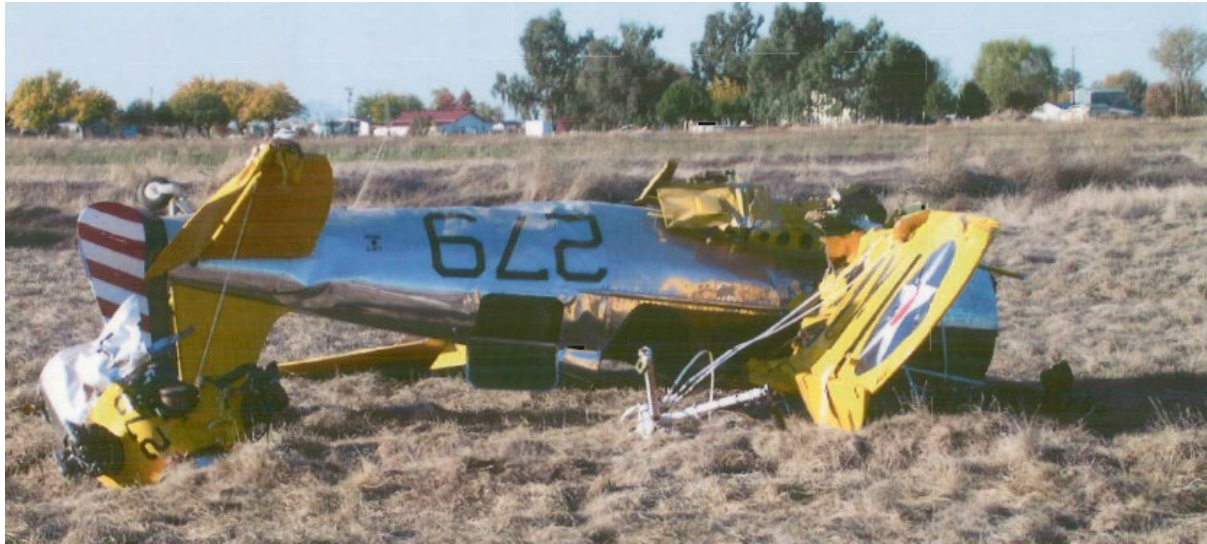
On November 15, 2005, at 1540 Pacific standard time, a Ryan Aeronautical ST3KR (Ryan PT22) airplane, N56038, impacted terrain following a loss of control while maneuvering near Lincoln, California (see figure 5). The airline transport pilot, who was the owner of the airplane, operated it under the provisions of 14 CFR Part 91 as a personal flight. The pilot, who was the sole occupant, received serious injuries, and the airplane sustained substantial damage.

**Figure 6.** Ryan Aeronautical ST3KR, N56038, at the accident site in Lincoln, CA.

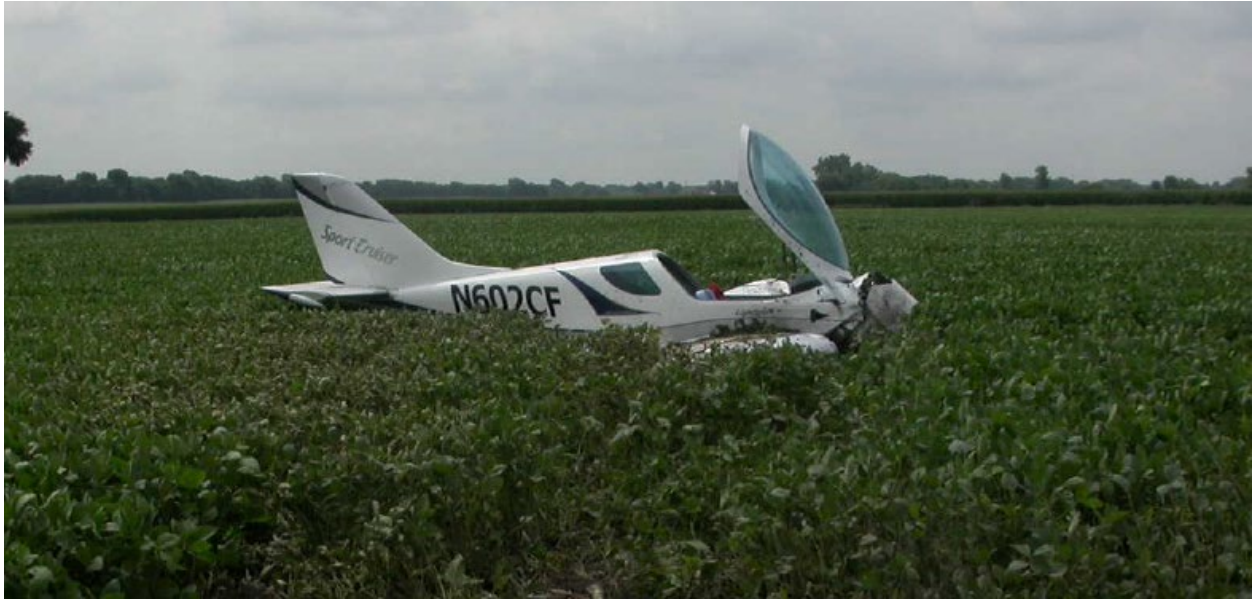
On July 21, 2008, about 1030 central daylight time, a Czech Aircraft Works Sport Cruiser, N602CF, sustained substantial damage when it impacted terrain near Cushing Field (0C8), Newark, Illinois (see figure 6). The sport pilot received fatal injuries.

**Figure 7.** Czech Sport Cruiser, N602CF, at the accident site in Newark, IL.

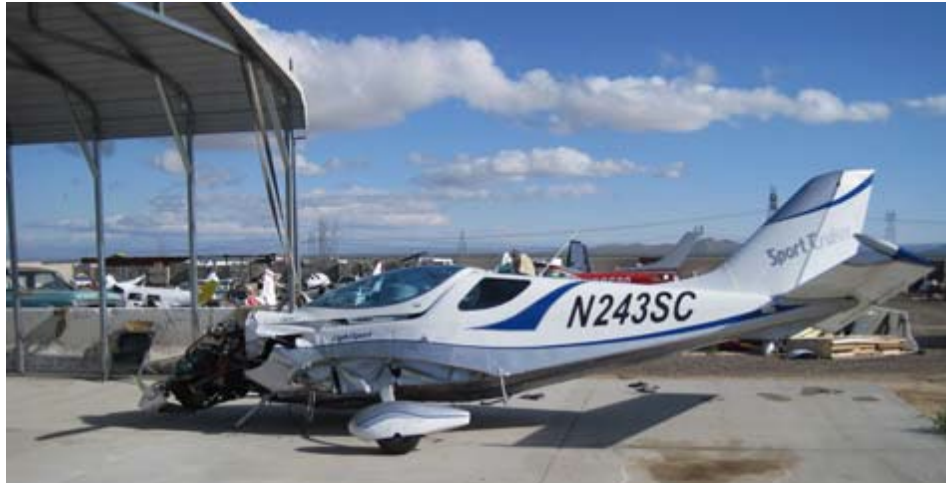
On January 25, 2010, about 1521 Pacific standard time, a Czech Aircraft Works Sportcruiser airplane, N243SC, was substantially damaged during a forced landing following a loss of engine power in cruise flight near La Quinta, California (see figure 9). The airplane was registered to Desert West Aviation, Palm Springs, California, and operated by the pilot under the provisions of Title 14 Code of Federal Regulations Part 91. The airline transport pilot and pilot-rated passenger sustained serious injuries.

**Figure 9.** Czech Sport Cruiser, N243SC, at the salvage facility in La Quinta, CA.

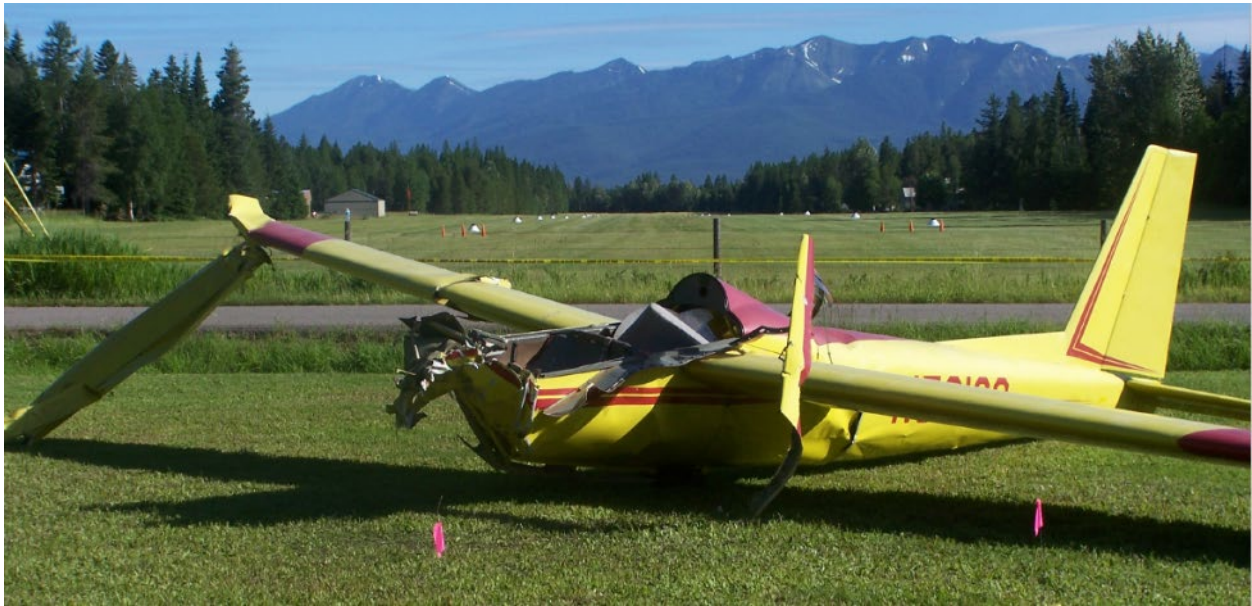
Bigfork, Montana (see figure 10). The airline transport rated pilot sustained fatal injuries and the airplane transport rated pilot examiner sustained serious injuries.

**Figure 11.** Schweitzer, N591CC at the accident site in Bigfork, MT.

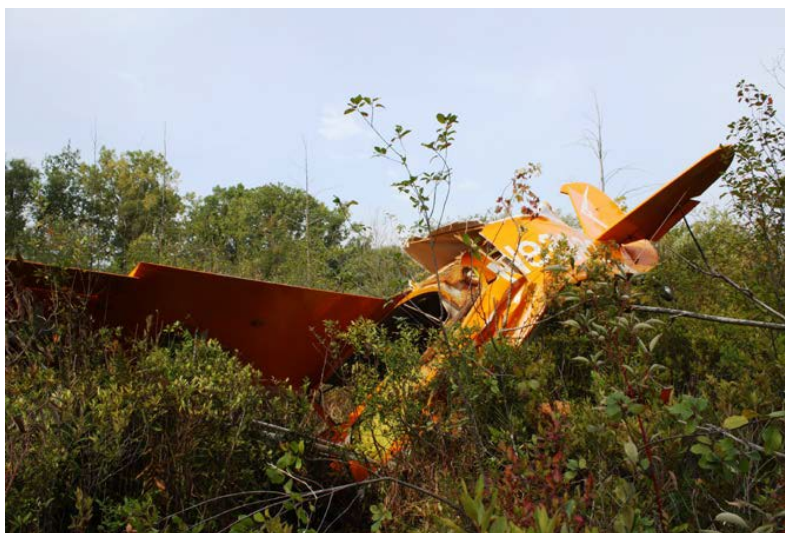
On September 1, 2012, approximately 0830 eastern daylight time, an Aeronca 7AC single-engine airplane, N82383, sustained substantial damage when it impacted terrain following a loss of control during initial takeoff climb from the Brighton Airport (45G), Brighton, Michigan (see figure 12). The private pilot sustained serious injuries, and the passenger sustained fatal injuries.

**Figure 13.** Aeronca Champ, N82383, accident site in Brighton, MI.

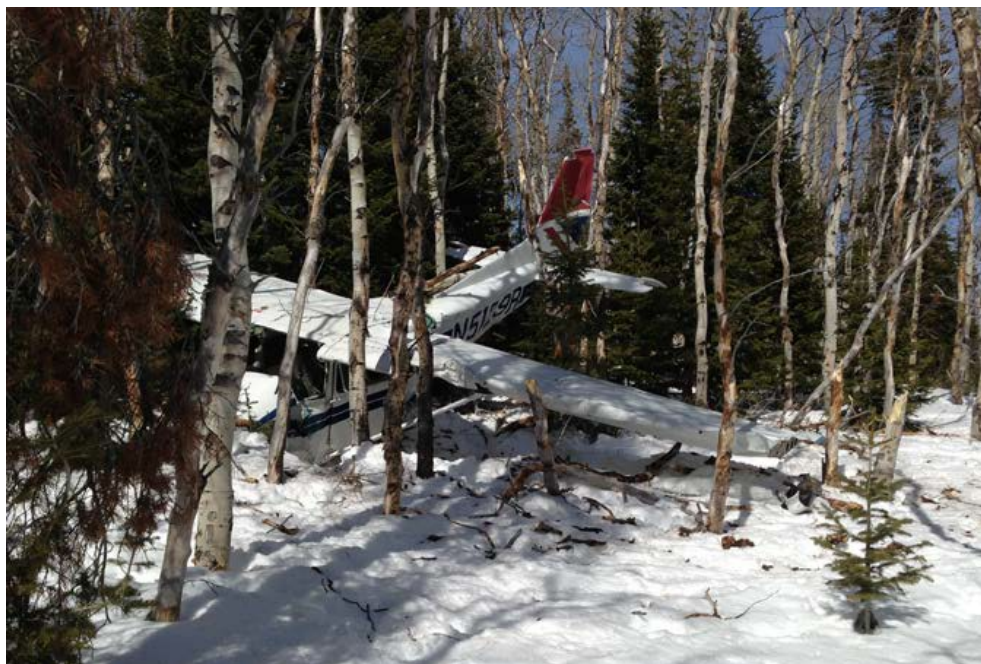
On March 3, 2013, about 1558 mountain standard time, a Cessna 172M airplane, N5129R, impacted trees and snow-covered mountainous terrain nautical miles east northeast of Saratoga, Wyoming (see figure 14). The pilot was fatally injured, and the airplane sustained substantial damage. The airplane was registered to and operated by the pilot under the provisions of 14 Code of Federal Regulations Part 91, as a cross-country flight. Visual meteorological conditions prevailed for the flight, which operated on a visual flight rules (VFR) flight plan. The flight originated from Bryce Canyon Airport, Bryce Canyon, Utah, at about 1223.

**Figure 15.** Cessna 172, N5129R, accident site in Saratoga, WY.

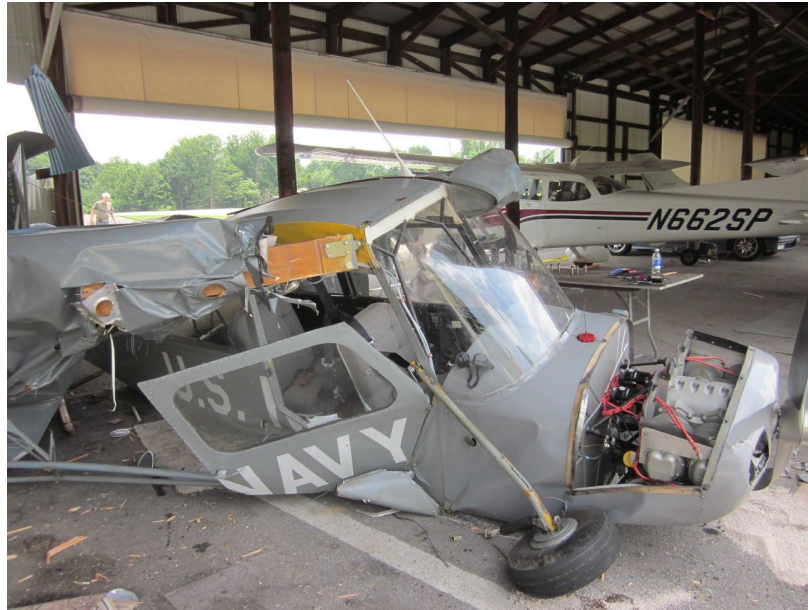
On June 1, 2016, about 0854 eastern daylight time, an Aeronca 7AC, N83547, was substantially damaged when it was involved in an accident near Toughkenamon, Pennsylvania. The student pilot and flight instructor sustained minor injuries. The airplane was operated as a Title 14 Code of Federal Regulations Part 91 instructional flight.

**Figure 17.** Aeronca 7AC, N83547, at accident site in Toughkenamon, PA.

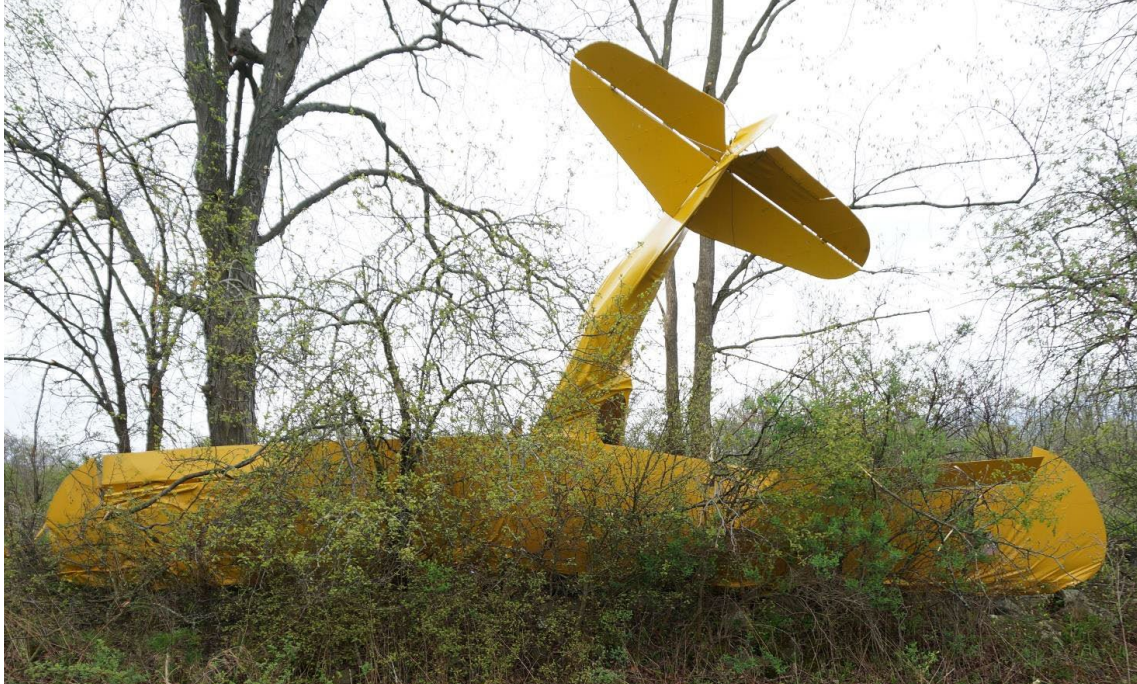
On May 5, 2018, about 0905 eastern daylight time, an Aeronca 7AC, N84396, was substantially damaged when it was involved in an accident near Randall Airport, Middletown, New York (see figure 19). The pilot was fatally injured, and the flight instructor was seriously injured. The airplane was operated as a Title 14 Code of Federal Regulations Part 91 instructional flight.

**Figure 19.** Aeronca 7AC, N84396, accident site in Middletown, NY.

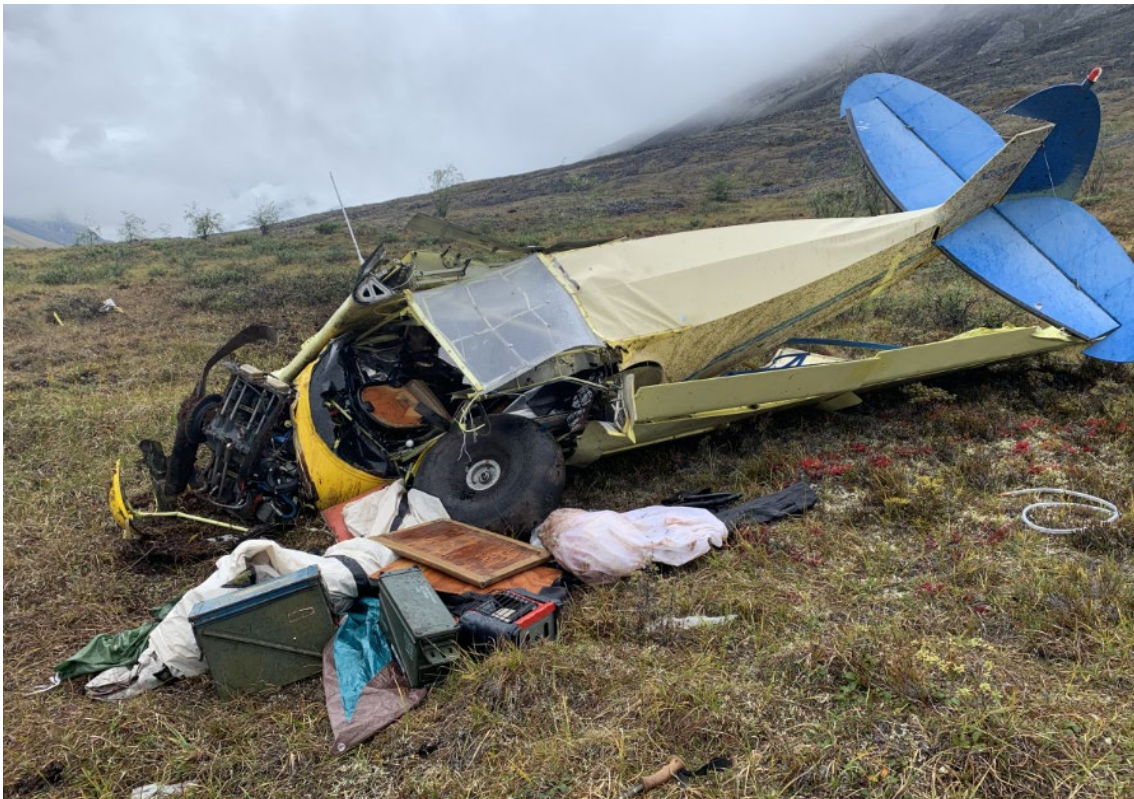
On August 11, 2022, at 1152 Alaska daylight time, a Piper PA-12 airplane, N3937M, was substantially damaged when it was involved in an accident near the Marsh Fork Canning River, about 40 nautical miles (nm) northwest of Arctic Village, Alaska (see figure 22). The pilot was fatally injured. The airplane was operated as a Title 14 Code of Federal Regulations Part 91 personal flight.

**Figure 22.** Piper PA-12 N3937M, accident site near Marsh Fork Canning River, AK.

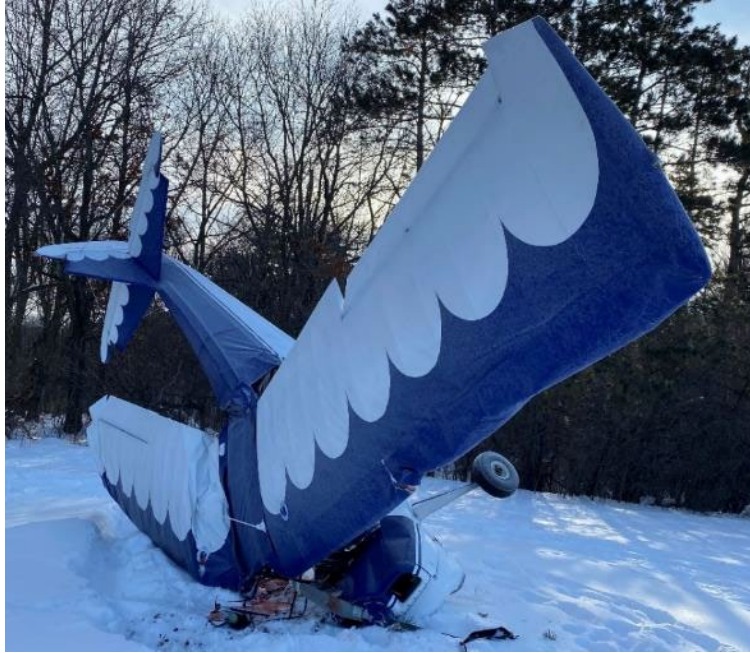
On February 4, 2023, about 1630 central standard time, a Bellanca Aircraft 7ACA, N9111L, was substantially damaged when it was involved in an accident near Bayport, Minnesota (see figure 24). The pilot sustained minor injuries. The airplane was operated as a Title 14 Code of Federal Regulations Part 91 personal flight. The flight originated from Lake Elmo Airport, Lake Elmo, MN, at about 1330.

**Figure 24.** Bellanca Aircraft 7ACA, N9111L, at the accident site in Bayport, MN.

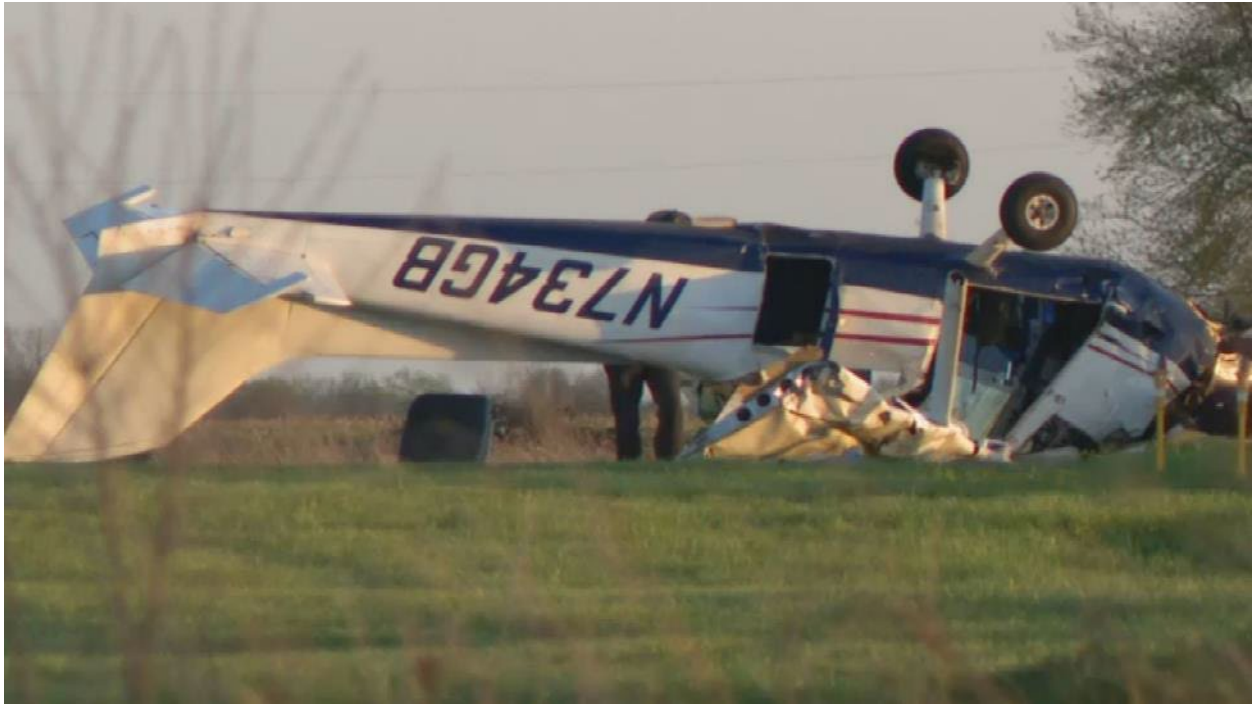
On April 18, 2023, at 1820 eastern daylight time, a Cessna 172N, N734GB, was substantially damaged when it was involved in an accident near Madison County Airport (UYF), London, Ohio (see figure 26). The flight instructor and student pilot were fatally injured. The airplane was operated as a Title 14 Code of Federal Regulations Part 91 instructional flight.

**Figure 26.** Cessna 172 Skyhawk, N734GB, at the accident site in London, OH.

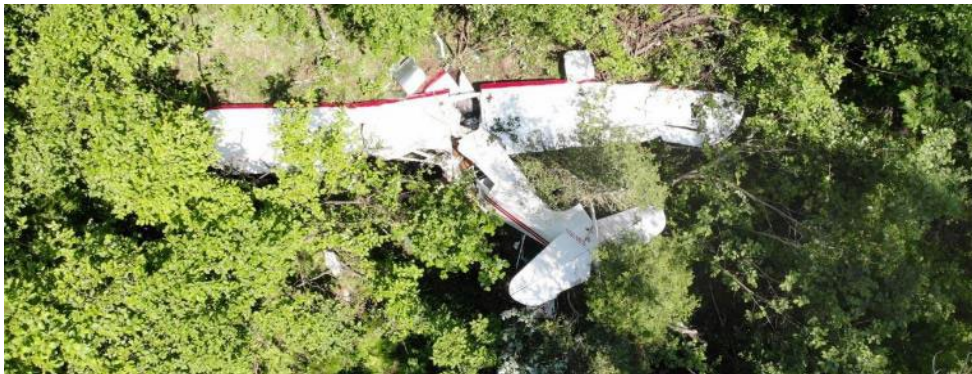
On June 21, 2023, at 0714 central daylight time, an Aeronca 7CCM airplane, N308ED, was substantially damaged when it was involved in an accident near Duluth, Minnesota (see figure 28). The pilot and passenger were fatally injured. The airplane was operated as a Title 14 Code of Federal Regulations Part 91 personal flight.

**Figure 28.** Aeronca 7CCM, N308ED, at the accident site in Duluth, MN.
