# National Transportation Safety Board

ERA23FA219

## **AIRPLANE INFORMATION AND BRS SYSTEM DESCRIPTION AND EXAMINATION SUMMARY**

Location: Reliance, Tennessee  
Date: May 7, 2023  
Time: 1849 Eastern Daylight Time  
2249 Coordinated Universal Time (UTC)  
Airplane: N725AS, Cessna 182Q

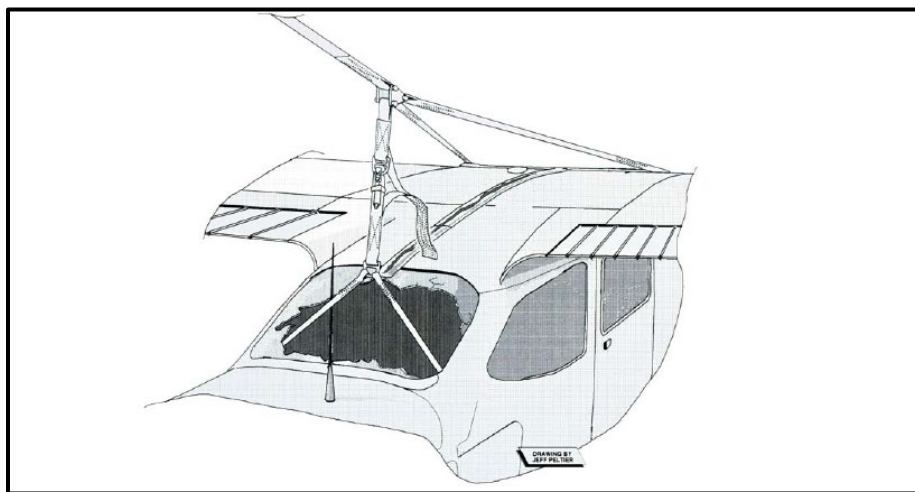
**Figure 2 Illustration From BRS of Aircraft Attachment Harness After Parachute Extraction But Before the Rear Harness was Fully Extended**

Following activation, the rocket would penetrate the rear window and extract the parachute bag away from the airplane, pulling/dragging the harness out. A tethered line connecting the parachute bag to the rear harness would pull the rear harness out which would also by friction drag the front harness out (Figure 2). BRS reports that even if the riser was not attached to the 3-Pt. shackle, the front harness would partially be pulled from under the protective cover on the top skin of the wing center section.

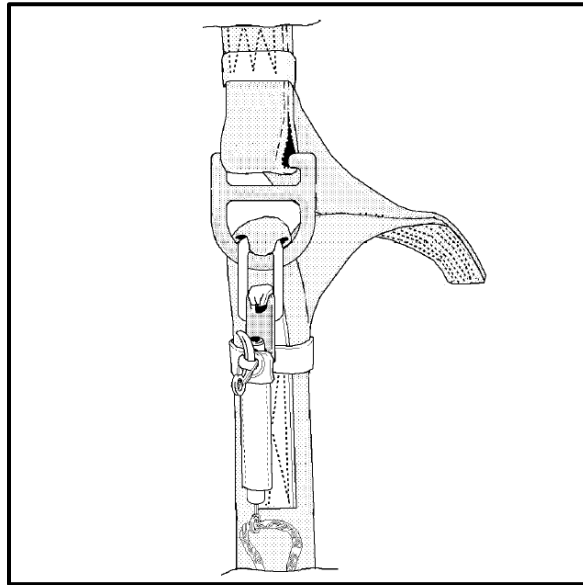
**Figure 3 Rear Harness Release Mechanism Illustration From BRS**

The BRS-182 harness system is designed to control the pitch dynamics of the airplane during the deployment cycle by limiting the length of the rear harness strap until the deployment cycle is complete. The rear harness assembly has two sections of different length. The shorter section has

a mechanical release mechanism that is activated through the tether connected to the bag activating a fused pyrotechnic reefing line cutter (Figure 3).
