# National Transportation Safety Board

ERA23FA256

## **AIRWORTHINESS**

Group Chair's Factual Report

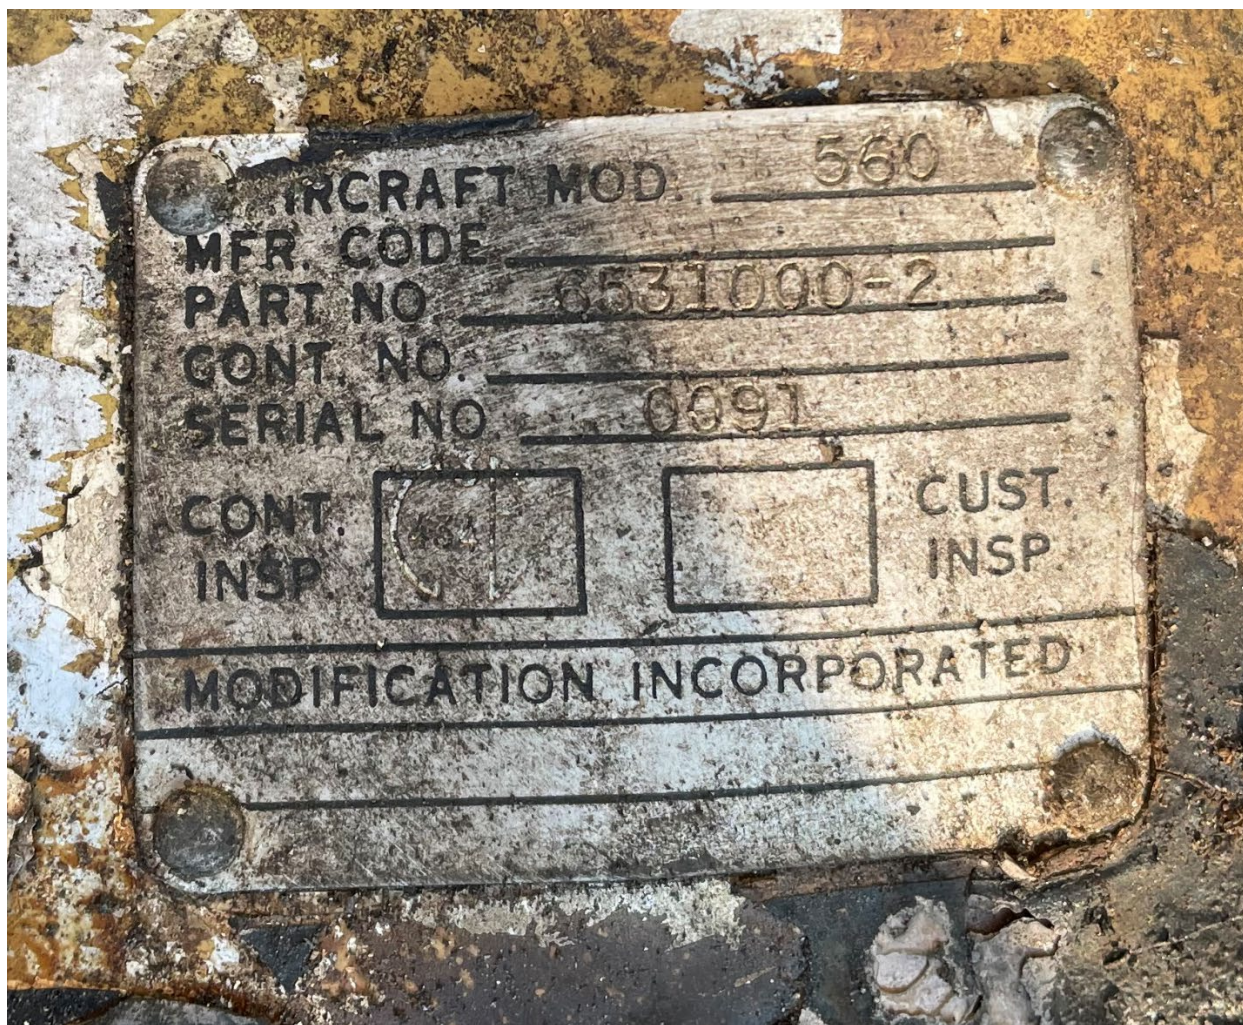
**Figure 12.** Aircraft data plate.

The group met at Anglin Air Recovery Services' facility in Clayton, DE on 6-7 September 2023 to examine the wreckage recovered from the accident site. The group examined eighteen bags of wreckage looking for the CVR, pressurization, bleed air, oxygen, and flight control components. The aircraft data plate was recovered (see Figure 12). The wreckage was highly fragmented (see Figure 13). No components of the CVR were found.

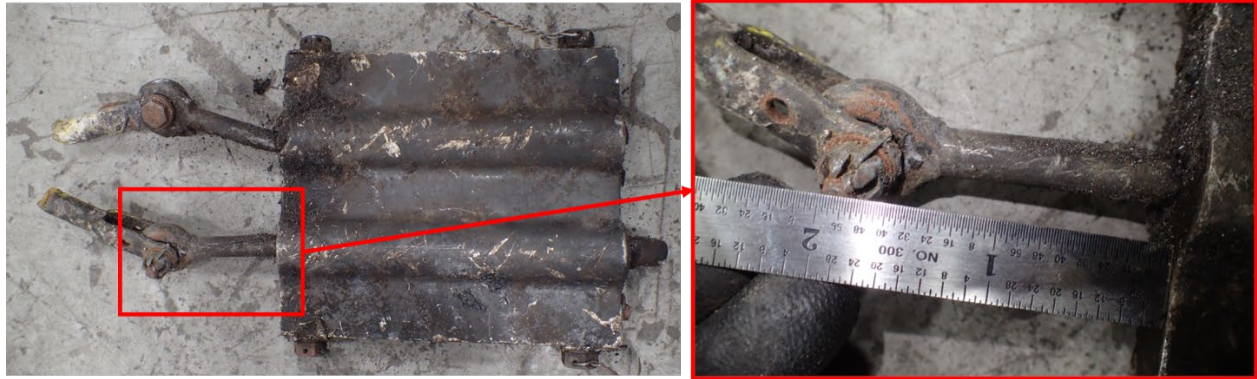
**Figure 17.** Photo of rudder trim actuator.

The rudder trim actuator was measured at 1.93 inches, which corresponds to 5 degree trim tab left (see Figure 17). The aileron trim actuator 1.81 inches, which corresponds 5 degree trim tab down (see Figure 18). The aileron trim tab is installed on the left aileron.

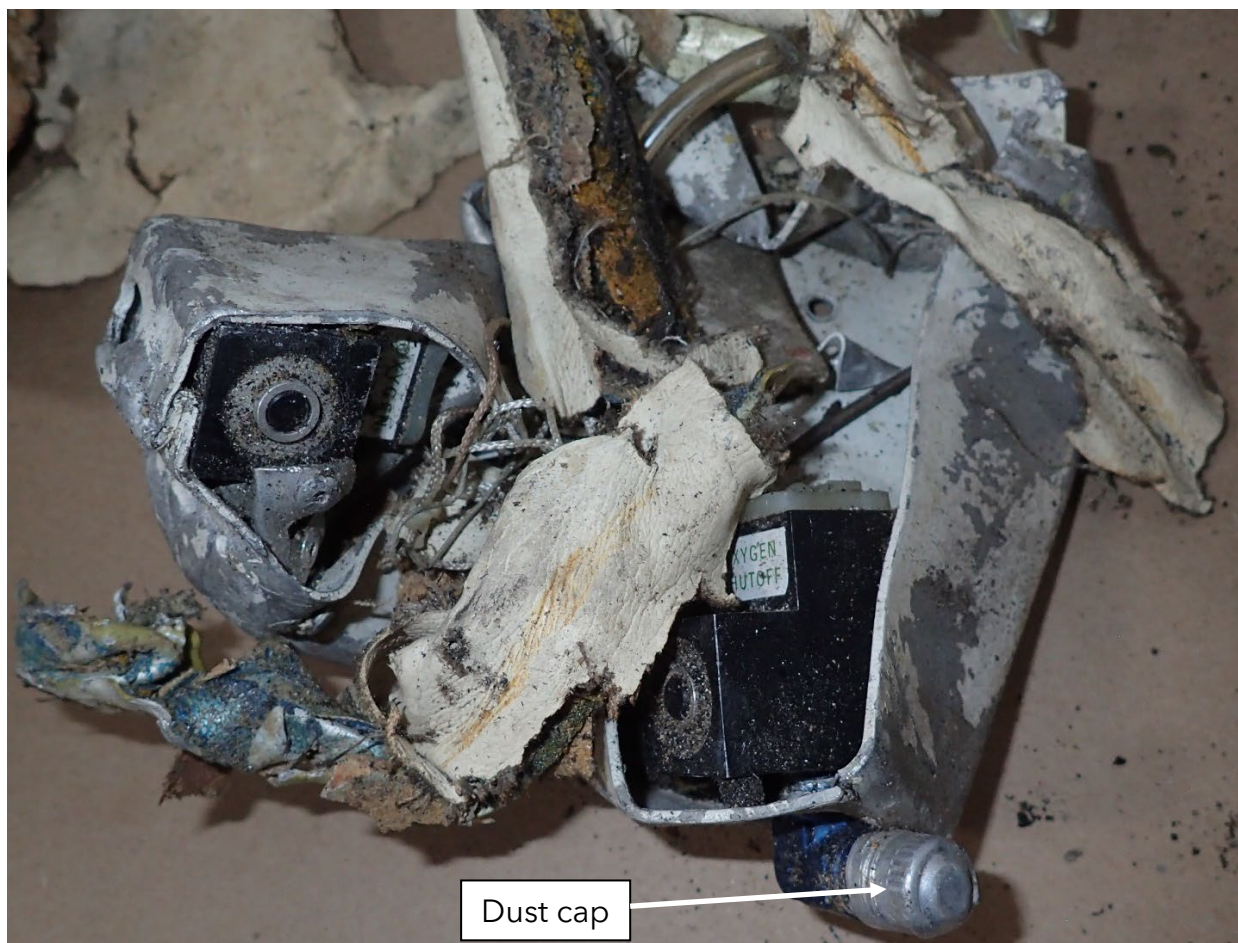
Two passenger oxygen masks were located in the debris. They remained attached to their respective box assemblies next to the oxygen shutoff valve. The unit was found loose in the debris and sustained heavy impact and thermal damage. One oxygen mask stowage/dropout box assembly and its oxygen shutoff valve were found capped with a dust cap (see Figure 21), rather than an approved AN cap (see Figure 22). No other major portions of the oxygen or pressurization system were located in the debris.

**Figure 21.** Photo of passenger oxygen mask stowage/dropout box assembly with dust cap installed.

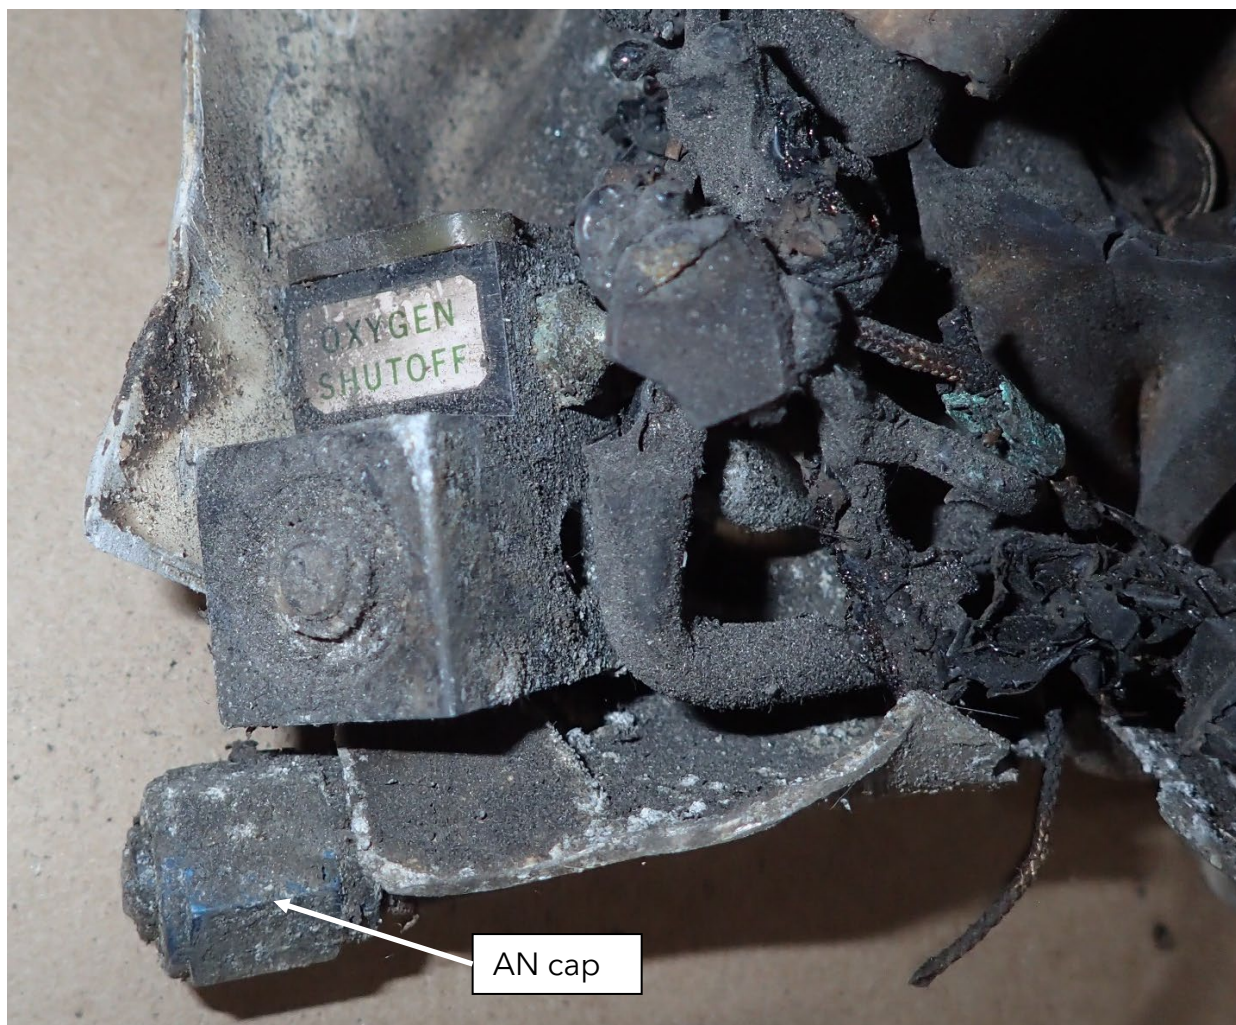
**Figure 22.** Photo of passenger oxygen mask stowage/dropout box assembly with AN cap installed.

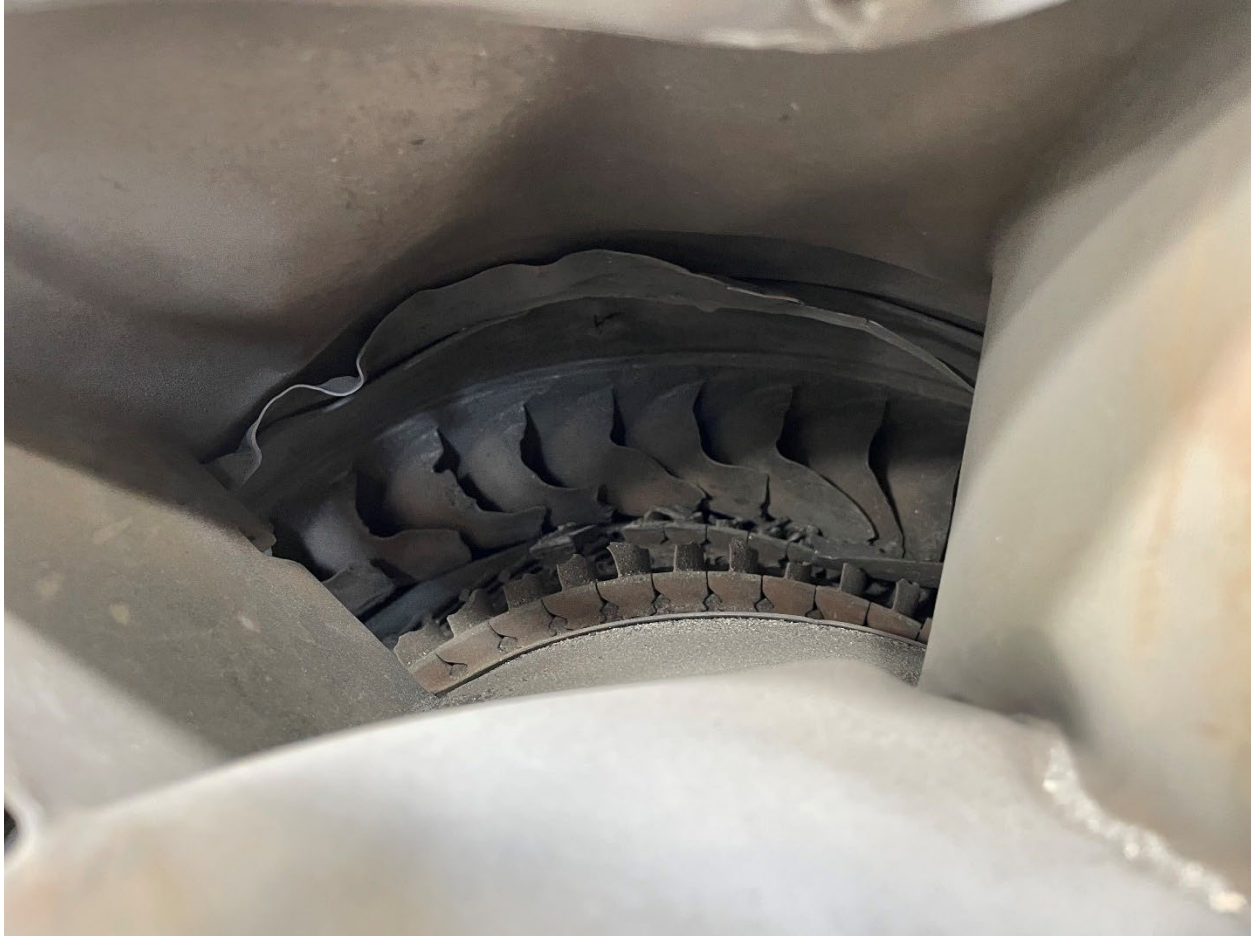
**Figure 30.** Photo of engine B second stage LPT.

- Aft looking forward, the exhaust nozzle was attached and deformed. There were holes observed on the exhaust nozzle, with evidence of foreign material and melted deposits near the holes (see Figure 29).
- The exhaust center cone and support struts were present.
- The second stage LPT blades were fractured and separated at the platforms (see Figure 30). The LPT module appeared displaced aft. About half of the second stage LPT vanes were fractured and exhibited trailing edge impact damage. First stage LPT blades were fractured at the platform or were separated and missing.

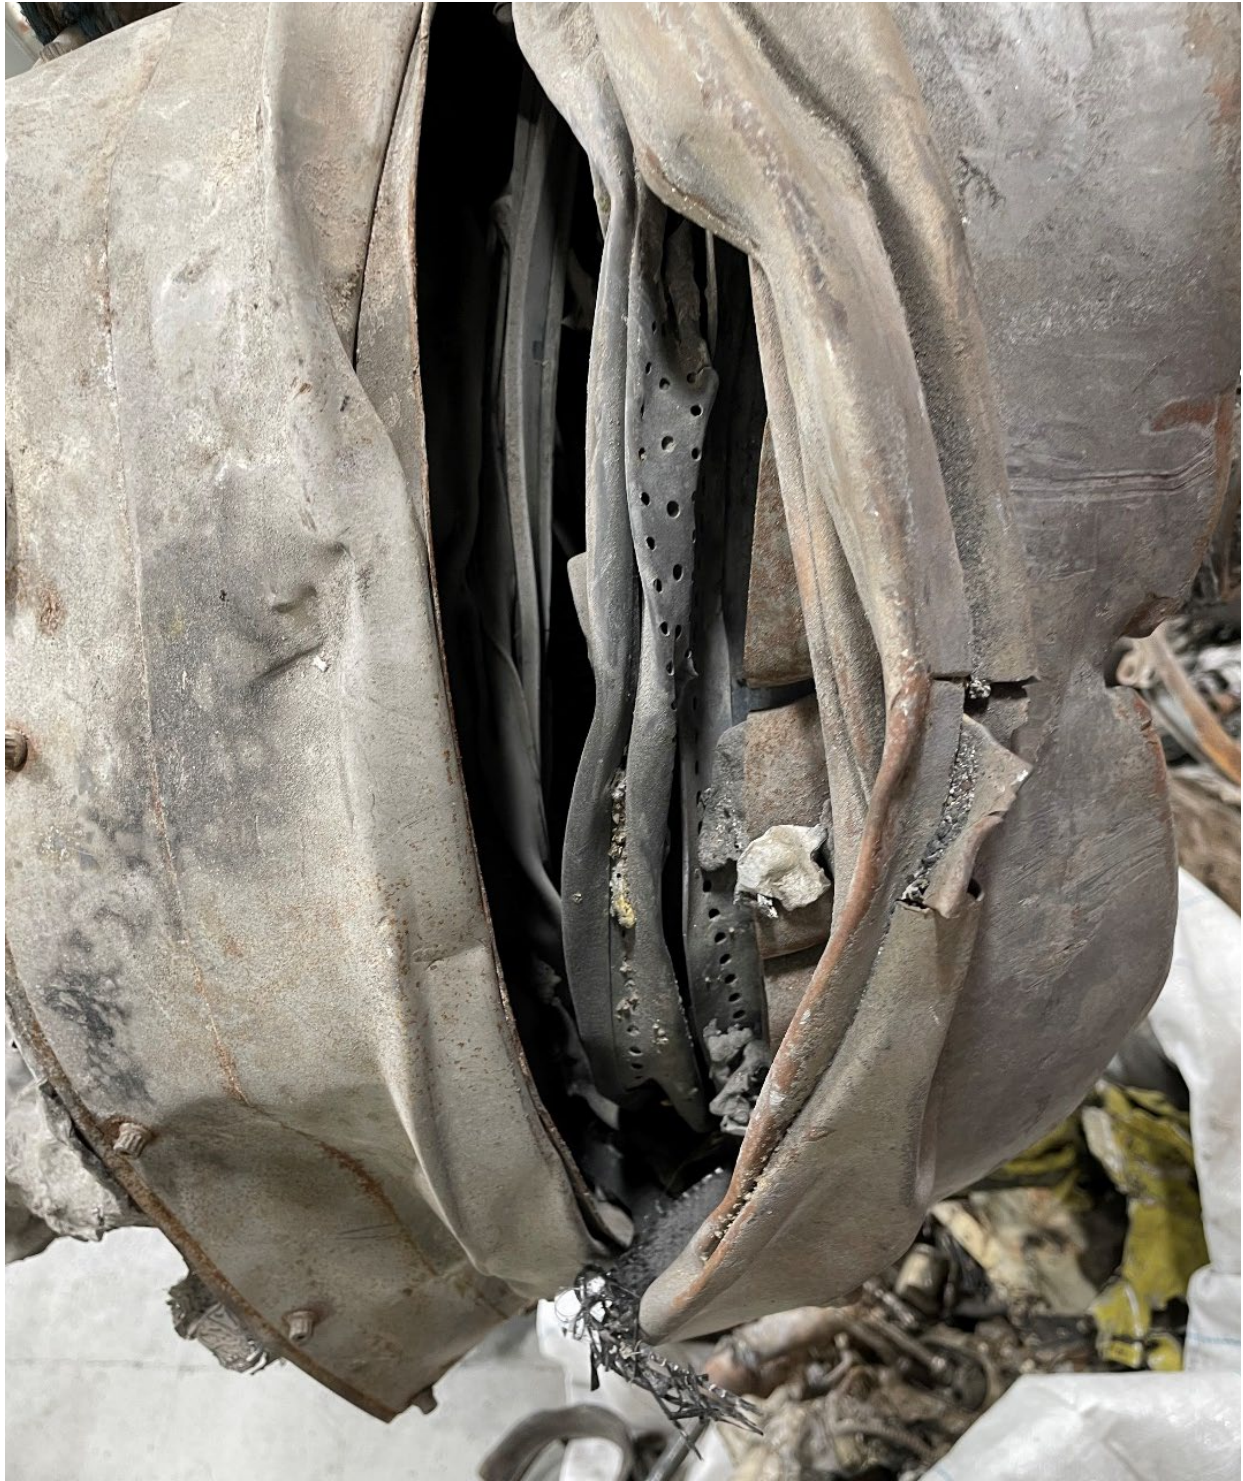
**Figure 32.** Photo of engine B case separation.

- The HPC impeller remained on the shaft. The majority of the blades were fractured at the root and missing. The remaining blades were bent opposite direction of rotation (see Figure 31).
- The HP and LP shafts were fractured forward of the impeller.
- The engine case had partially separated due to impact related damage, allowing a view of the combustor and the HPT rotor (see Figure 32). The HPT blades were missing.
- The HPC impeller shroud was deformed. It showed marks of rotational scoring (see Figure 33).
