# National Transportation Safety Board

ERA23LA313

## **WRECKAGE EXAMINATION**

Location: Churchville, MD  
Date: July 25, 2023  
Time: 1906 EDT  
2306 UTC  
Airplane: Piper PA-28R-200; N34PT

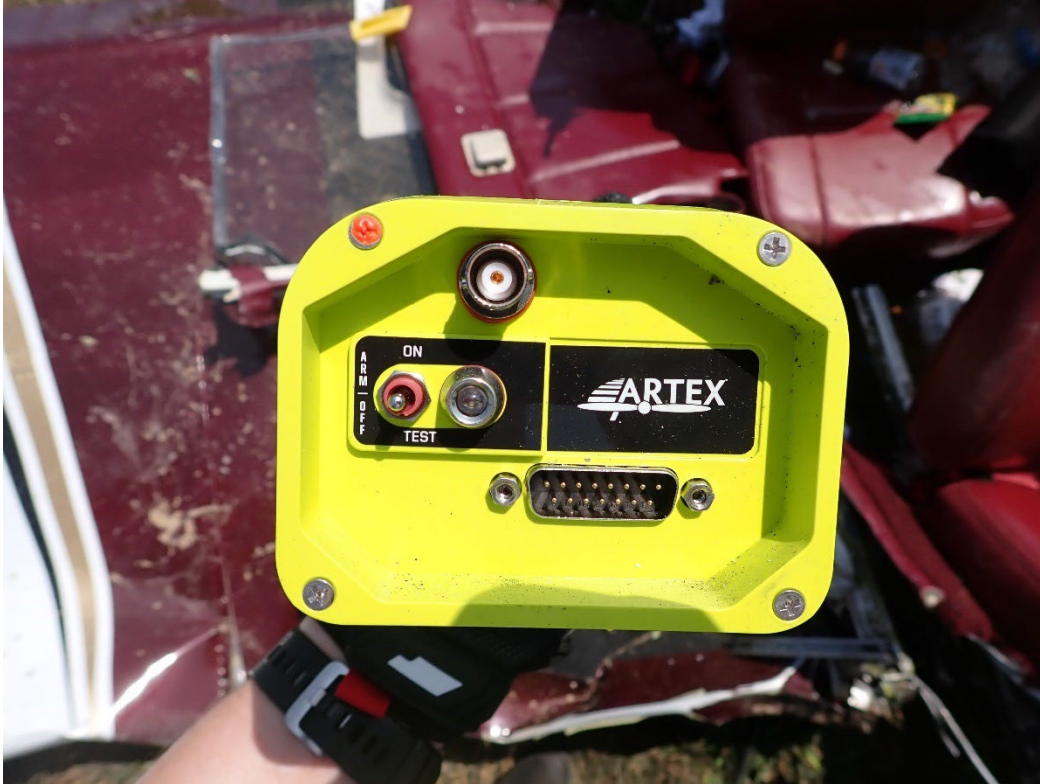
Photo 26: ELT

The Emergency Locator Transmitter (ELT) was removed and turned off by a Federal Aviation Administration Inspector who responded to the scene on the day of the accident.

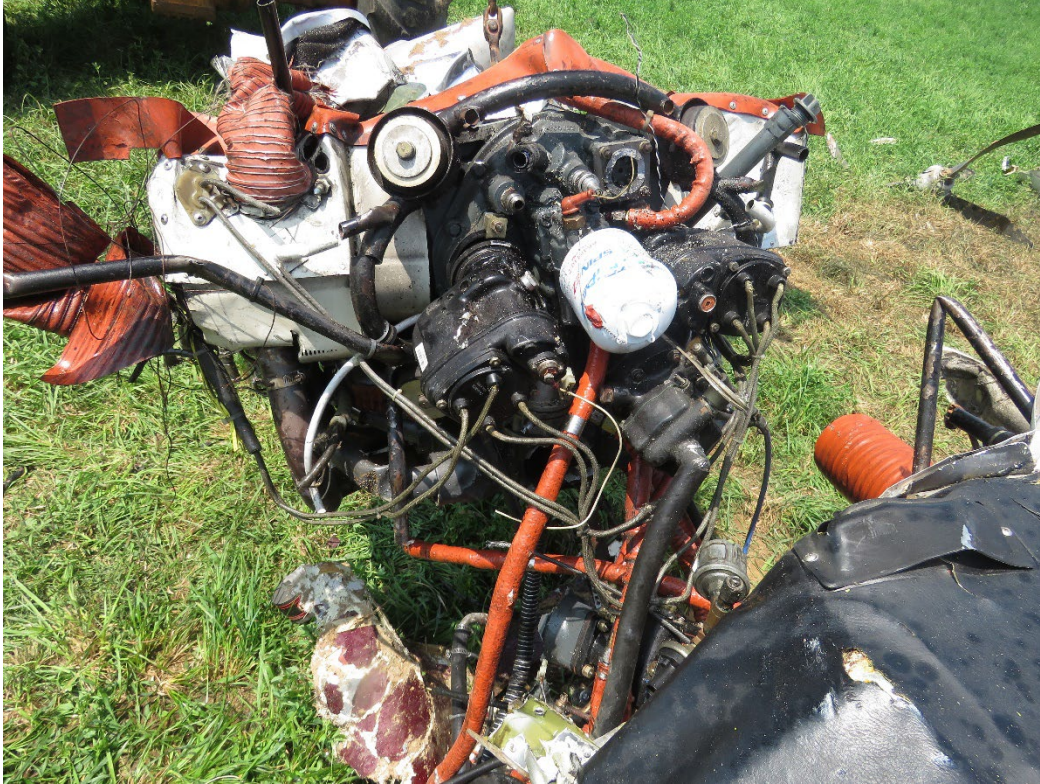
**Photo 29: View of the engine accessories. (Lycoming Photo)**
