# National Transportation Safety Board

ERA23FA317

## **WRECKAGE EXAMINATION FACTUAL REPORT**

Location: Springfield, Ohio  
Date: July 29, 2023  
Time: 1206 EDT  
Airplane: Bell 206-L4, N652HA

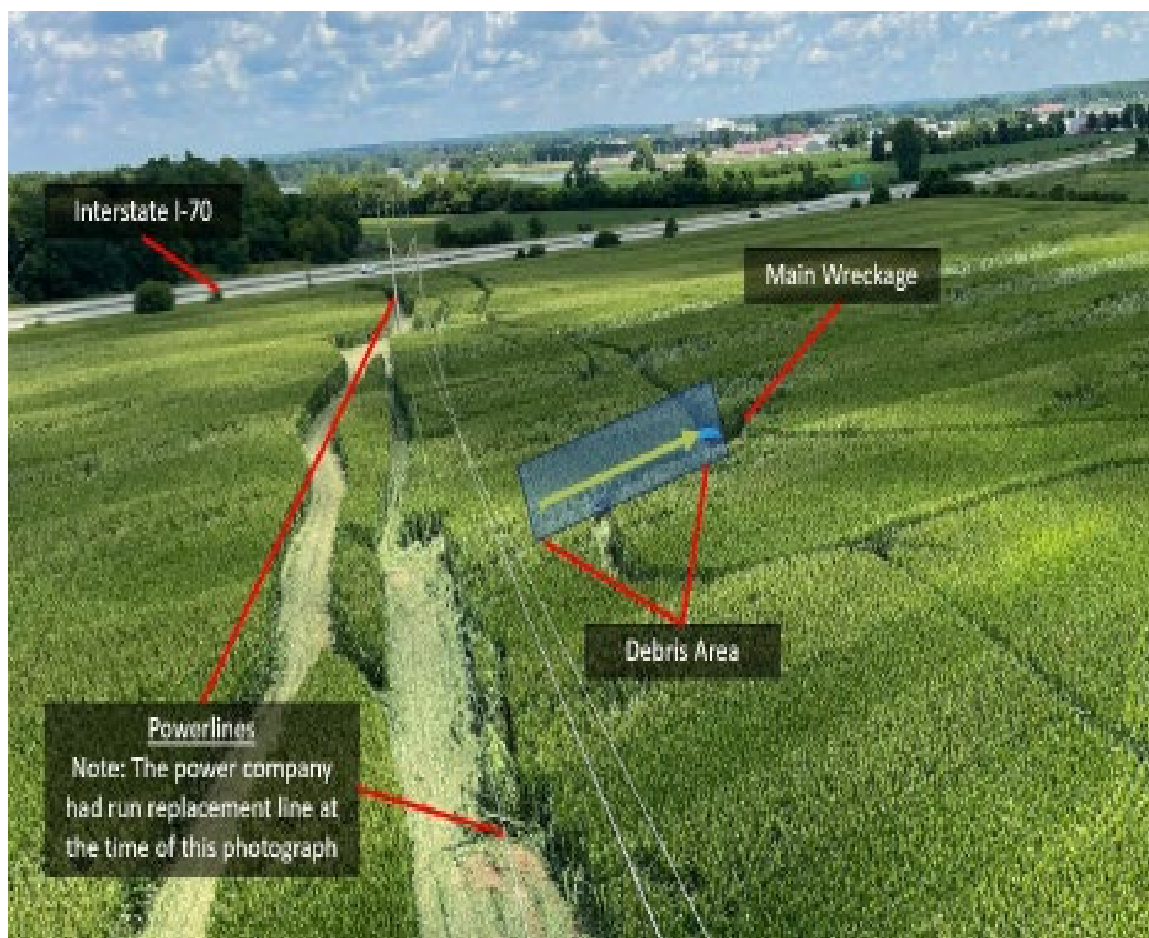
High tension power lines spanned the length of the corn field being overflown. The four lines ran across the field toward the northeast oriented on a heading of 030 degrees. The middle two high tension lines had been severed. The end of the separated lines exhibited splayed ends, fraying, and cuts. The top line, which was a guy wire, and the bottom high tension line, were undamaged and remained running across the field. One power line structure holding the lines was also damaged, and its top area had fallen to the ground. The two middle lines were estimated to be about 75-100 ft above ground level.

The helicopter came to rest on its right side oriented on a heading of about 360 degrees. The tail boom had separated near the aft portion of the fuselage and was found forward of the main wreckage. The main wreckage was located about 150 ft east of the powerlines. Debris was located along a flight path of about 090 degrees.
