# National Transportation Safety Board

ERA23FA352

Group Chair's Factual Report

Location: Pompano Beach, Florida  
Date: August 28, 2023  
Time: 0844 eastern daylight time  
Helicopter: Airbus Helicopters Deutschland EC135 T1, registration N109BC

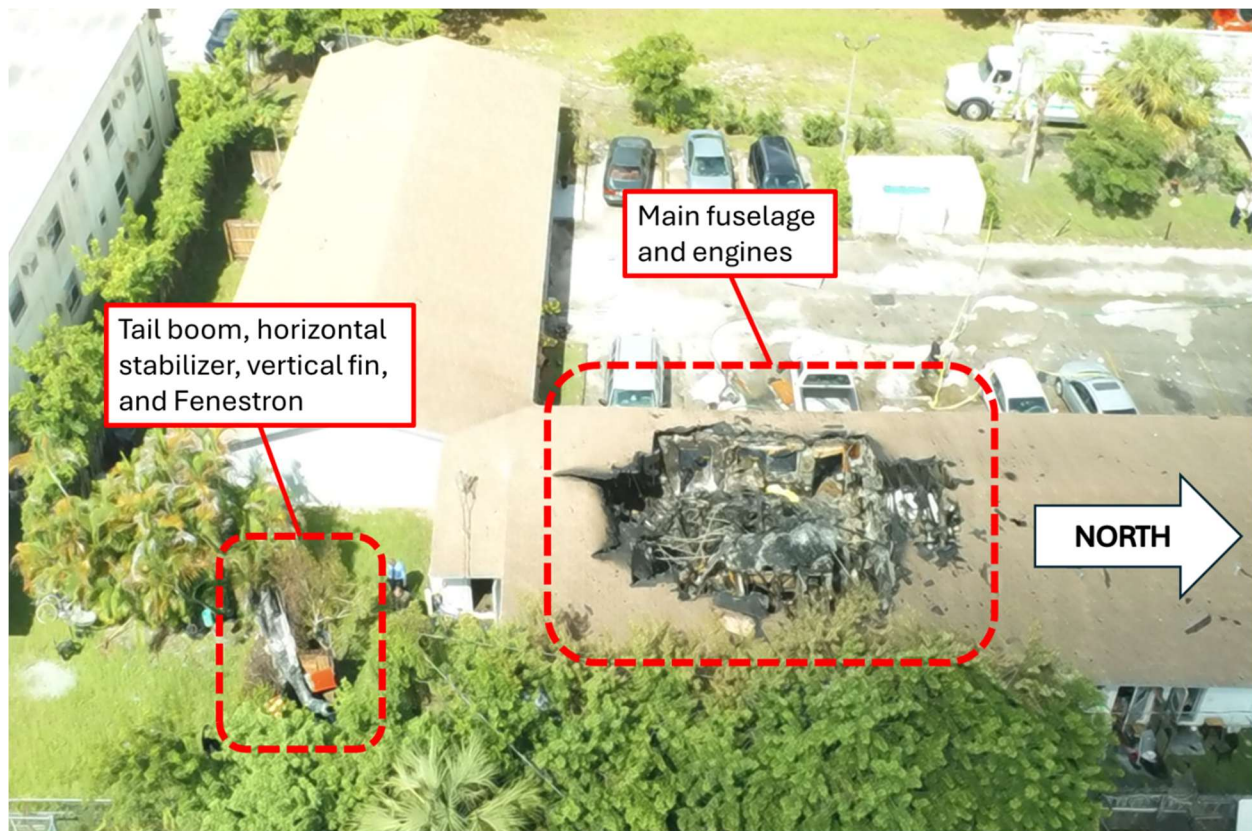
The main fuselage was located about 26°14'24.67"N by 80° 7'19.92"W at a heading of about 200° magnetic, approximately ¼ mile southwest of Pompano Beach Airpark (KPMP) Runway 6 in Pompano Beach, FL (**Figure 7**). The main fuselage of the helicopter came to rest on its left side within a one-story apartment building. A postcrash fire consumed the majority of the main fuselage. Building materials were intermixed with the main wreckage.

**Figure 7.** The accident site showing where the main fuselage, engines, and the tail boom wreckage were found. (Image courtesy of BSO and modified by the NTSB)

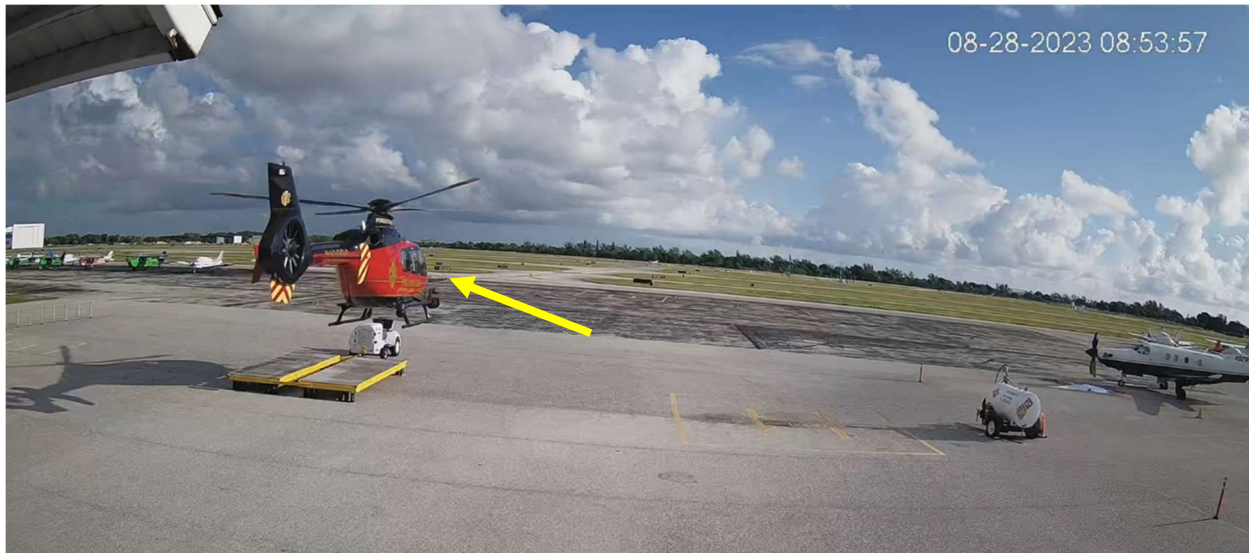
**Figure 26.** A still image from the surveillance video of the operator's hangar at KPMP showing the accident helicopter (yellow arrow) after liftoff from the dolly. (Video courtesy of BSO, still image captured and modified by the NTSB)

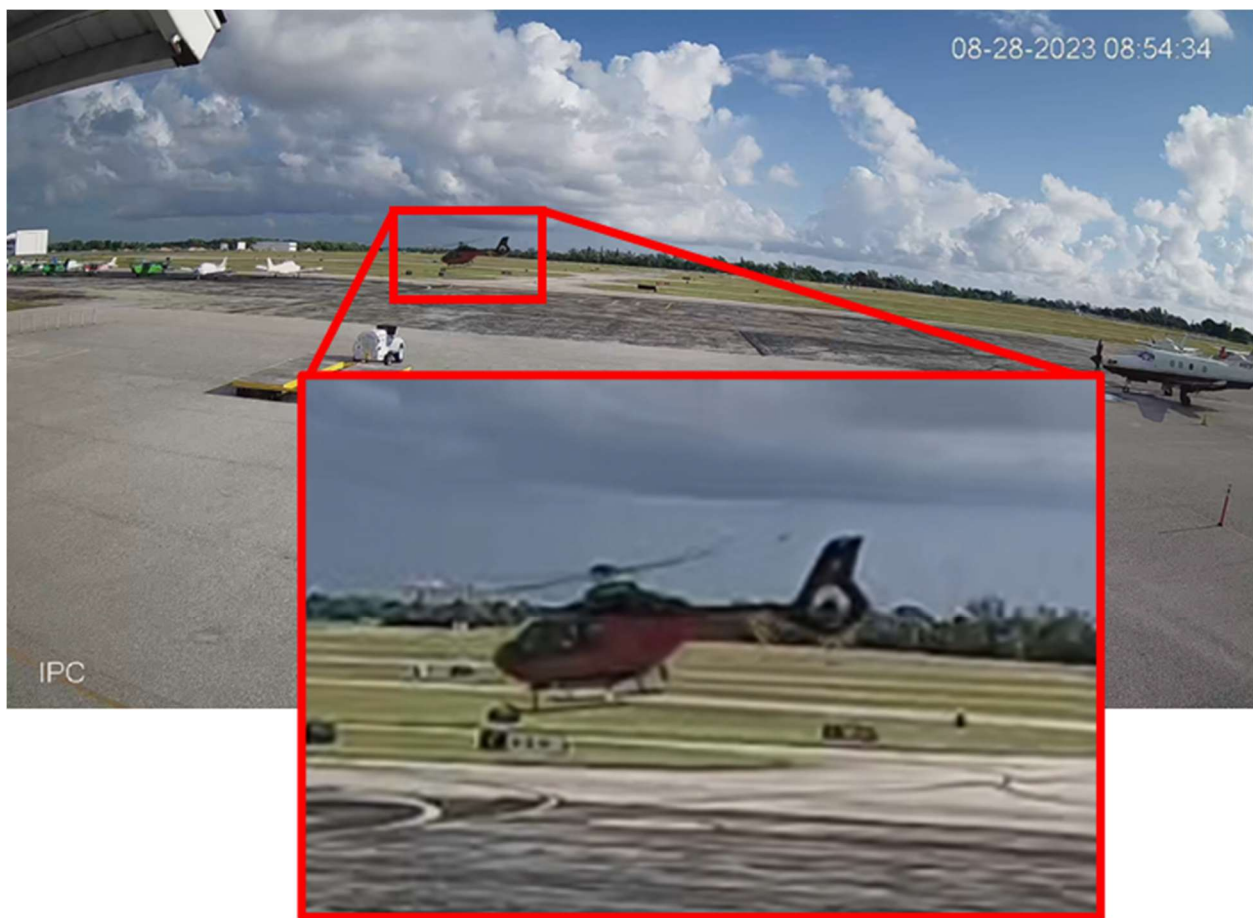
A surveillance video of the operator's hangar at KPMP showed the accident helicopter was on a dolly when the operator received a call for an air medical flight (the accident flight). **Table 2** shows notable observations and their timestamps based on a review of the ramp surveillance video. A tractor towed the helicopter and dolly to the ramp. Another surveillance video of the ramp in front of the operator's hangar showed the helicopter's start up and departure (**Figure 26**). No flames or smoke was visible in the surveillance video showing the helicopter's departure from KPMP (**Figure 27**).

**Figure 27.** A still image from the surveillance video of the operator's hangar at KPMP showing the departure of the accident helicopter. (Video courtesy of BSO, still image captured and modified by the NTSB)

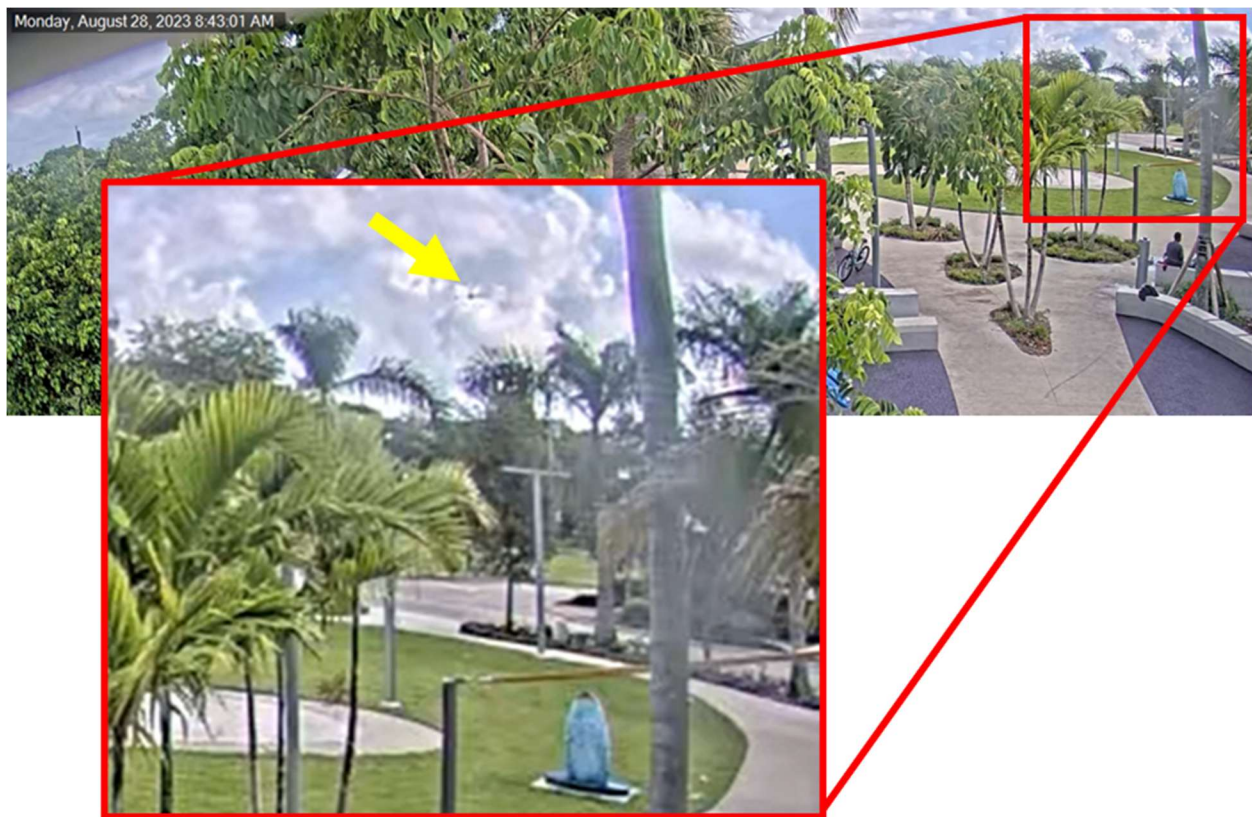
A north-facing ground surveillance video from a camera located at the southwest corner of Annie Adderly Gillis Park in Pompano Beach, FL showed the helicopter after its departure from KPMP. The helicopter remains in view from the start of the video to about 17 seconds into the video, with no discernable smoke trail (**Figure 28**). The tree in the vicinity of this camera obscures the helicopter after 17 seconds. About 23 seconds later (40 seconds into the video), the helicopter becomes visible again and showed a light-colored line behind it. The light-colored line could be interpreted as a smoke trail (**Figure 29**). The helicopter exits the video frame 8 seconds later (48 seconds into the video). Based on the location of the surveillance camera and the field of view, the Airworthiness Group estimated these 8 seconds when the light-colored line was present was between 8:43:38 to 8:43:46 eastern daylight time (**Appendix A, Figure A-2**).

**Figure 28.** A still image from the ground surveillance video from Annie Adderly Gillis Park that shows the helicopter with no discernable smoke trail behind the helicopter (yellow arrow). (Video courtesy of BSO, still image captured and modified by the NTSB)

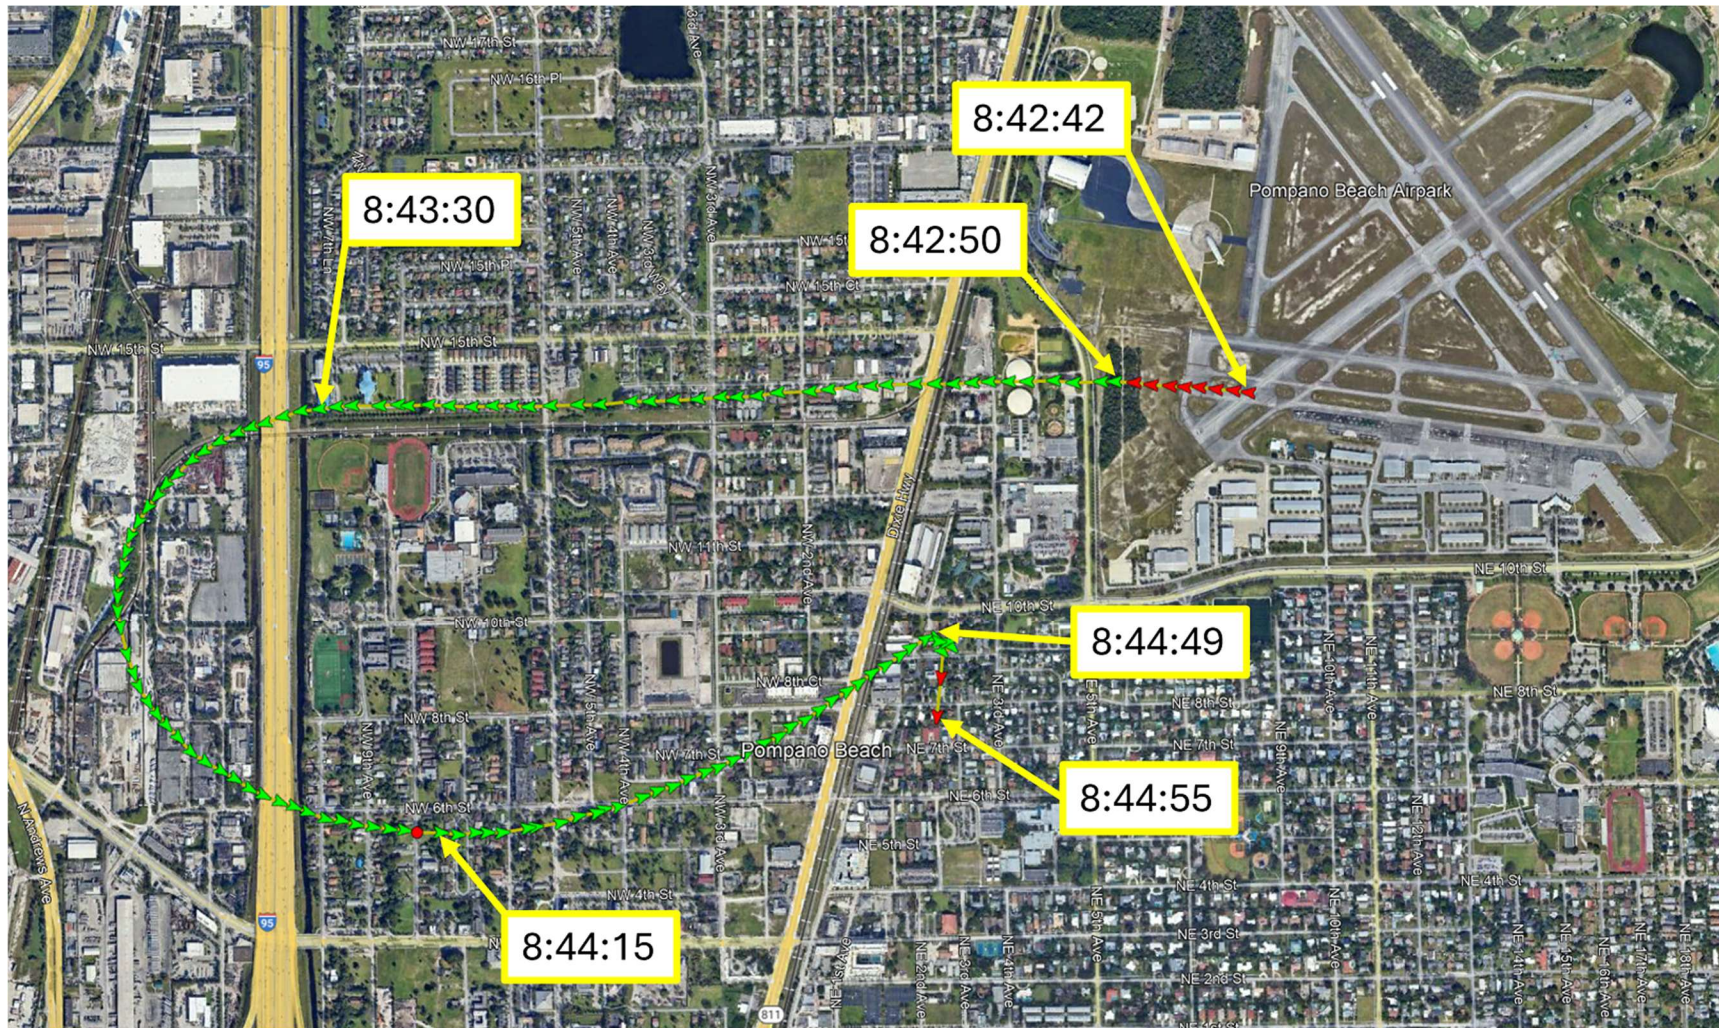
**Figure A-1.** The ADS-B data for the accident flight with notable datapoints marked with timestamps. The red-colored ADS-B data points signify those that are flagged for an “integrity/accuracy failure.”

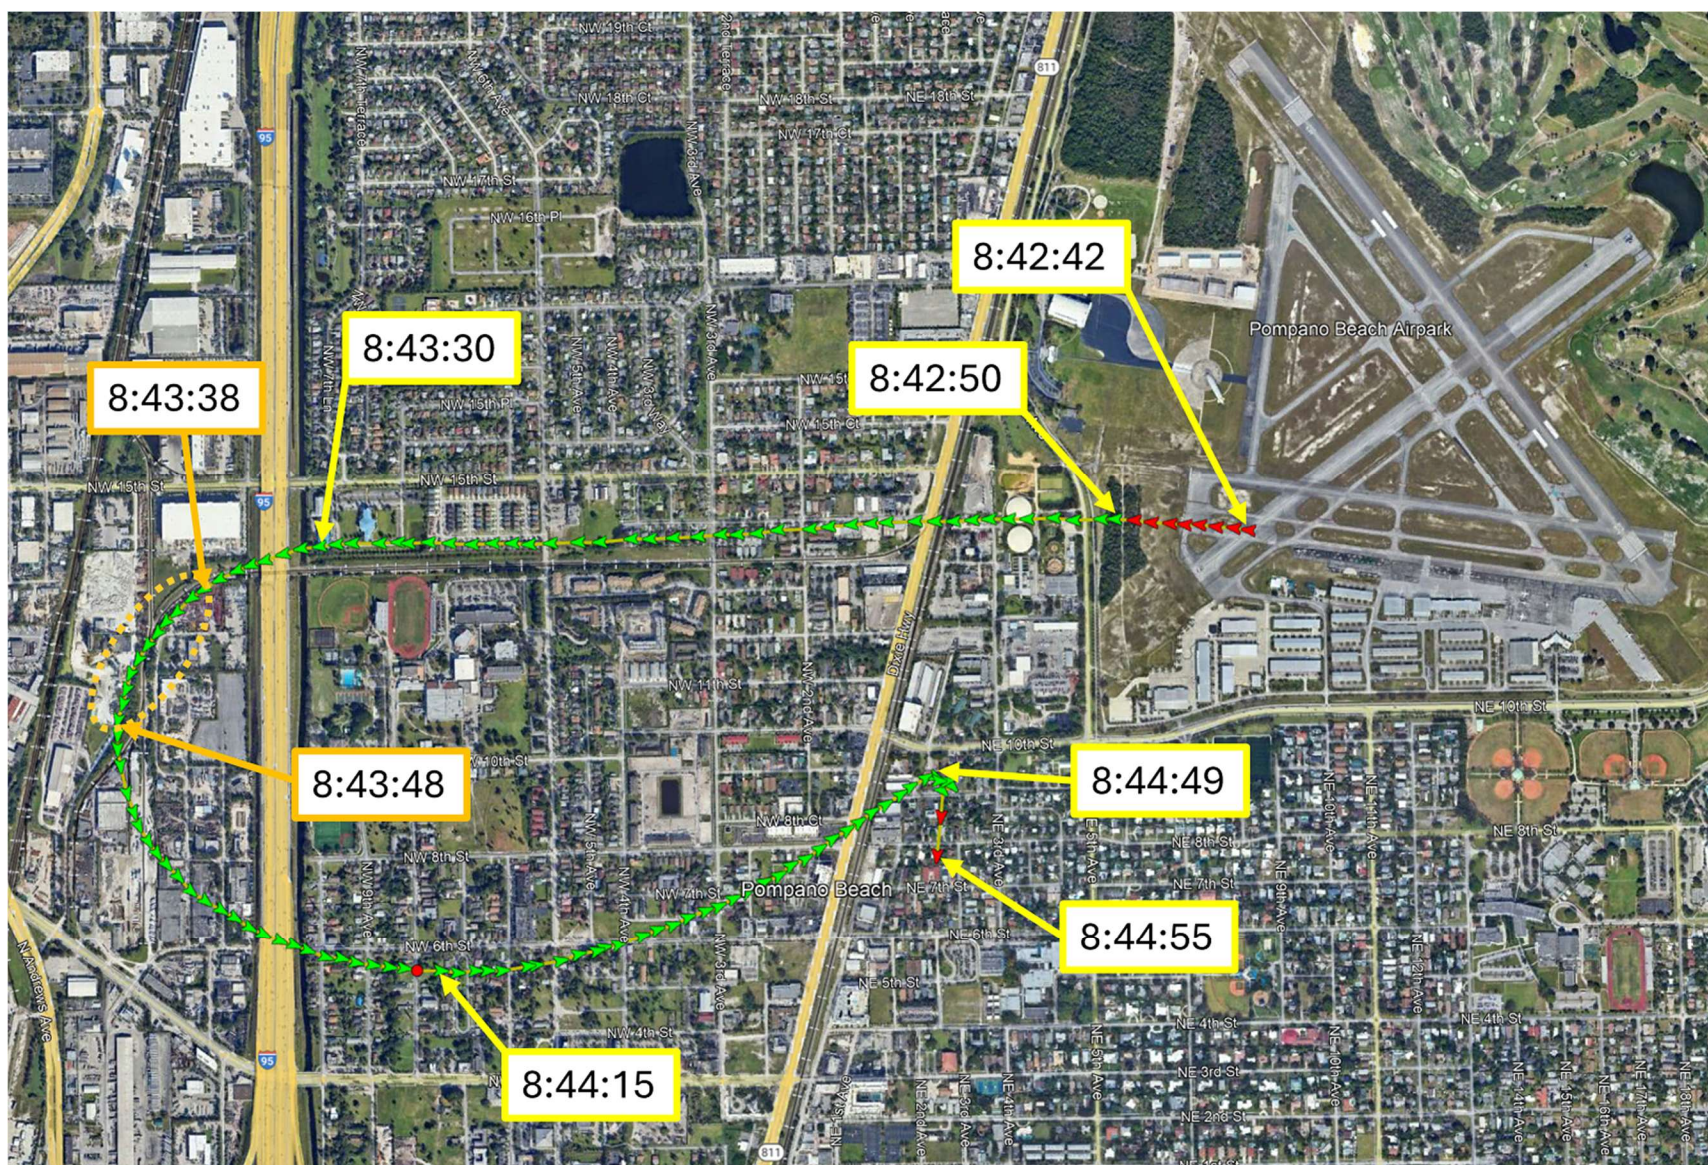
**Figure A-2.** The orange dashed oval (left side of the figure) and timestamps showing the ground witness and surveillance videos showing signs of smoke emanating from the accident helicopter.
