ERA23FA352

BEA Technical Document No. 2023-0379\_tech04

**ECU #1 examination**

Accident on **28th August 2023**  
near **Pompano Beach (United States)**  
to the **helicopter EUROCOPTER > EC135 > T1**  
registered **N109BC**

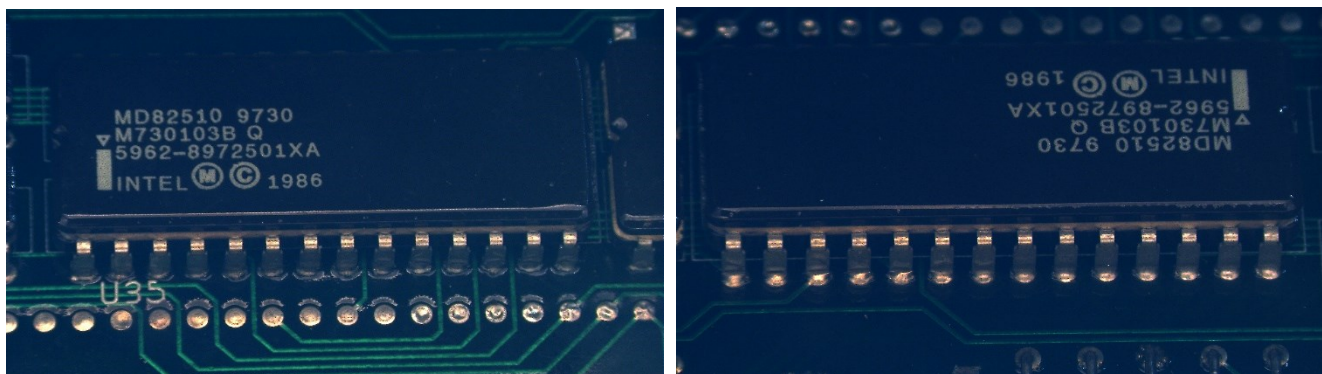
#### 2.1.2. Component U35

The components mentioned in Triumph **EMC-35B EECU Potential Failure Modes.pdf** were examined more closely.

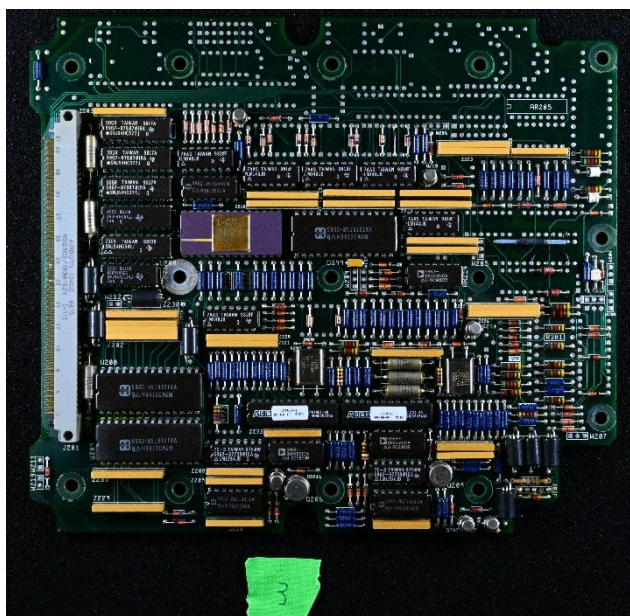
Figure 5 : Board 3 top side

No discrepancy was found on the board itself or its surface components.
