# National Transportation Safety Board

ERA23FA352

## **POWERPLANTS**

Group Chair's Factual Report

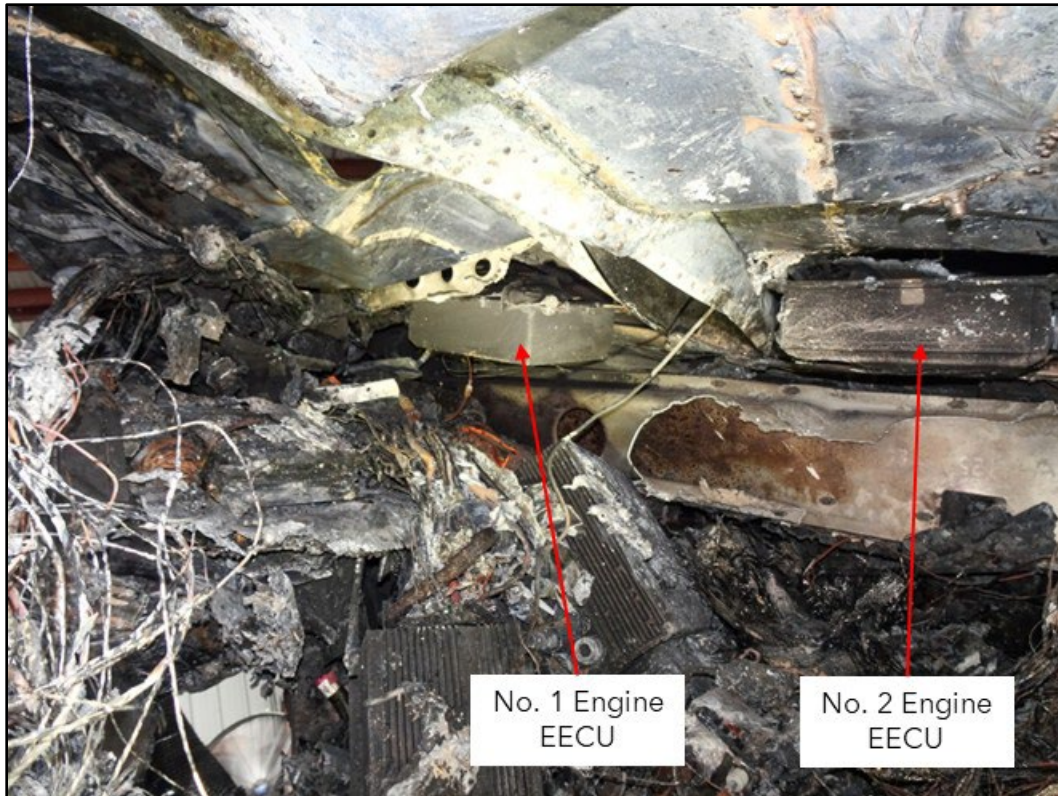
**Figure 6.** View of EECUs in Aft Compartment

The No. 1 engine EECU and the No. 2 engine EECUs were found within the avionics compartment of the helicopter, both exhibited thermal damage and were discolored with soot (Figure 6). The No. 2 EECU housing was not intact and partially consumed, making internal components visible with the edges of the hole in the housing bent inward. The data plate for the No. 1 EECU showed part number (P/N) 70EMF01290 and serial number (S/N) 8ALD0295CE, and the data plate for the No. 2 EECU showed P/N 70EMF01290 and S/N 8ALD0258CE.

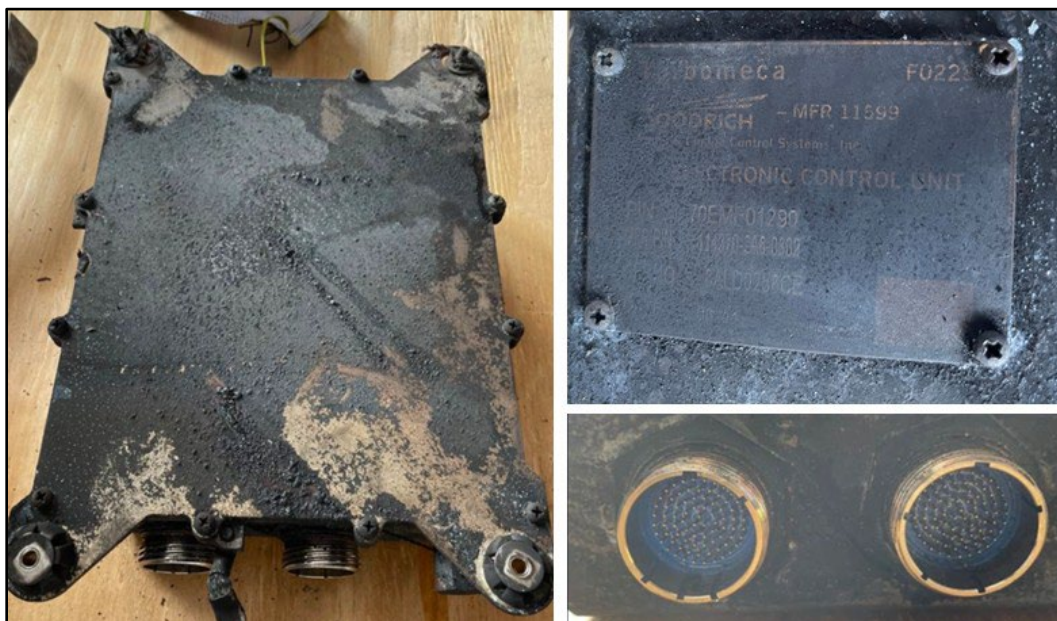
**Figure 7.** No. 1 Engine EECU - Removed

The EECUs were retained for further examination (Figure 7 and Figure 8).

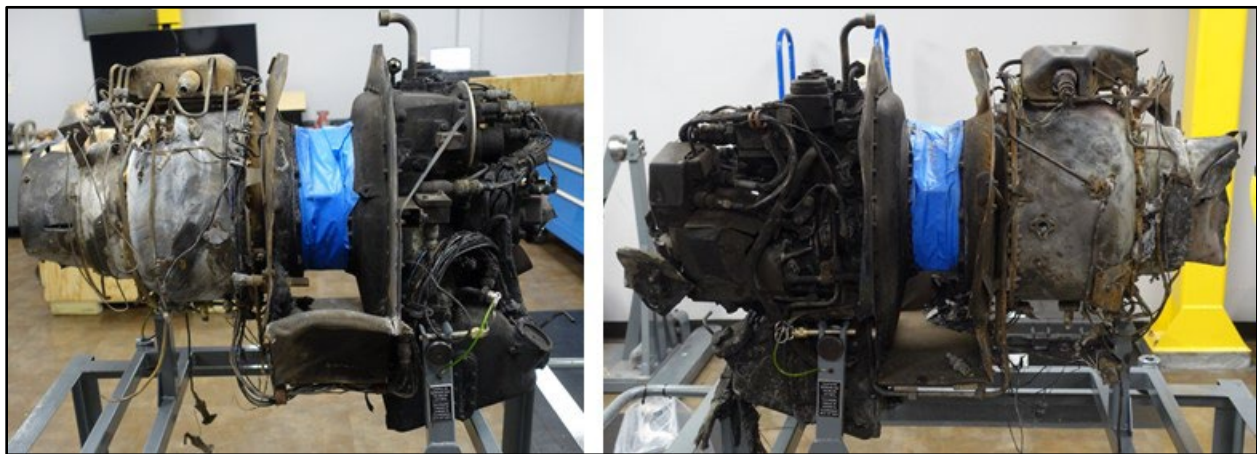
**Figure 10.** ESN 30175 As Received - Left Side (L) Right Side (R)

The No. 1 and No. 2 engines and engine logbooks were secured in a wood shipping crate in the Safran Helicopter Engines Training Center when the investigation team arrived (Figure 9). The No. 1 engine bottom mounting bracket was not shipped with the engine, so the No. 2 engine bottom bracket was removed and installed on the No. 1 engine to facilitate installation in a work stand (Figure 10). The ESN on the engine data plate was verified as 30175 (Figure 11).

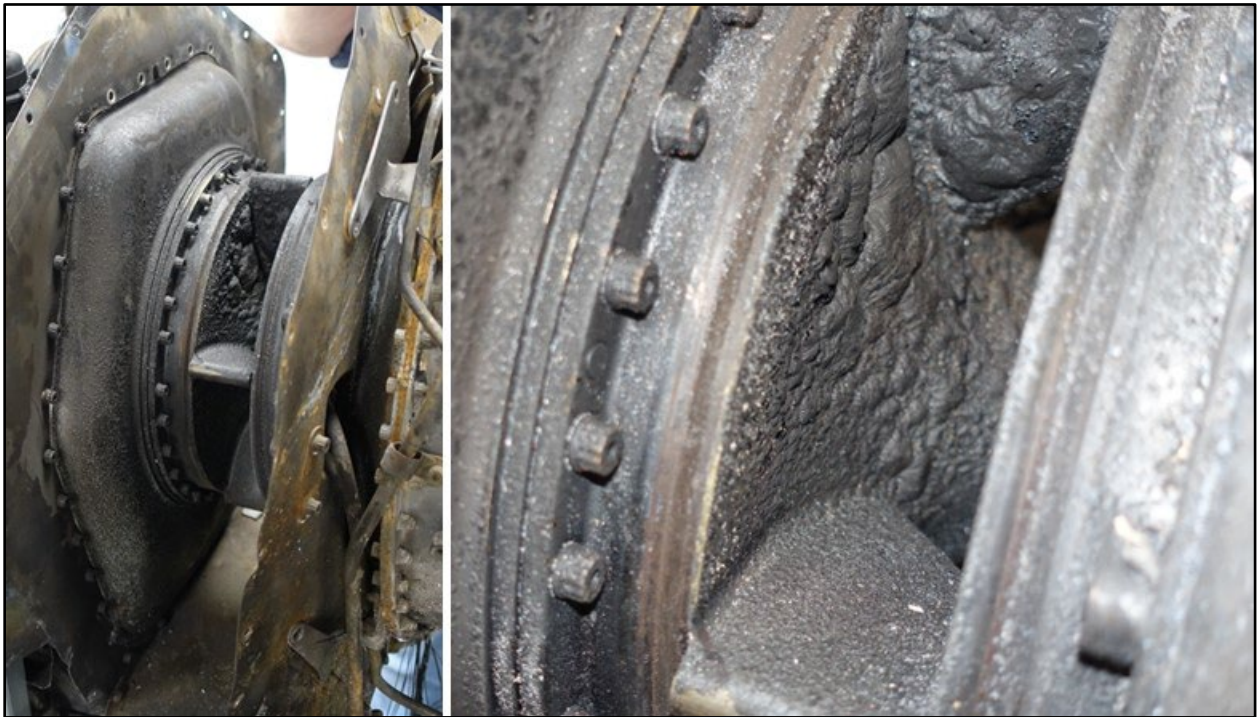
All external engine surfaces were sooted/discolored. Multiple engine wire harnesses exhibited thermal damage and were charred and brittle. The engine inlet was coated with a dark residue that was bubbled from the 9:00 to 6:00 o'clock positions (upper right quadrant, ALF) (Figure 12). Samples of the dark residue on the inlets were collected for analysis at SafranHE and the inlet case was retained for shipment to the NTSB Materials Laboratory in Washington, DC for analysis. The aft intake firewall had 360-degree deformation. Resolidified metal slag was adhered to external lines/wires on the turbine case at the 9:00 o'clock position<sup>4</sup>.

**Figure 12.** Engine Inlet Residue

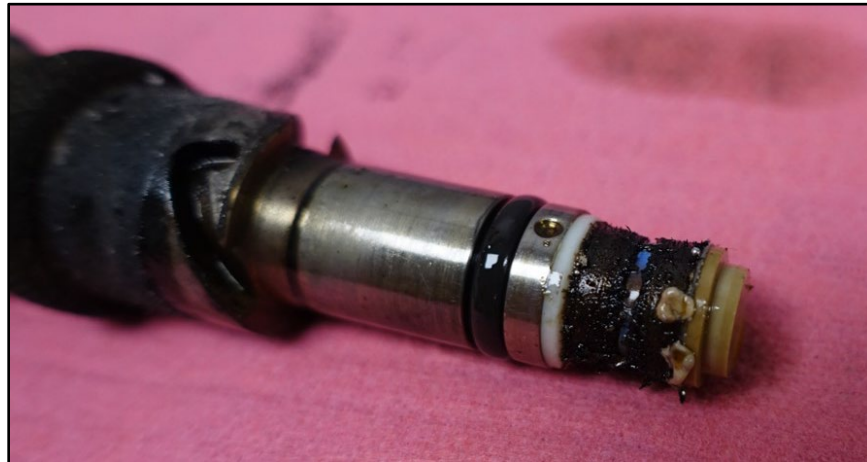
Residue was adhered to the oil filter housing on the accessory gearbox (AGB), and a sample collected for analysis at SafranHE. The fuel filter was dry, and no debris/obstructions were visible between the filter pleats. There was residual oil in the oil filter and no debris/obstructions were visible (Figure 15). The M01 electrical magnetic chip detector (MCD) plug had fine magnetic debris accumulated on the magnet that appeared to bridge the gap<sup>5</sup> (Figure 16). A sample of the chip detector

**Figure 16.** AGB Magnetic Chip Detector Plug Debris

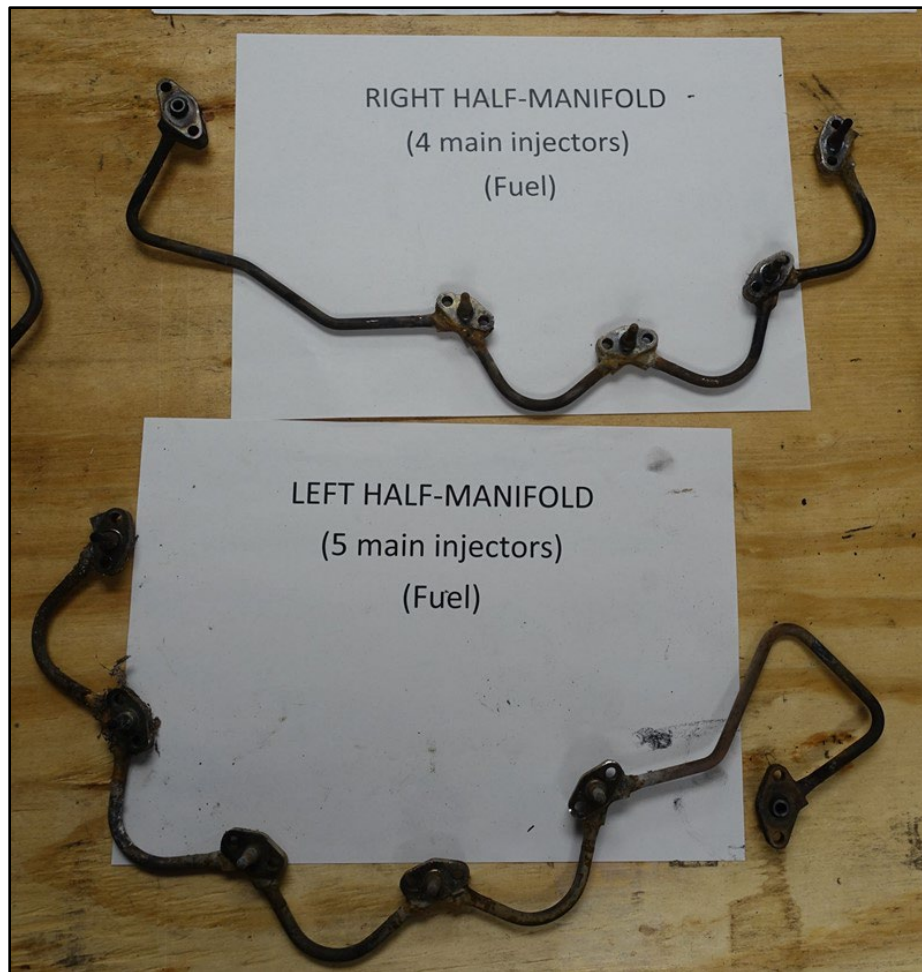
The combustion chamber was intact with no evidence of burn through or uneven wear, and the flame tubes and pre-vaporization tubes appeared undamaged (Figure 20). Black spots were observed under the fuel pre-vaporization tubes in the combustor that were typical for service run engines according to SafranHE. A small amount of fine ash like debris was present in the chamber. The left and right main fuel manifold injectors and the preference injector were intact with dark black discoloration on multiple injector tips (Figure 21).

**Figure 21.** Fuel Injector Manifolds

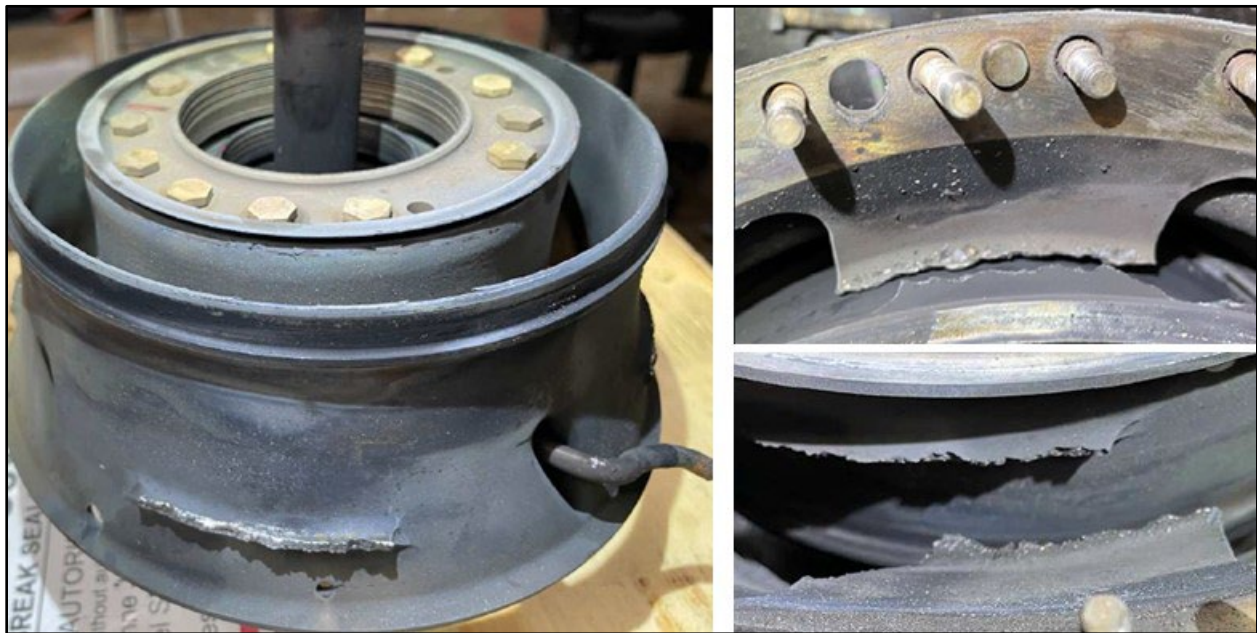
The inner support struts located at the 6:00 and 9:00 o'clock positions of the rear bearing support were fractured near the fillet between the strut and the inner ring (Figure 32). The oil supply tube and the oil scavenge tube, located within the 12:00 and 6:00 o'clock struts respectively, were visually undamaged. All four of the outer flange struts of the rear bearing support struts were found fractured (Figure 33) from the outlet diffuser case.

**Figure 33.** Rear Bearing Support - Aft Side

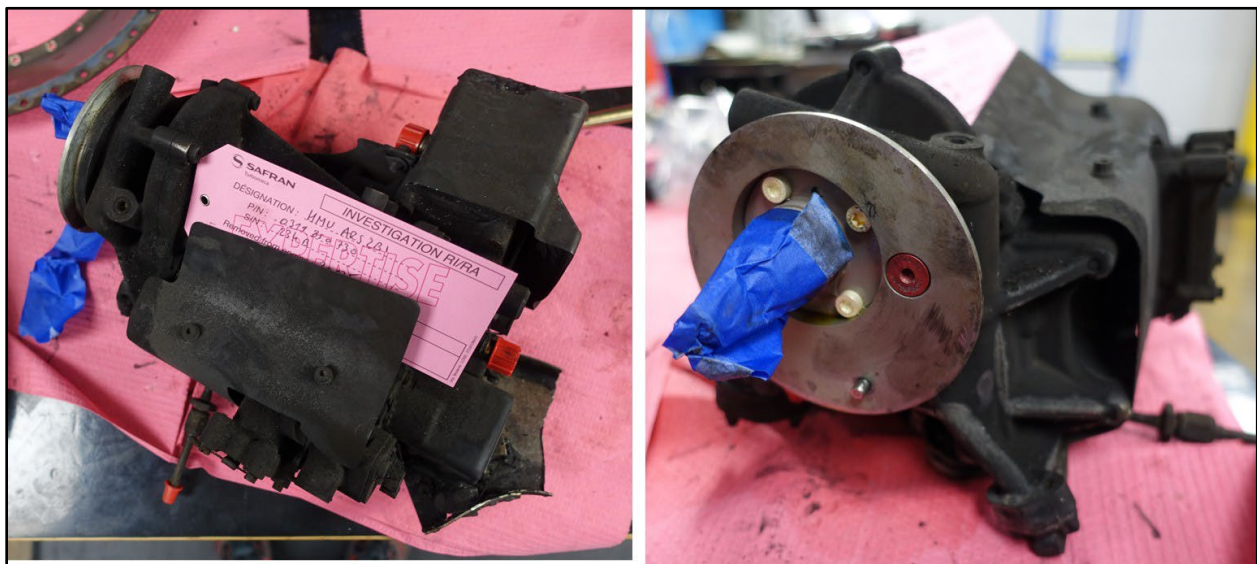
**Figure 34.** No. 1 Engine HMU

The No. 1 engine HMU was darkly discolored and covered in soot residue but otherwise appeared intact (Figure 34). The input drive spline could be rotated smoothly by hand. The HMU was retained for future bench testing and examination. See Section E Paragraph 1 for further details.

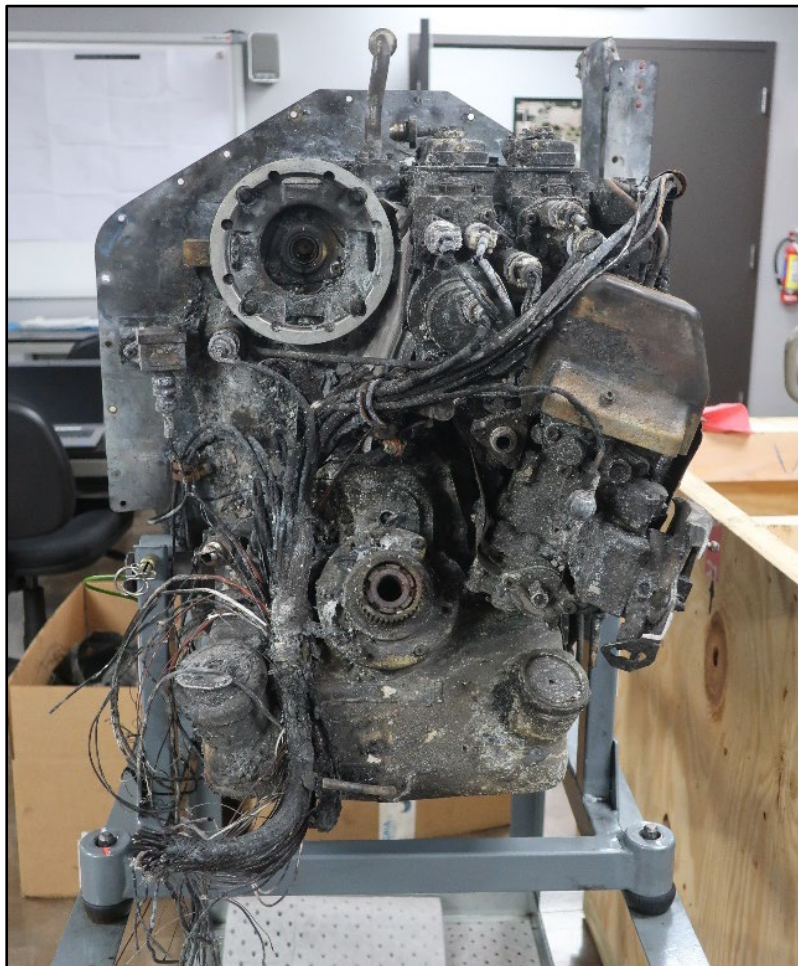
All external engine surfaces were sooted/discolored (Figure 35). Multiple engine wire harnesses exhibited thermal damage and were charred and brittle (Figure 36). The ESN on the engine data plate was verified as 30182 (Figure 37).

**Figure 36.** ESN 30182 As Received - Front/Gearbox Side

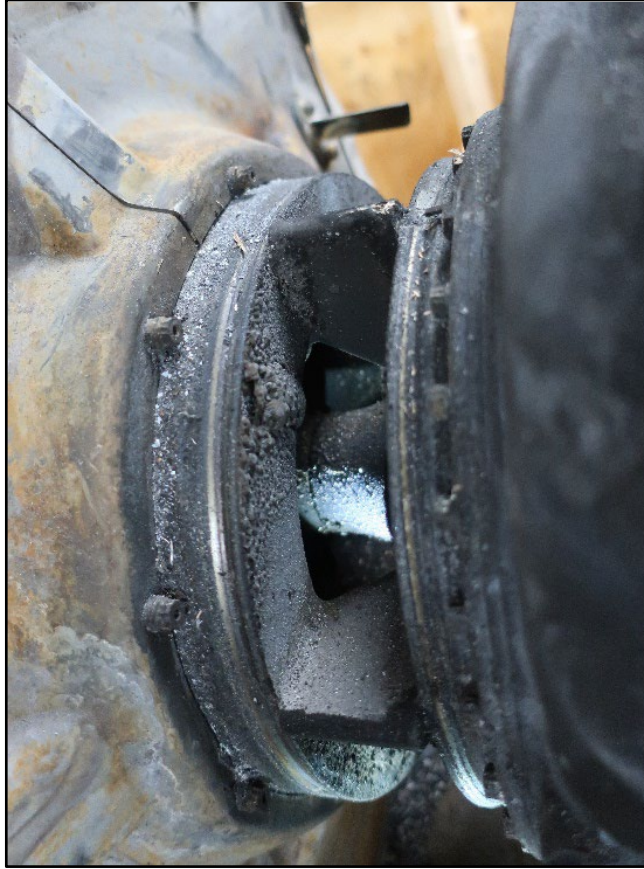
The engine inlet was coated with a dark residue that was bubbled from the 11:00 to 5:00 o'clock positions (upper right quadrant, ALF) (Figure 38). A residue sample was collected for analysis at SafranHE and the inlet case was retained for shipment to the NTSB Materials Laboratory in Washington, DC for analysis.

**Figure 38.** Engine Inlet Residue

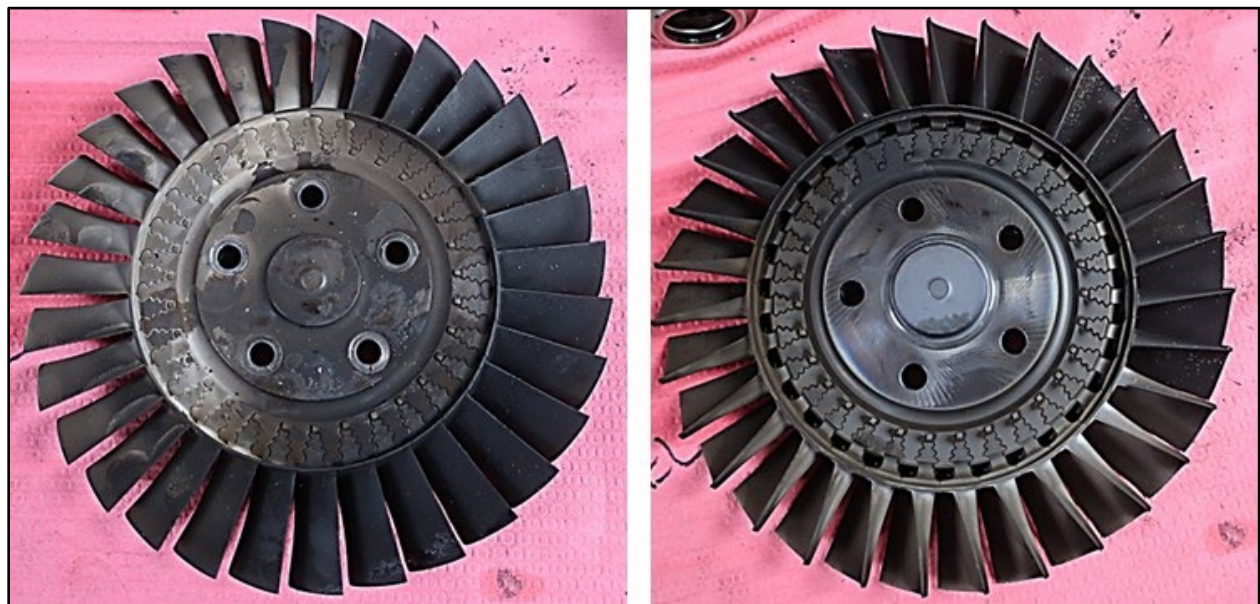
**Figure 51.** PT Disk/Blades - Trailing Edge Side (L), Leading Edge Side (R)

All PT disk blades were intact and complete with no evidence of damage (Figure 50 and Figure 51). The PT inner shroud was removed, revealing static blade contact marks resulting from the radial sliding action and contact between the PT disk blade tips and the PT inner shroud (Figure 50). With the removal of the PT inner shroud, the PT disk freely rotated with corresponding rotation of the power drive shaft through the reduction gearbox.

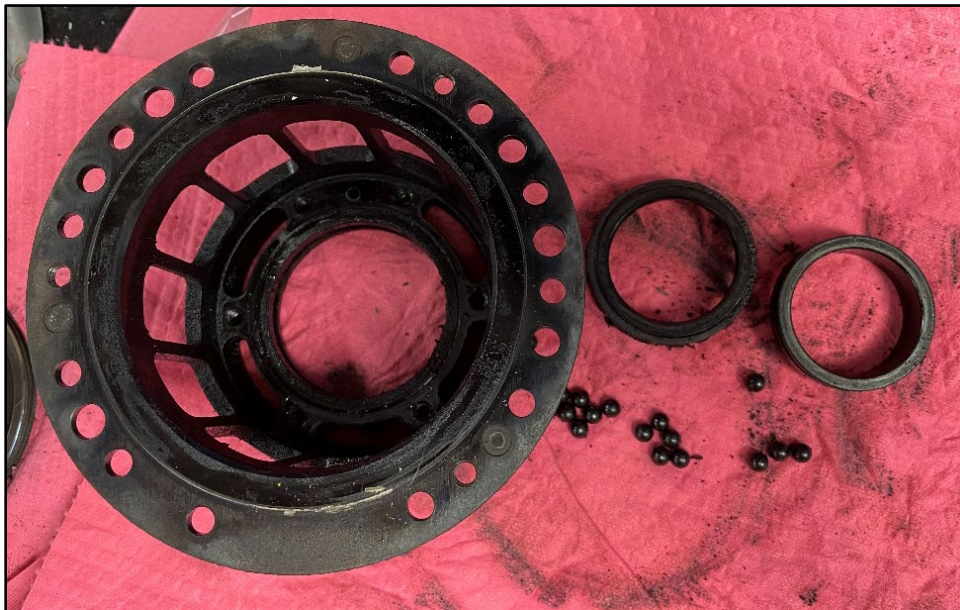
**Figure 53.** PT Thrust Bearing

The PT thrust bearing appeared oil wetted and discolored with coking. The bearing elements came out of the bearing cage upon removal of the bearing, but otherwise there was no evidence of damage (Figure 53).

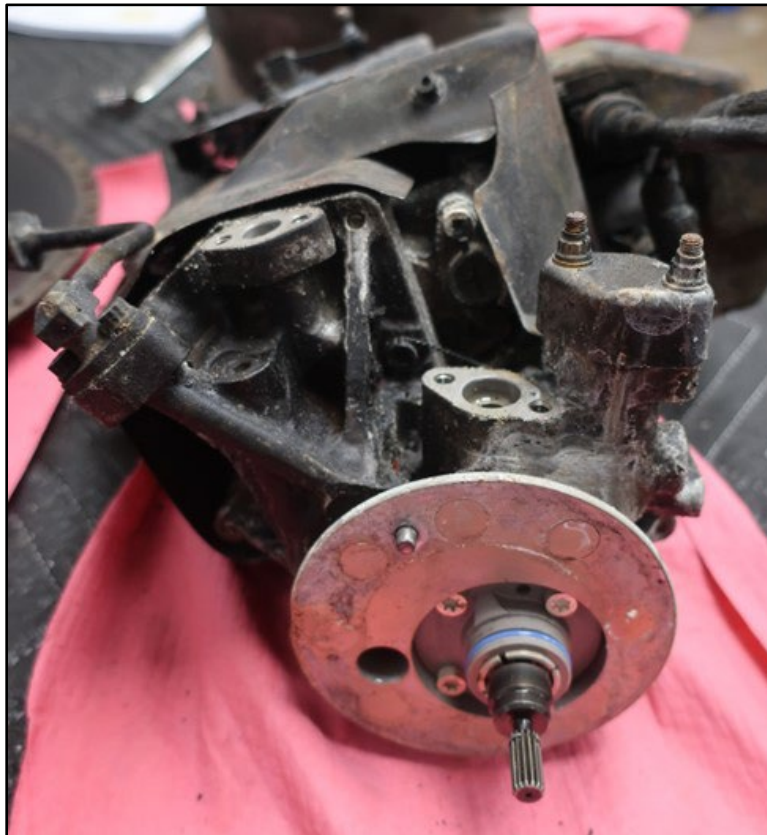
**Figure 54.** No. 2 HMU

The No. 2 engine HMU had dark discoloration and was covered in soot residue. The HMU case appeared to be intact (Figure 54). The input drive spline could be rotated smoothly by hand. The HMU was retained for further disassembly at SafranHE. See Section E Paragraph 1 for further details.

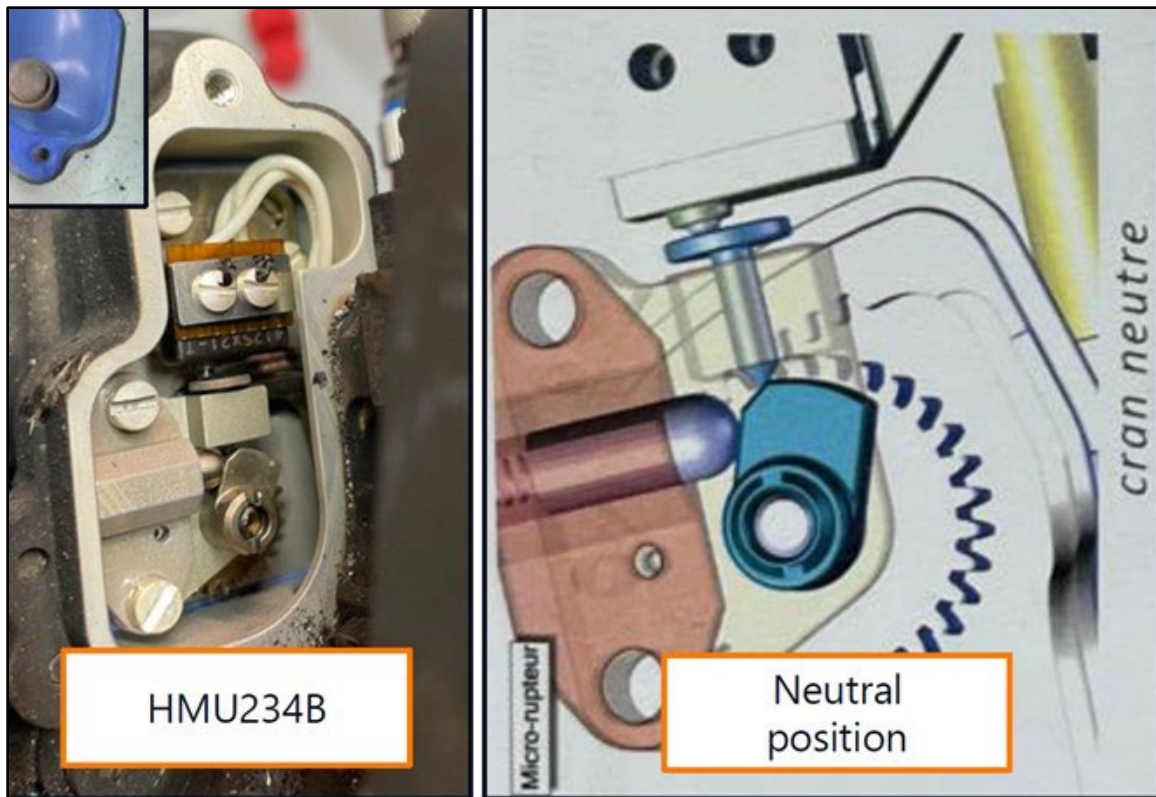
**Figure 57.** HMU Manual Mode Control Lever

The HMU was then disassembled for examination of the internal components. The manual mode control lever was located in the neutral position, the microswitch position was consistent with that of the manual mode control lever position, and the load limiter was also in the neutral position (Figure 57). The disk connected to the manual control lever was found slightly rotated but not enough for the control lever to be out of the neutral position, consistent with the deformed manual mode control lever and likely a result of the disassembly process to access the load limiter (Figure 58). The microswitch housing cover membrane appeared dry but otherwise undamaged.

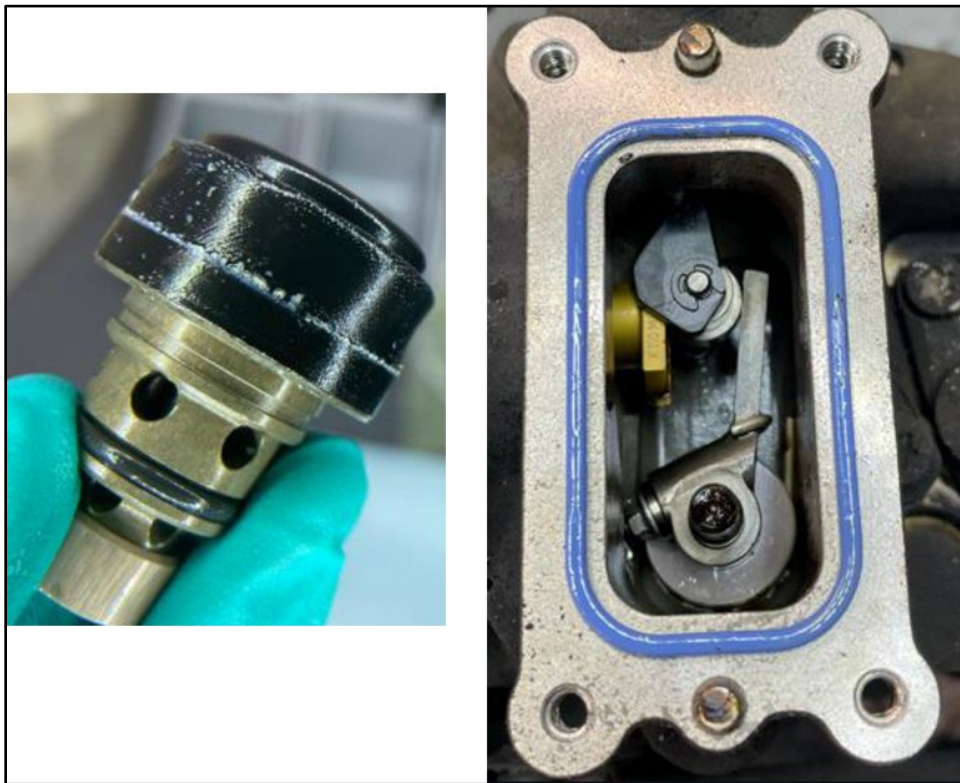
**Figure 59.** A-P membrane (L), P3 Housing Seal (R)

The pressure differential ( $\Delta$ -P) membrane was shiny but undamaged, consistent with there being remnant fuel within the housing. The P3 housing seal appeared undamaged, and the housing smelled of fuel (Figure 59). The resistive torque of the high-pressure pump was tested, and measured 0.078 deca-Newton meters, which was

within SafranHE's ATP specification 0319948750 of less than 0.15 deca-Newton meters.

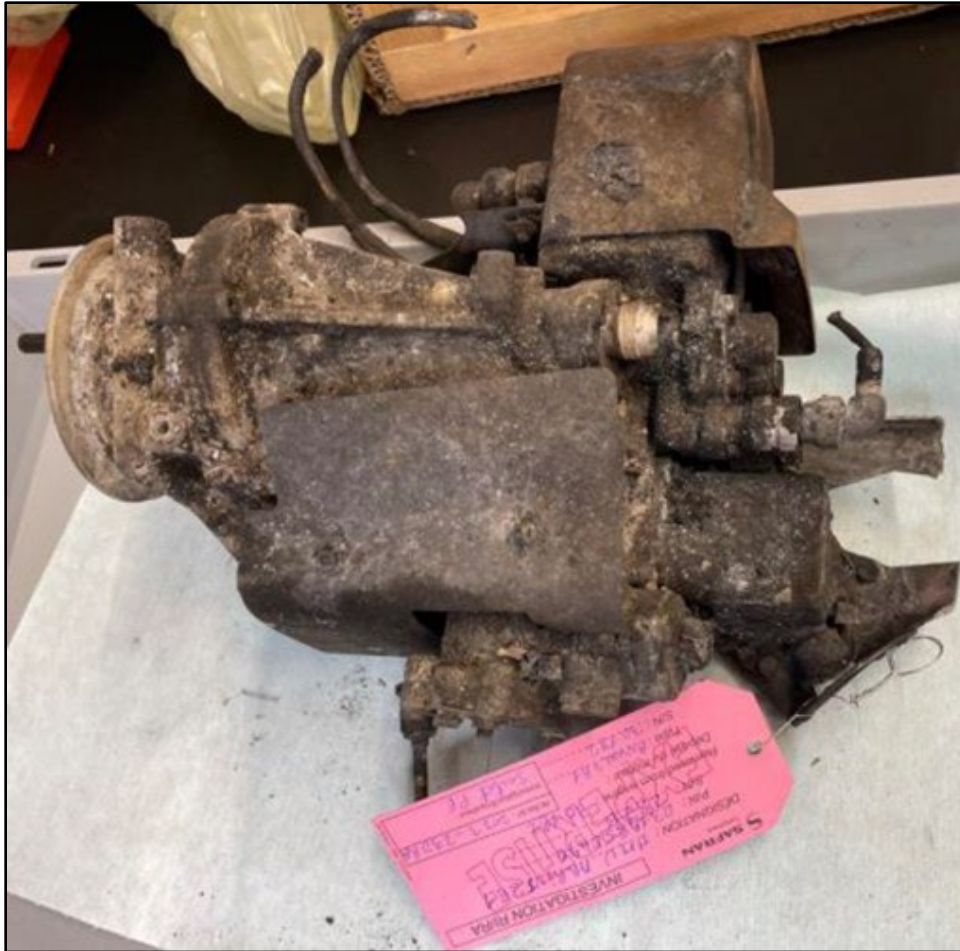
**Figure 60.** No. 2 Engine HMU - As Received

The as-received visual examination found the No. 2 engine HMU S/N 287B external surfaces to be covered in debris with an oily residue (Figure 60). The manual mode control lever was found in a position consistent with the neutral position. The o-ring seals, located on the fuel drain and the fuel pump input shaft, appeared undamaged.

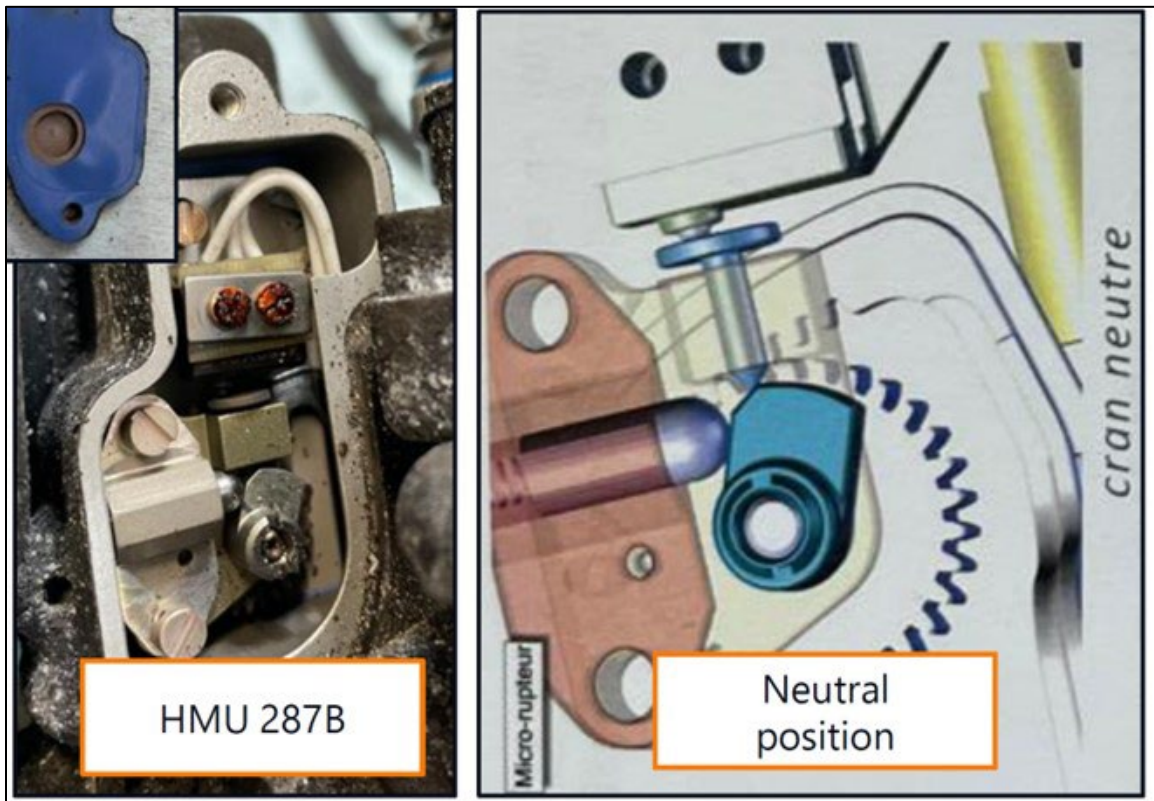
**Figure 62.** HMU Manual Mode Control Lever

The HMU was not bench tested but was disassembled for examination of the internal components. The manual mode control lever was found in the neutral position, the microswitch position was consistent with that of the manual mode control lever position, and the load limiter was clutched in the neutral position (Figure 62). The microswitch housing cover membrane appeared dry but otherwise undamaged (Figure 63).

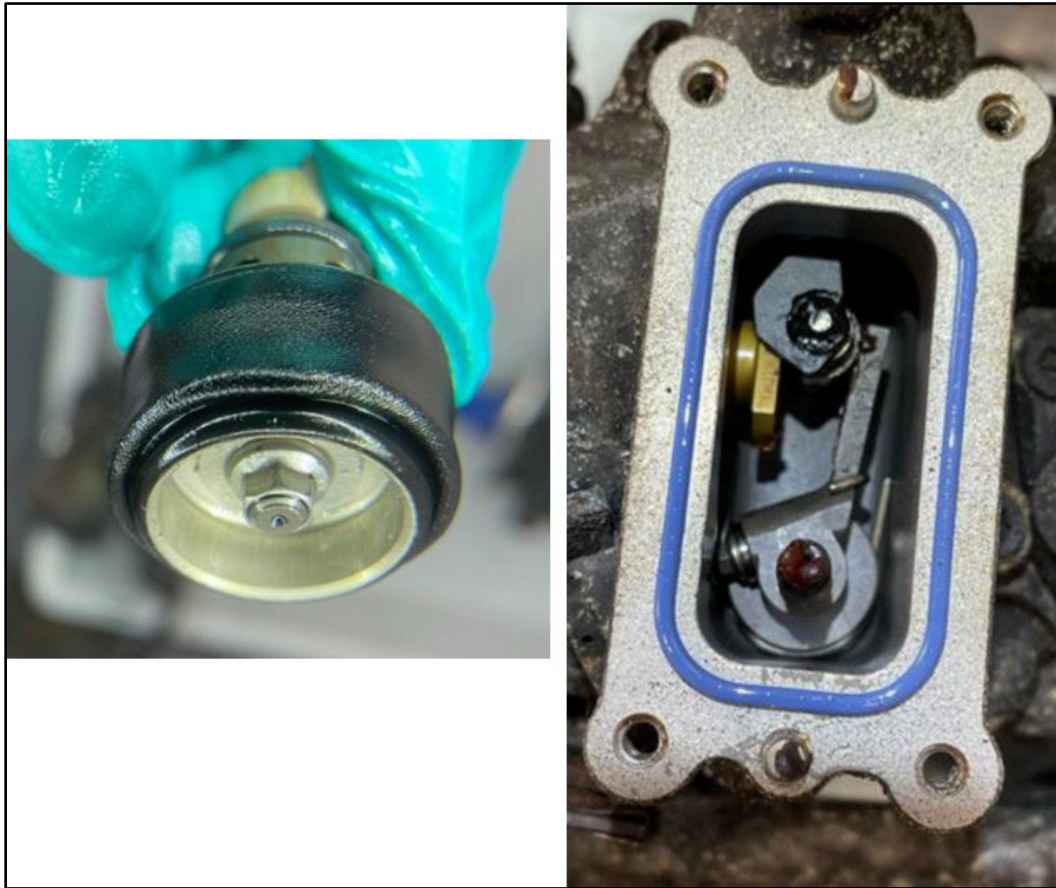
**Figure 64.**  $\Delta$ -P membrane (L), P3 Housing Seal (R)

The  $\Delta$ -P membrane was shiny but undamaged, consistent with there being remnant fuel within the housing. The P3 housing was found to be dry and the seal appeared undamaged (Figure 64). The resistive torque of the high-pressure pump was tested, and measured at 0.059 deca-Newton meters, which was within SafranHE's ATP specification 0319949570 of less than 0.15 deca-Newton meters.

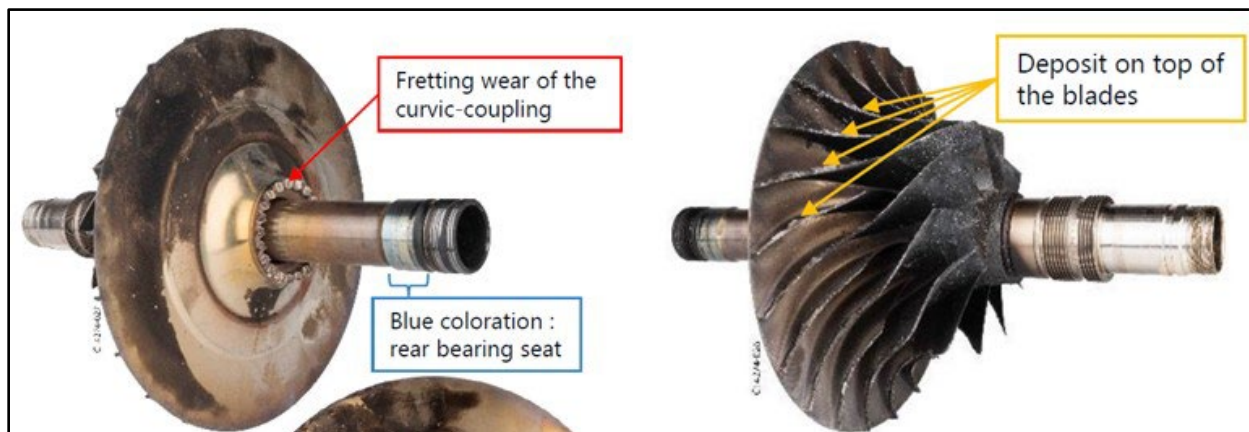
**Figure 74.** Impeller

The impeller, P/N 0319213400, contained areas of varying color discoloration: 1) a small area of blue-purple coloring on the backside of the impeller along the outer diameter (Figure 74), 2) an area of blue coloration on the rear bearing inner race, and 3) an area of yellow-blue discoloration next to the curvic coupling teeth. The aft curvic coupling teeth exhibited fretting wear and material deformation at all locations on the coupling teeth and around the whole circumference. The diameters of the 4 labyrinth seals on the front of the gas generator shaft were measured; the diameter values varied between 43.974 and 43.945 millimeters, and all were within the part drawing specification of 44.0 -0.5/+0 millimeters. The diameters of the 7 rear lips (rear and nearest the impeller) on the gas generator shaft were measured, the diameter values varied between 43.905 to 43.925 millimeters, which are within the part drawing specifications. The length (dimension denoted as W1 in CRM 24140) of the gas generator shaft was measured at 277.087 millimeters, which is within the part drawing specification of 277.5 -0.55/+0 millimeters. The length measurement performed by SafranHE on this part at the time of engine assembly was between 277.41 millimeters and 277.44 millimeters. Hardness measurements were made at various locations on the impeller in both the gas path and non-gas path for comparison. Hardness values varied between 470 HV<sup>13</sup><sub>30</sub> and 480 HV<sub>30</sub>. Material analysis of the impeller found the chemistry to be within the material specification. No metallurgical transformation or material abnormalities were observed during metallographic analysis of the impeller at various locations (Figure 75).

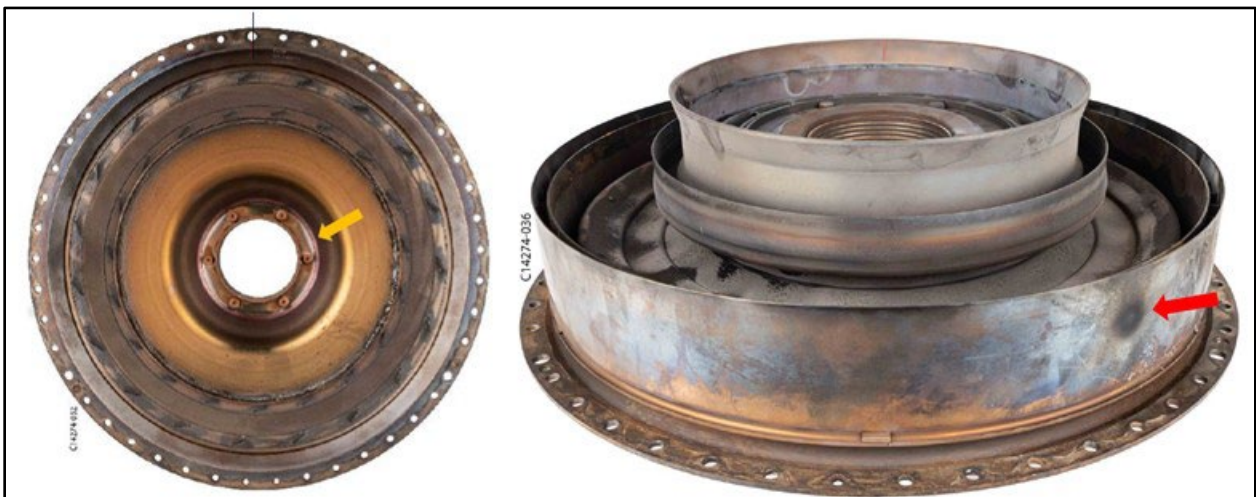
**Figure 76.** Compressor Diffuser  
(Figure Courtesy of SafranHE)

The centrifugal diffuser, P/N 0319210050, a martensitic stainless steel alloy, contained an area of pinkish discoloration around inner flange (Figure 76). Material analysis of the rear outer flange surface found the presence of a singular microstructure with fewer and smaller carbides with finer martensitic needles as compared to the nominal material specification. A black spot, approximately 15 millimeters in diameter, was present at the 5:00 o'clock position on the external ferrule surface, which corresponds to the location of the air tube that transmits compressor discharge pressure/air (P3 pressure) to the P3 sensor and HMU.

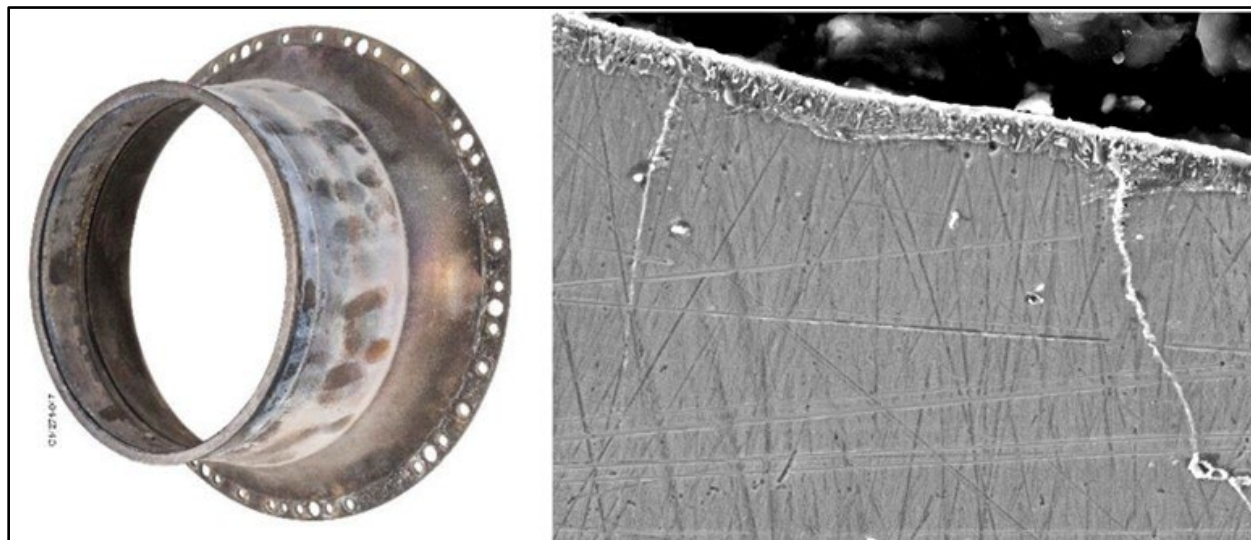
**Figure 77.** Gas Generator Turbine Shroud

Material analysis of the gas generator turbine shroud, a nickel-based alloy, found the presence of a singular microstructure with tangled eta phase needles (Figure 77).

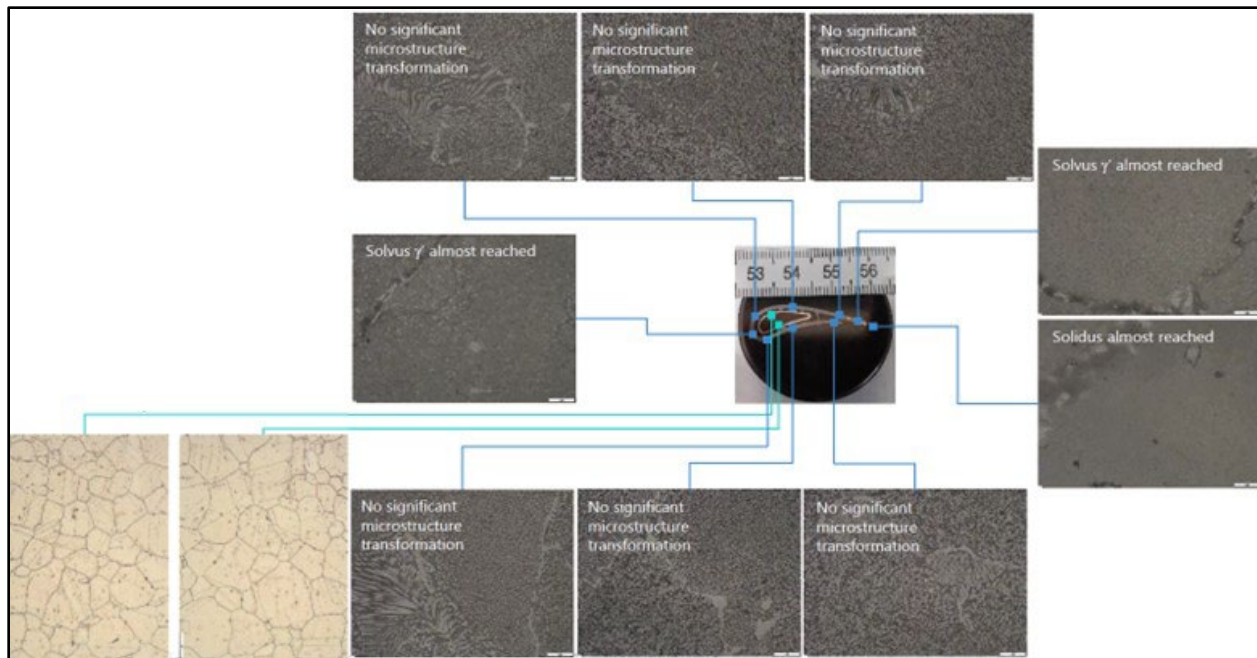
**Figure 79.** Gas Generator Turbine NGV Metallography - Vane at 6:00 O'clock  
(Figure Courtesy of SafranHE)

Examination of the gas generator turbine NGVs, P/N 0319217780, a nickel-based alloy, found the presence of multiple cracks on the inner air flow ring and all visible cooling holes and paths appeared free of obstruction. Multiple vanes exhibited both impact and thermal damage to the airfoil trailing edges. Axisymmetric circumferential rubbing of the labyrinth rings was observed. Two NGVs exhibited cracks at the inboard side of the airfoil leading edge. One of the two cracks was excised and opened for the purpose of performing fractography. The fractographic examination found a dark, oxidized and grainy fracture surface consistent with an interdendritic fracture morphology. Thermal and secondary damage was consistent with post cracking damage.

Metallurgical analysis was performed on the NGV airfoils, a nickel based alloy, at the 6:00 and 12:00 o'clock positions. The outer surface of the airfoils exhibited microstructural transformation to varying degrees but the largest transformation was observed at the trailing edge of the airfoils (Figure 78, Figure 79, and Figure 80). The inner walls of the airfoils exhibited dissolution of material precipitates within a band of approximately 5 to 10 micrometers in depth (Figure 81 and Figure 80). The microstructural transformation was due to an overheating/over temperature condition.

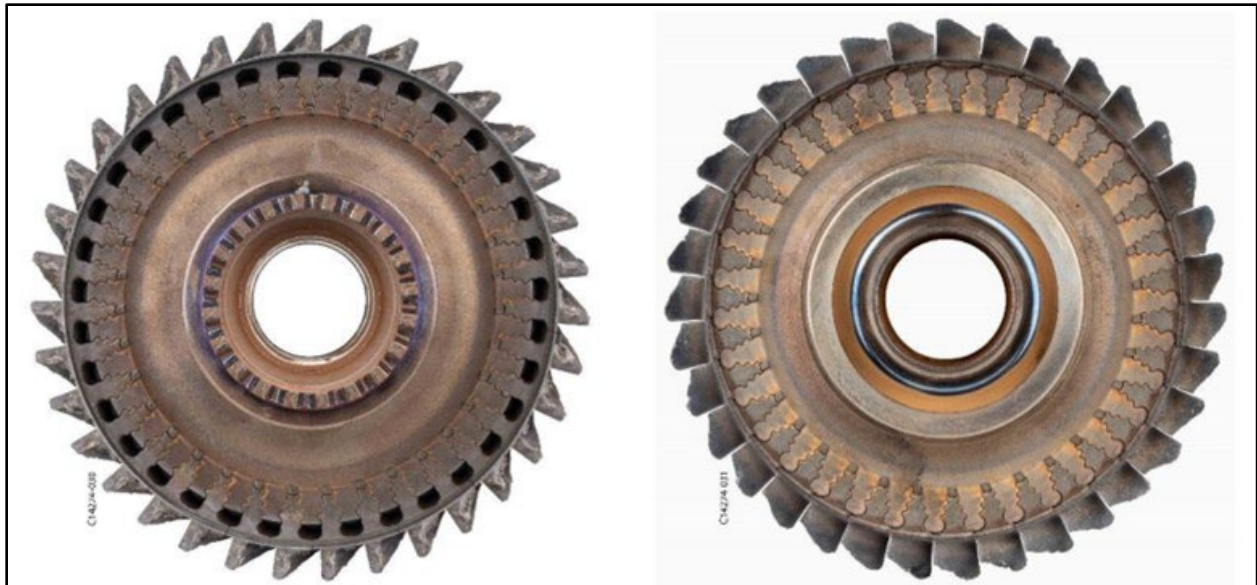
**Figure 83.** Gas Generator Turbine Disk - FWD Side (L), AFT Side (R)  
(Figure Courtesy of SafranHE)

The front side of the gas generator turbine disk exhibited multiple areas of discoloration. The diameter next to the curvic coupling teeth exhibited a purple discoloration and the diameter material between the labyrinth seals exhibited a purple discoloration (nearest the curvic coupling) that transitioned to a blue discoloration at the rear of the last front labyrinth seal (Figure 83). The rear side of the gas generator turbine disk exhibited a blue discoloration on the face of the disk between the rear labyrinth seals and the hub. Based on the total time of the event flight, the blue and purple discolored regions indicate an engine operating temperature that was at least 120 degrees C above the typical operating temperature (calculated temperatures at each location). Metallurgical analysis of the gas generator turbine disk surface found a band of delta phase dissolution that was approximately 1 micrometer in depth which, based on the material properties, is indicative of a temperature above 1,000 degrees C for a very short period of time (Figure 84).

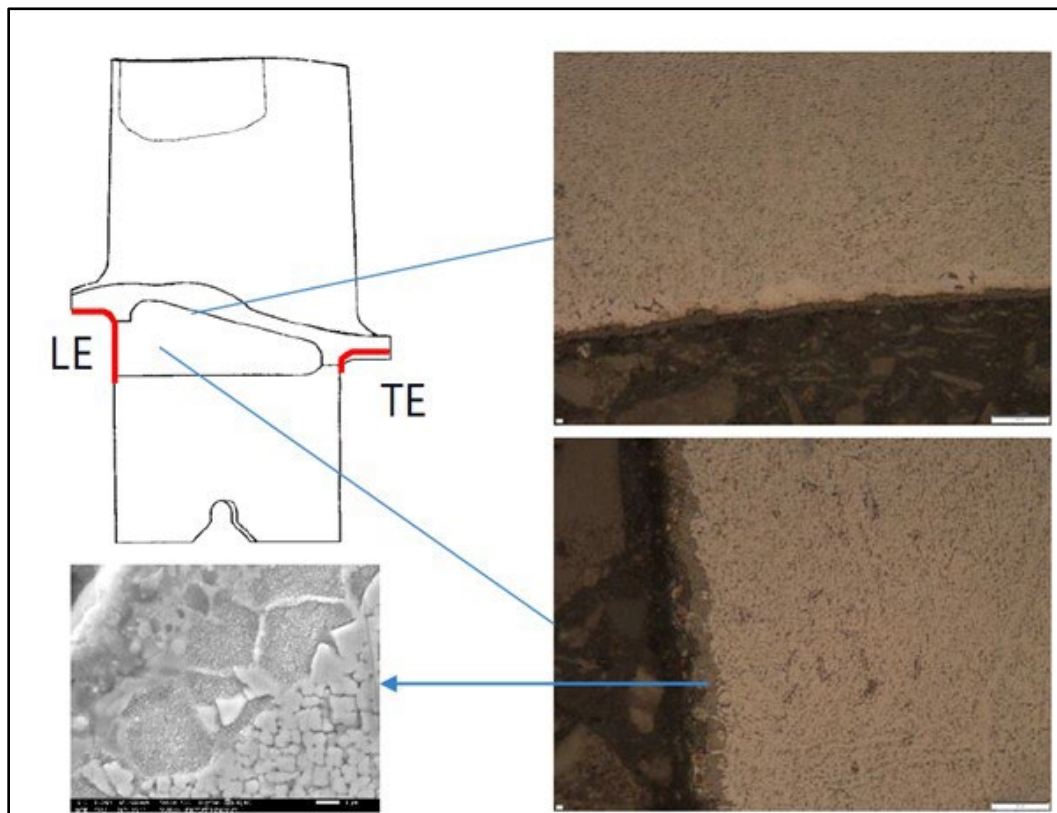
**Figure 85.** Gas Generator Turbine Blade S/N 45988 Metallography - Below Platform  
(Figure Courtesy of SafranHE, Etchant: copper sulfate reagent)

Metallurgical analysis of the No. 11 blade, S/N 45988, was performed below the blade platform and found a portion of the forward and aft faces of the blade root exhibited dissolution of gamma prime precipitate within a depth of 5 to 10 micrometers (Figure 85). Based on the material's properties and a solvus temperature

of 1,295 degrees C, this layer of gamma prime dissolution is indicative of an operating temperature above 1,295 degrees C for a very short period of time.

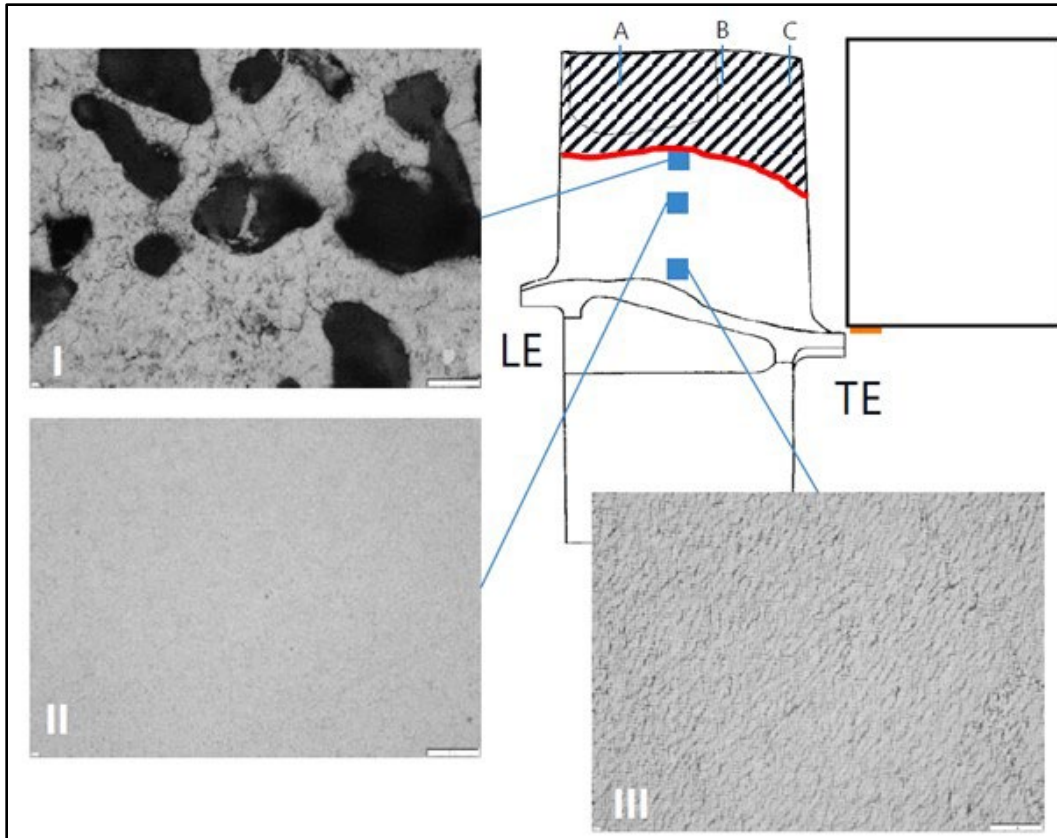
**Figure 86.** Gas Generator Turbine Blade S/N 45988 Metallography - Above Platform  
(Figure Courtesy of SafranHE, Etchant: copper sulfate reagent)

The airfoil region exhibited inter-dendritic melting at the fracture surface, the total dissolution of the gamma prime precipitates at a location on the airfoil near the fracture surface and similarly indicates a gas path temperature that is at least 400 degrees C above the typical temperature calculated for a take-off power setting. The nominal microstructure of dense single crystal cuboidal gamma/gamma prime structure was found on the airfoil near the blade fillet (Figure 86).
