# National Transportation Safety Board

ERA23FA352

## **POWERPLANTS**

Group Chair's Factual Report

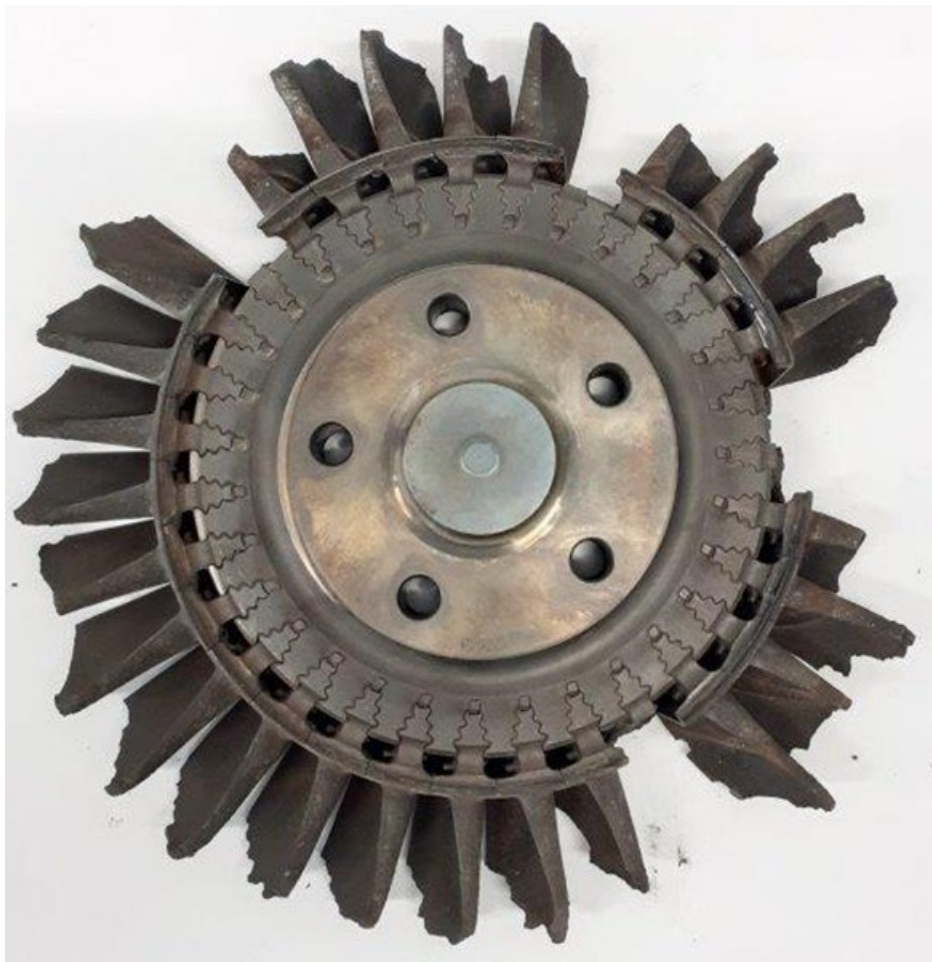
**Figure 87.** No. 1 Engine PT Disk and Blades

The PT disk, P/N 2319411650, a nickel based alloy, exhibited a blue to purple discoloration of the fir trees around the entire circumference (Figure 87). Metallurgical analysis of the disk on the front face near the fir trees showed evidence of total dissolution of the gamma prime precipitates on the front and rear faces of fir trees to a depth of approximately 1.0 micrometer. Based on the material's properties, this layer of gamma prime dissolution is indicative of an operating temperature above 1,000 degrees C for a very short period of time. Hardness measurements were made at multiple locations on both the front and rear sides that included the fir tree faces (top and bottom) and the disk center. The hardness measurements on the front face of the fir trees were between 550 HV and 560 HV<sub>30</sub>, the hardness measurements on the rear face of the fir trees were between 520 HV<sub>30</sub> and 530 HV<sub>30</sub>, the hardness measurements on the front disk center were approximately 470 HV<sub>30</sub>, and the hardness measurements on the rear disk center were approximately 475 HV<sub>30</sub>.

The PT blade set was comprised of 31 power turbine blades, P/N 231941A0D0, a nickel based alloy, with 5 out of the 31 blades fractured. The five fractured blades

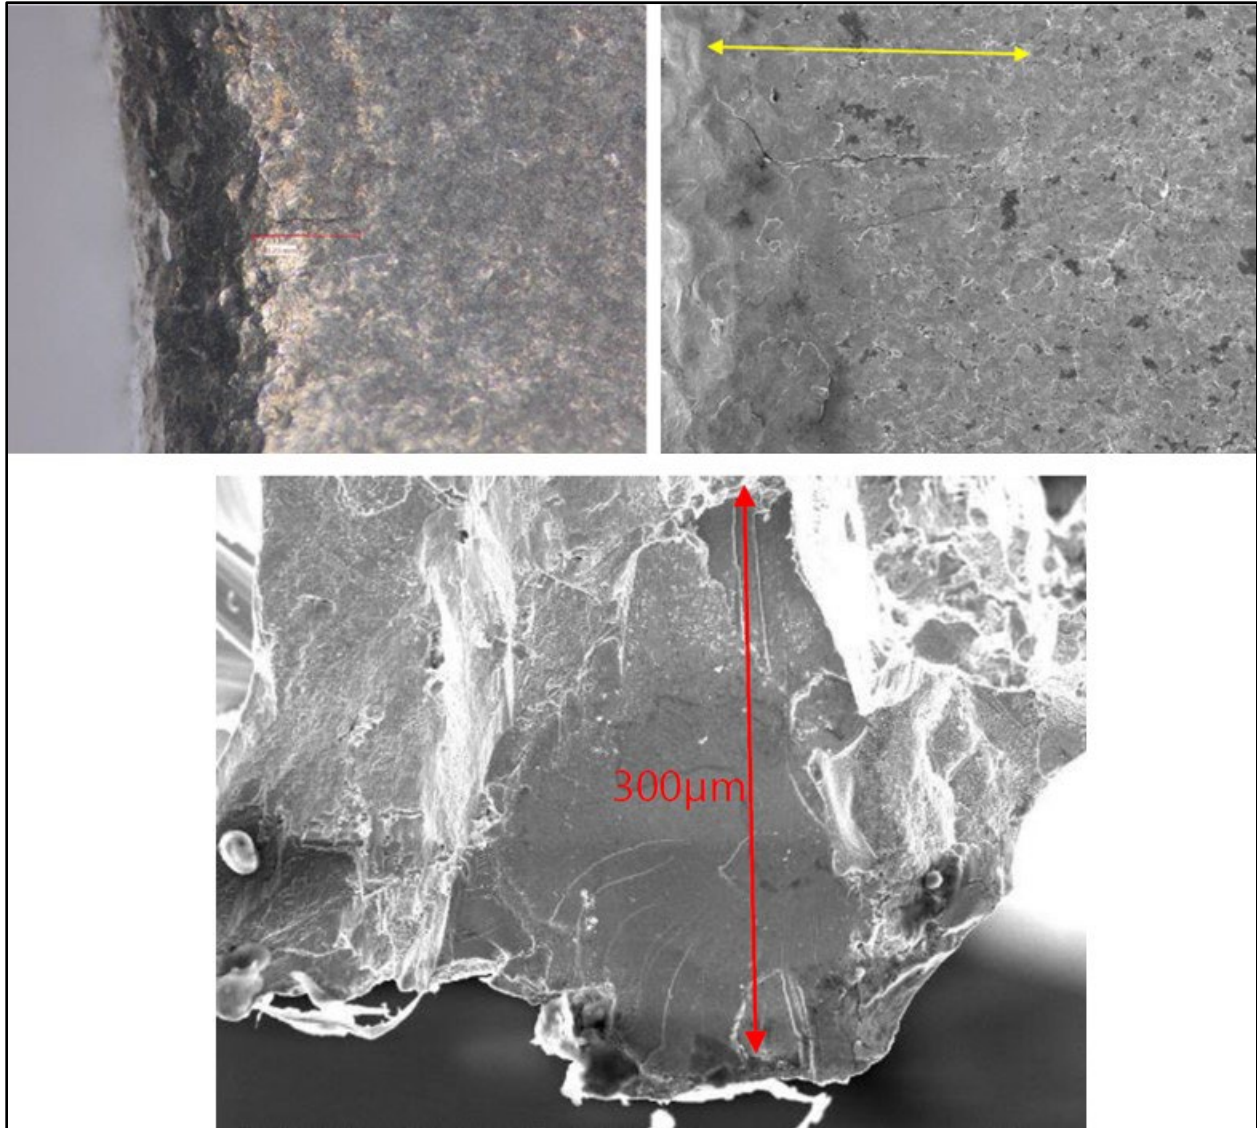
**Figure 89.** PT Blade S/N 164631

Fluorescent penetrant inspection was performed on 24 of the 31 blades (the other 7 blades included the 5 broken blades and 2 other blades, these were set aside for preservation purposes). Crack indications were observed within the fir tree fillets on all 24 blades; however, S/Ns 164622, 164626, and 164631, had crack indications in the shank region on the leading edge of pressure side, with crack lengths measured between 0.5 and 2 millimeters, these indications do not meet the acceptance criteria defined in ACMMB repair task 72-42-22-222-801-A01.

The crack located in the shank of blade S/N 164631 (blade No. 20) was excised and opened under controlled lab conditions to perform fractography of the crack faces, and this was performed with representatives from the BEA and Airbus in attendance. Fractographic analysis found crystallographic facets, consistent with initiation sites of the 5 broken blades; no characteristics of fatigue propagation were observed (Figure 89).

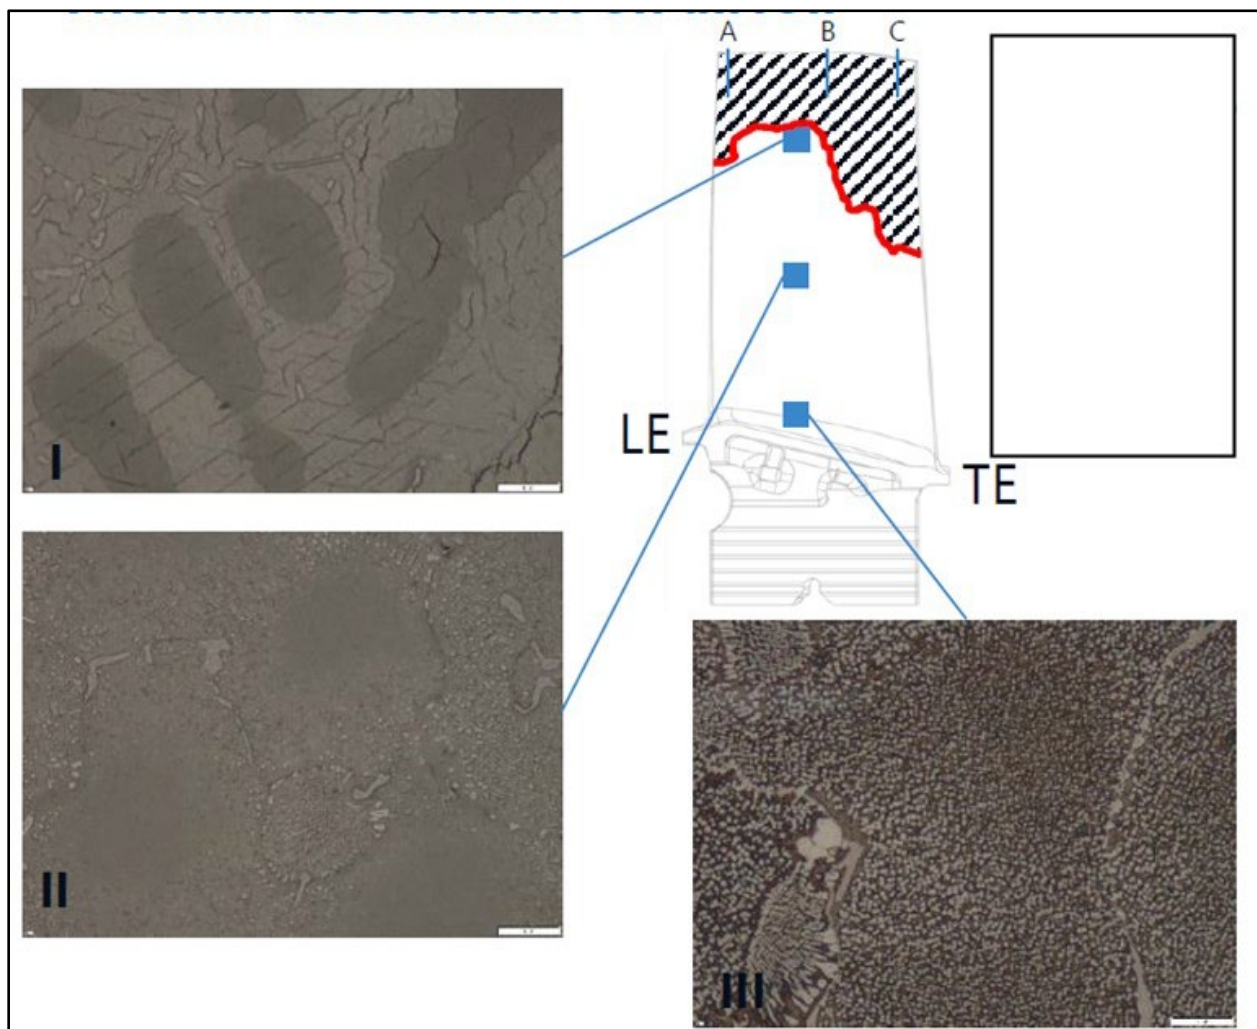
**Figure 90.** PT Blade S/N 164637 Metallography - Above Platform

Metallurgical analysis was performed on blade S/N 164637 (blade No. 21), which found the total dissolution of the material/alloy precipitates and eutectic phases at the fracture surface and significant dissolution of the material/alloy precipitates and eutectic phases at a location above the blade platform (approximately mid-span and mid-chord) (Figure 90). Based on the material's properties and a solvus temperature of 1,132 degrees C, this dissolution layer indicates a gas path temperature that is at least 400 degrees C above the typical temperature calculated for a take-off power setting. The nominal microstructure of dense gamma/gamma prime structure was found at a location on the airfoil near the blade fillet.

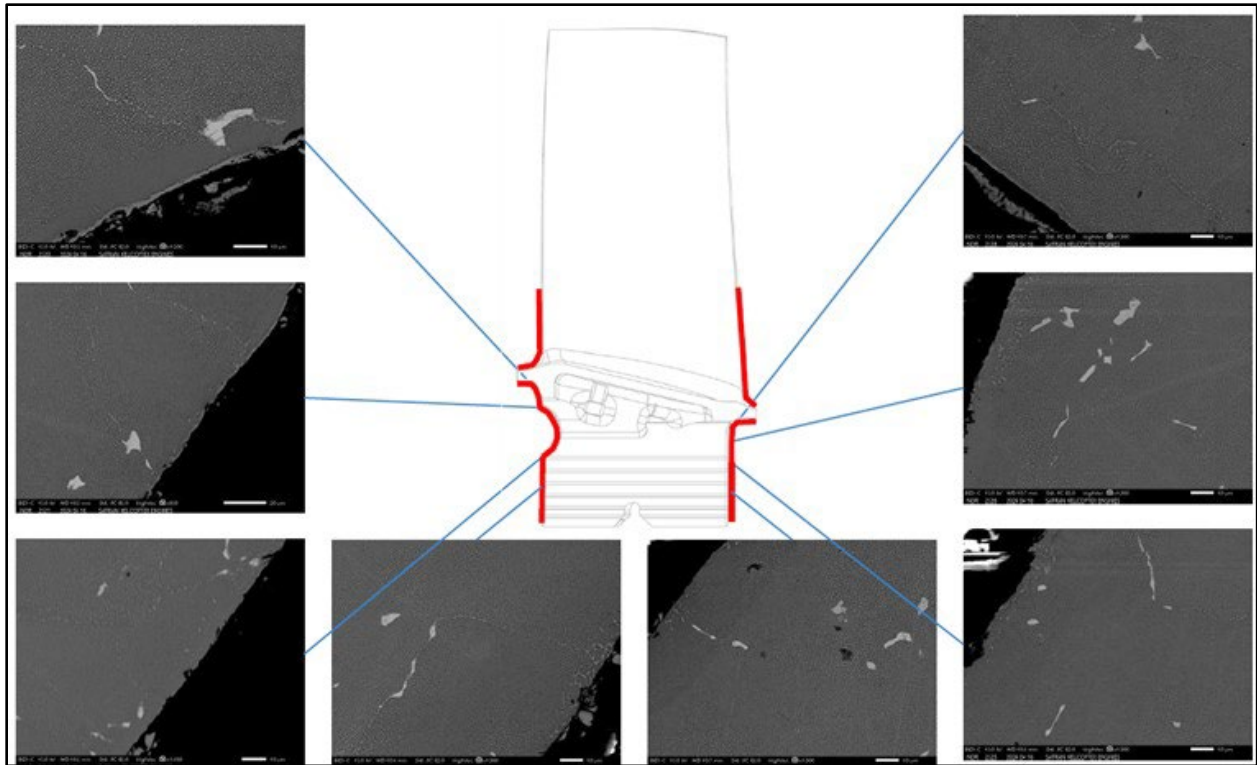
**Figure 91.** PT Blade S/N 164628 Metallography - Below Platform  
(Figure Courtesy of SafranHE, Etchant: copper sulfate reagent)

Metallurgical analysis was performed on blade S/N 164628 (No. 12), S/N 164649 (No. 29), S/N 164640 (No. 4), and S/N 164644 (No. 18), which found dissolution of

gamma prime precipitates within a band of approximately 5 to 15 micrometers in depth on the blade root surfaces at both the leading and trailing edge sides (Figure 91). Similarly, this dissolution indicates a gas path temperature that exceeds the material's solvus temperature.

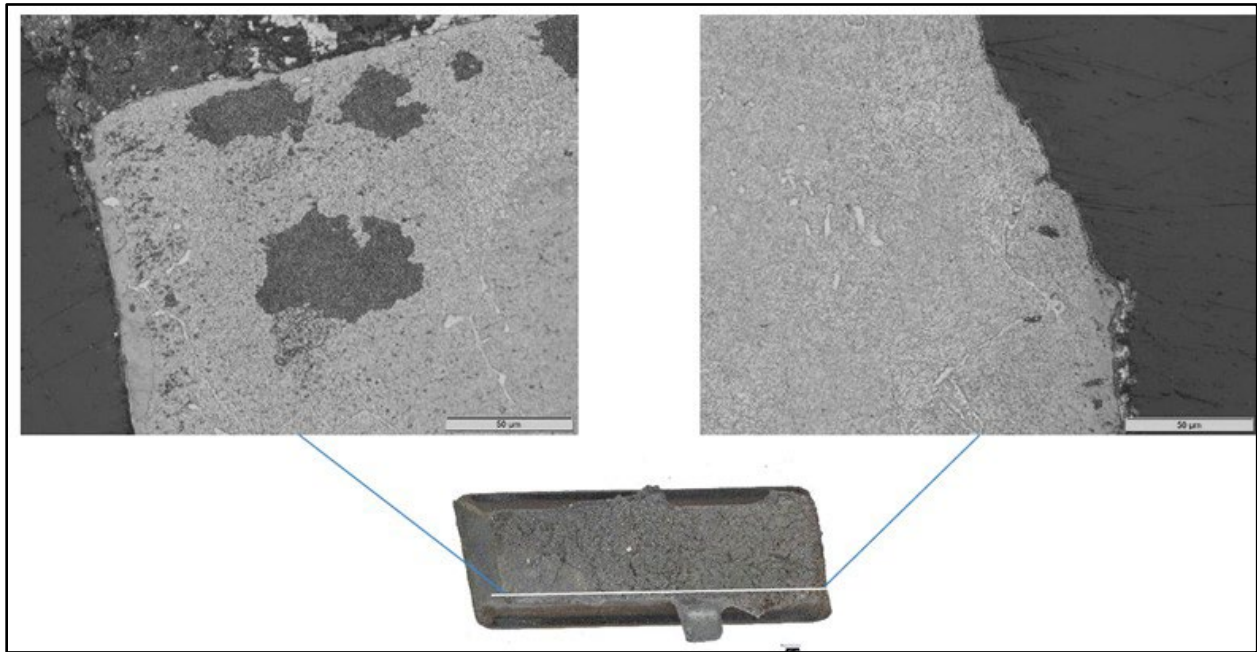
**Figure 93.** PT Blade S/N 164640 Metallography

The blade root of blade S/N 164640 (No. 4) was sectioned and metallurgical analysis performed across the root profile just below the fracture surface found the nominal microstructure of dense gamma/gamma prime structure, with no dissolution of the gamma prime precipitates observed (Figure 93).

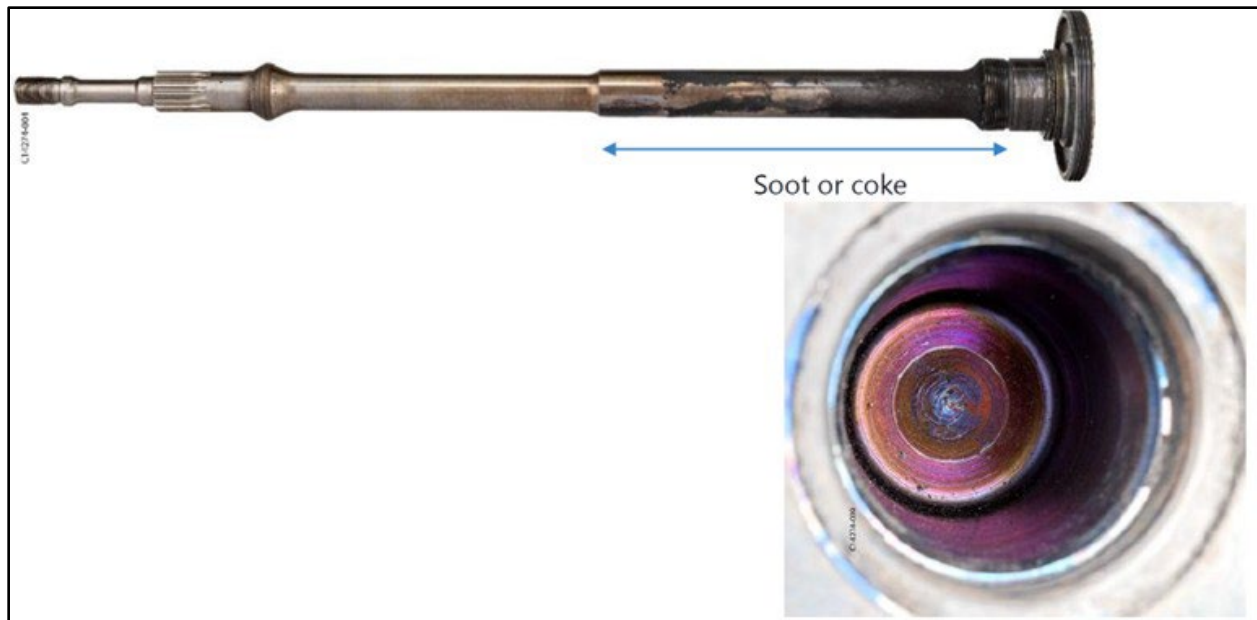
**Figure 94.** PT Shaft

The PT shaft, P/N 0319417690, a stainless steel alloy, exhibited multiple areas of discoloration; a blue discoloration around the inner diameter at the rear of the shaft and a pink to purple discoloration around the inner bore of the at the rear of the shaft (Figure 94). Based on the total time of the event flight, the discolored regions indicate an engine operating temperature that is at least 700 degrees C, which is 300 degrees C above the typical operating temperature (calculated temperatures at each location) for a take-off power setting.

The rear labyrinth seals exhibited damage on approximately one third of the circumference, with the seals completely worn down at the center of the damaged area, while the seals opposite this location appeared undamaged. The shaft splines appeared undamaged, but the rear half of the shaft was discolored black with soot.

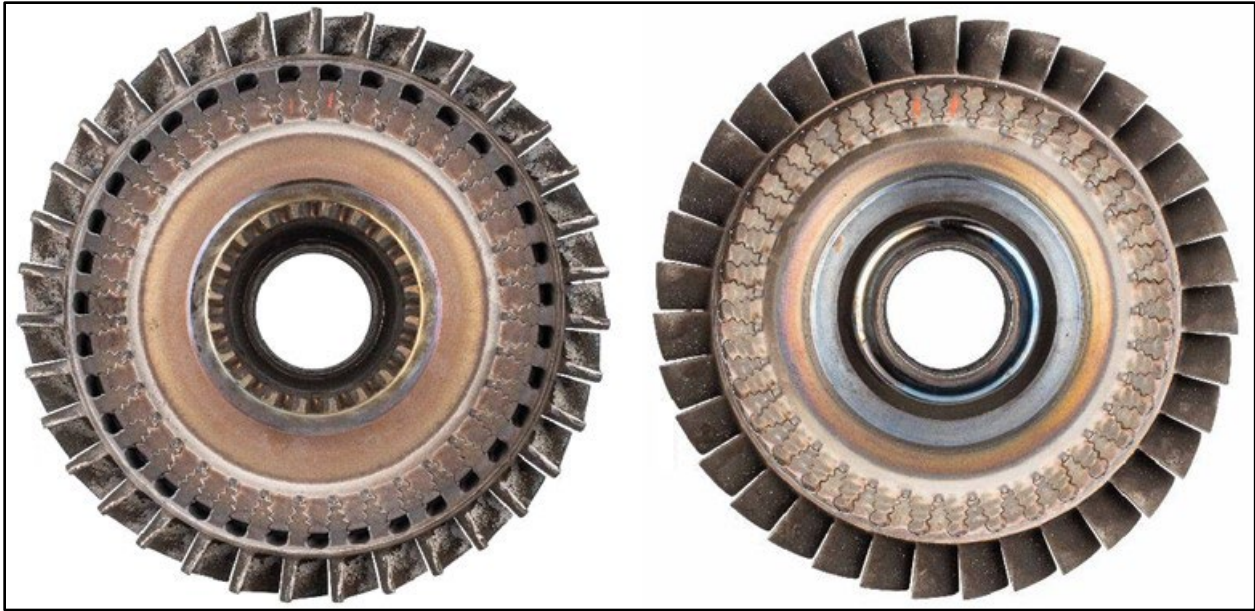
**Figure 95.** Gas Generator Turbine Disk and Blades

The gas generator turbine disk contained purple discoloration of the disk's outer web region, just inboard of the disk posts, around the entire circumference (Figure 95).

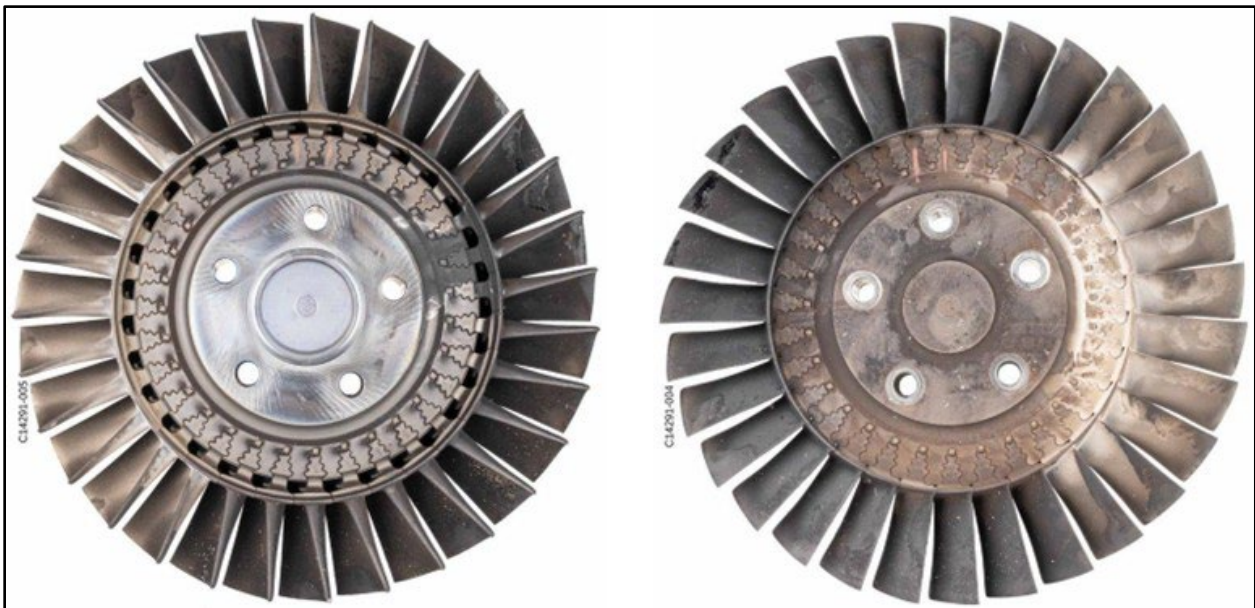
**Figure 96.** Gas Generator Turbine Disk and Blades

All gas generator turbine and PT blades were intact and full length (Figure 96).

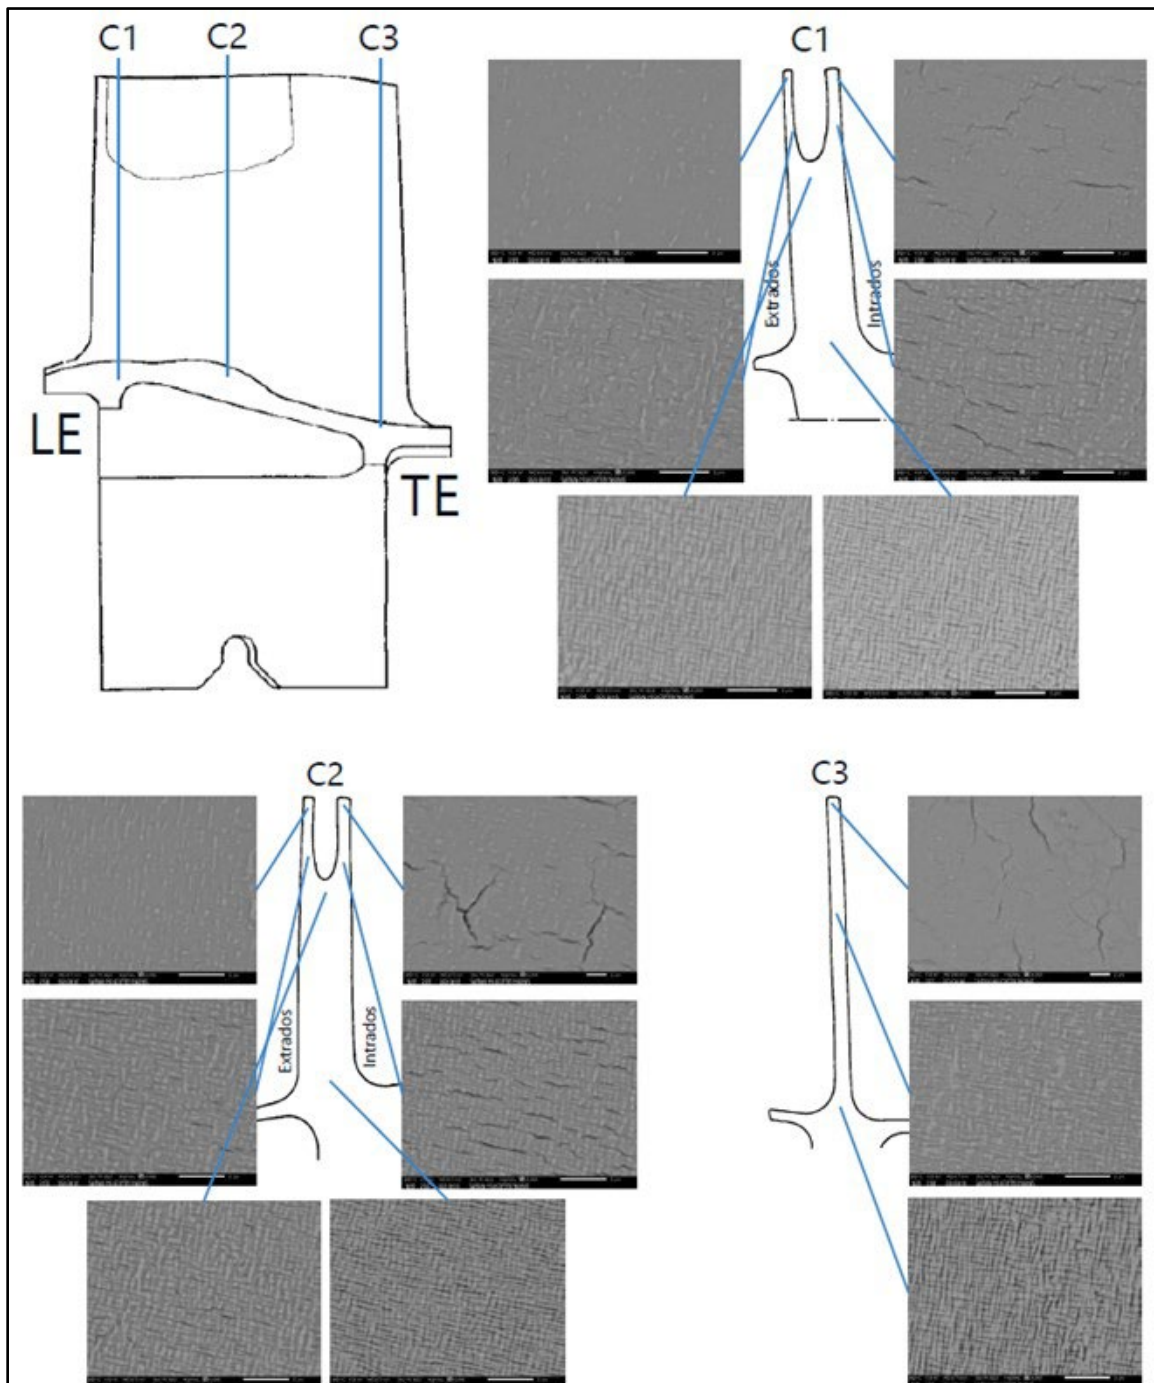
**Figure 97.** Gas Generator Turbine Blade Metallography - Above Platform  
(Figure Courtesy of SafranHE, Etchant: copper sulfate reagent)

Metallurgical analysis was performed on multiple gas generator turbine blades, both above and below the blade platform. Above the blade platform, there was evidence of quasi dissolution of the gamma prime precipitates at the top of the airfoil and significant dissolution of the gamma prime precipitates at the middle of the airfoil (Figure 97). There was no evidence of creep rafting of the gamma prime precipitates. Based on the material's properties and a solvus temperature of 1,295 degrees C, this layer of dissolution indicates a gas path temperature that is at least 300 degrees C

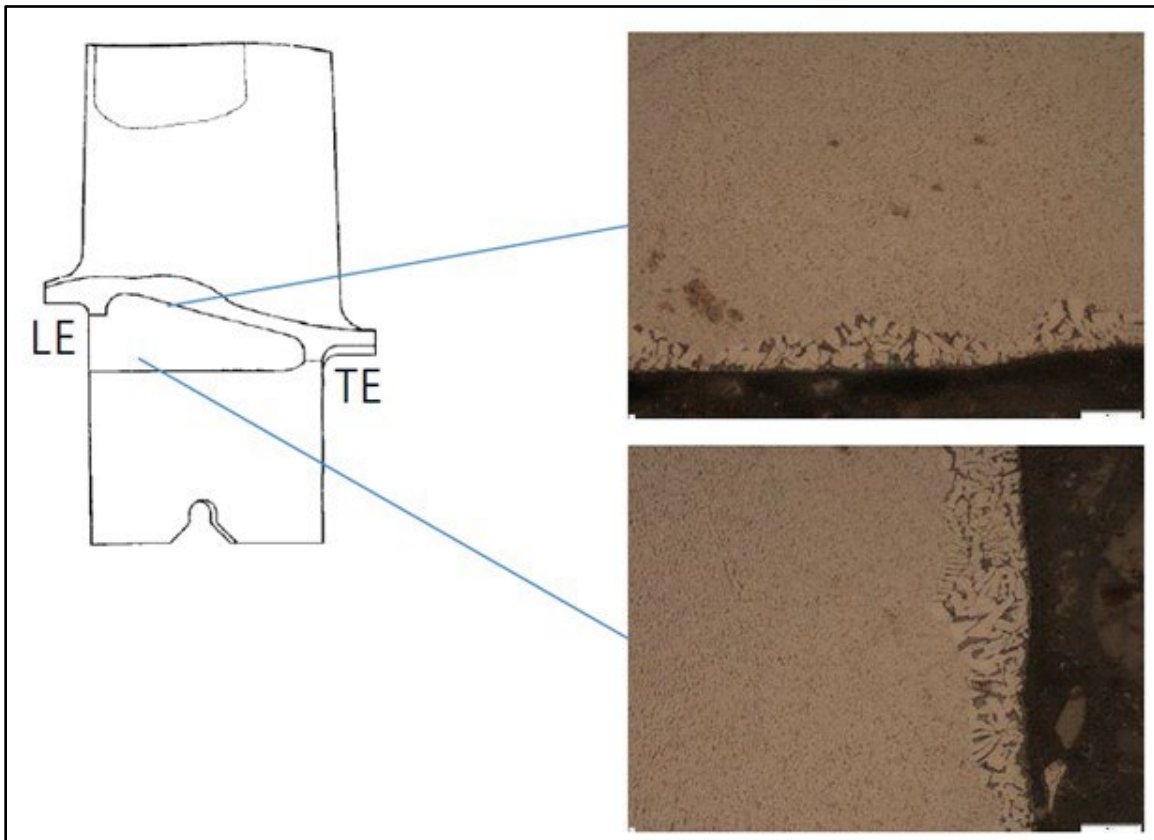
**Figure 98.** Gas Generator Turbine Blade Metallography – Below Platform

above the typical temperature calculated for a take-off power setting. The nominal microstructure of dense gamma/gamma prime structure and equiaxed grains were found on the airfoil near the blade fillet. Below the blade platform, there was no evidence of dissolution of the gamma prime precipitates and the presence of a secondary reaction zone (SRZ) is consistent with used, in service, blades (Figure 98).

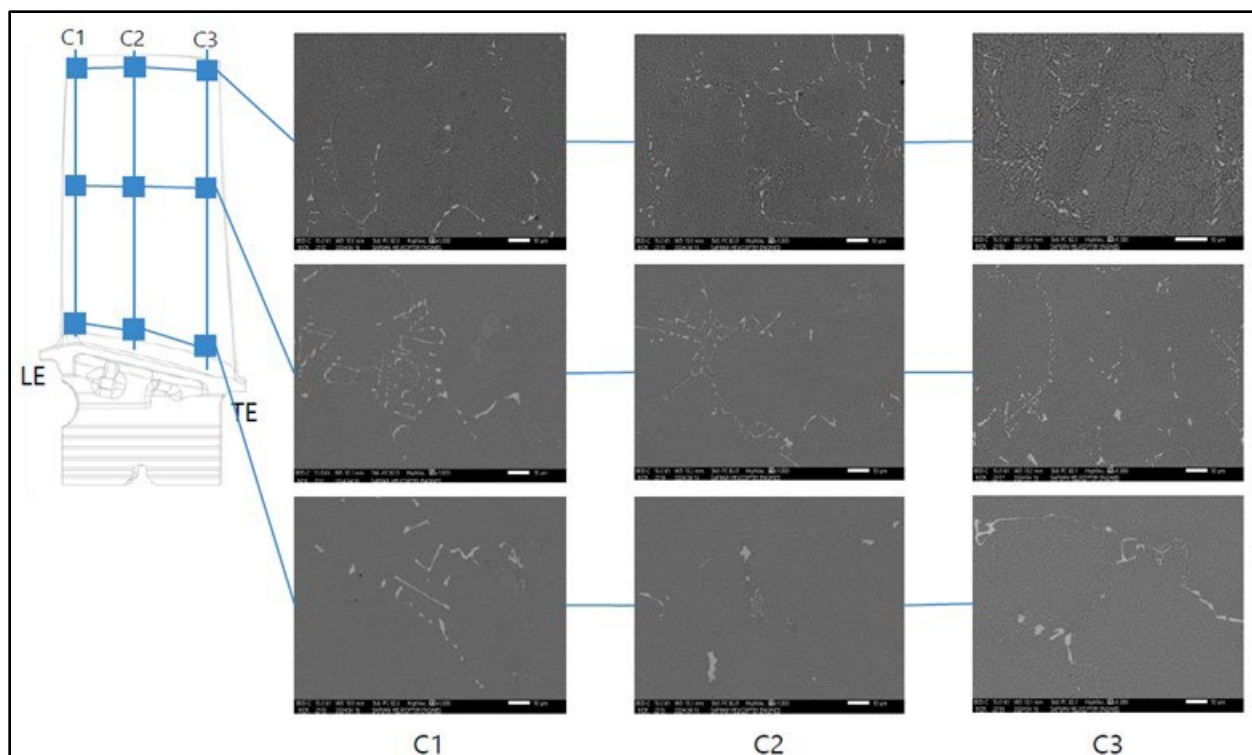
**Figure 99.** PT Blade Metallography - Above Platform  
 (Figure Courtesy of SafranHE, Etchant: copper sulfate reagent)

Visual inspection of the PT blades found corrosion on both the suction and pressure sides of the platform and along the profile of all blades, contact wear marks on the blade tips and loss of material (erosion) along the leading edges. Fluorescent penetrant inspection was performed on 28 PT blades of the 31 blade set (3 blades were preserved). The presence of cracks were found within the third fillet of the blade fir tree on all blades, blade Nos. 2, 8, 10, and 17 contained cracks that exceeded the limits defined in CMM task 72-42-22-222-801-A01 for continued operation.

Metallurgical analysis was performed on select PT blades, both above and below the blade platform. Above the blade platform, there was evidence of partial dissolution of the gamma prime precipitates and eutectic phases at the trailing edge tip of the airfoils, similarly indicating a gas path temperature that is at least 300 degrees C above the typical temperature calculated for a take-off power setting. The nominal microstructure of dense gamma/gamma prime structure and equiaxed grains were found on the airfoil near the blade fillet (Figure 99). Below the blade platform, there was no evidence of dissolution of the gamma prime precipitates (Figure 100).

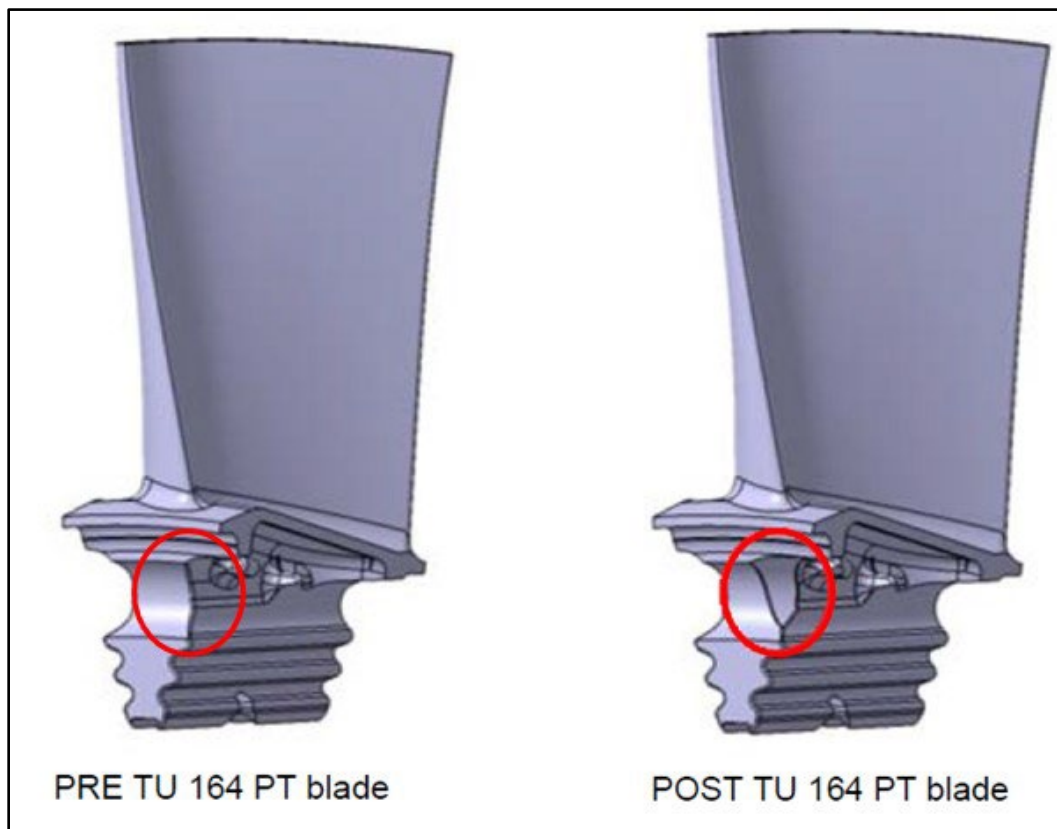
**Figure 101.** PT Blade Model - Original Design (L), TU164 Re-design (R)  
(Figure Courtesy of SafranHE)

For reference: The PT blades on the accident helicopter, installed new in 2016, were P/N 231941A0D0 (pre-TU164)

The corrective actions taken by SafranHE included a PT blade redesign effort, known as TU164<sup>14</sup>, that modified the shape of the blade root and shank regions to decrease the maximum stress and improve the dynamic margin of the PT blade's endurance limit (Figure 101). The TU 164 redesign increases the mechanical strength of the PT blade shank relative to HCF and separates the HCF maximum stress location from the LCF maximum stress location.

This SB calls for replacement of the PRE TU 164 PT blades with POST TU 164 PT blades. The geometry of the POST TU 164 blade separates the HCF maximum stress area from the LCF maximum stress area. This geometry increases the mechanical strength of the PT blade against HCF. POST TU 164 PT blades are either new blades or existing PRE TU 164 blades changed into POST TU 164 blades.

The original part numbers of the PT blade used in Arrius engine applications were P/N 231941A0D0, 2319411630, and 2319411640. The TU164 redesign effort introduced new blade P/N 231941A7J0 (new manufacture) and P/N 731941A0D1 (reoperated from 231941A0D0) for incorporation into all Arrius engine applications.
