# National Transportation Safety Board

ERA23LA011

## **COCKPIT DISPLAY**

Location: Fort Myers, FL  
Date: October 8, 2022  
Time: 18:00 eastern daylight time (EDT)  
Helicopter: Bell Textron Canada LTD 505, N5DF

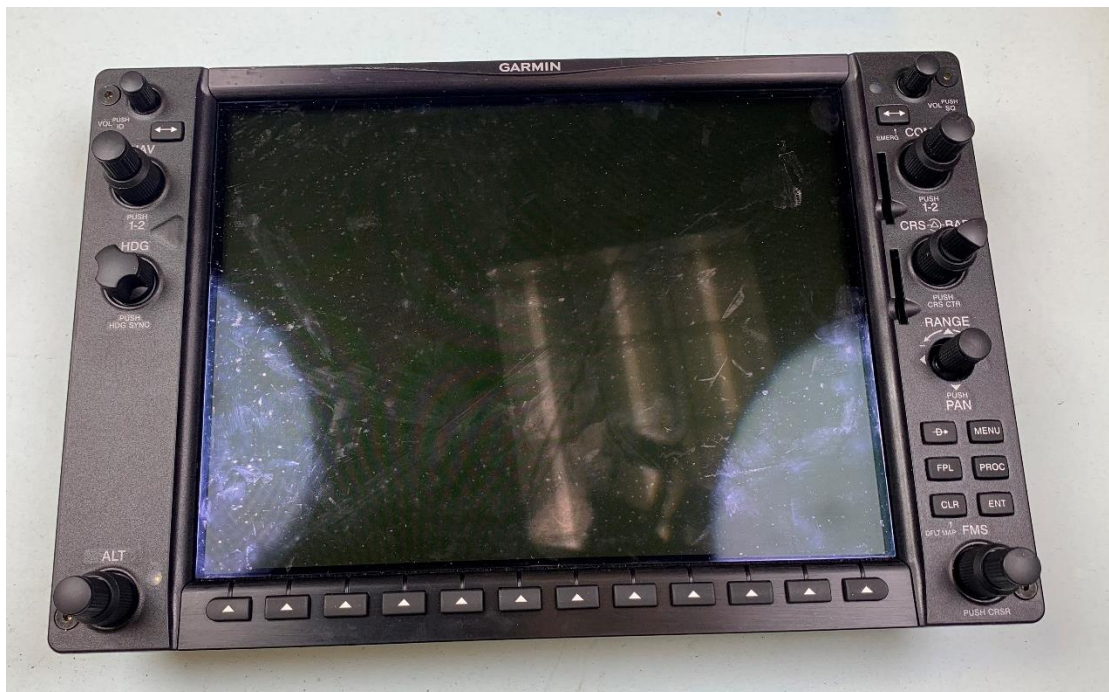
The GPS was in good condition and the data were downloaded normally using the manufacturer's procedure. The device is shown in figure 1. The device was

**Figure 1.** Photo of Garmin GDU-1050H.
