# National Transportation Safety Board

ERA23LA011

## **SURVIVAL FACTORS**

Group Chair's Factual Report

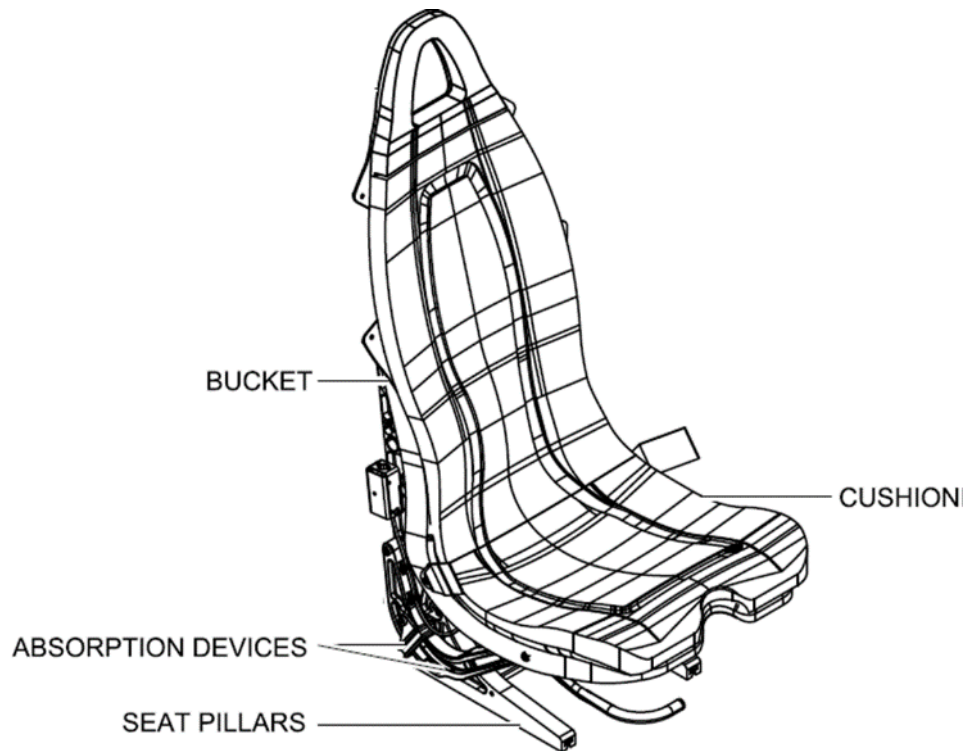
**Figure 11.** Elements of the seat, including the frame and bucket.

Both seats consisted of a composite bucket affixed to two machined frames (see figure 11). The lower portion of the frames contained absorption devices that deformed to absorb vertical energy to meet the requirements referred to in 14 CFR sections 27.785 and 27.562. The upper portion of the frames contained a sliding mechanism that guided the bucket downwards while the lower absorption devices are deformed (see figure 12).

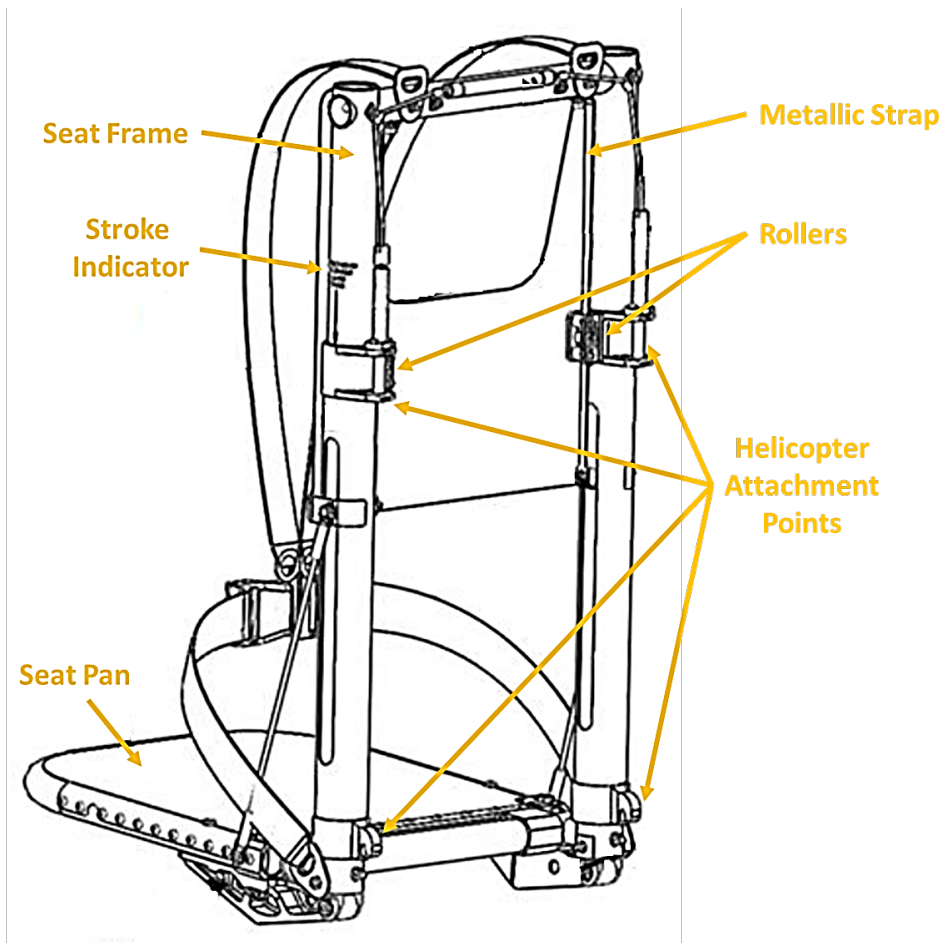
**Figure 22.** Elements of the seat (excluding cushions), including the frame and seat pan.

The seats were composed of an aluminum frame and seat bottom (see figure 22). The vertical tubes of the frame were designed to transmit the load of an occupant to the helicopter structure. The seat bottom was an aluminum pan attached to a tubular frame that included cables on each side and a rigid set of fasteners at each aft area that transmitted loads to the vertical tubes. The seat was designed to attenuate energy through downward displacement, where metal strips on the rear part of the frame were deformed over a set of rollers to meet the requirements referred to in 14 CFR sections 27.785 and 27.562. There were indicators (arrows) located on the side of the seat that indicated whether the seat was stroked (see figure 23).
