# MANDATORY SERVICE BULLETIN

**DATE:** January 30, 2003**Service Bulletin No. 475C**  
(Supersedes Service Bulletin No. 475B)  
Engineering Aspects are  
FAA Approved**SUBJECT:** Crankshaft Gear Modification and Assembly Procedures**MODELS AFFECTED:** All Lycoming direct drive piston aircraft engines (including VO-360 and IVO-360; excepting O-320-H, O-360-E, LO-360-E, TO-360-E, LTO-360-E, and TIO-541 series engines).**TIME OF COMPLIANCE:** During overhaul, after a propeller strike, or whenever crankshaft gear removal is required.

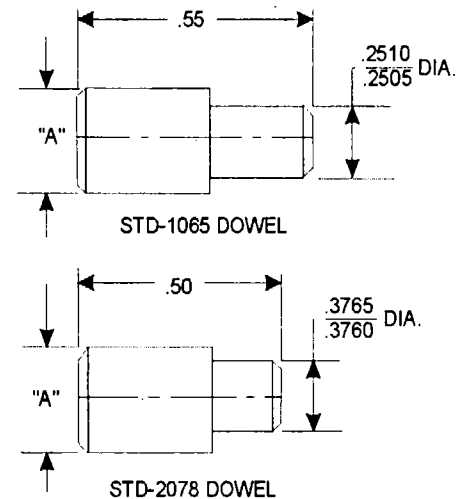
Figure 4. Details of Crankshaft Dowel

- e. Chamfer edge of pilot diameter 45° x .03 as shown in Figure 1.
4. If the dowel has been removed, check the condition of the dowel hole in the crankshaft. If out of round or oversize, ream as required for installation of an oversize dowel. Available oversize dowels and the corresponding size for reamed holes are shown in Table 1.
5. Install a new dowel in the crankshaft as shown in Figures 2 and 3. Insure that the correct dowel is installed.
