# N8129M

Total Loss Aircraft Fire

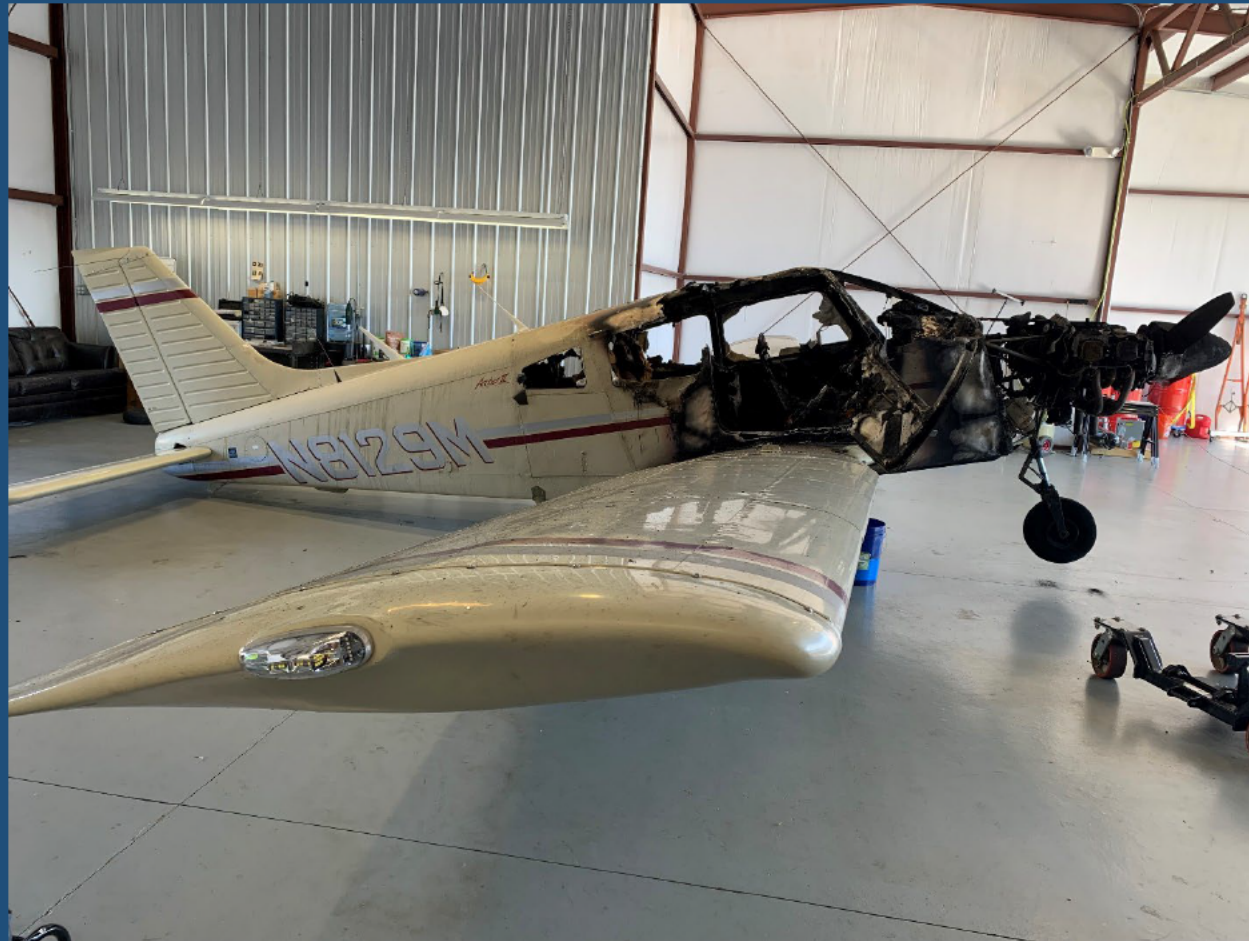
- Two sections of the generator wire are believed to have shorted to ground
- Slide 3-7 are related to area 1. This is [REDACTED] secondary damage from the initial short to ground.
- The wire arced against a worm clamp and the fuel drain line coming off the rear cylinder.
- Slide 8-11 is [REDACTED] the initial grounding point of the generator wire.
- The clamp on the structure side is melted and arc damage is present on the area it is mounted.
- The clamp on the wire side appears oversized [REDACTED]
