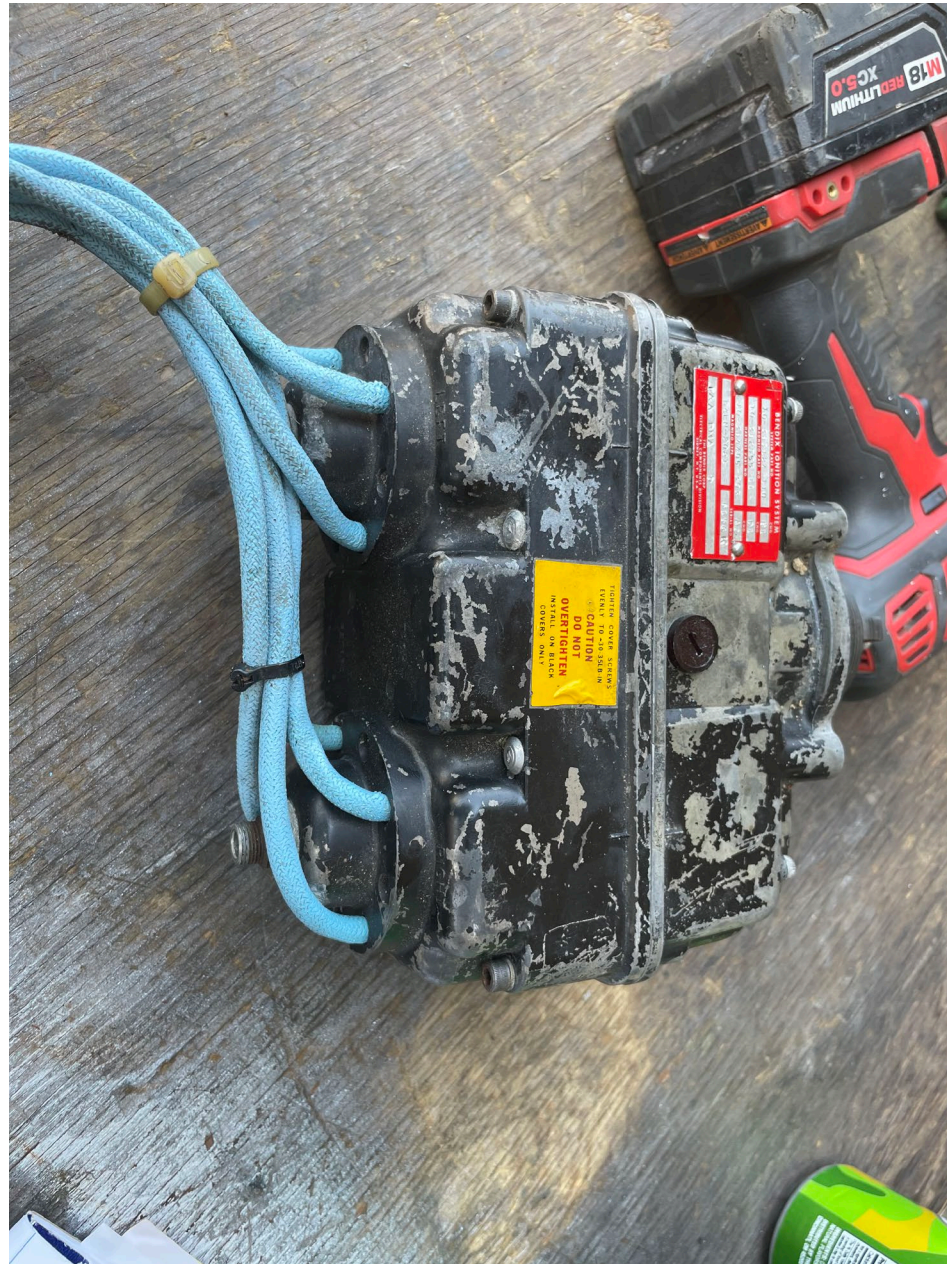
**Photo 4 – FAA Digital Photograph. View of the Retained Magneto.**

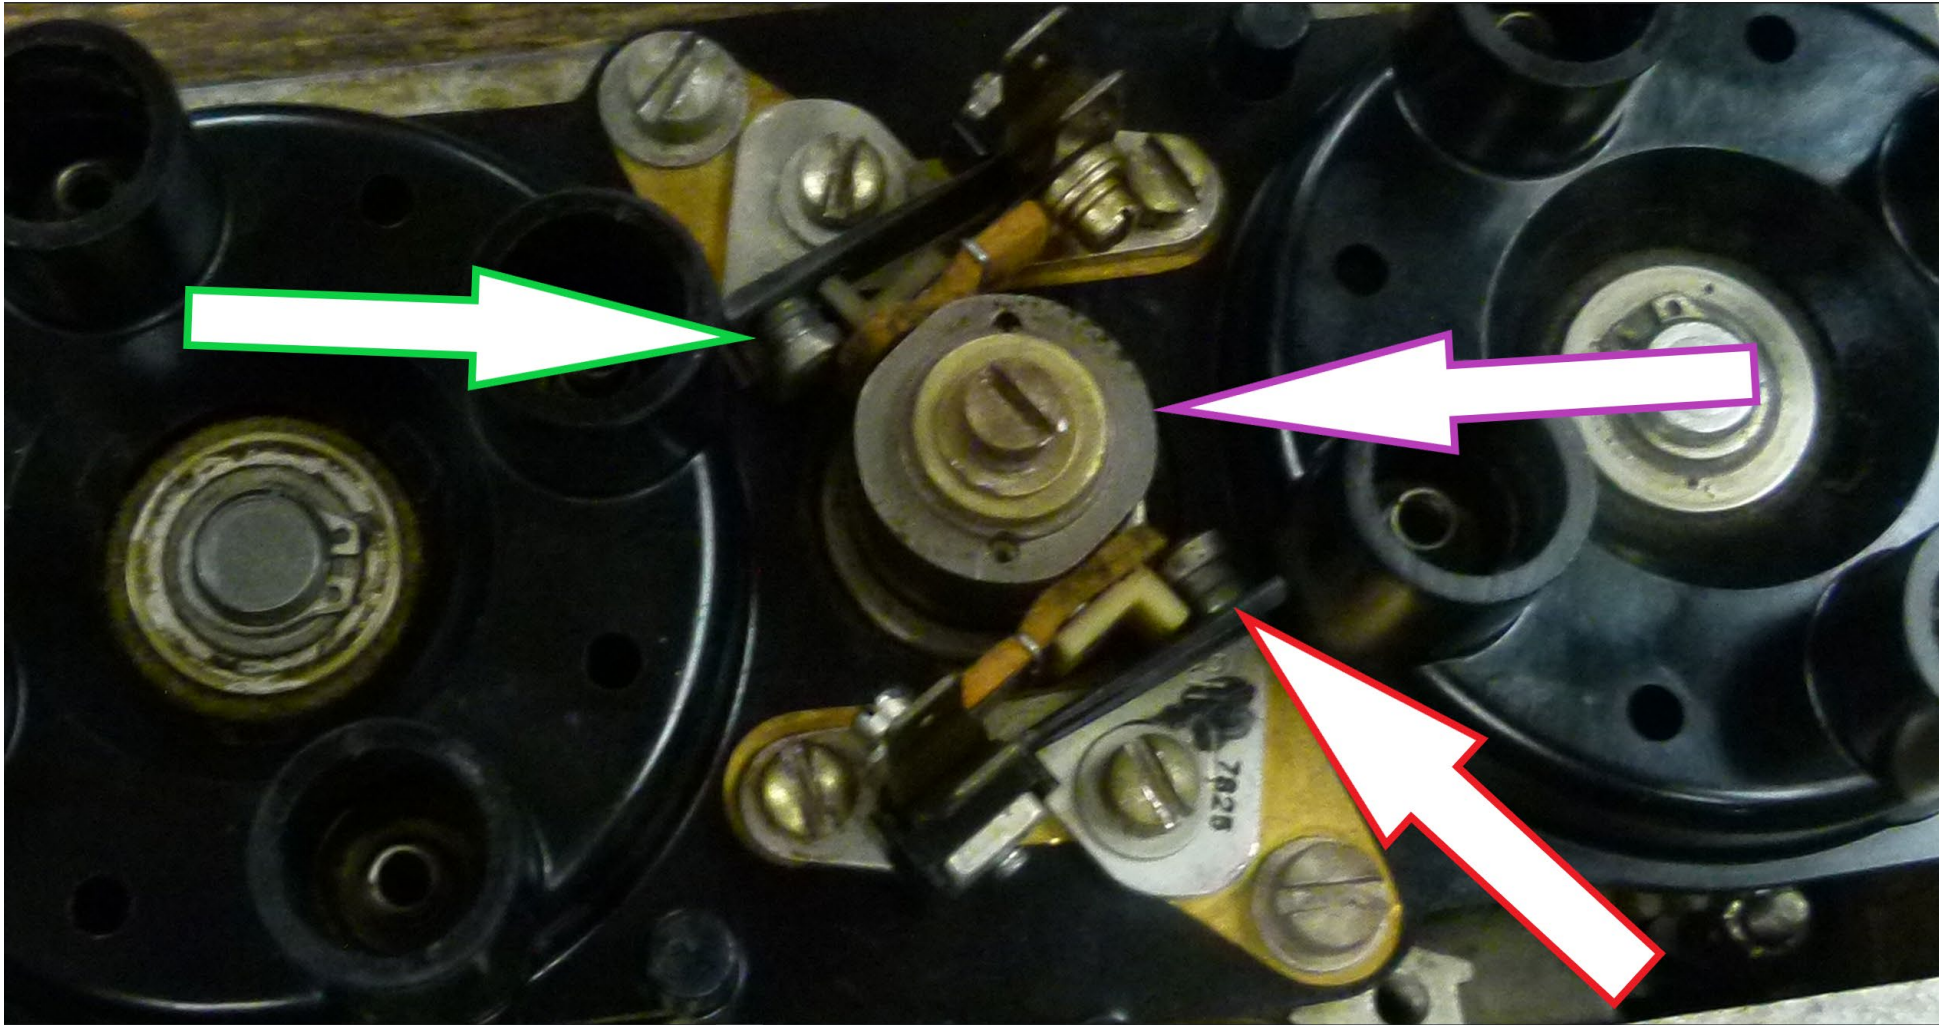
**Photo 5 – Continental Aerospace Technologies Digital Photograph. Red Lined Arrow Points to Left Contact Assembly, Green Lined Arrow Points to Right Contact Assembly, and Purple Lined Arrow Points to Breaker Cam.**
