NTSB  
Attention: Mr. Dennis Diaz  
Supervisory Air Safety Investigator  
NTSB - Eastern Region

I am responding to your invitation to submit additional information regarding the gear collapse of C-GPEX at Bridgeport, CT Tuesday April 26 2023.

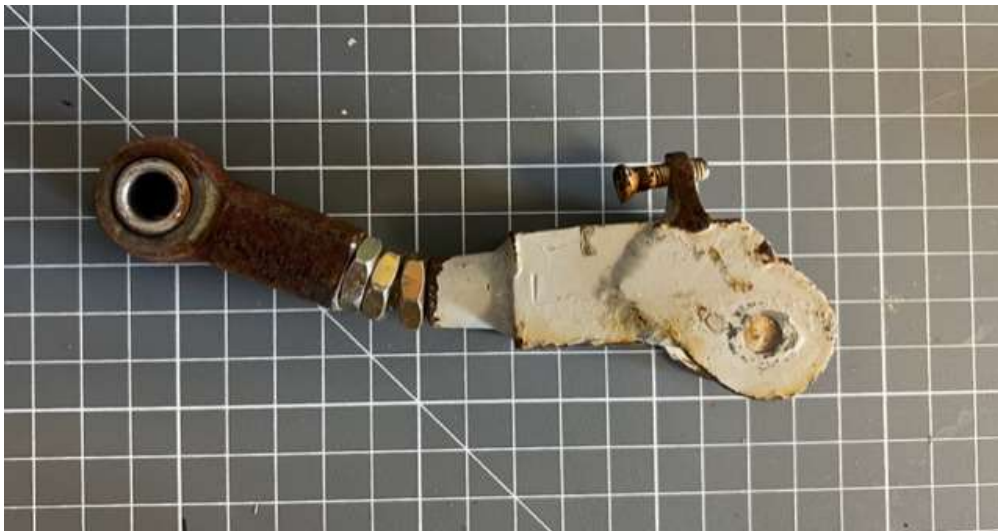
Photograph 1a & 1b

The owner invited me to see his new acquisition and I discovered that the threaded rod on the LHS of the aircraft had bent. (Photograph 1a & 1b) The owner had a spare threaded rod, and I did a non-destructive of the piece and found it to be 136,000 psi. (Photograph 4) I/A/W Engineering series manual "Aerospace metals, general data and usage factors" T.O. 1-1A-9 dated 11-17-2016. I feel that the tensile strength is lower than the industry standard of 180,000 psi that is used by Boeing, North American, Waco and Fairchild aircraft, to name a few.

My opinion is that the design is inherently weak and the builder's deviation from the plans contributed to the part failure. Another item that we are reviewing is if the main landing gear has "toe in" on the wheel alignment. It visually appears to have "toe in" and aircraft that I have worked on in the past, the wheel alignment is set to zero with no toe in or toe out. If the main gear is "toe in" this will cause excess pressure on the over center link, contributing to the failure.

The owner is treating the aircraft as unairworthy until an appropriate redesign of the over-center lock is implemented.
