## Accident / Incident Report

Report No.: 23-093

Roma Air  
Air Tractor AT-802A, N3069S  
Wellington, Florida, USA  
20 June 2023  
PT6A-65AG, PN0077

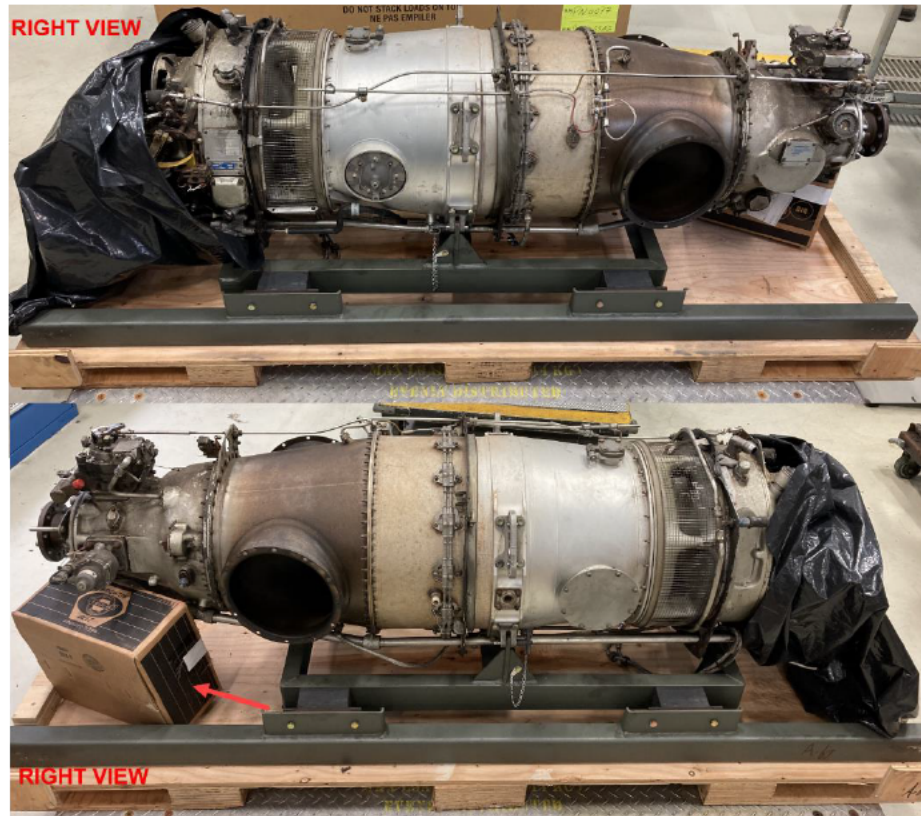
**Photo No. 2, Engine Side Views**

The as received engine shipping container showed no external signs of any damage, Photo No. 1. Opening of the container showed that the engine was mounted on a standard P&WC engine shipping cradle with the rear side covered in a black plastic bag, Photo No. 2. A cardboard box, in which the engine exciter was shipped in, was found to the left side of the reduction gear box, red arrows, Photo No. 2 & 3. The engine data plate, Photo No. 4, confirmed the engine model to be a PT6A-65AG with serial no.: PN0077.

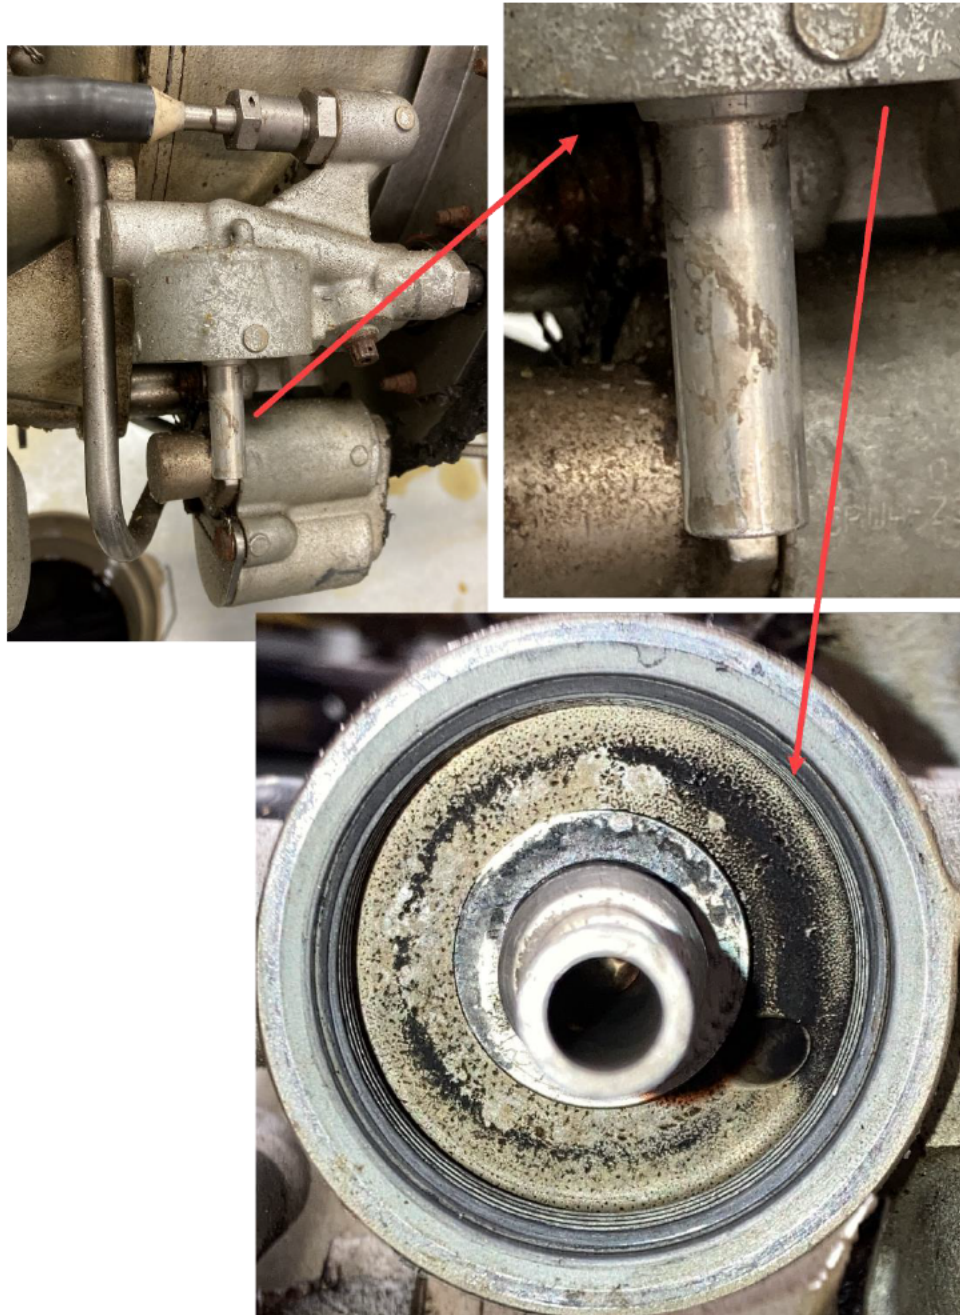
Photo No. 15, P3 Filter Bowl Interface

**Compressor Discharge Air (P3) and P3 Filter:** It was observed that the P3 filter bowl safety lockwire was cut, yellow arrows, Photo No. 13. The bottom of the filter bowl exhibited dark staining, right view, Photo No. 13. The air filter was clean with no visible debris, Photo No. 14. The filter bowl interface top surface exhibited a black sticky powder like substance, bottom view, Photo No. 15. The B-nuts on the P3 line between the GGC and the FCU were tight and secured with lockwire. A leak test of the P3 line was not performed.

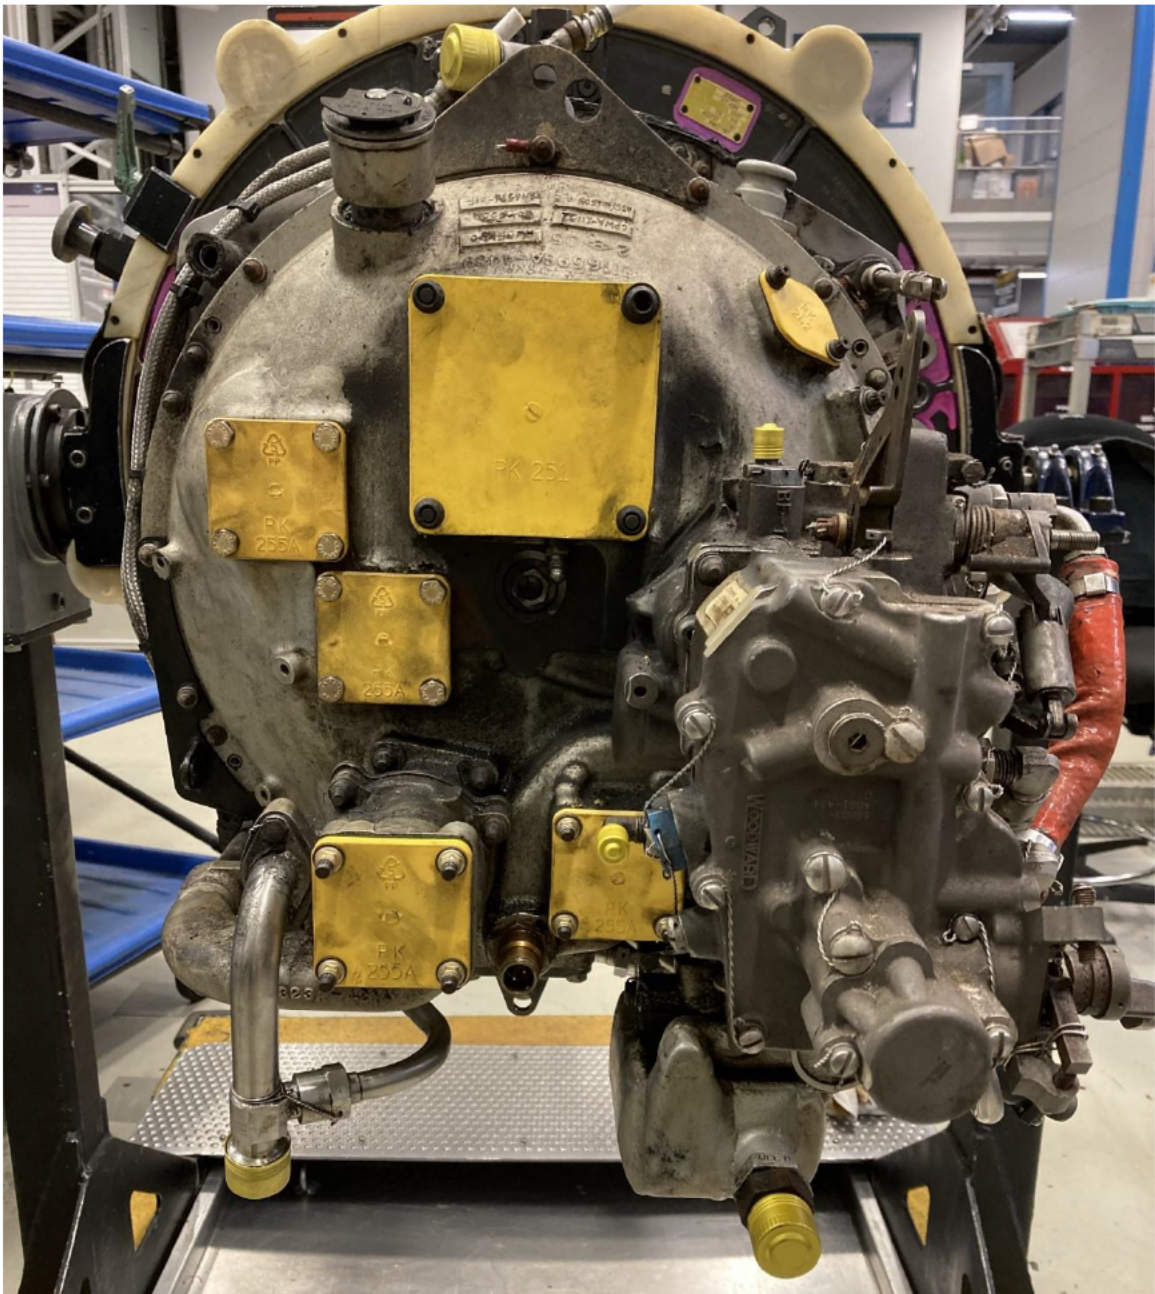
Photo No. 21, AGB Airframe Hardware Removed

- AGB, Photo No. 21
  - A/C compressor drive
  - Operator drive pump mating with scavenge pump drive
  - Starter Generator quad pad
  - Tachometer\Speed probe
- Cam Box, Photo No. 22
  - Aircraft cam lever with follower
  - Adjacent electronic switch
- RGB, Photo No. 23
  - Tachometer\Speed probe

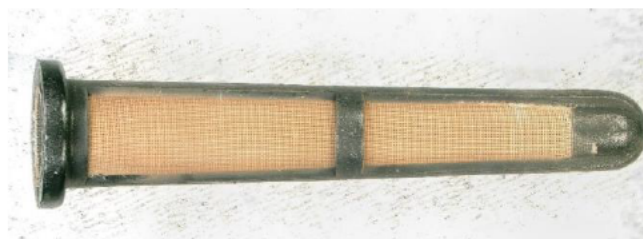
Figure 12

The fuel inlet strainer (Figure 11) and the tachometer valve strainer (Figure 12) showed a brownish-red deposit. The deposit was identified as a mixture of iron-sodium-sulfur-zinc rich particles as well as silicon rich particles (Figure 13).

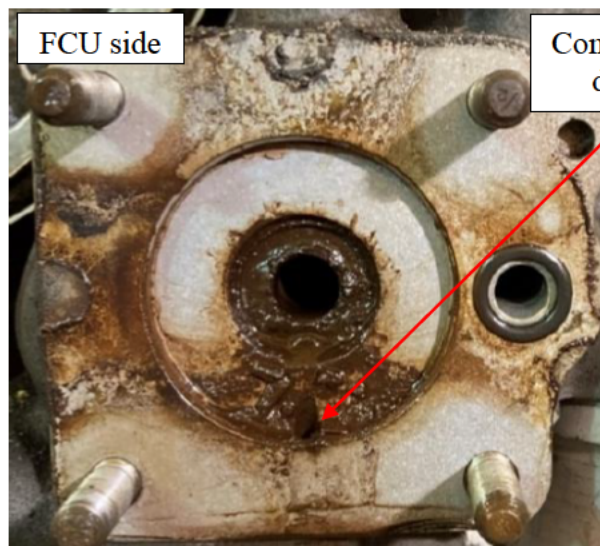
Figure 14

The external surfaces of the fuel pump were soiled. The FCU mounting flange face of the fuel pump showed brownish deposits and the drain area had presence of wet brownish debris (Figure 14). The brownish deposits were observed in the vicinity of the drain cavity on the engine accessory gearbox (AGB) side of the fuel pump. The surface between the AGB side carbon seal and the drain cavity was slightly wet (Figure 15). The drain port showed a brownish deposit with a wet appearance. The outlet filter was removed and found unremarkable. The inlet strainer was removed, and some debris was observed in the bottom of the strainer. The debris was collected and sent to the chemical laboratory for analysis. The fuel pump drive shaft was turning freely with the typical resistance and the running torque was measured at approximately 7 inch-pounds using a dial torque wrench. With the fuel pump drive shaft removed, the drive gear splines on the fuel pump drive shaft side were found in good condition, with presence of dark brownish debris (Figure 16). The drive shaft splines end face showed chipping, on the fuel pump side (Figure 17). Examination of the drive gear internal splines with a borescope showed wear on the FCU side (Figure 18 and Figure 19). The lockwire between the BF-1 and BF-2 fittings was loose. The lockwire on the outlet filter bowl was missing. All other lockwire and safety cable were present in the correct locations and in good condition.

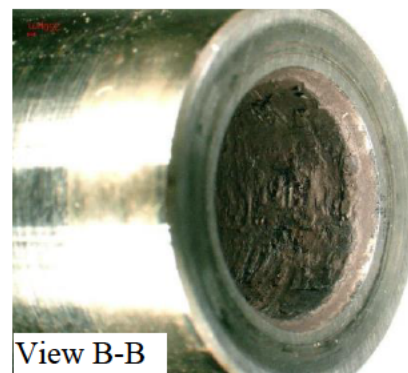
Figure 33

SEM-EDX analysis of the residue from the AGB side of the fuel pump drive gear (Figure 31, Figure 32) displayed iron, fluorine, oxygen, some carbon, and traces of chromium, aluminum, and sodium. FTIR displayed an organic material suggesting a perfluorinated grease. The residue is possibly a mixture of an iron-oxide material with a grease. The residue present in the FCU drive side (Figure 31, Figure 33) was rich in iron, oxygen, and traces of chromium suggesting an iron-oxide material.
