# National Transportation Safety Board

## **MATERIALS LABORATORY**

Factual Report 24-030

Location: Waldorf, Maryland  
Date: July 9, 2023  
Vehicle: Hughes 369D, N5027P  
Investigator: Chihoon Shin, AS-40

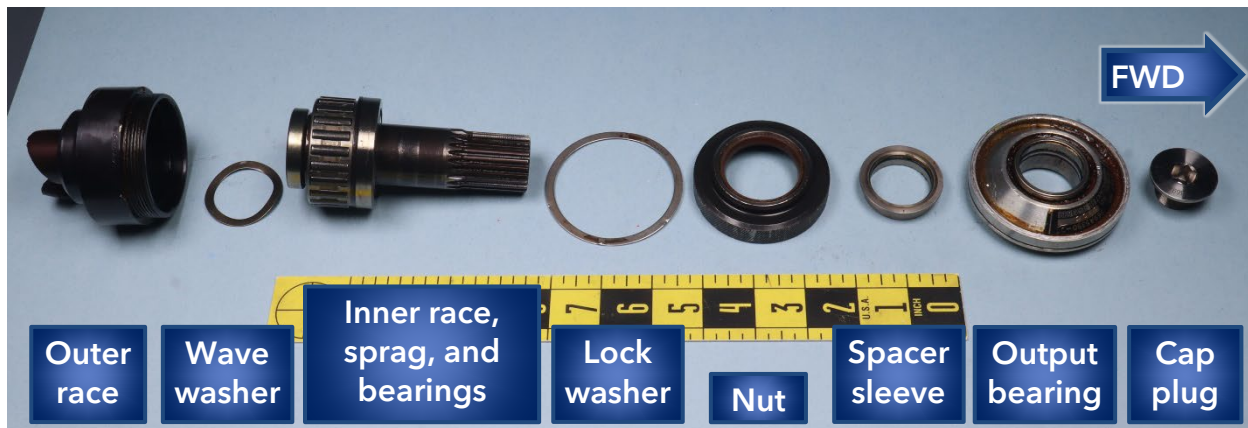
To facilitate further examination of the overrunning clutch subassembly and fractured clutch outer race, the subassembly was disassembled as shown in figure 7, where the labeled parts are displayed in their relative positions in the assembly. The clutch outer race was then cleaned using an ultrasonic cleaner while submerged in a beaker of acetone. Views of the interior surfaces of the outer race after cleaning are shown in figures 8 and 9. Wave washer contact marks were observed at the forward end of the interior cavity as indicated in figure 8. The shoulder associated with contact with the sprag cage is also indicated. The sprag cage contact face had a slightly rubbed surface appearance, and part markings on the aft side of the sprag cage were observed transferred to the corresponding shoulder on the clutch outer race. The part markings were repeated at multiple locations around the circumference consistent with relative rotation between the sprag cage and the clutch outer race.

**Figure 7.** Disassembled pieces of the overrunning clutch subassembly.

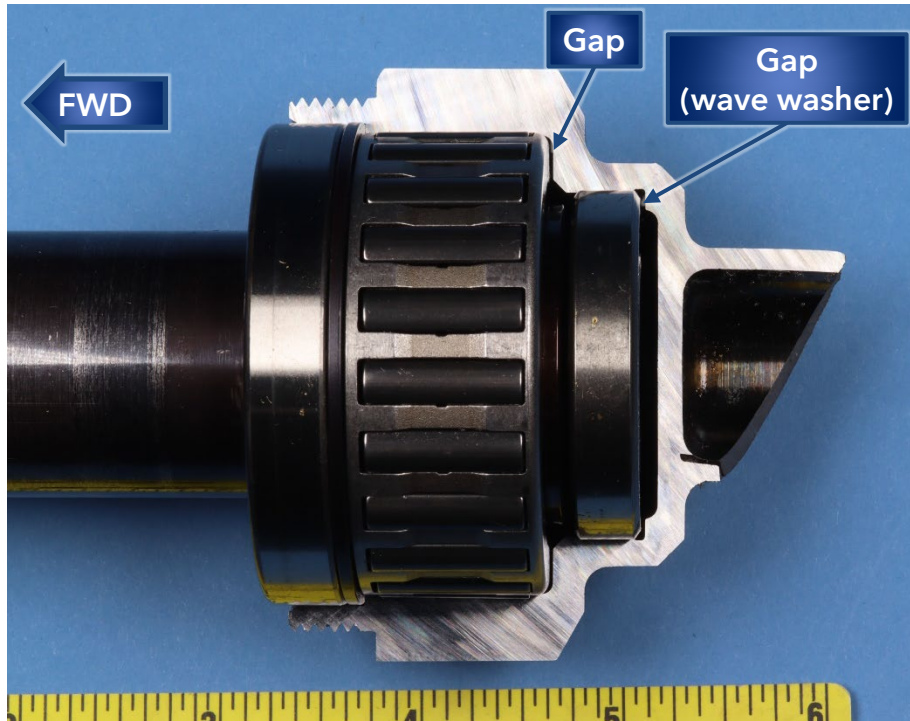
The clutch outer race was sectioned using water-cooled abrasive saws to facilitate a more detailed examination of fracture features. After sectioning, the inner race with attached bearings and sprag assembly were placed in the sectioned clutch outer race as shown in figure 12. Based on measurements of the length of the sprag raceway on the clutch outer race and the length of the sprag assembly cage, the combined total gap on each side of the sprag assembly was 0.014 inch with the ring spacer tight against the corresponding shoulder on the clutch outer race. At the aft face of the aft sprag bearing, the gap for the wave washer was calculated to be 0.018 inch to 0.020 inch. The thickness of the wave washer was 0.0160 inch.

**Figure 12.** View of the clutch inner race and attached sprag assembly and sprag bearings positioned in the sectioned clutch outer race.

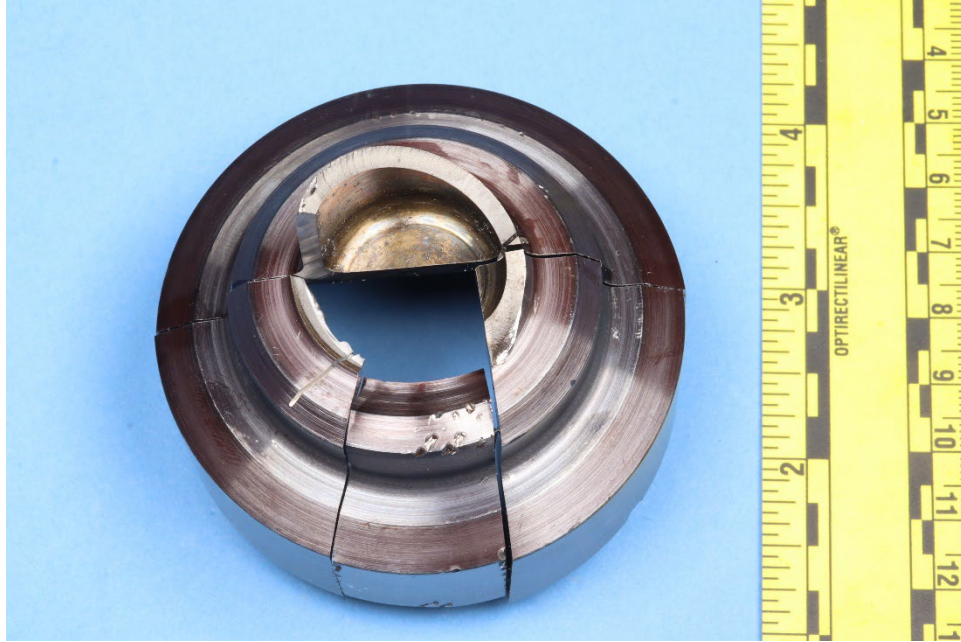
Multiple cuts were made through the clutch to reveal fracture features for examination. Several longitudinal cuts were made with water-cooled abrasive saws, and then handheld metal hacksaws, jeweler's saws, and files were used to make wedge-shaped backcuts into the wall toward the circumferential crack tip on each piece. The pieces containing the cracks were then bent and pinched as needed in a vice and with pliers to facilitate the opening of the cracks. A view of the clutch outer race after lab fractures were completed is shown in figure 13.

**Figure 13.** Clutch outer race after sectioning and subsequent lab-induced fractures to open the circumferential crack in the fillet radius.

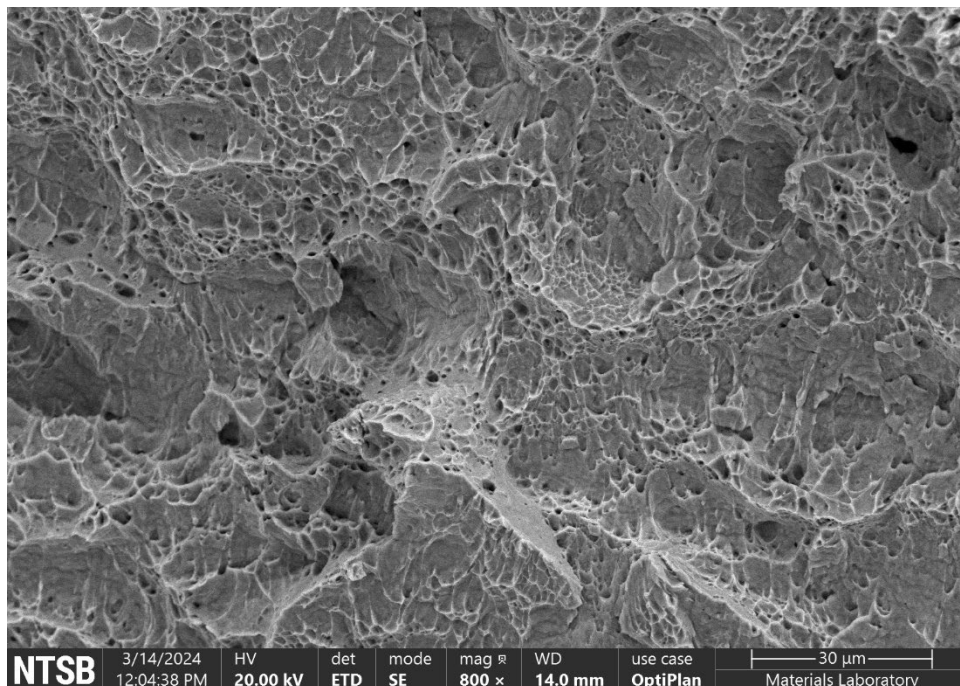
A view of typical circumferential crack fracture features where the intergranular fracture transitioned to transgranular fracture is shown in figure 22. Another view of typical fracture features in the transgranular portion of the crack is shown in figure 23. The transgranular fracture features had feathery features with limited secondary crack openings consistent with high cycle fatigue. In the lab-induced overstress region, ductile dimple features were observed as shown in figure 24.

**Figure 24.** Typical ductile dimple fracture features in the overstress region in the lab-induced portion of the fracture.

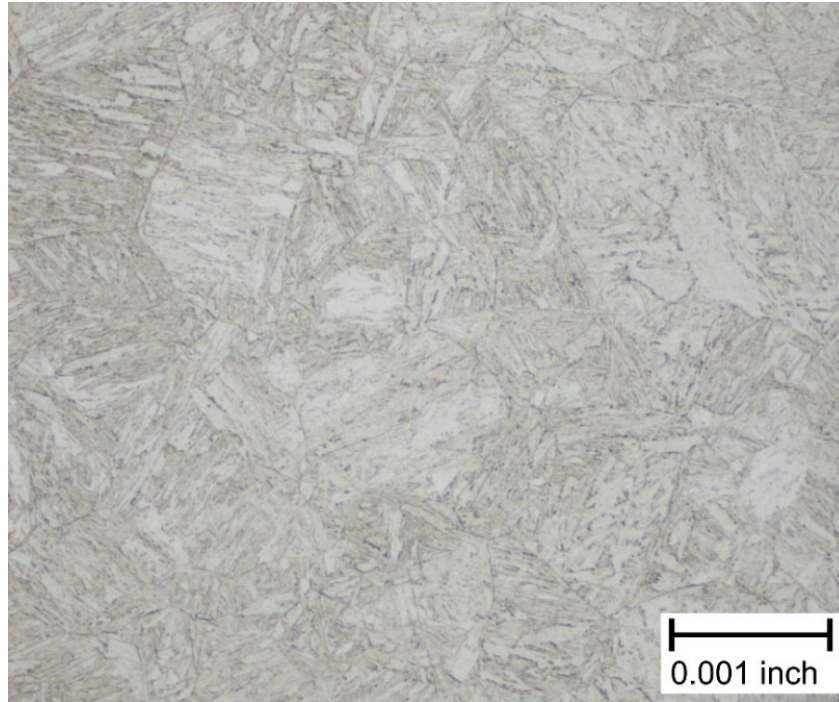
appearance adjacent to the external surface (figure 31) as in the core away from the surface (figure 32). The opened circumferential crack showed an intergranular fracture path extending from the external surface that appeared to follow the prior austenite grain boundaries. Some crack branching was observed as indicated, but the branching cracks were generally limited less than 2 grains from the main crack path. A secondary microcrack with limited branching and an intergranular fracture path extending approximately 2 grains deep in the polished plane was observed emanating from the external surface in the fillet area adjacent to the primary crack as shown in figure 31.

**Figure 32.** Optical micrograph of typical microstructural features at the core of the clutch outer race. (Etchant: 2% nital)

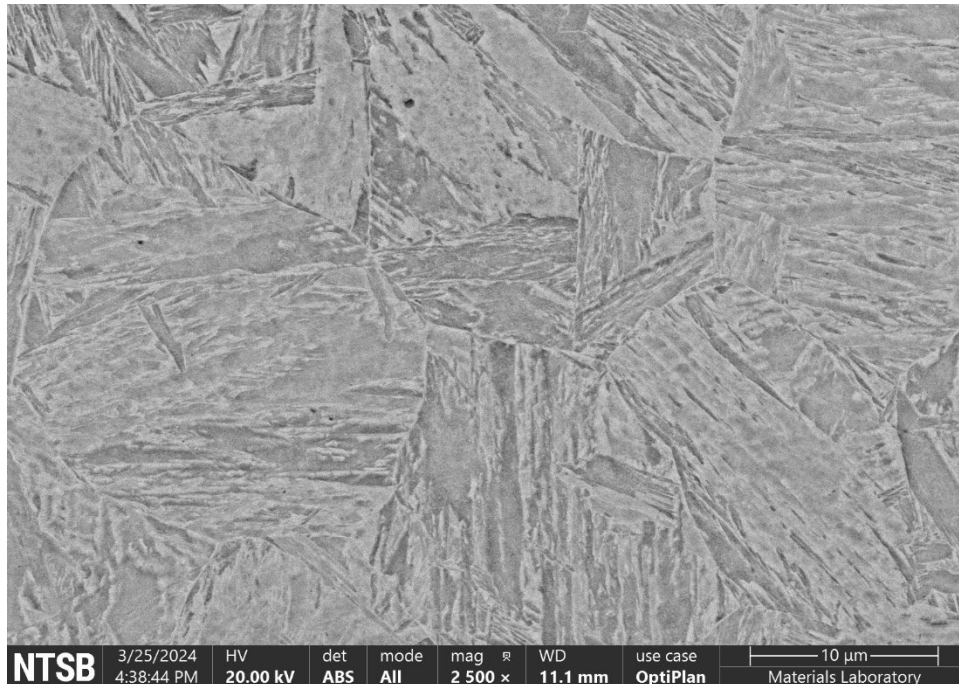
The metallographic sample shown in figure 31 was further examined using the SEM. Images of the typical etched microstructure are shown in figures 33 through 35 as imaged using the backscattered electron detector in composition mode. The microstructure adjacent to the exterior surface in the fillet region is shown in figure 33, and the microstructure adjacent to the surface further forward on the shoulder for the clutch outer race is shown in figure 34. Both areas had similar microstructural features, and both were similar to the microstructure deeper into the wall thickness adjacent to the circumferential crack surface where the crack had a transgranular fracture path as shown in figure 35.

**Figure 33.** SEM image of typical etched microstructural features adjacent to the exterior surface in the fillet region viewed using the backscattered electron detector in composition mode. (Etchant: 2% nital)

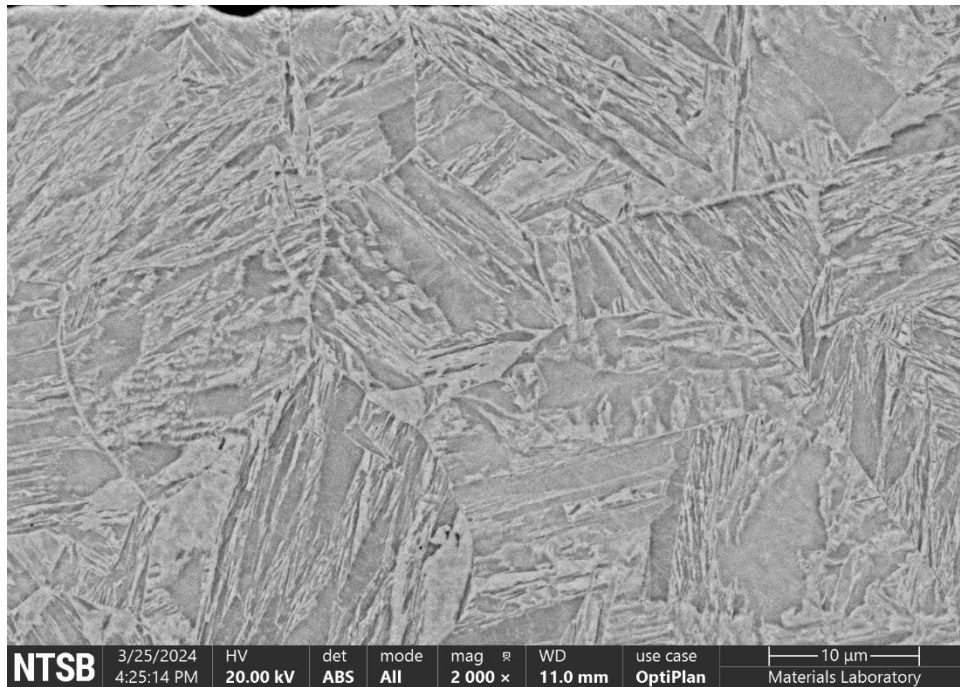
**Figure 34.** SEM image of typical etched microstructural features adjacent to the exterior surface in the shoulder forward of the fillet radius viewed using the backscattered electron detector in composition mode. (Etchant: 2% nital)
