# National Transportation Safety Board

ERA23LA293

Specialist's Factual Report

Location: Waldorf, Maryland  
Date: July 9, 2023  
Time: 1027 eastern daylight time  
Helicopter: MD Helicopters 369D, registration N5027P

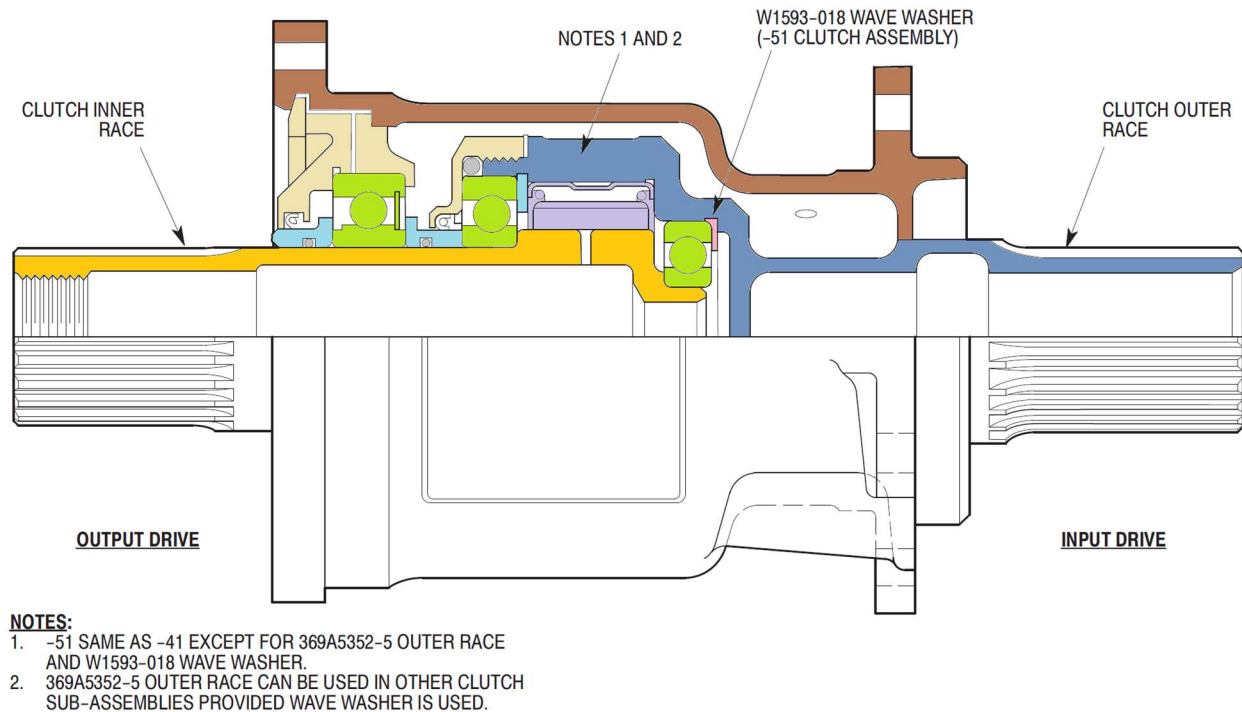
**Figure 3.** A cutaway view showing the internal components of the overrunning clutch assembly. The input drive (right side) is driven by the engine. The output drive (left side) provides drive to the engine-to-transmission (Kaflex) drive shaft. (Image courtesy of MD Helicopters)
