# Investigator notes

USA (Leipsic, OH) Air Tractor AT502B N5048S engine fire 04 August 2023. 1954 eastern daylight time, an Air Tractor AT-502B, N5048S, was substantially damaged when it was involved in an accident near Leipsic, Ohio. The pilot was not injured. The flight was operated as a Title 14 Code of Federal Regulations Part 137 aerial application flight. The pilot had been applying fungicide to several fields, during which he noted no engine performance anomalies. Shortly after starting the second spray run in a field, he heard a pop sound. He saw flames coming out of the engine exhaust stacks and the engine stopped producing power. He performed a forced landing to a neighboring field and the airplane ground-looped in the high crops. Examination of the wreckage by a Federal Aviation Administration inspector revealed that the airplane came to rest upright with substantial damage to the left wing. The NTSB is investigating.

WO 23-1215 reviewed

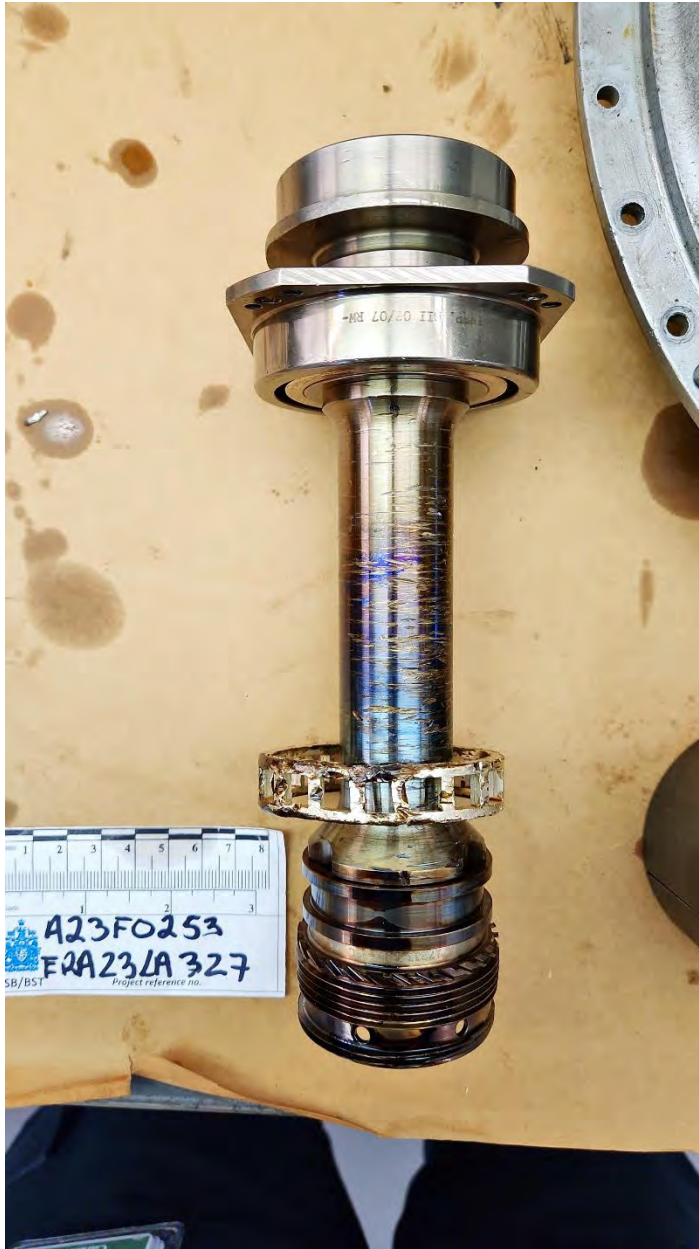
PT shaft overheat signature.

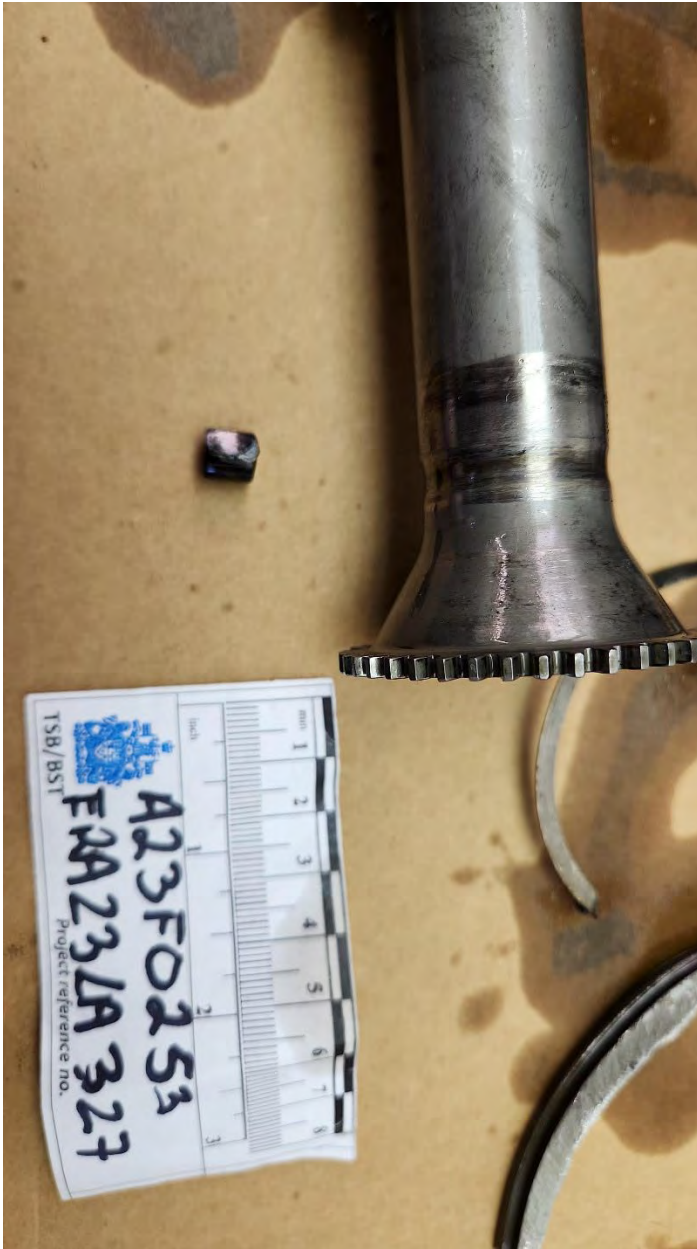
Most likely this roller was stuck between shaft and tube

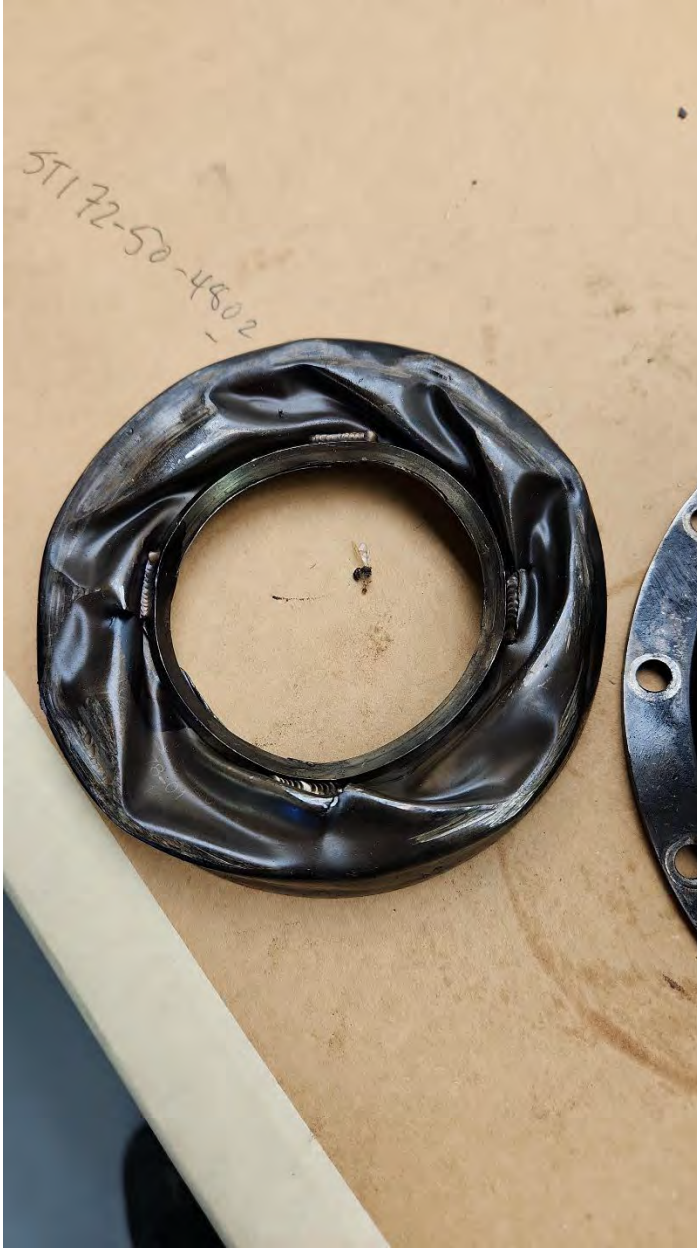
Tip of power turbine shaft casing between bearing 3 and PT wheel
