### N8443M Inspector Kachinski On-Scene Investigation Statement

On 09/14/2023 at approximately 1900Z, it was reported that N8443M, A 1976 Cessna 182P, Serial Number 18264605 experienced engine issues and made a forced landing in a soybean field located at [REDACTED] Prospect TN. Upon landing through the soybean field, it appeared that the nose landing gear (and confirmed by the pilot) struck a rut thus resulting in the separation of the nose landing gear from the aircraft and the aircraft flipping over and coming to a rest in an inverted state. It was reported that there were 2 POB with no injuries.

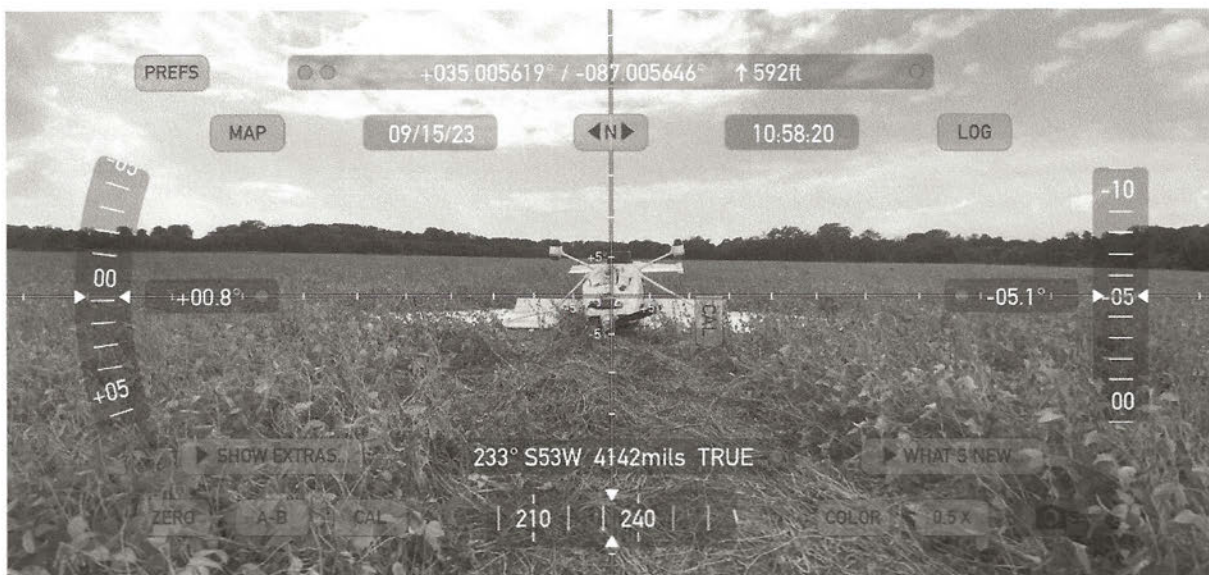
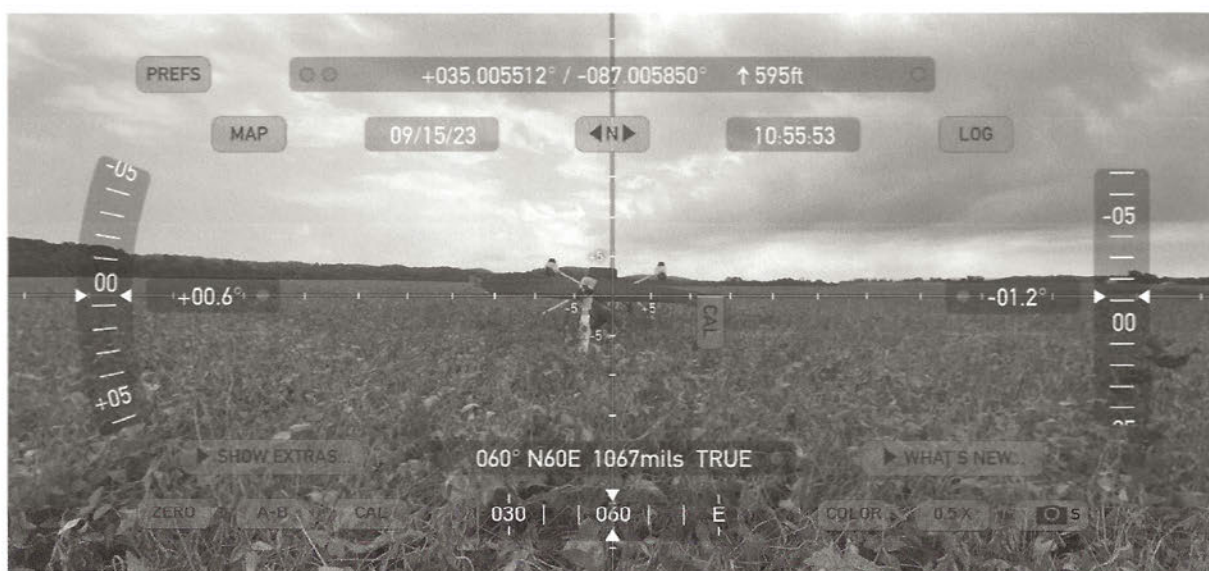
There was approximately 300 feet of soybean that appeared to be pushed down and showed the path of travel of the aircraft upon landing. The path was approximately 129 inches across. Direction of travel/landing was toward a southwest direction. The aircraft was in an inverted position with the tail facing a southwest direction and the nose facing a northeast direction.

Photos taken using Theodolite app on Inspector Kachinski's Apple iPhone.
