# National Transportation Safety Board

ERA24FA078

## **SOUND SPECTRUM**

Location: Mooresville, North Carolina  
Date: December 31, 2023  
Time: 12:13 eastern standard time (EST)  
Aircraft: Piper Aircraft PA46R-350T, N539MA

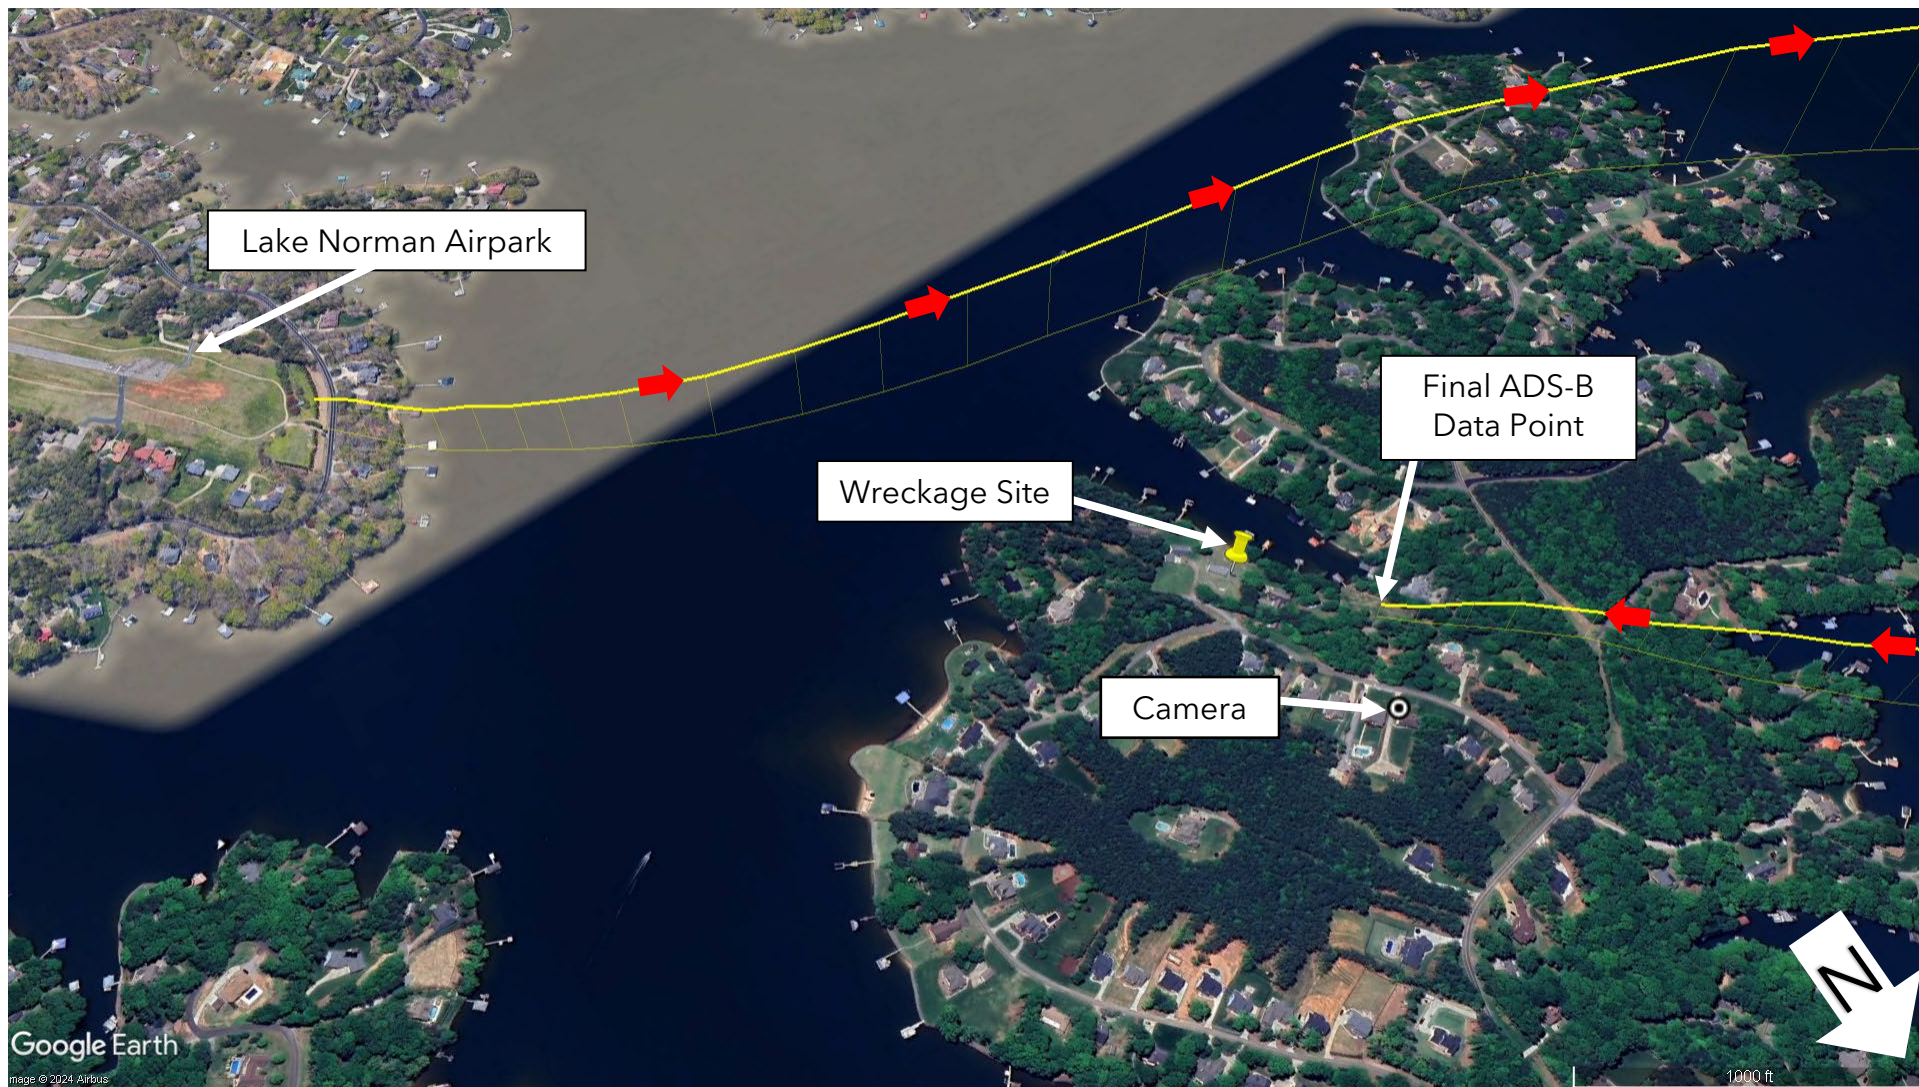
Figure 1 is a Google Earth overview of the accident area. The location of the camera, Lake Norman Airpark, the ADS-B track of the accident aircraft including the final recorded data point, and the approximate location of the wreckage are shown. Note that the weather and lighting conditions in the Google Earth overview are not necessarily representative of the weather and lighting conditions at the time of the accident.

**Figure 1.** Google Earth overview of the flight path, location of the camera, Lake Norman Airpark, and the accident aircraft's wreckage. Red arrows along the flight path show the direction of travel.
