# National Transportation Safety Board

ERA24FA104

## **AIRCRAFT INFORMATION AND WRECKAGE EXAMINATION SUMMARY**

Location: Clearwater, Florida  
Date: February 1, 2024  
Time: 1907 EST  
0007 coordinated universal time (UTC), UTC Date February 2, 2024  
Airplane: N6659L, Beech V35B

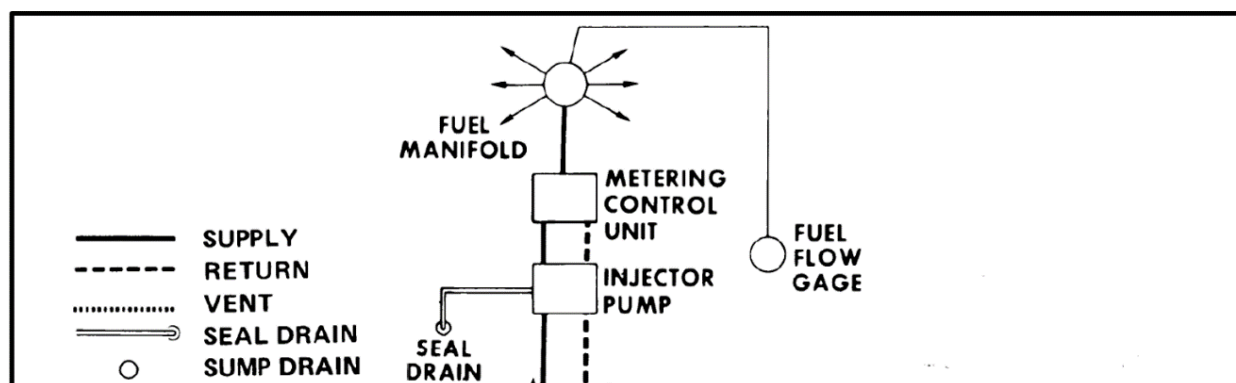
**Figure 4 View of the Fuel Supply and Return Systems Firewall Forward.**

The airplane's fuel supply and return systems forward of the firewall consisted in part of an engine-driven fuel pump, unmetered fuel hose from the engine-driven fuel pump to the metering valve, mixture return hose from the metering valve to the engine-driven fuel pump, metered fuel hose from the metering valve to the fuel manifold valve, fuel injector lines from the fuel manifold valve to fuel injector nozzles installed in each cylinder (Figure 4).

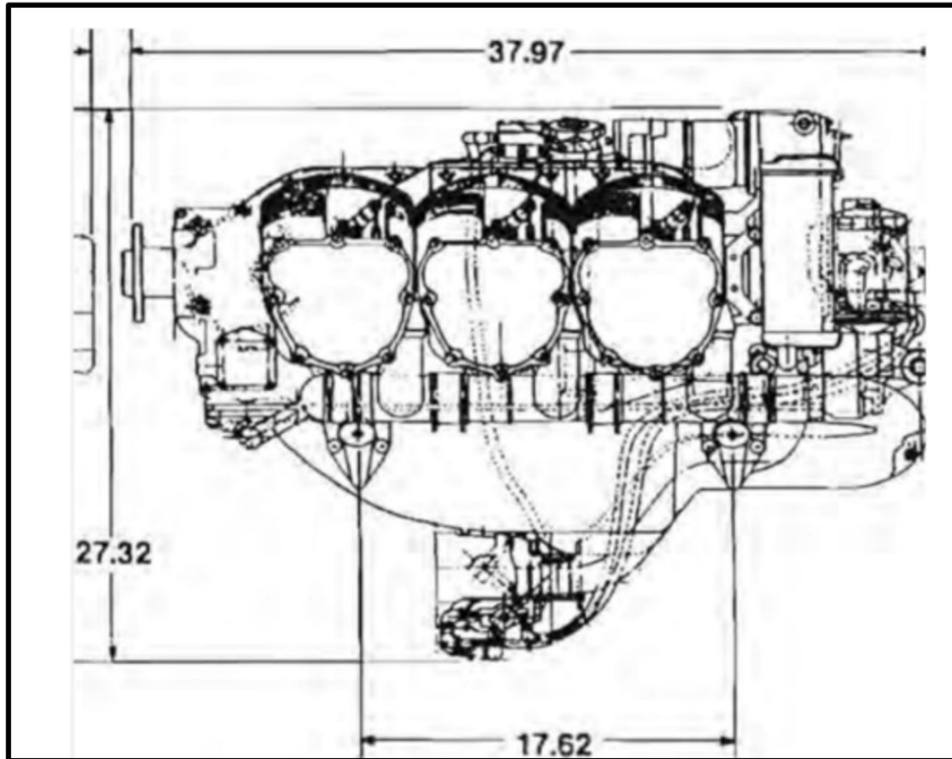
The unmetered fuel supply hose from the engine-driven fuel pump to the metering valve, the metered fuel supply hose from the metering valve to the manifold valve, and the mixture return hose from the metering valve to the engine-driven fuel pump were routed on the right side of the engine (Figure 5).

**Figure 5 Left Side Engine View from the Continental IO-520 Permold Series Overhaul Manual. Note the fuel supply and mixture return hoses on the right side of the engine compartment.**

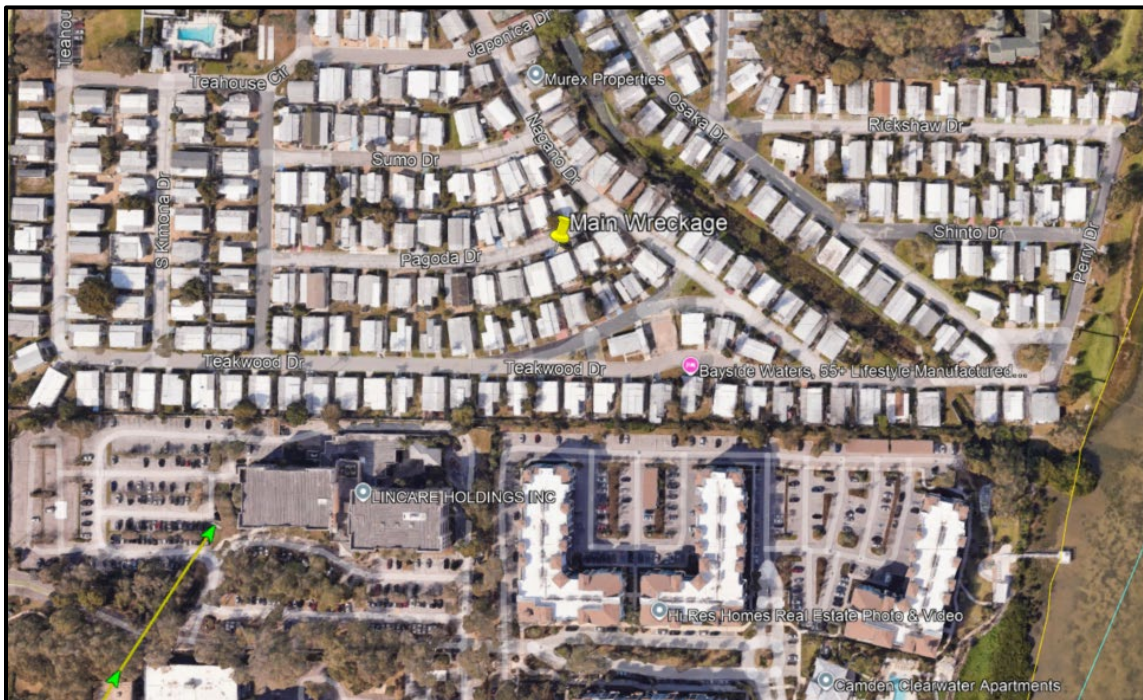
The airplane crashed in a densely populated manufactured home community called Bayside Waters (Figure 6). Four manufactured homes sustained varying degrees of damage.

Further examination of the accident site revealed the first impact location along the route of flight was on the roof of the adjacent manufactured home at 2645 Pagoda Road. A portion of the right-wing fuel tip tank was found on top of the house. Fragments of the right fuel tip tank were also found inside the home. The roof exhibited a tear in the roof oriented on a magnetic heading of 075°. The damage was located at 27.950134° north latitude and -082.727050° west longitude.

**Figure 6 Annotated Google Earth Image Showing ADS-B Targets, and Accident Site Location**
