ERA24FA110

Group Chair's Factual Report – Attachment 5

GE Research CF34 Filter Analysis 051624

# — GE Aerospace Research CF34 Filter Analysis

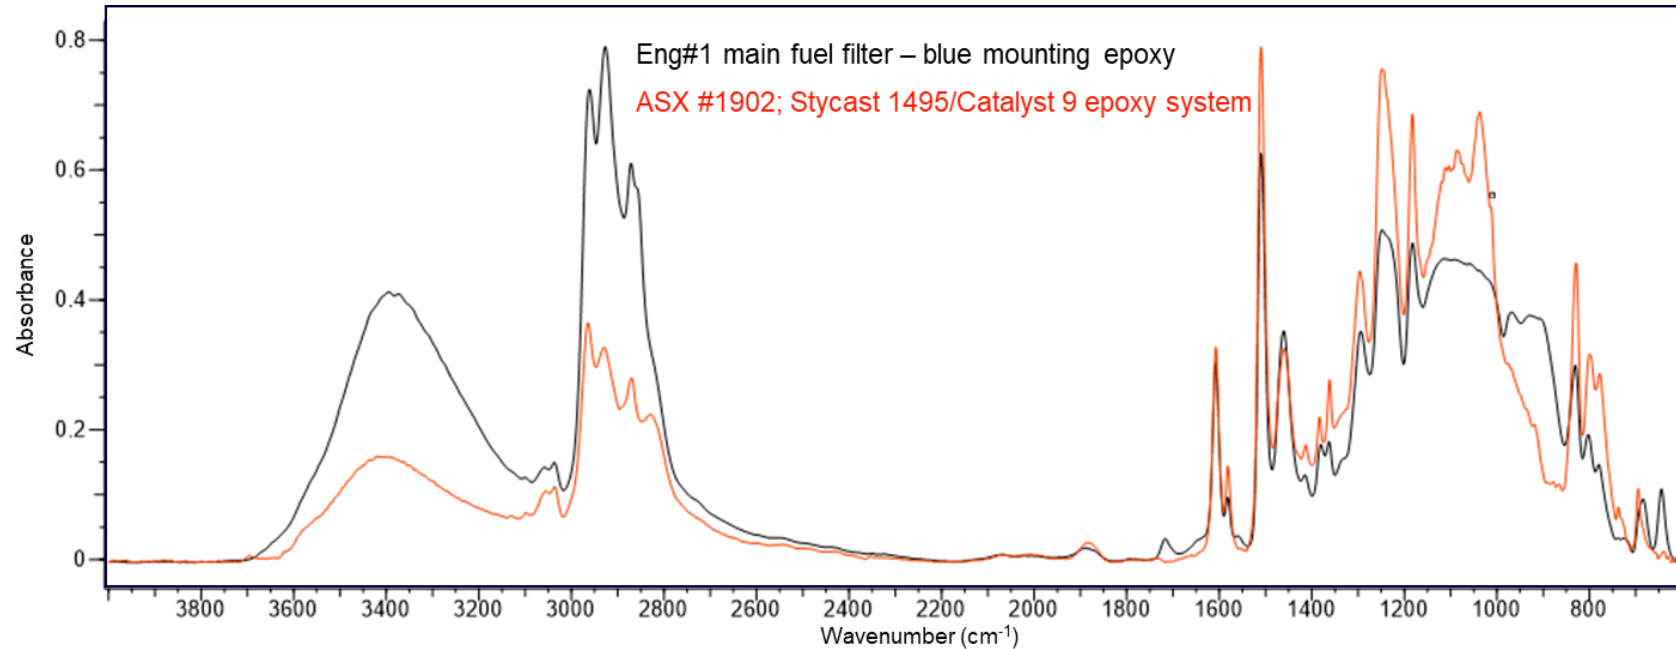
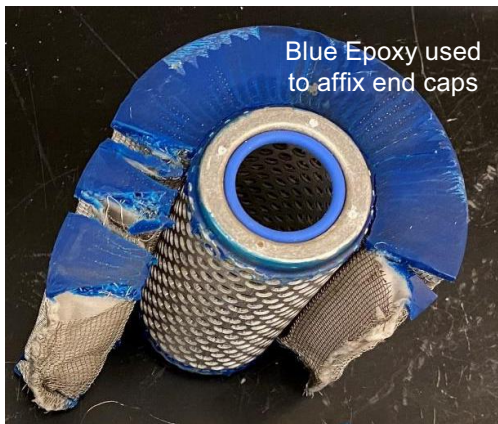
# IR Spectroscopy of Epoxy used to Assemble Main Fuel Filter

The blue epoxy used to affix the fuel filter end caps was also analyzed for comparison to the IR features of any recovered FOD.

Disassembling the filter yields a fair number of blue epoxy particles which need to be distinguished from the FOD

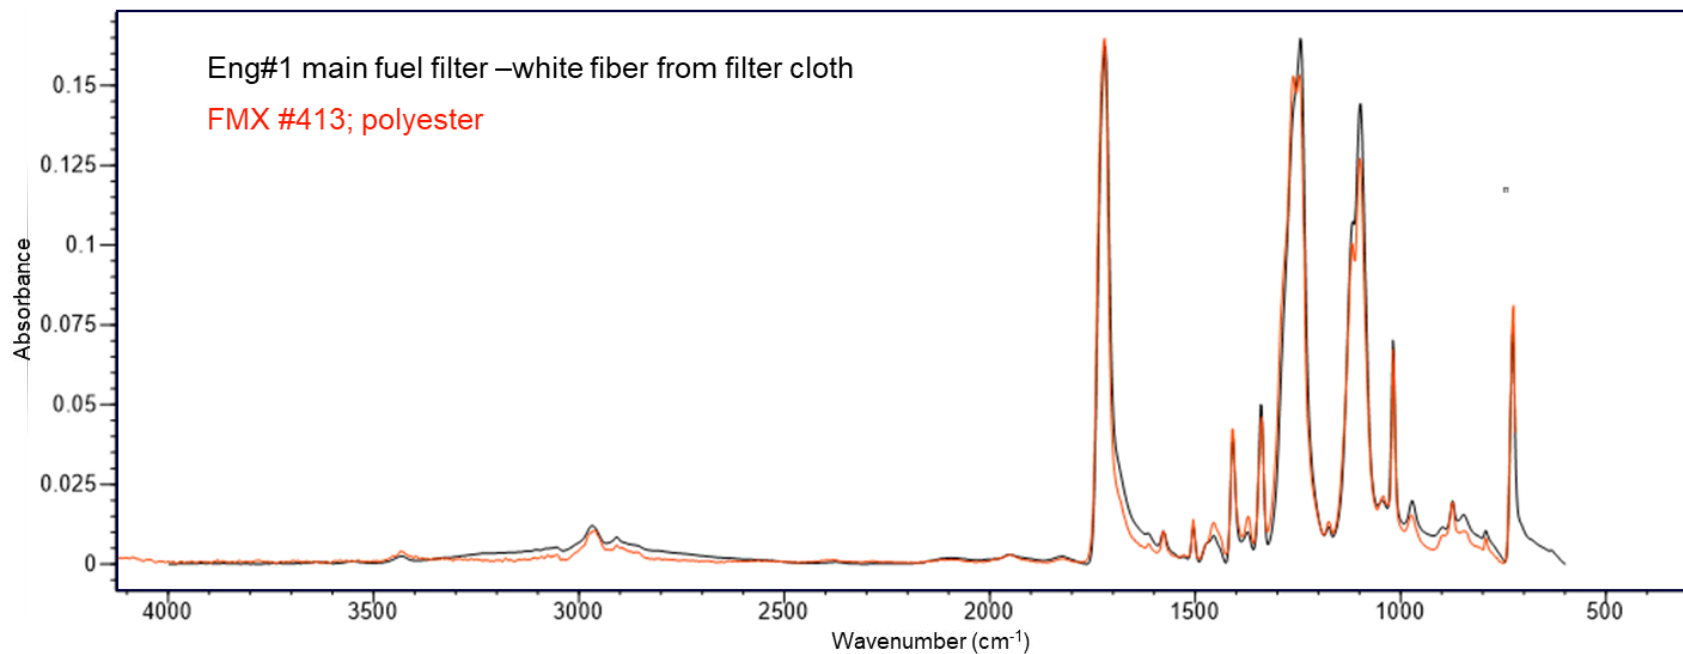
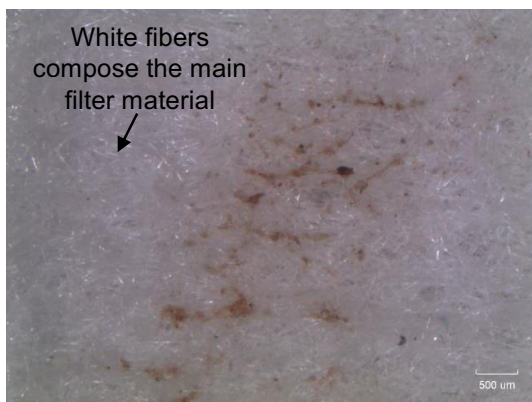
# IR Spectroscopy of Filter Media from Main Fuel Filter Eng#1

The filter material was also analyzed for comparison to the IR features of any recovered FOD.

White fibers that compose the cloth filter layer are a good match to the IR spectral features of a **polyester**.

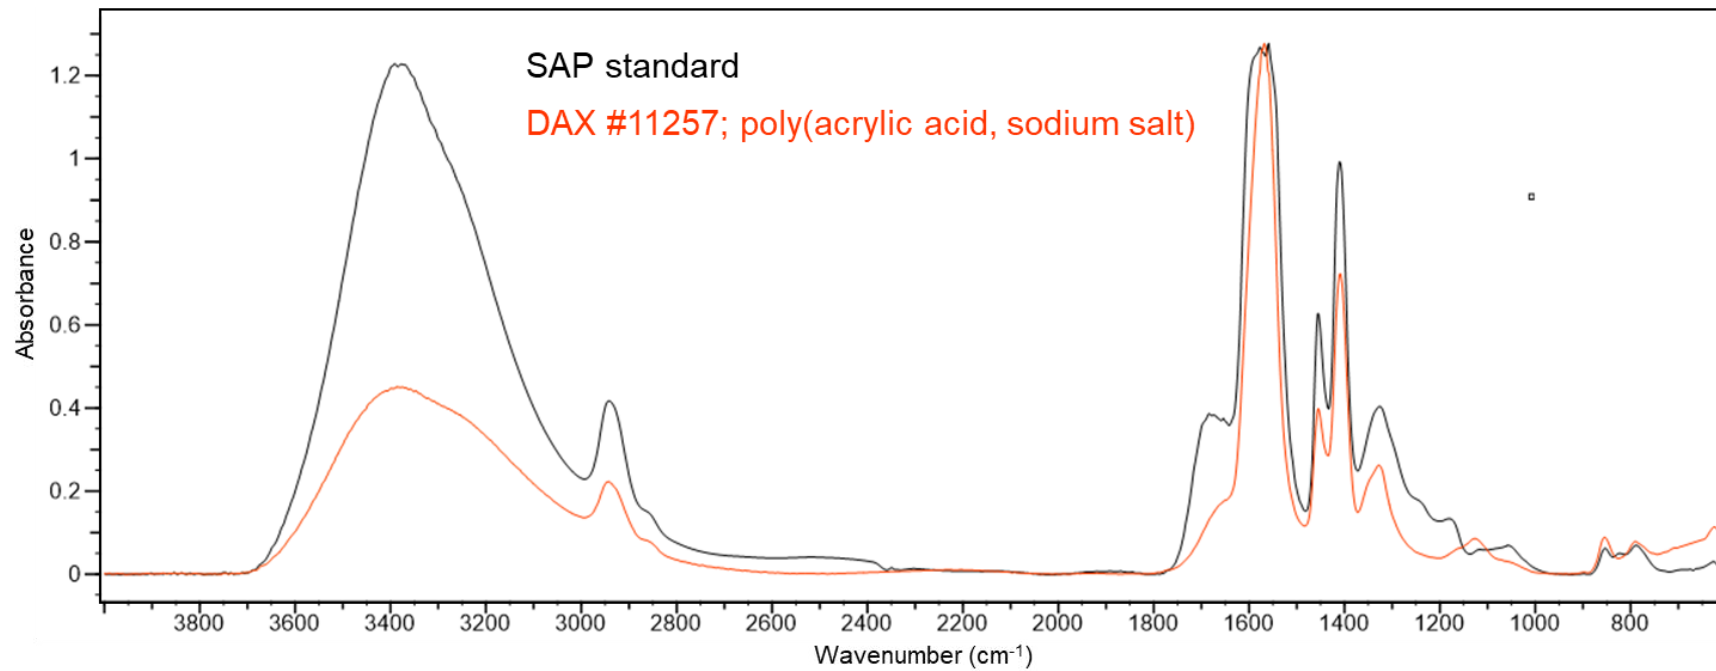
# IR Analysis of SAP Standard

The IR spectrum of SAP (super absorbent polymer) is shown here for comparison.

No signs of the SAP IR signature were found in these fuel and filter samples
