# National Transportation Safety Board

ERA24FA127

## **SOUND SPECTRUM**

Location: Nashville, Tennessee  
Date: March 4, 2024  
Time: 19:43 central standard time (CST)  
Aircraft: Piper Aircraft PA32RT-300T, C-FBWH

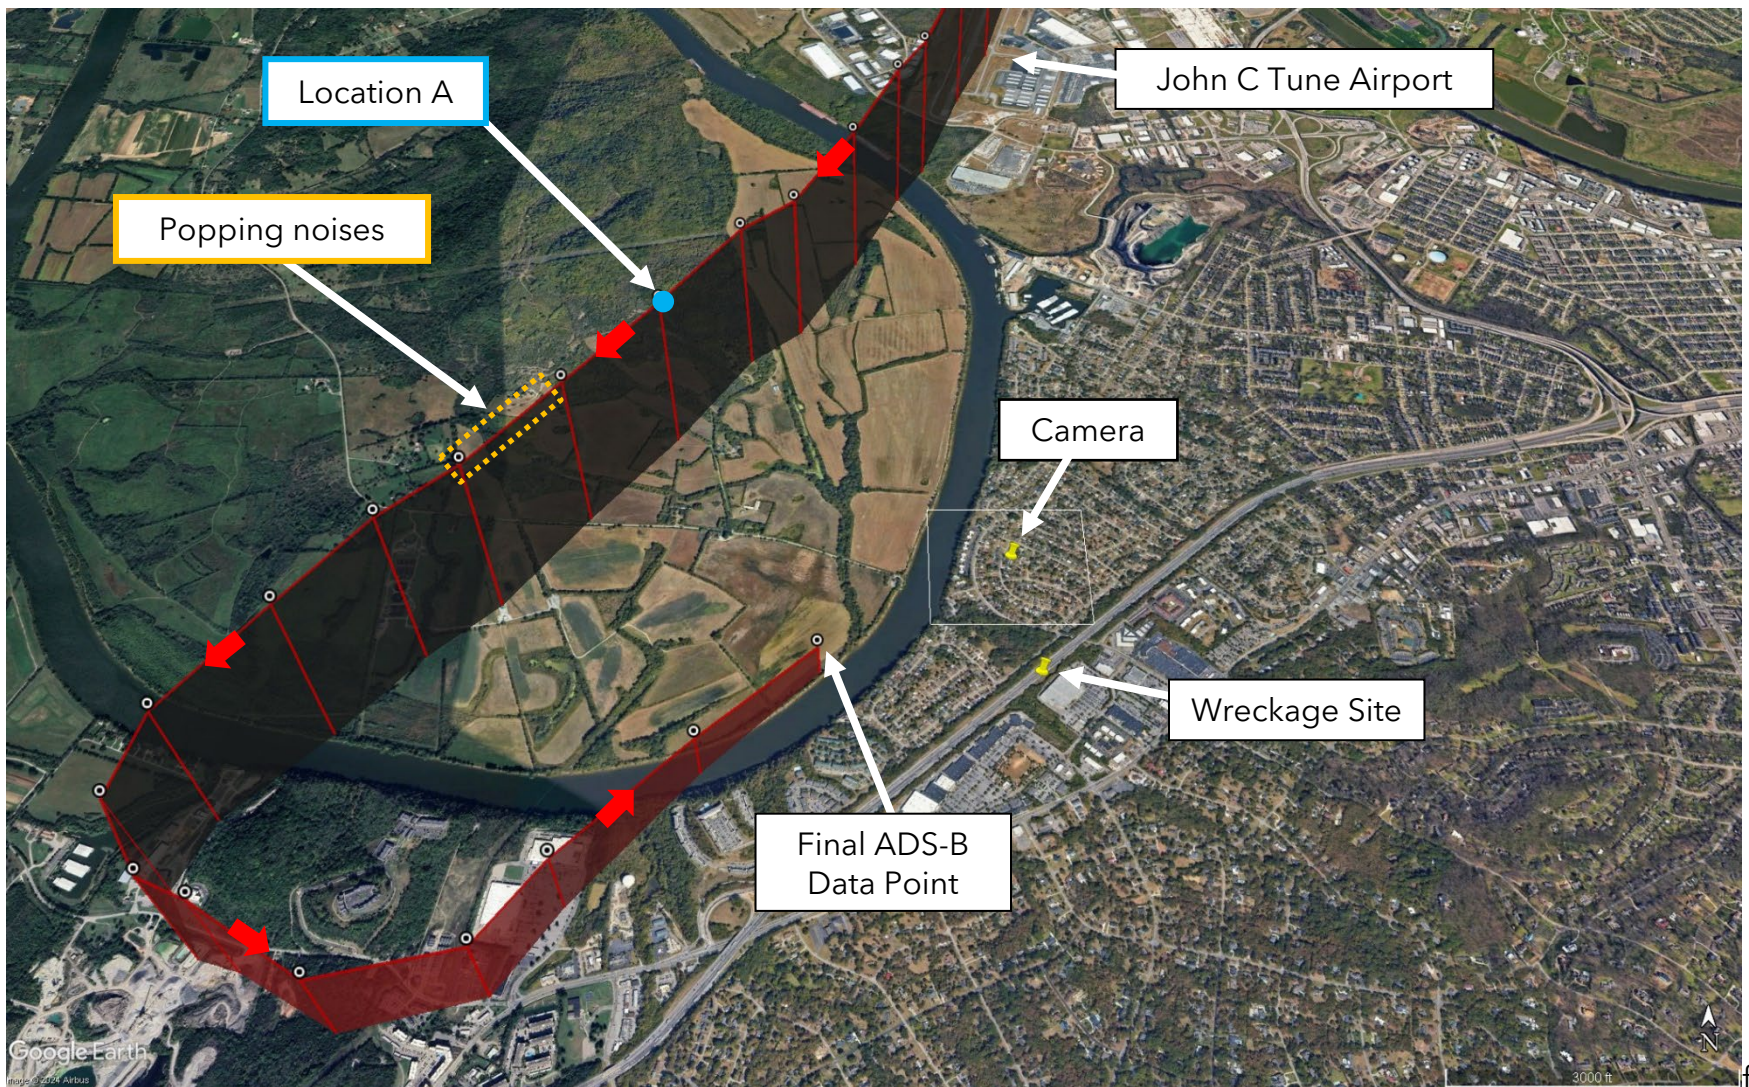
Figure 1 is a Google Earth overview of the accident area. The location of the camera, John C. Tune Airport (JWN), the ADS-B track of the accident aircraft including the final recorded data point, and the approximate location of the wreckage are shown. Note that the weather and lighting conditions in the Google Earth overview are not necessarily representative of the weather and lighting conditions at the time of the accident.

To simplify the engine speed calculation, a point on the flight path where the Doppler effect was not present was identified. At approximately 19:41:17 CST, the airplane was moving perpendicularly to the camera's line of sight (Location A in Figure 1). At this point, the frequency recorded by the camera matched the frequency emitted by the airplane.

**Figure 1.** Google Earth overview of the final 3 minutes of the accident flight, annotated with locations and events. Red arrows along the ADS-B flight path show the direction of travel. (Source: Google Earth, annotated by NTSB)
