# National Transportation Safety Board

ERA24FA160

## WRECKAGE EXAMINATION

Location: Mulberry, Florida  
Date: April 2, 2024  
Time: 1038 EDT  
1438 UTC  
Motorglider: N622PC; Aeromarine Merlin Lite

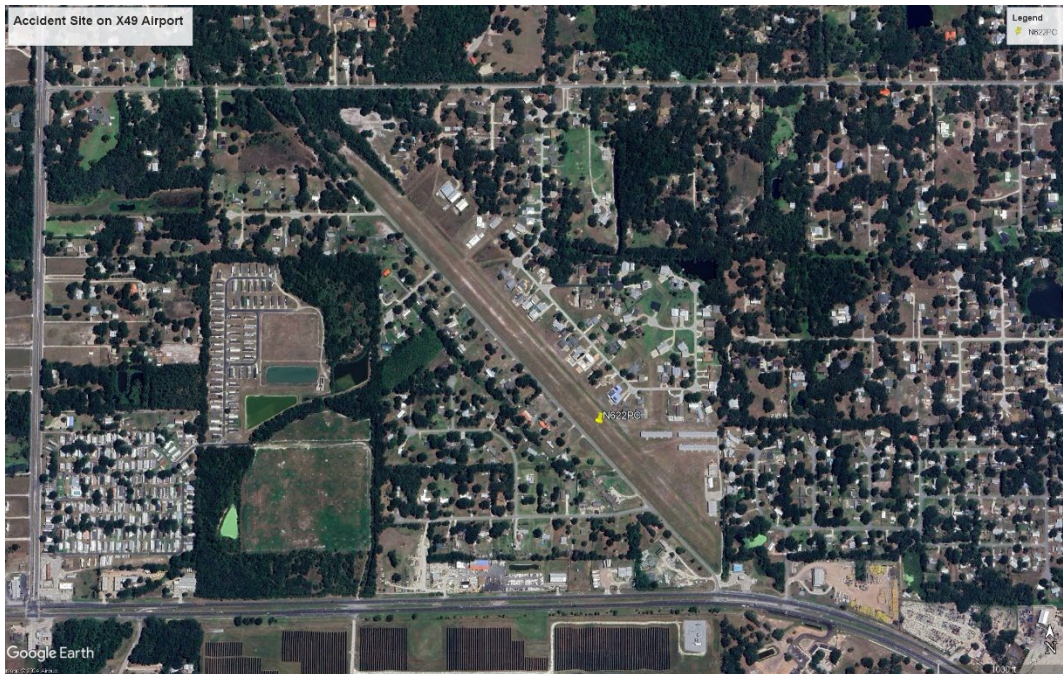
The motorglider came to rest on runway 14/32 at South Lakeland Airport (X49), Lakeland, FL about 1500 ft from the threshold of runway 14.

**Photo 1: Google Earth view of the accident site.**

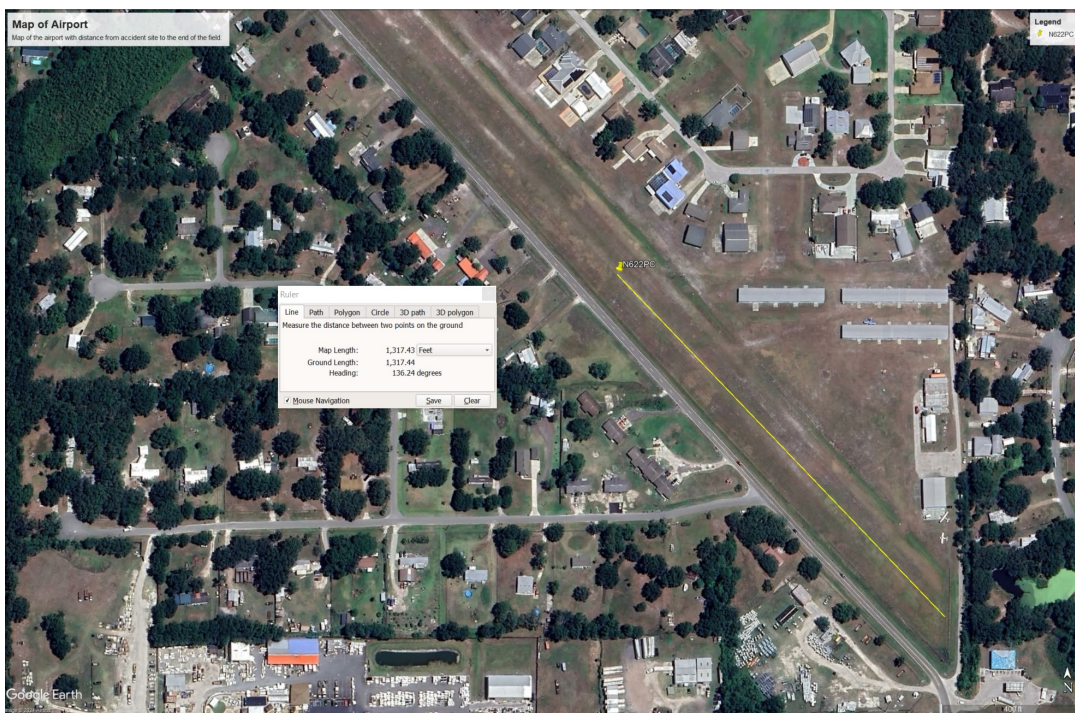
**Photo 2: Google Earth view with distance remaining from the accident site to the end of the available grass area.**
