# National Transportation Safety Board

ERA24FA209

## **STRUCTURES**

Group Chair's Factual Report

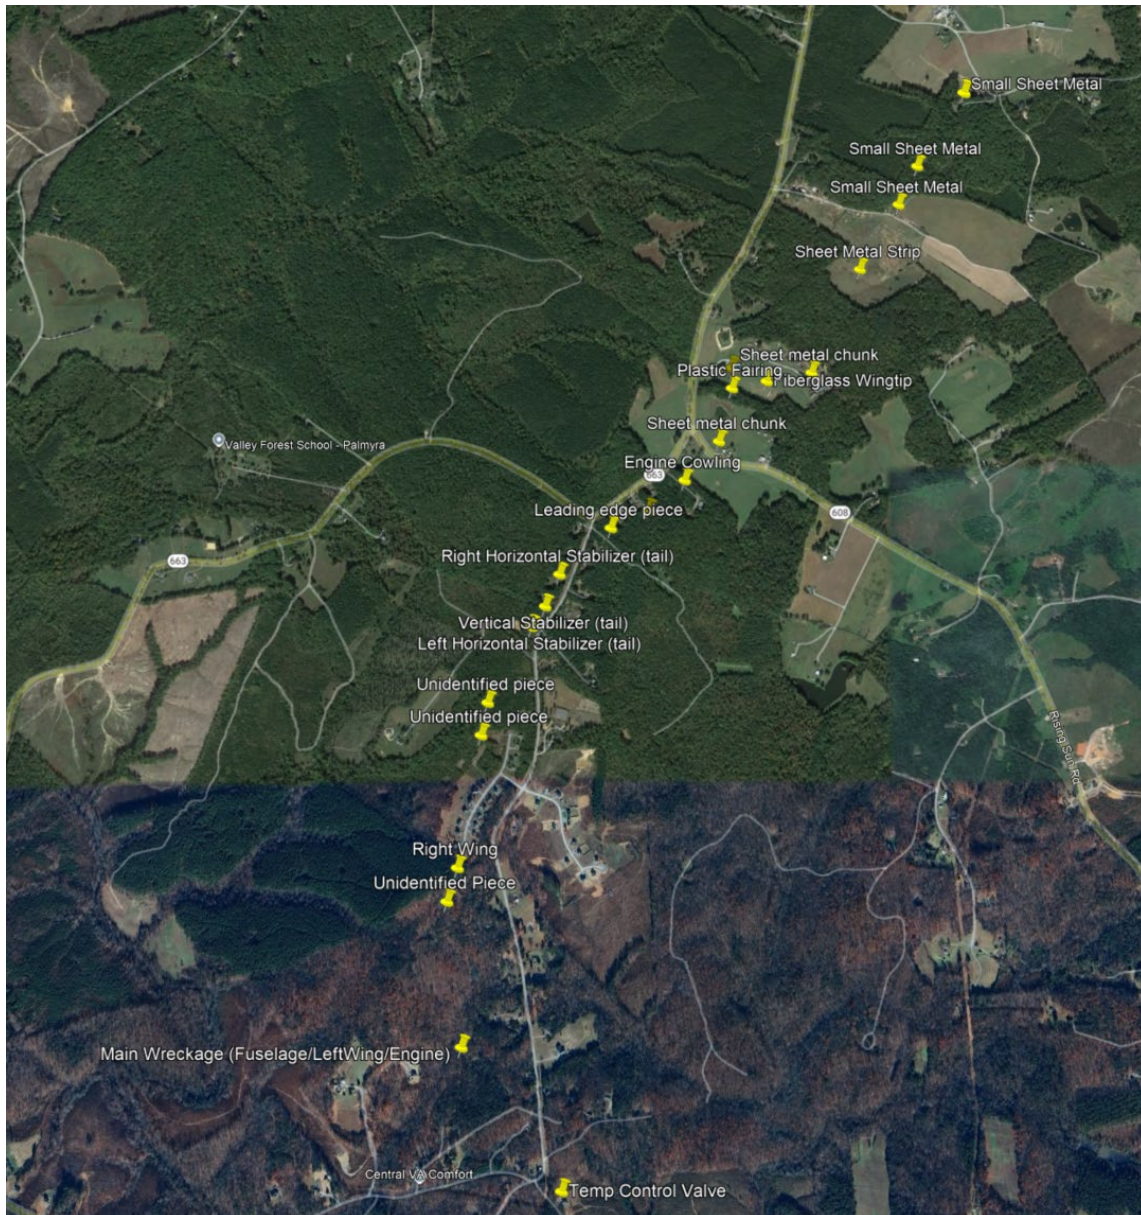
**Figure 2.** Wreckage Debris Map (NTSB image)

The airplane was found in the woods near Palmyra, VA and several components of the airplane were found scattered through the terrain. Farthest from the main wreckage were sheet metal pieces, followed by the right horizontal stabilizer, the vertical stabilizer, and the left horizontal stabilizer and then the right wing.
