# National Transportation Safety Board

ERA24LA066

## **MATERIALS LABORATORY**

Factual Report 24-072

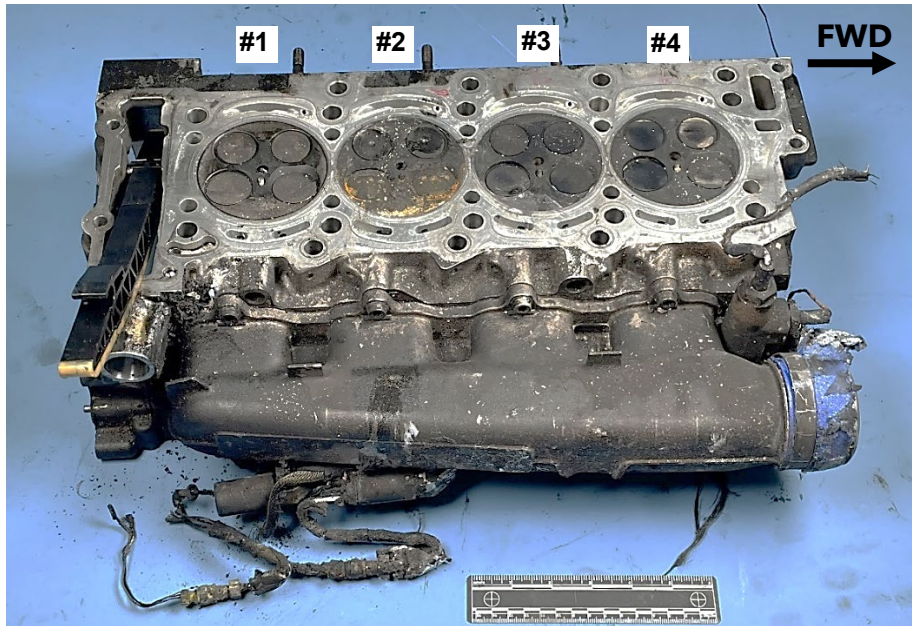
**Figure 3.** As-received cylinder head showing the bottom surface. Cylinders are numbered #1 through #4.

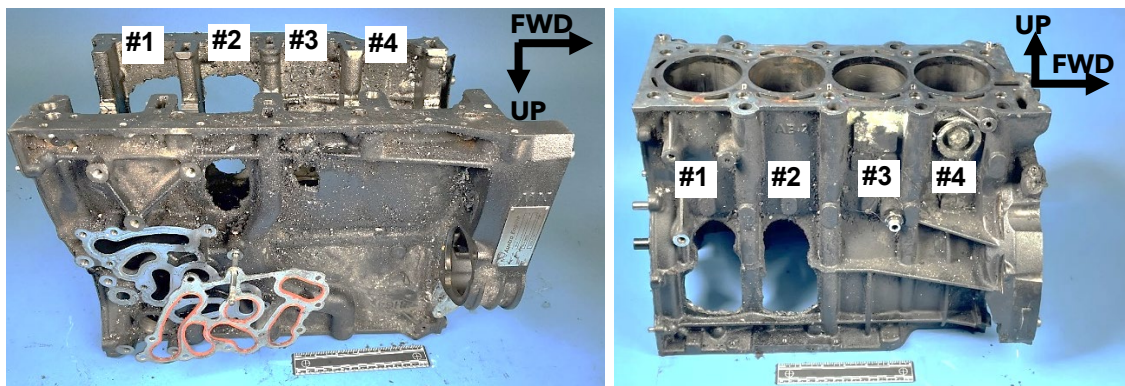
**Figure 4.** As-received engine block looking at the pressure side (left side of page); and looking at the counterpressure side (right side of page).

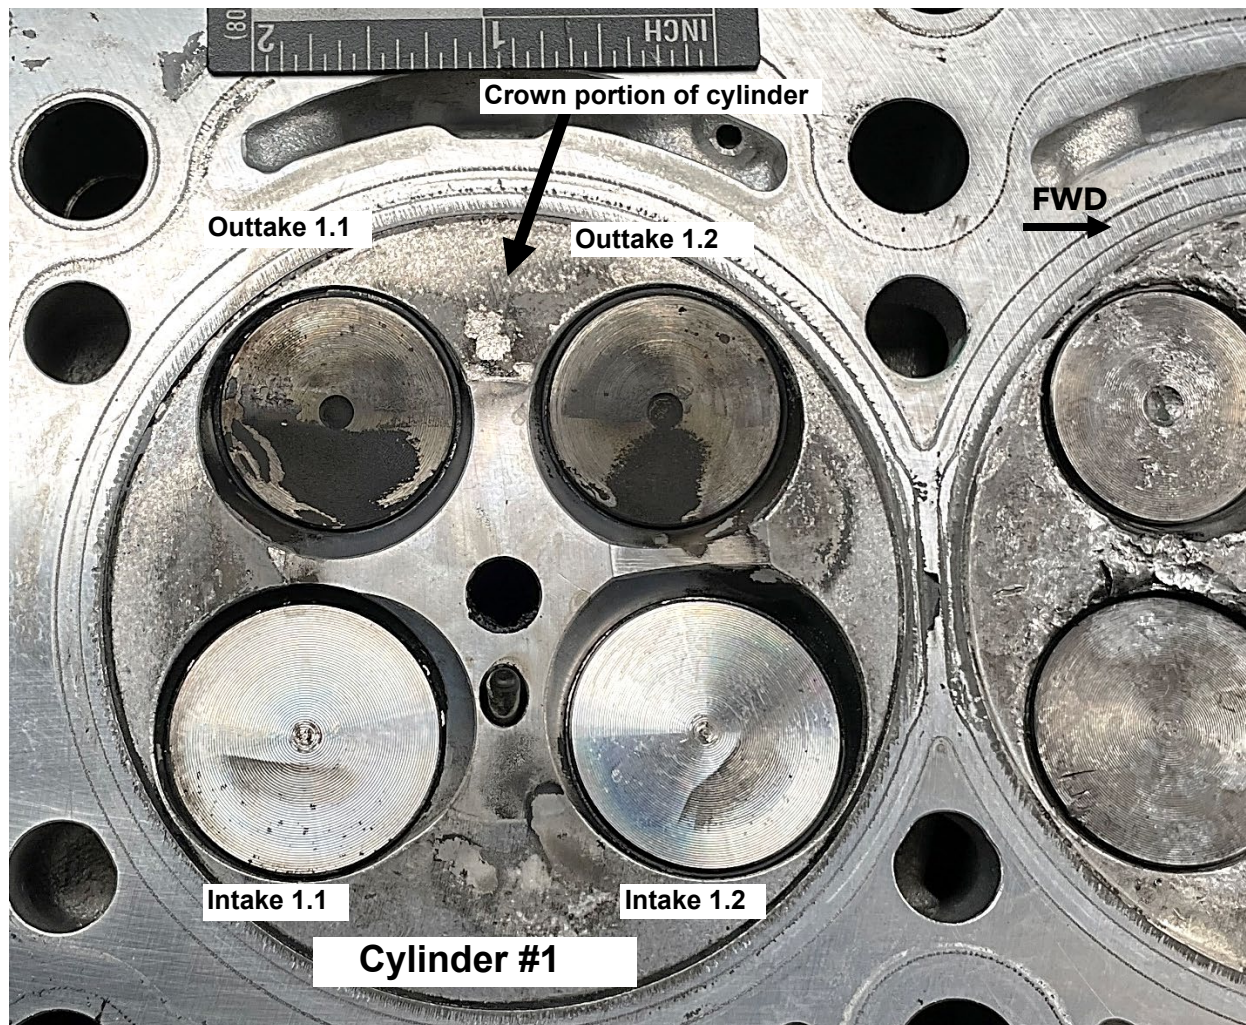
**Figure 17.** View of the intake and outtake valves for the #1 cylinder.

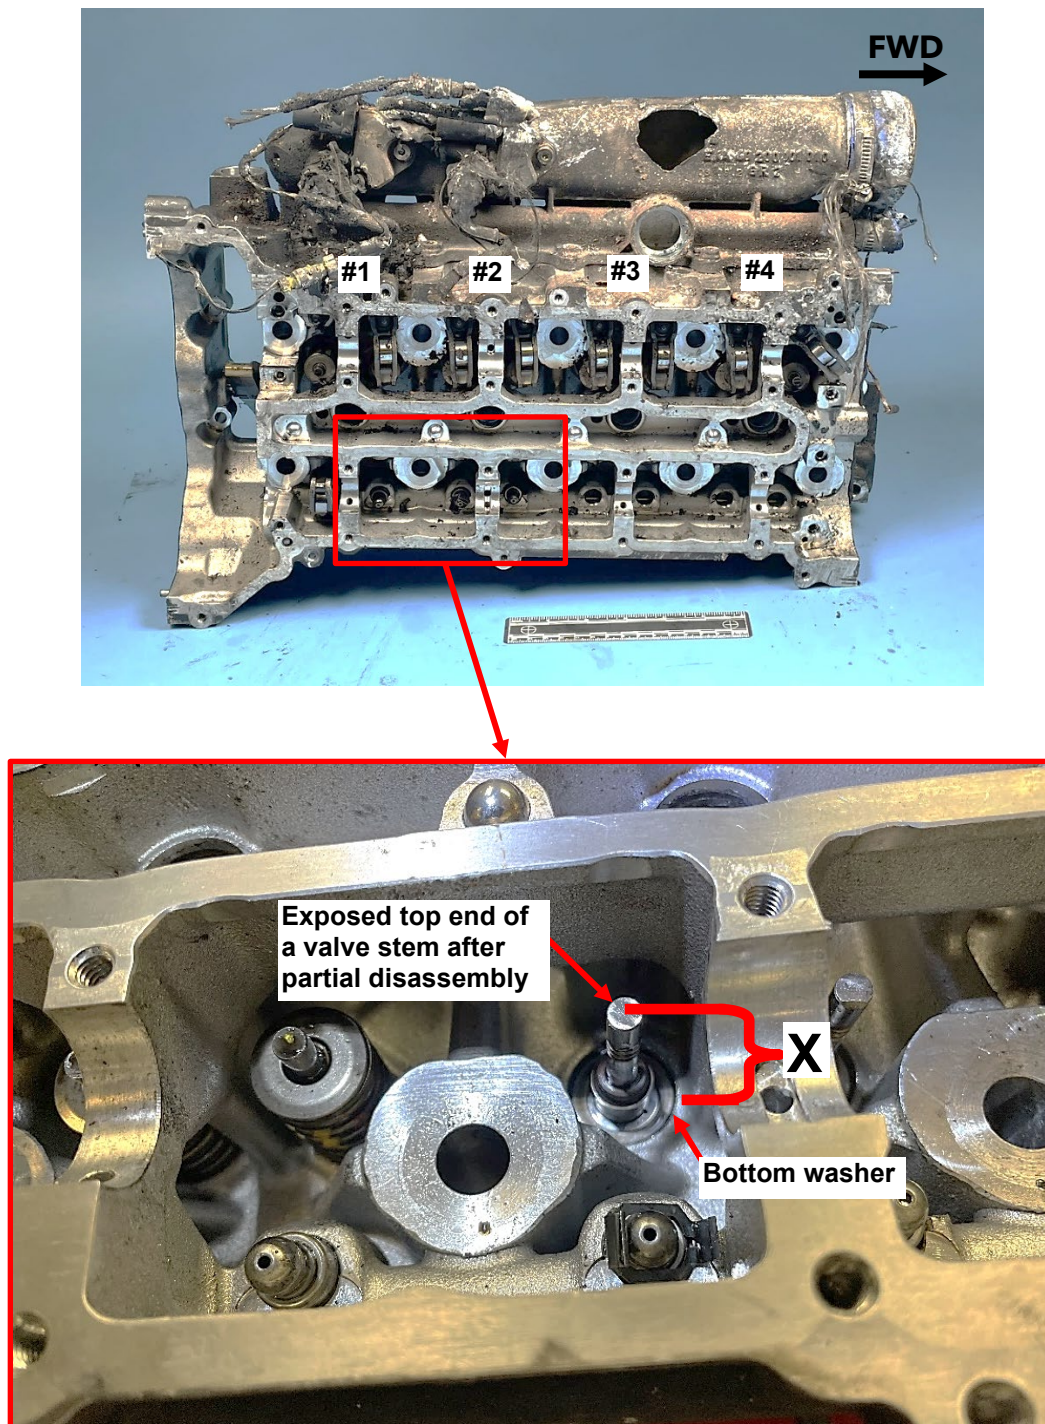
**Figure 19.** View of the top side of the as-received cylinder head (top image); and close-up view of the exposed top end of a valve stem from the #2 cylinder without the spring, washer, and shim halves after partial disassembly (bottom image).

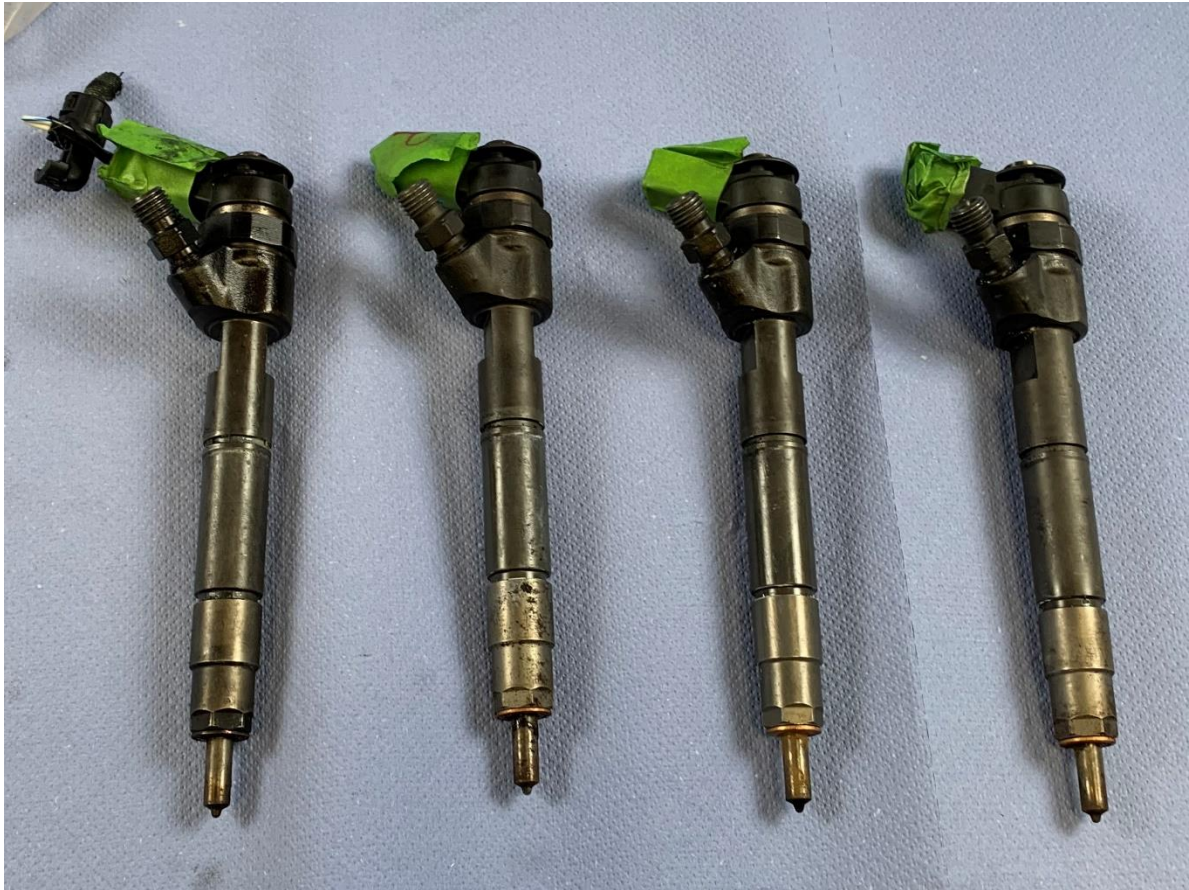
Figure 5 Injectors 1-4

Prior to testing, all injectors were visually inspected to detect any external damage. No signs of abnormal or excessive wear could be detected. Connections of the fuel inlet and return were free of dirt and debris and the electrical connection for the control unit taped off. The connector of the first injector was still connected with a cut cable. The spray nozzles were also free of dirt and debris without deformations. No excessive or abnormal wear visible.

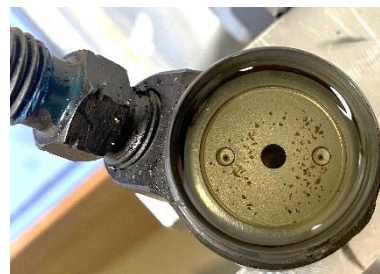
Figure 16 - Injector 3, armature removed

1. Solenoid valve and spring removed  
(see Figure 11 and Figure 12)
2. Armature removed  
(see Figure 14, Figure 15 and Figure 16)
3. Armature guide removed  
(see Figure 17, Figure 18 and Figure 19)  
Spots of corrosion can be clearly seen, both on the guide and in the injector itself
4. Ball valve safely packed in a lockable bag

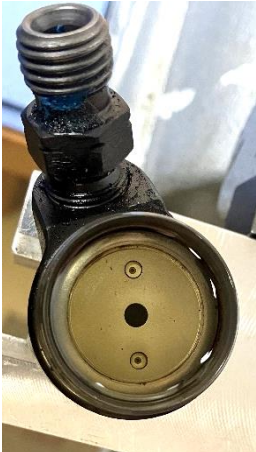
Figure 30 - Injector 1, armature removed

Corrosion can be found on armature guide, and inside the injector.

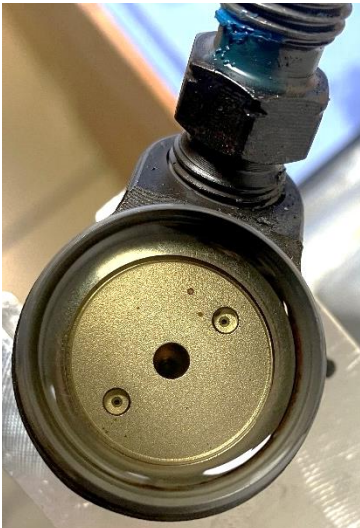
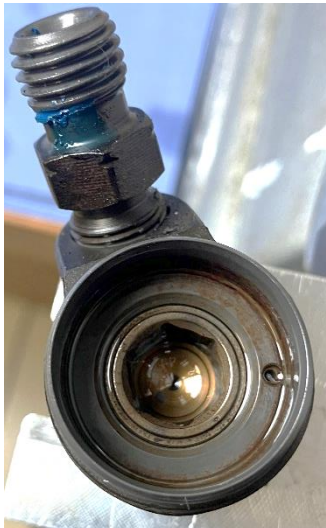
During disassembly of injector 2, corrosion was found on armature guide and within the injector as shown in the pictures below.

Figure 34 - Injector 2, armature removed

Figure 35 - Injector 2, armature guide removed

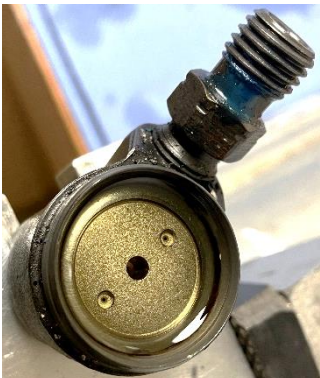
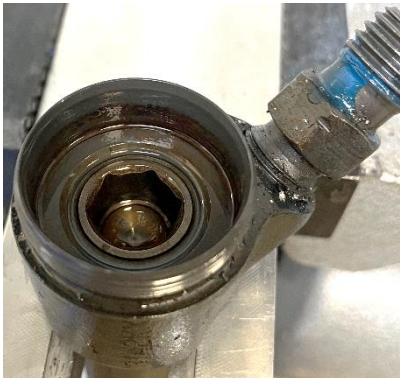
Corrosion on amature guide and inside the injector visible.

Figure 38 - Injector 4, armature removed

Figure 39 - Injector 4, armature guide removed

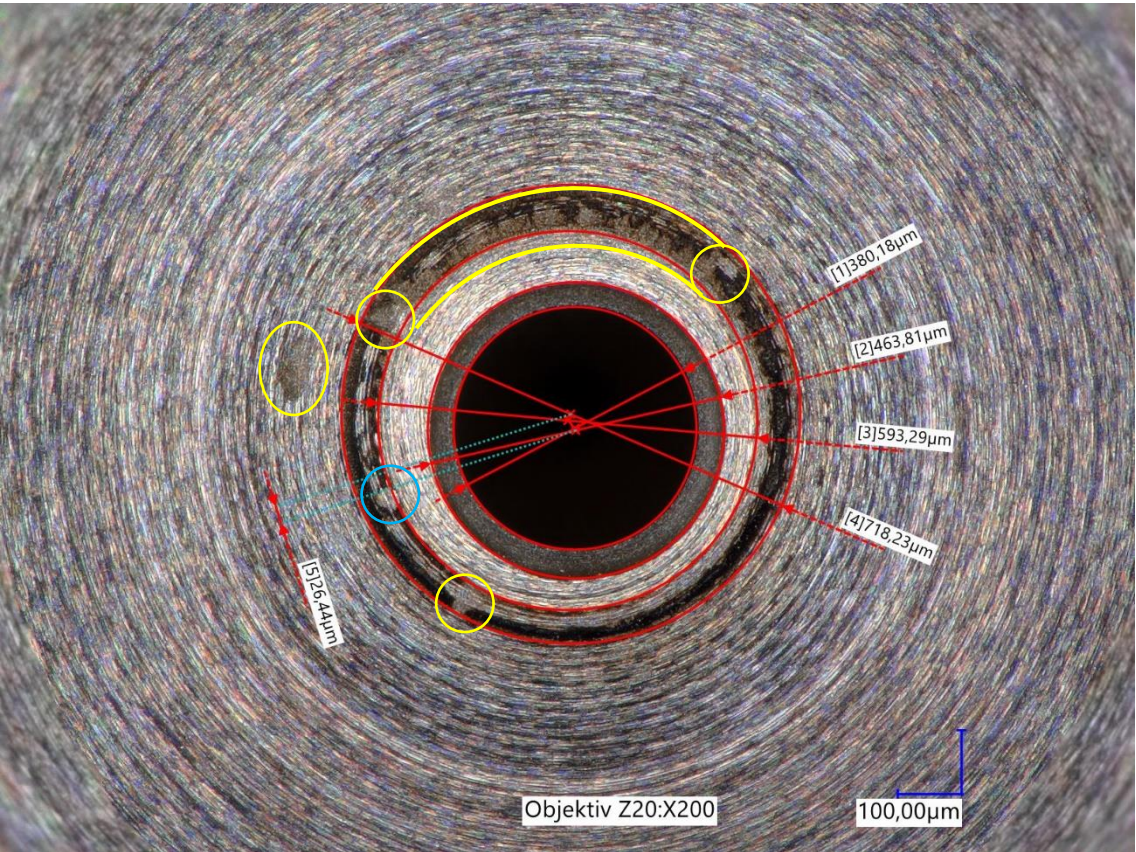
Figure 41 - Injector 1, A-throttle

The throttles of all 4 injectors show no significant signs of cavitation erosion wear (Figure 72 shows an example of cavitation erosion wear). On all injector throttles are some irregularities (marked in blue and yellow, Figure 41-Figure 65) on the outer ring where the ball valve contacts the throttle present.

The blue marked spot at injector 1 (see Figure 41) is a small indentation on the conical surface. These indentations are mostly caused by contaminated fuel particles.

In practical application, these types of wear mean an uncontrolled start and end of injection. It can lead to a higher combustion chamber temperature and thereby the piston is subjected to a greater thermal load, as the firing cycle lasts longer.

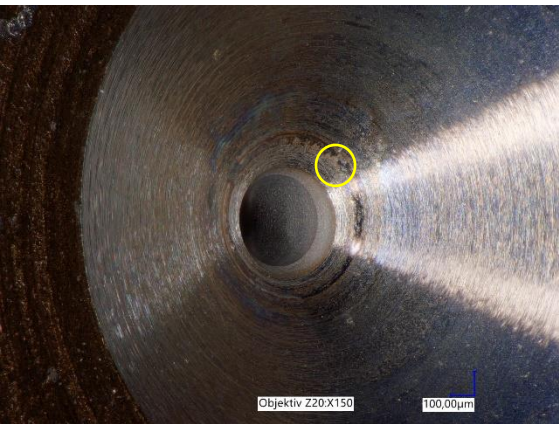
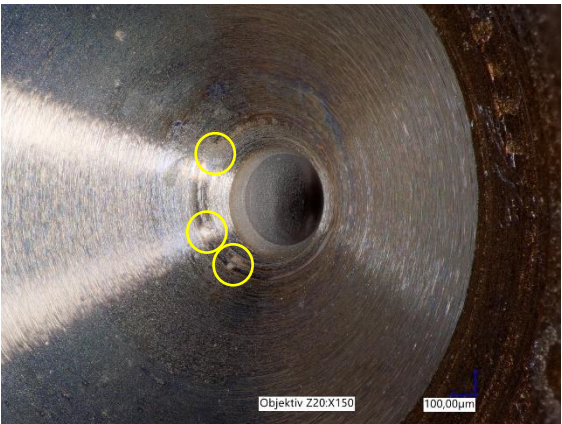
Figure 42 - Injector 1, A-throttle ~35° left

Figure 43 - Injector 1, A-throttle ~ 35° right

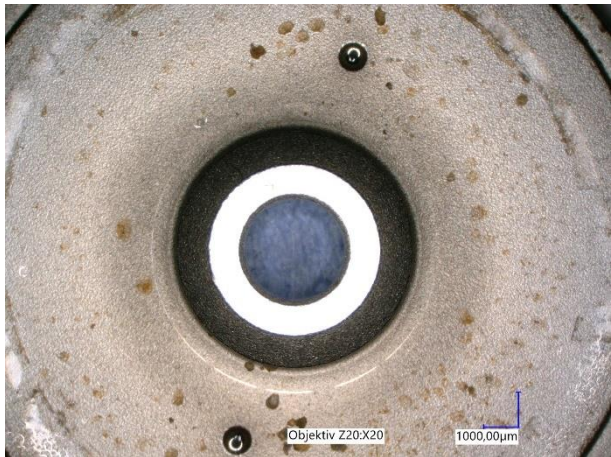
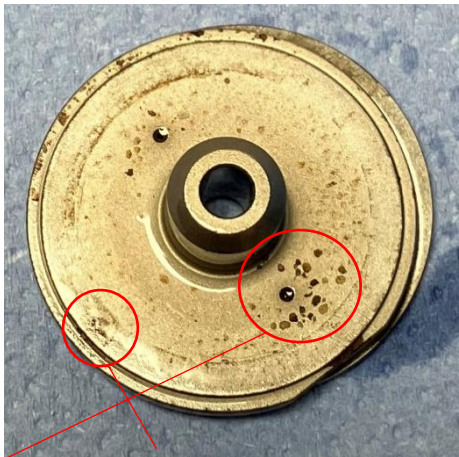
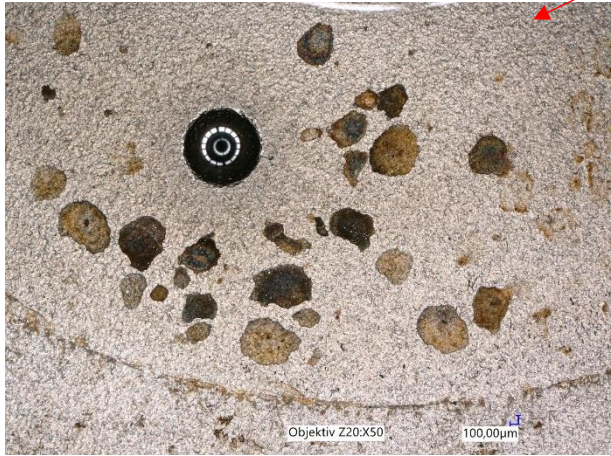
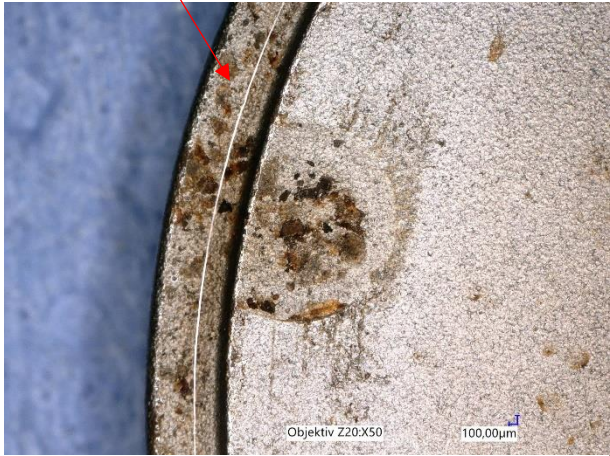
Figure 44 - Injector 1, armature guide x20

Figure 45 - Injector 1, armature guide

Figure 46 - Injector 1, armature guide x50 (1)

Figure 47 - Injector 1, armature guide x50 (2)

During disassembly all 4 injectors showed clear signs of corrosion on several parts of the injector (armature guide, control piston, injector housing).

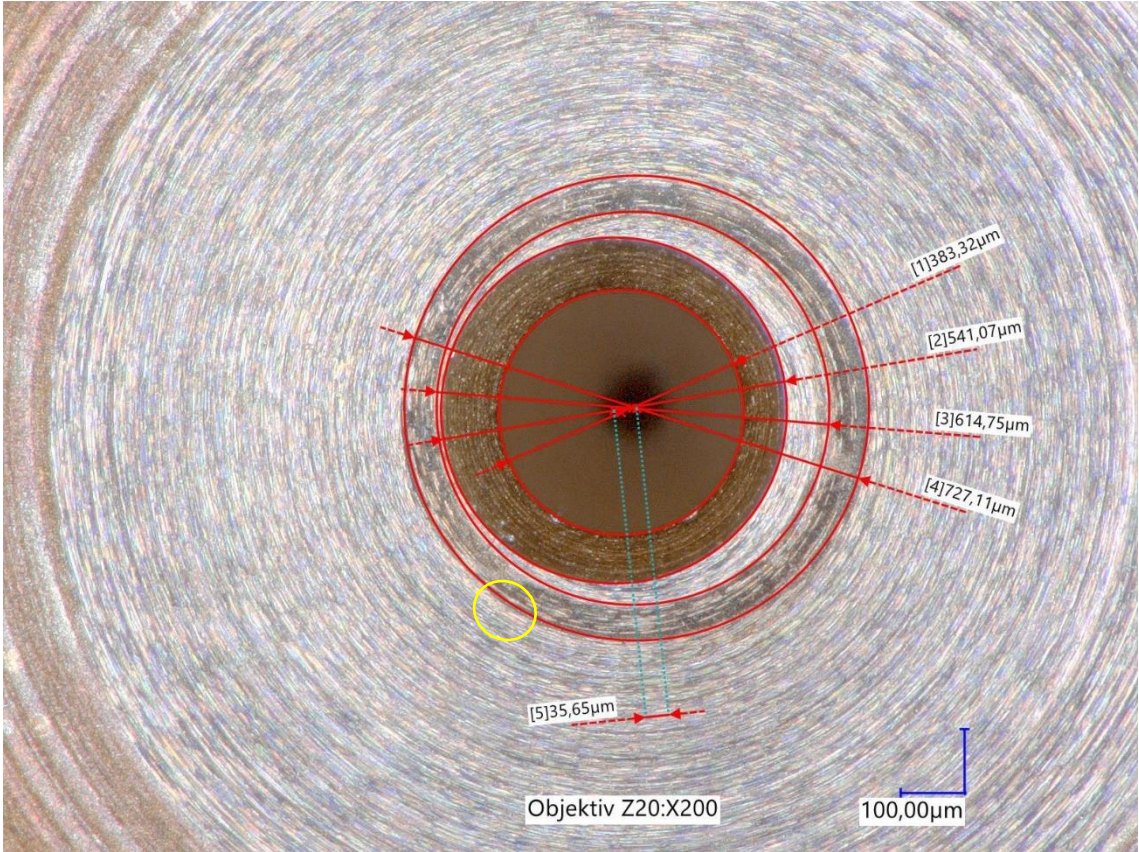
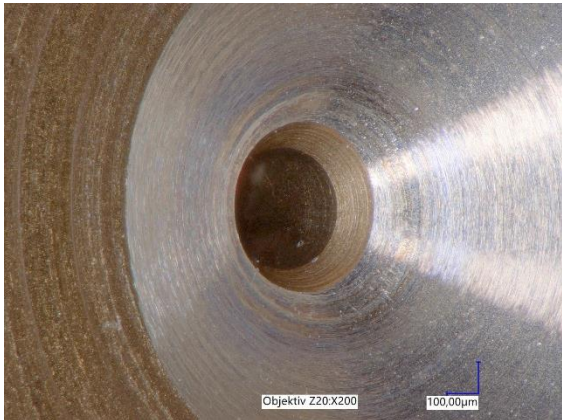
Figure 49 - Injector 2, A-throttle

Figure 50 - Injector 2, A-throttle ~35° left

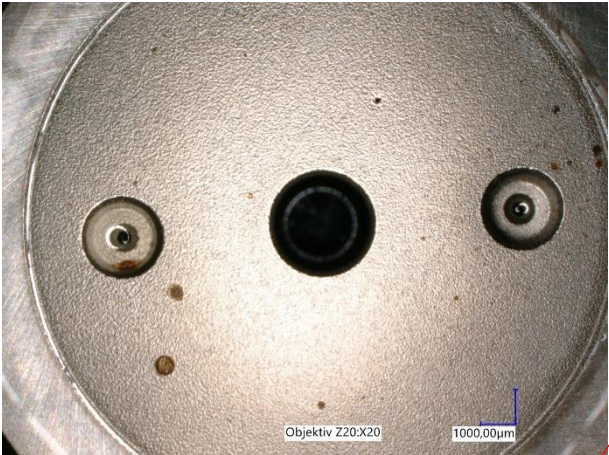
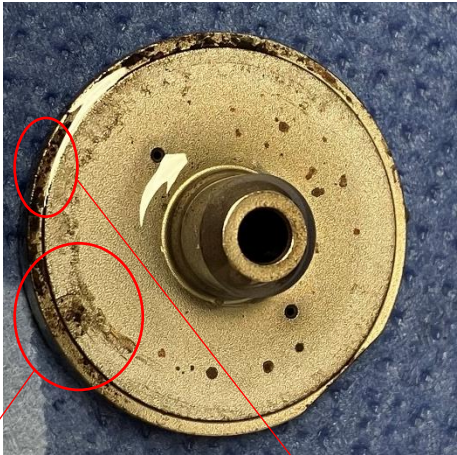
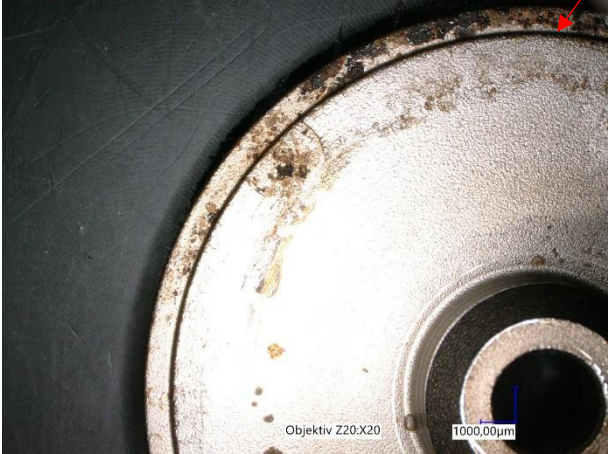
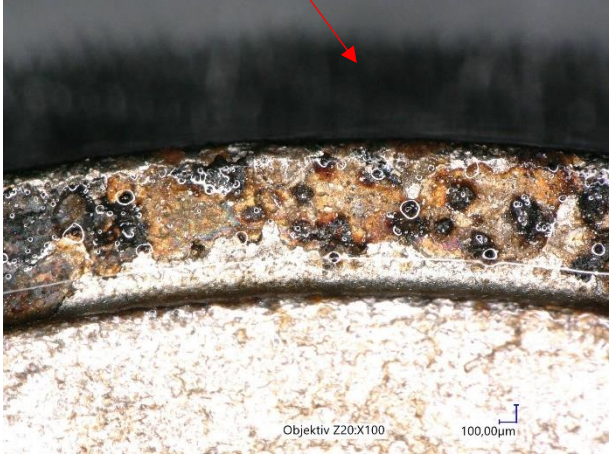
Figure 52 - Injector 2, armature guide top side x20

Figure 53 - Injector 2, armature guide

Figure 54 - Injector 2, armature guide x20

Figure 55 - Injector 2, armature guide x50

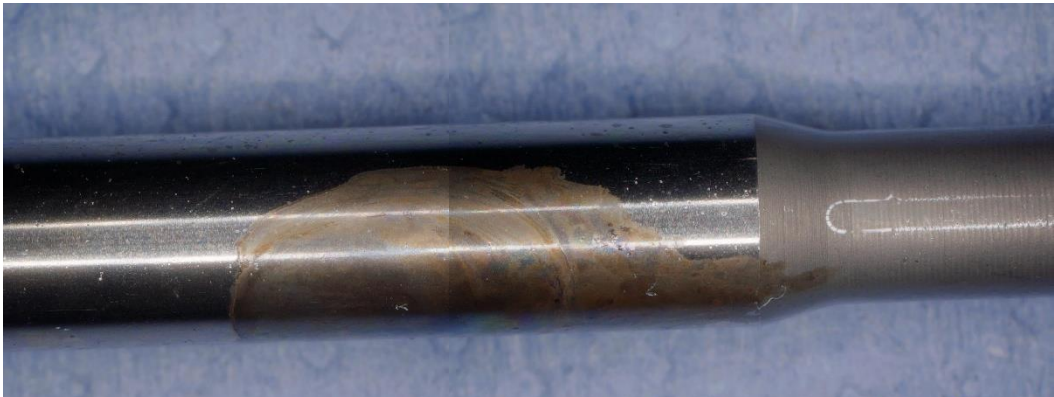
Figure 56 - Injector 2, control piston x30

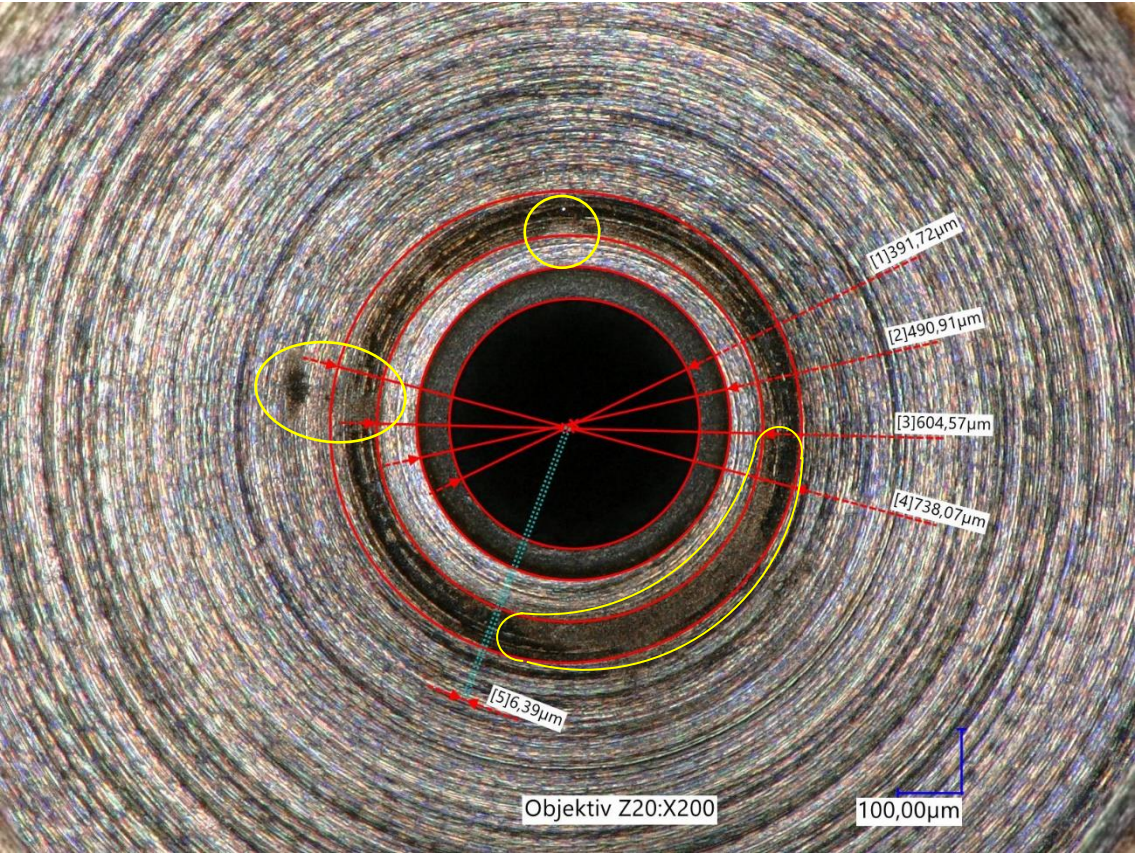
Figure 57 - Injector 3, A-throttle

On all 4 injector throttles, this area has some roughened spots which looks like the ball did not rest evenly. Injector 1 and 3 are the most affected, there are several places where it looks like the ball valve is hardly touching the throttle surface at all (see Figure 57, Figure 74, Figure 75). If the ball is not properly seated, the valve does not close completely and fuel can continue to enter the combustion chamber.

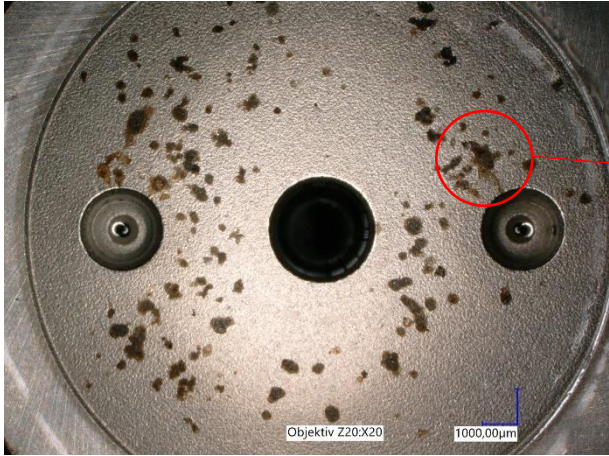
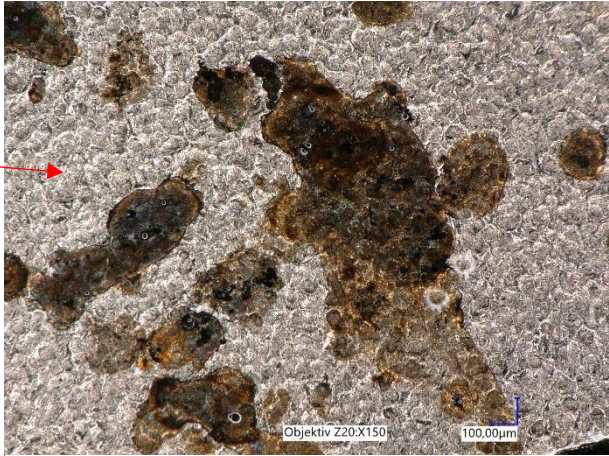
Figure 60 - Injector 3, armature guide x20

Figure 61 - Injector 3, armature guide x150

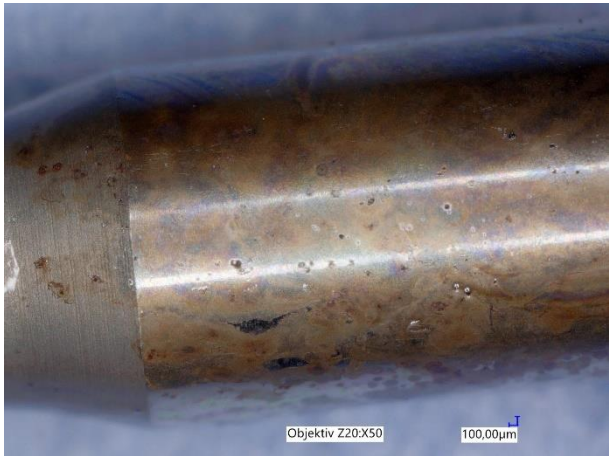
Figure 62 - Injector 3, control piston x50

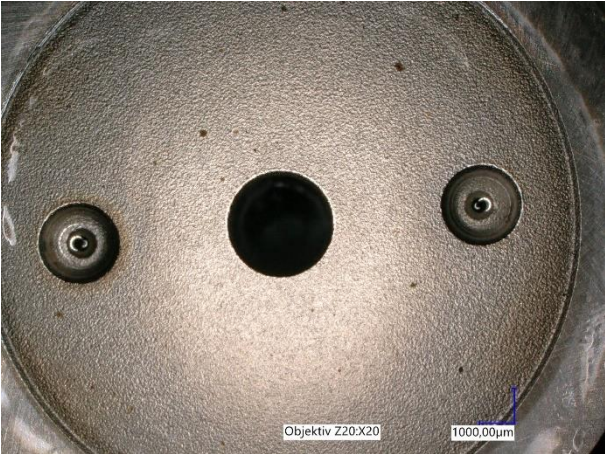
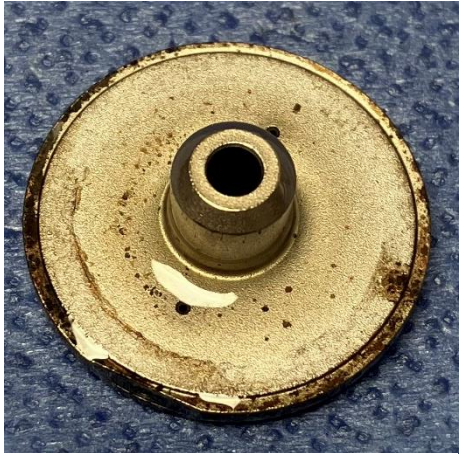
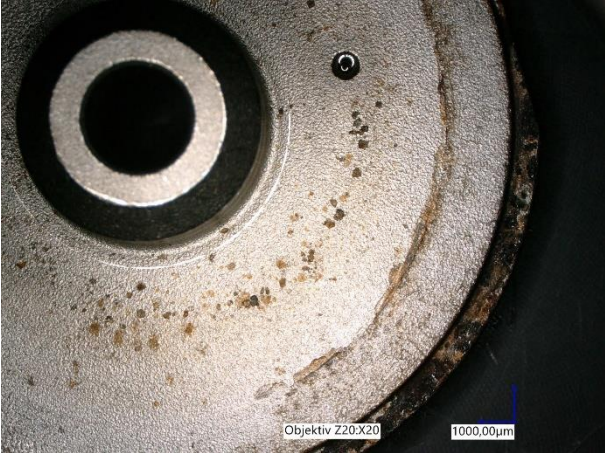
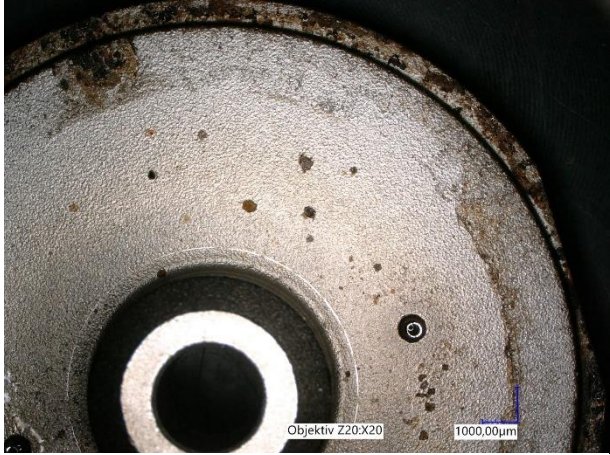
Figure 66 - Injector 4, armature guide top side x20

Figure 67 - Injector 4, armature guide

Figure 68 - Injector 4, armature guide x20 (1)

Figure 69 - Injector 4, armature guide x20 (2)

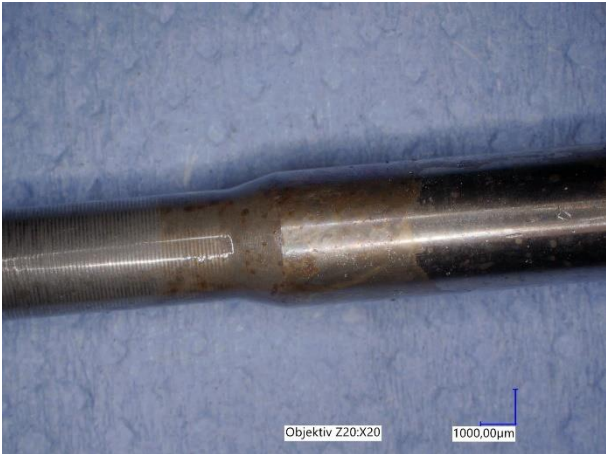
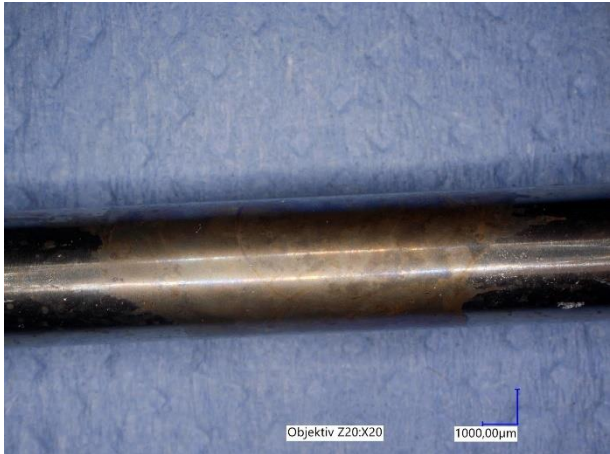
Figure 70 - Injector 4, control piston x20 (1)

Figure 71 - Injector 4, control piston x20 (2)

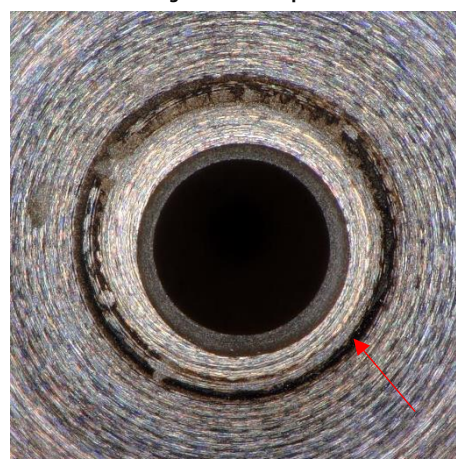
Figure 73 - A-throttle injector 1

The outermost dark circle on the A-throttle (marked red on Figure 73) is the surface on which the ball valve rests. When the engine is running, the ball valve hits this area of the A-throttle so often that it usually looks polished over time.

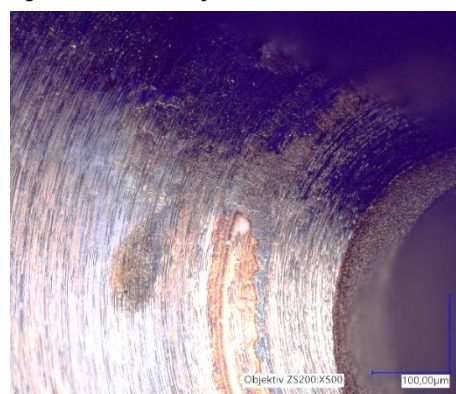
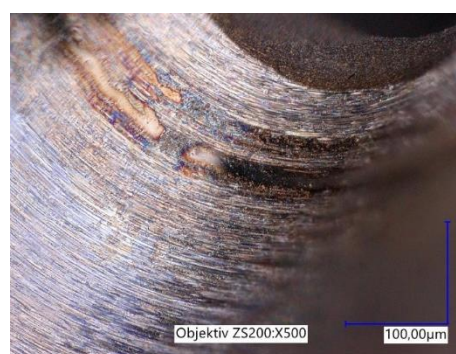
Figure 74 - Close up, A-throttle injector 1

Figure 75 - 2nd close-up, A-throttle injector 1

The exact cause of this roughness is difficult to determine as this damage was seen here for the first time.

1. The ball valve does not rest evenly on the surface, fuel continues to flow through the small openings causing the surface to roughen. Contamination of the fuel would favor this damage pattern.
2. The surface is roughened by corrosion: Is this A-Throttle compared to a throttle which clearly showed corrosion, it can be seen that the surface is similarly roughened.

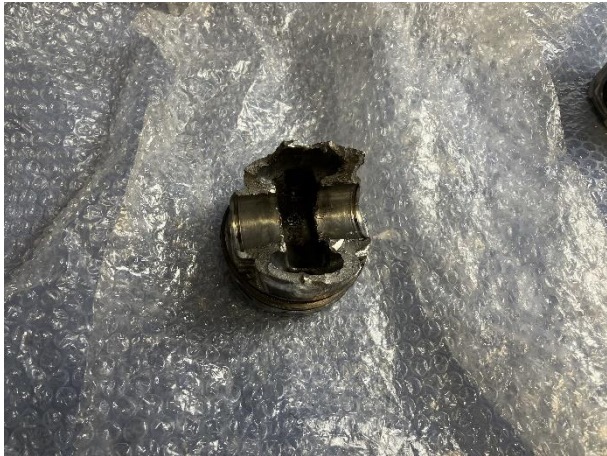
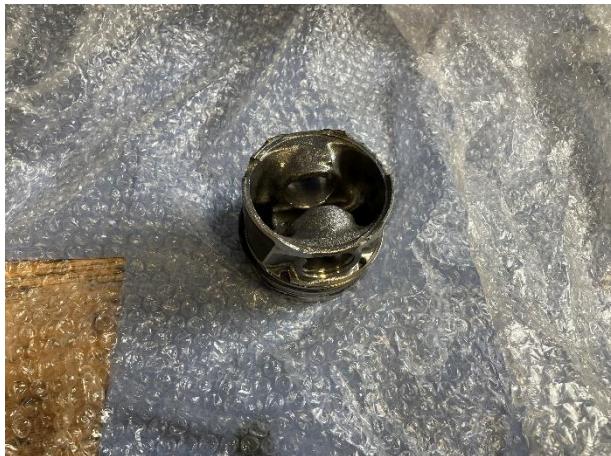
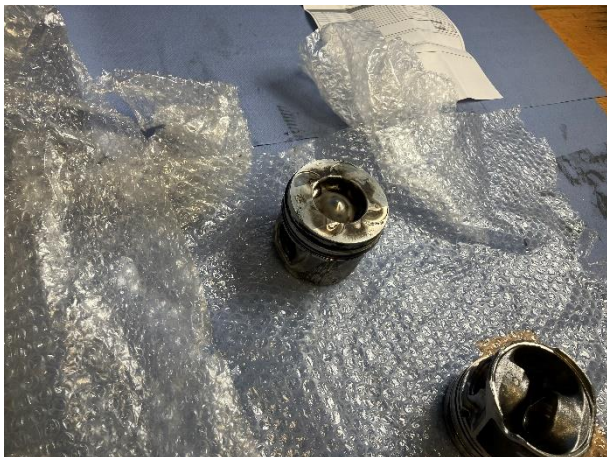
Figure 83 Piston number 1

Figure 84 Piston number 3

Figure 85 Piston number 4

At the start, it was important to secure the piston against the perpendicular test force during the test procedure in order to generate a comparable value for each test. To guarantee this, clamping blocks were used, as the piston skirt could no longer be used as a base due to the damage. Great care was taken to ensure that no further damage was caused during clamping.

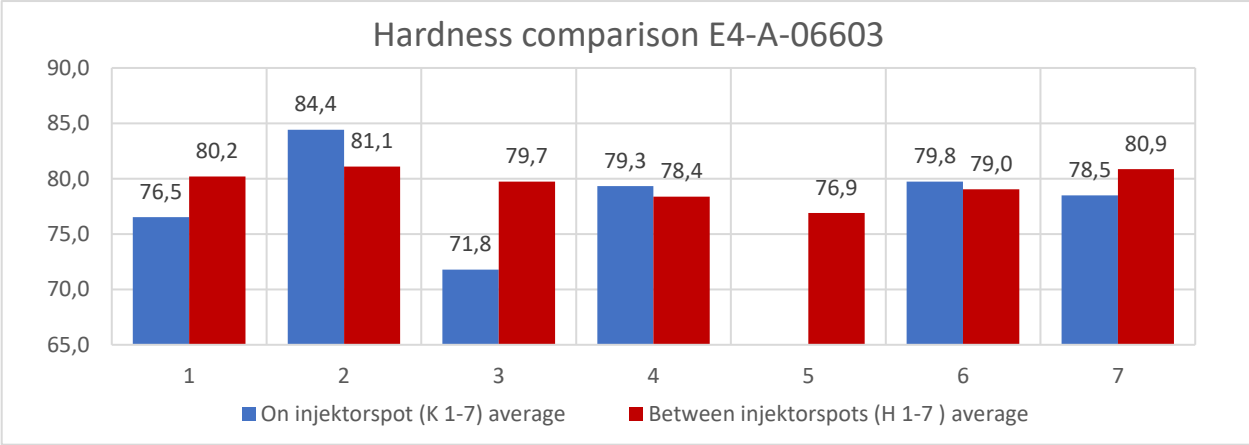
Figure 91 Hardness diagram K&H

This diagram aims to provide information about a general hardness distribution of the different spray spots. There is no big notable deviation of the areas at the injector spots and in between the injector spots. The respective K & H values are in a comparable range always between ~76,5 and ~84,4HBW except for K3, which was located on a valve notch and therefore did not provide a practical value.

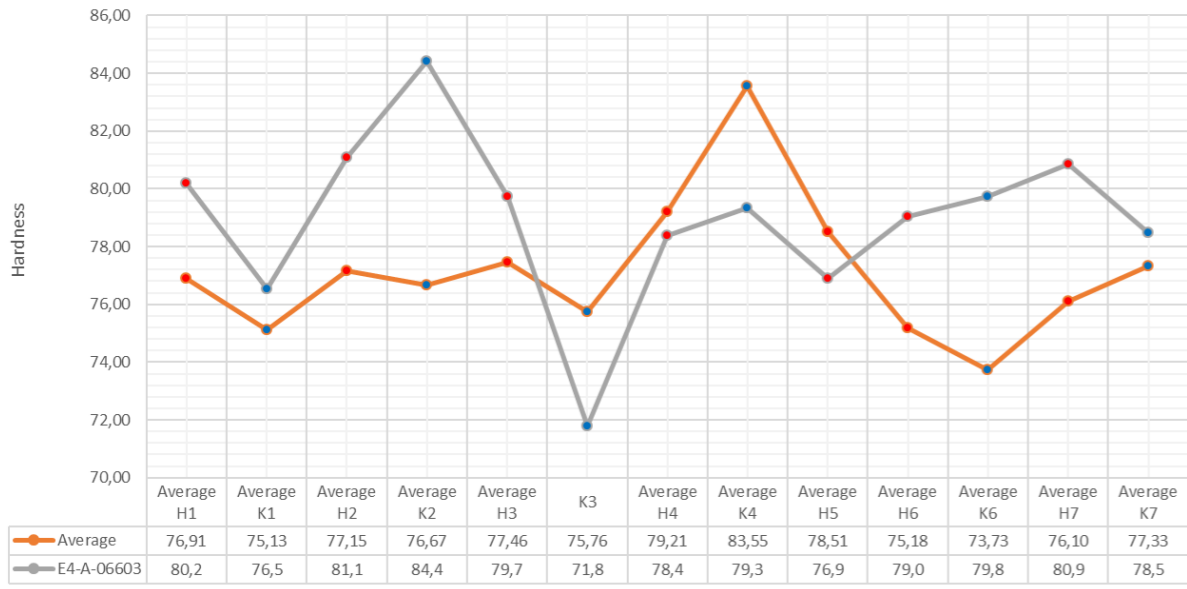
Figure 92 Hardness Comparison Average

The evaluation of the average values with empirically determined values from previous piston hardness measurements also reveals no anomalies.
