# Bundesstelle für Flugunfalluntersuchung

BFU23-1167

**Subject: Diamond DA-40 NG Aircraft Accident in Asheville, NC, Dec 14 2023 – Request for Readout of Engine Data from damaged Austro Engine Electronic Engine Control Unit (EECU)**

## Laboratory Report

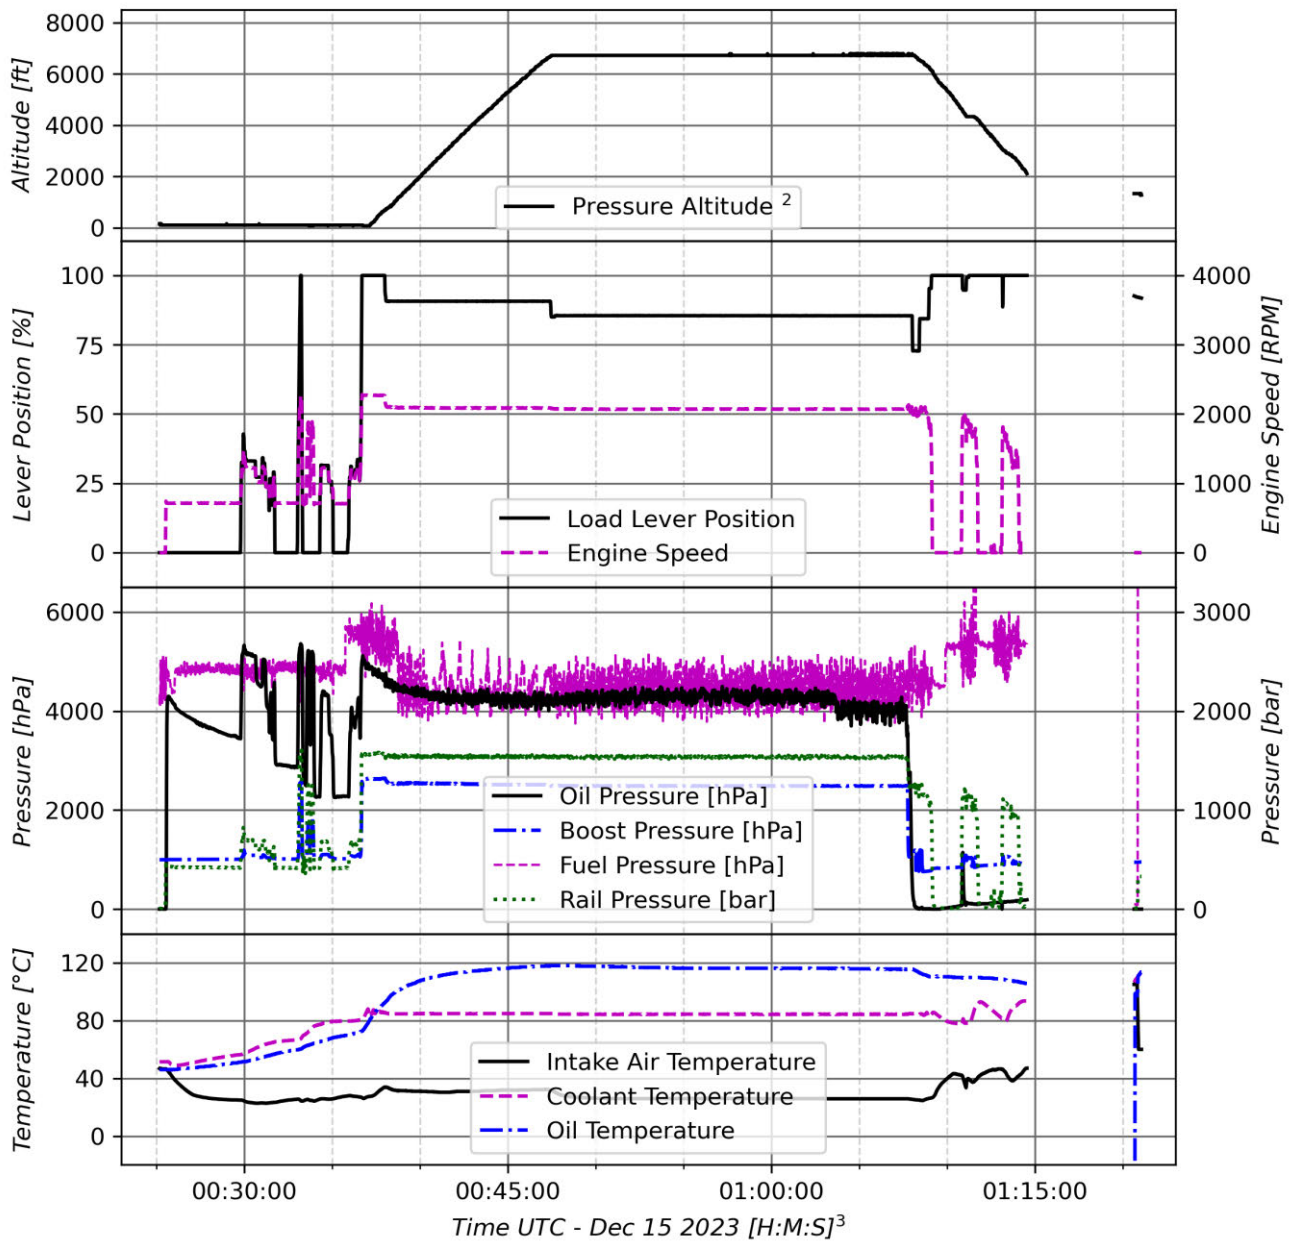
Figure 7: Overview plot accident flight

### BFU23-1167 | Austro Engine EECU Data Plot | Board B<sup>1</sup> | Flight Overview

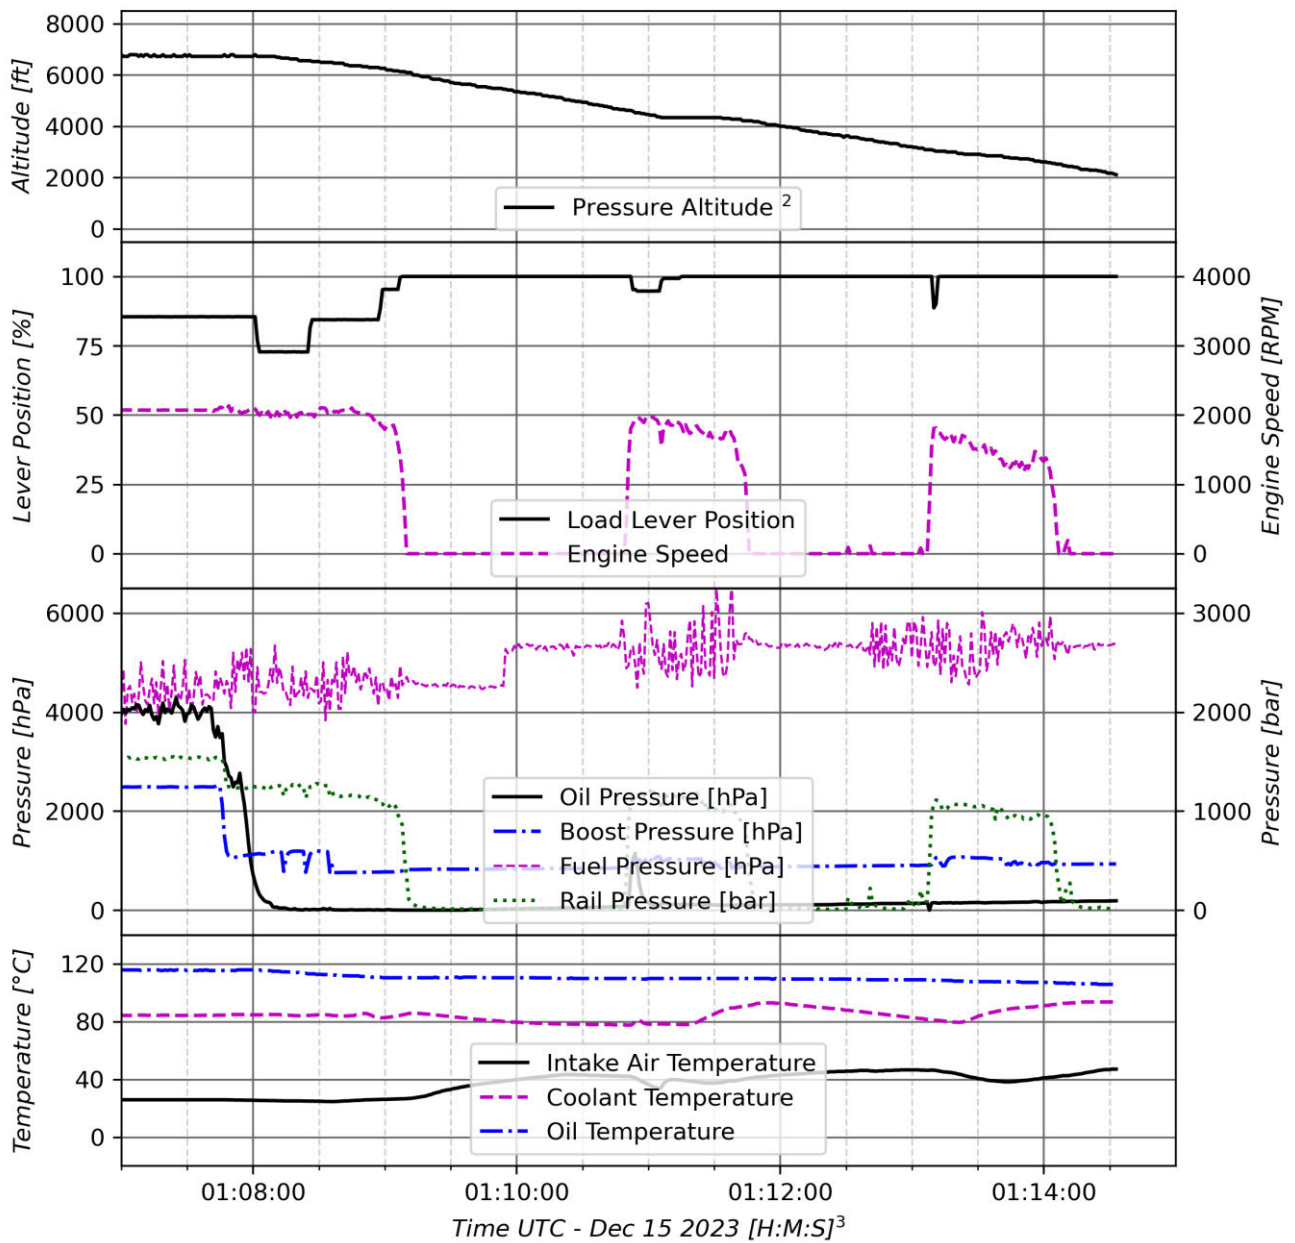
# BFU23-1167 | Austro Engine EECU Data Plot | Board B<sup>1</sup> | Descent
