# National Transportation Safety Board

ERA24LA094

## **POWERPLANTS**

Group Chair's Factual Report

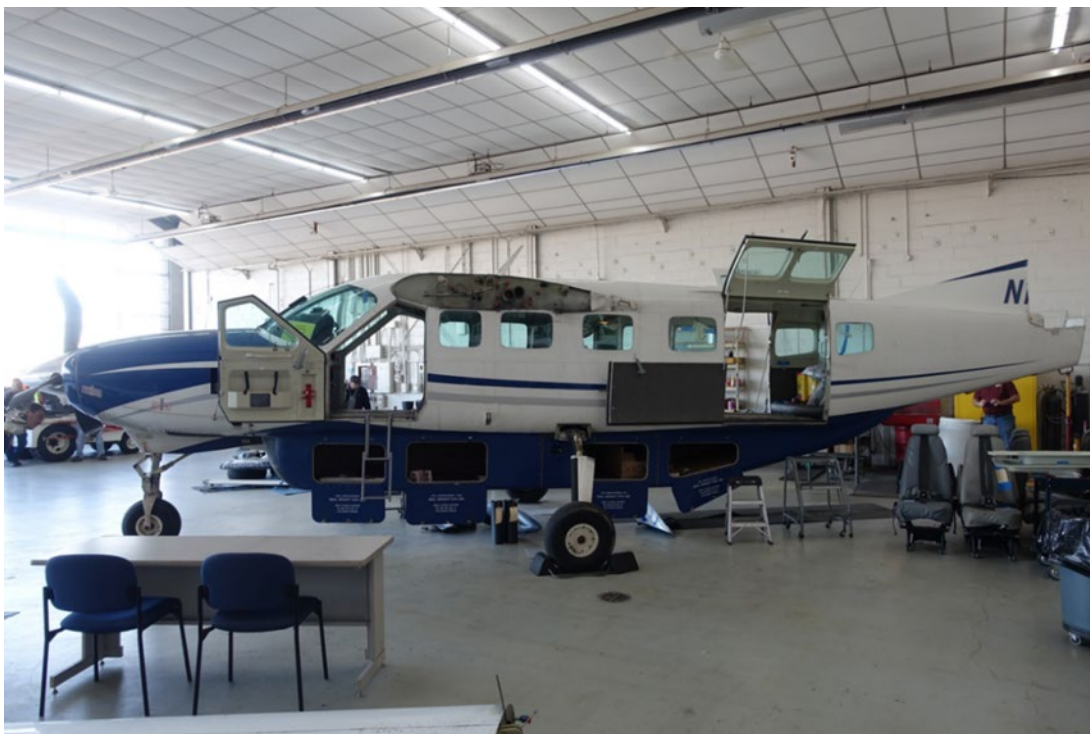
**Photo 2- N1983X, as Received**

The engine was secured in the Southern Airways express maintenance hangar when the investigation team arrived (**Photos 2 and 3**). The airplane wings, tail section, cabin seats and interior trim were stored next to the airplane in the hangar. According to Southern Airways Express, the battery was not disconnected prior to transport from Dulles, so after arrival the battery was disconnected, and the cowl doors were sealed shut with security tape.

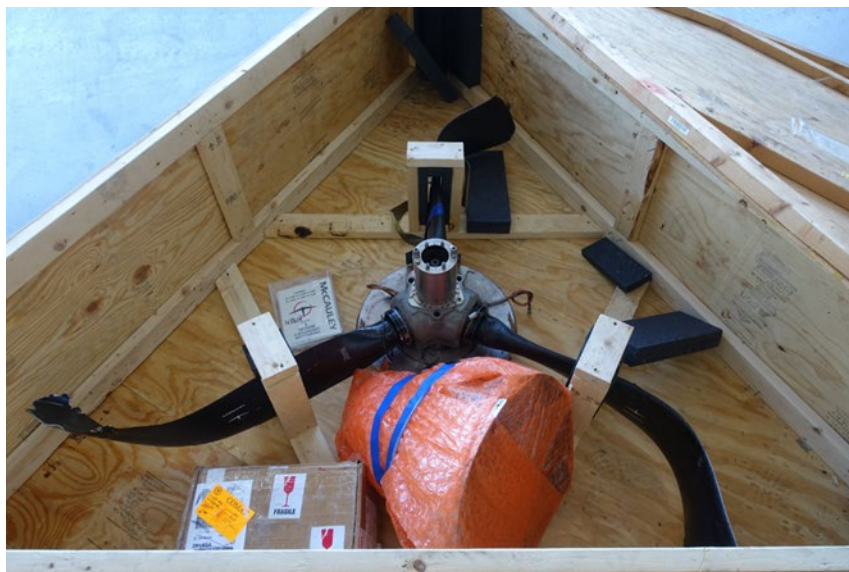
**Photo 9- Propeller, as Shipped to McCauley**

The propeller piston assembly was removed, and all pitch change attaching linkages inside the hub were fractured (**Photo 8**). The blade shanks had impact damage and gouging. The propeller was removed as an assembly and packaged for shipment to McCauley Propeller in Wichita, Kansas. The counterweight, nose cone, and propeller logbook were included in the shipping crate (**Photo 9**).

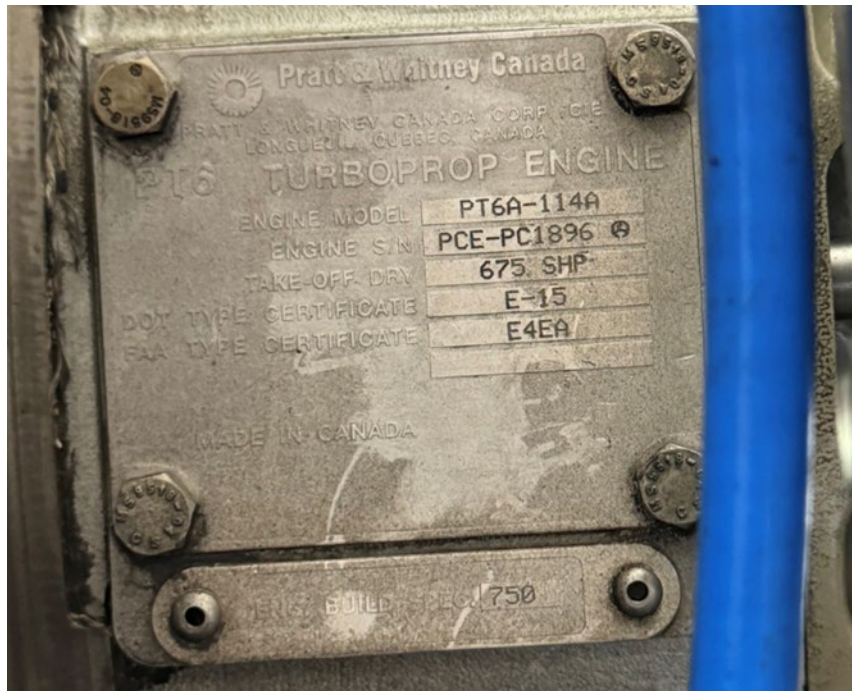
**Photo 11- ESN PCE-PC1896 Data Plate**

External engine surfaces appeared unremarkable with no evidence of uncontainment or undercowl fire (**Photos 10 and 11**). The gas generator (Ng) spool was manually rotated by turning the alternator/alternator pad in the accessory gearbox (AGB). The Ng spool rotated smoothly with no audible grinding. The reduction gearbox (RGB) and AGB magnetic chip detector plugs had no significant debris accumulation (**Photo 12**). The fuel, oil, and P3<sup>3</sup> filters were in good condition and free of debris (**Photos 13**). The P3 and Py<sup>4</sup> b-nut connections on the propeller governor, FCU, and bulkhead were torqued, and safety wired. A safety wire could be not inserted through the forward or aft clevis inspection holes that function as check points for proper thread engagement during engine rigging. The beta arm was installed on the correct side of the beta arm retaining pin and the beta block was intact and secure (**Photo 14**).

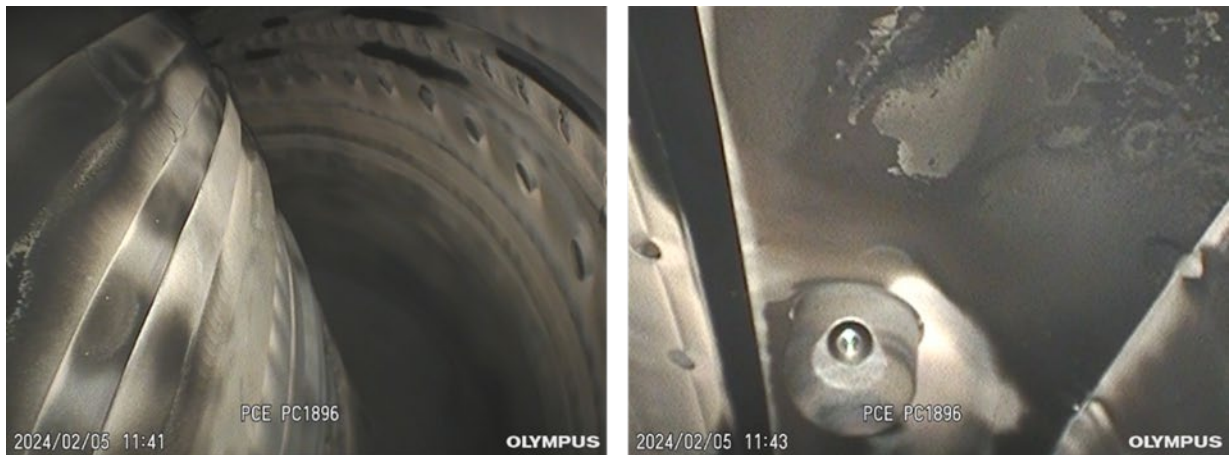
**Photo 16- (L) Combustion Liner, (R) Fuel Nozzle**

A borescope was inserted into the engine inlet to inspect the axial compressor blades. Minor 1<sup>st</sup> stage compressor leading edge erosion was observed but there was no evidence of impact/foreign object damage (FOD) on visible rotor blades or stator vanes (**Photo 15**). A fuel nozzle was removed to inspect the combustion liner, fuel nozzles, and compressor turbine. The combustion liner had minor discoloration but there was no evidence of burn through or excessive coking (**Photo 16**). According to PWC, the combustor condition was typical of similar service run engines. The power turbine blades visible through the exhaust were all complete and unremarkable. The PT rotor spun smoothly with no audible grinding (**Photo 17**).

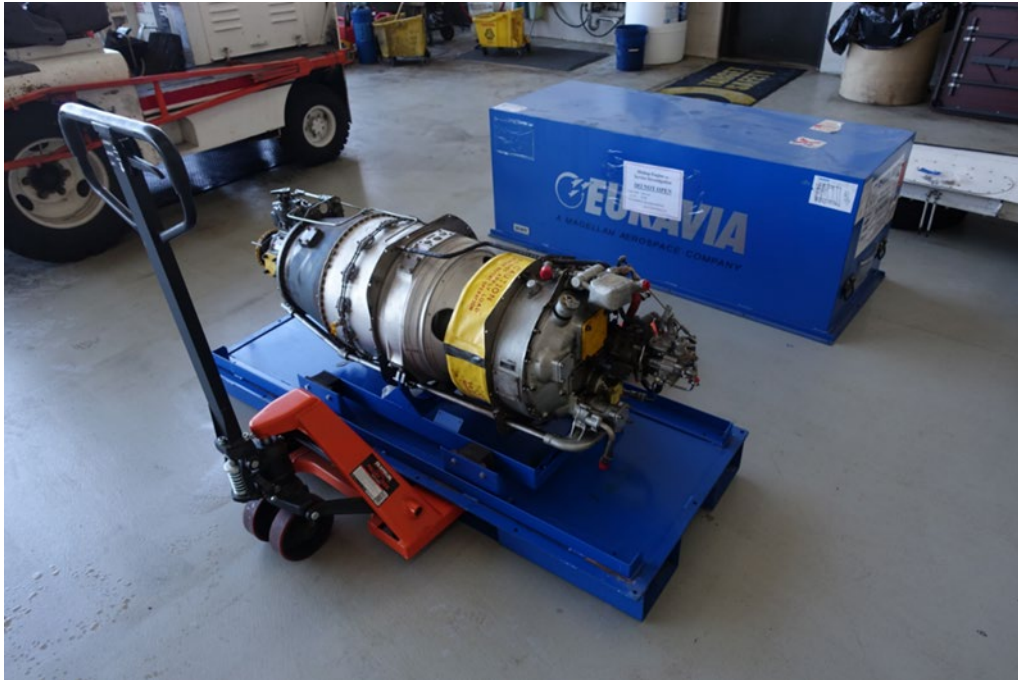
**Photo 19- Engine, Prepared for Shipment**

An engine alternator positive power cable attaching lug nut was partially backed off (**Photo 18**). The engine was removed from the airframe and placed in an engine container for shipment to PWC in Bridgeport, West Virginia for additional examination and testing (**Photo 19**).
