# National Transportation Safety Board

ERA24LA122

## **WRECKAGE EXAMINATION SUMMARY**

Location: Cape Coral, FL  
Date: February 24, 2024  
Time: 1003 EST  
1503 Z  
Airplane: N282SV, BELLANCA 17-30A, SERIAL NUMBER 98-301026

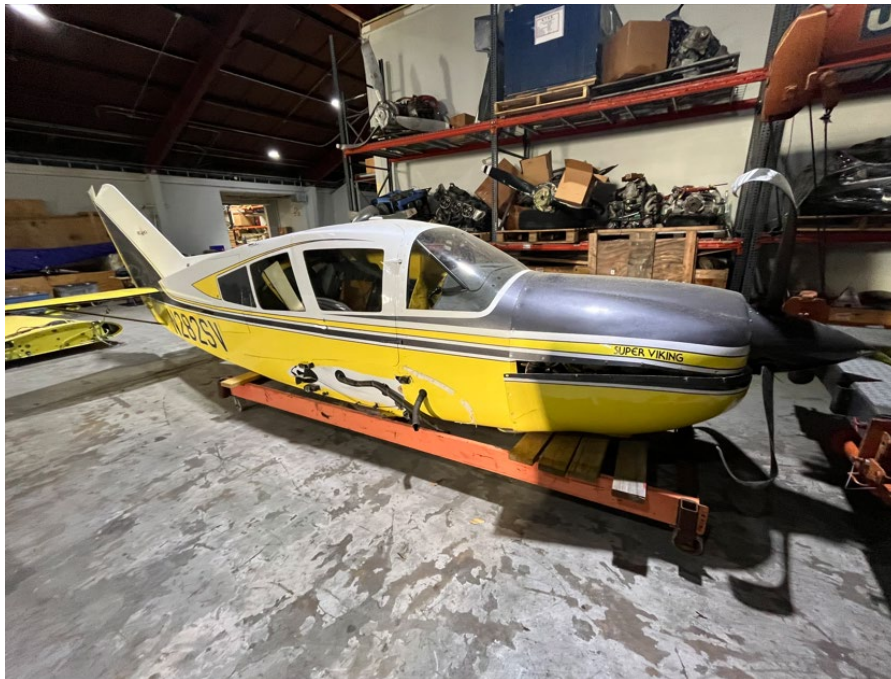
**Right Side of the Fuselage**

An airframe examination was conducted on March 20<sup>th</sup> at Florida Air Recovery in Jacksonville, FL. As first viewed, the wings were removed from the fuselage and the fuselage was supported on top of a metal support dolly. The engine remained attached to the airframe and the propeller remained attached to the crankshaft flange.

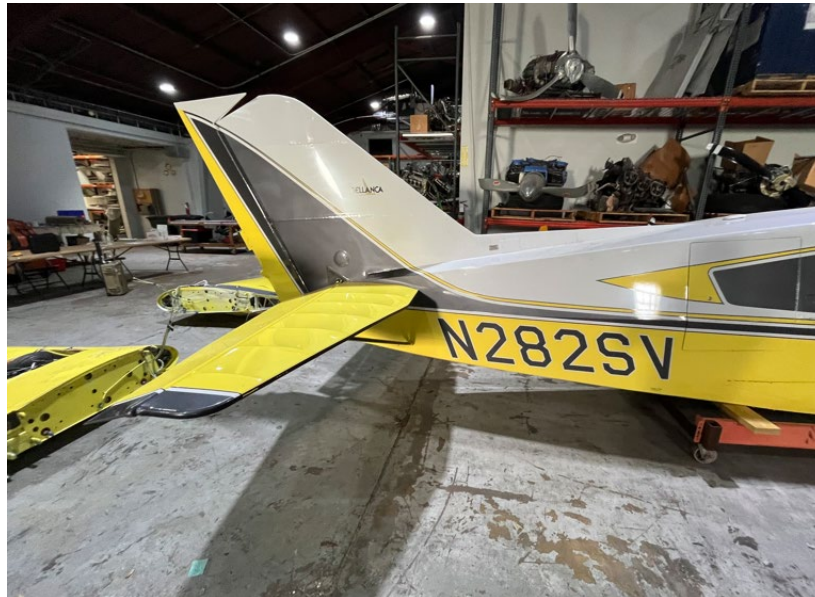
**Right Side of Empennage**

The empennage was undamaged. Flight control continuity from the cockpit to the rudder, elevator, and elevator trim was established.

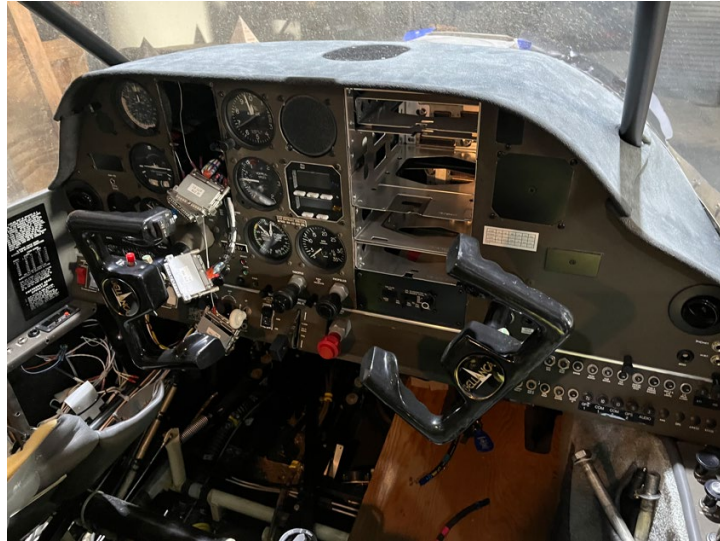
**Cockpit Instrumentation Overview**

Continuity of the throttle, mixture, and propeller controls was confirmed from the cockpit to their respective accessories. Full control travel was observed. As observed, all three controls were in the full forward position. The fuel selector was broken just below the indicator, but the selector was stuck in the right tank orientation. The Garmin accessories were removed by the recovery personnel to prevent damage during storage. The units were undamaged. No SD cards were present in any of the devices. The remaining instrumentation in the cockpit was undamaged. The remained installed in the fuselage and the aircraft powered on when the master switch was activated.

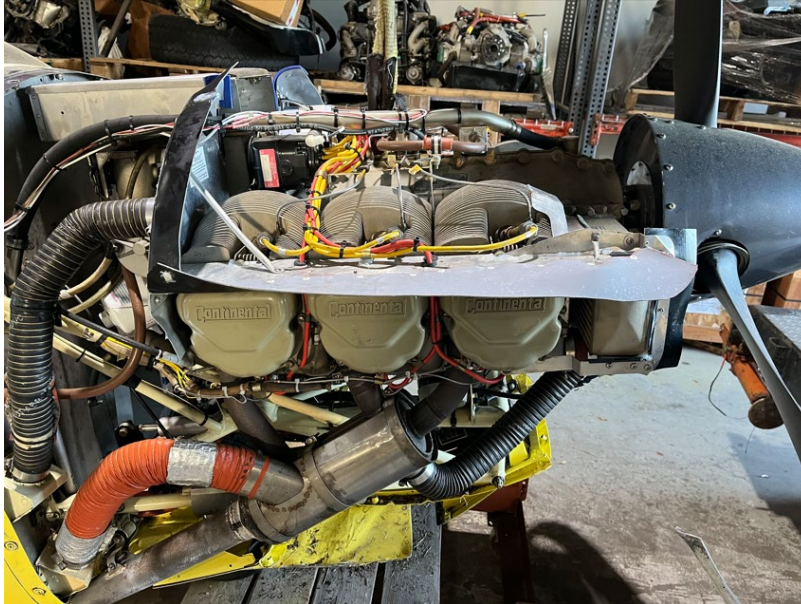
**Right Side of the Engine**

The cowling was removed, and the engine appeared to be undamaged. The top spark plugs were removed to facilitate a borescope inspection. The top spark plugs displayed coloration consistent with normal engine operation. The borescope

inspection did not show any discrepancies. The engine rotated 720 degrees when force was applied to the propeller and thumb compressions were observed on all cylinders. Continuity of the crankshaft to the camshaft was confirmed throughout the engine. The spark plugs were re-installed in their respective cylinder heads to facilitate an engine run.
