# National Transportation Safety Board

ERA24LA166

## **AIRFRAME AND ENGINE EXAMINATION**

N234ZT, R44

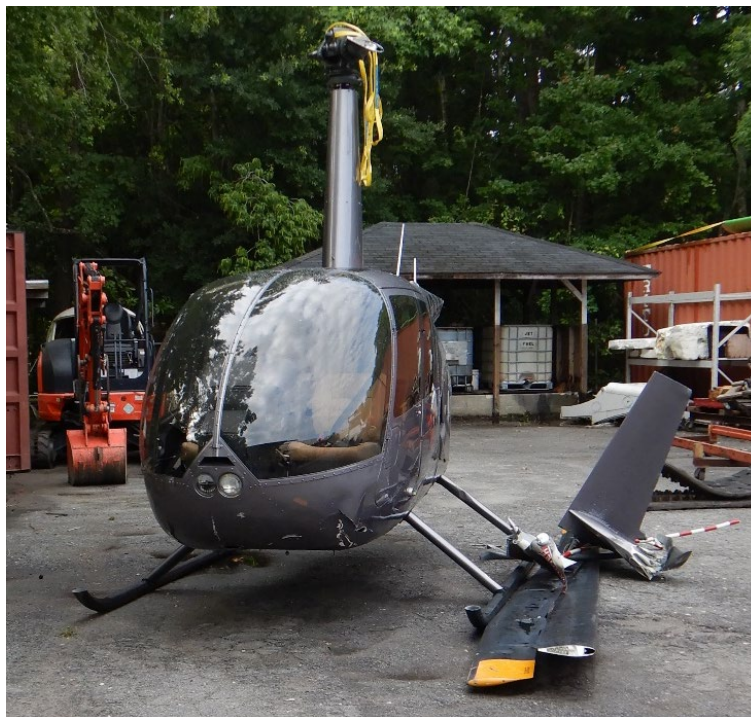
**Photo 1 - View of helicopter from the front.**

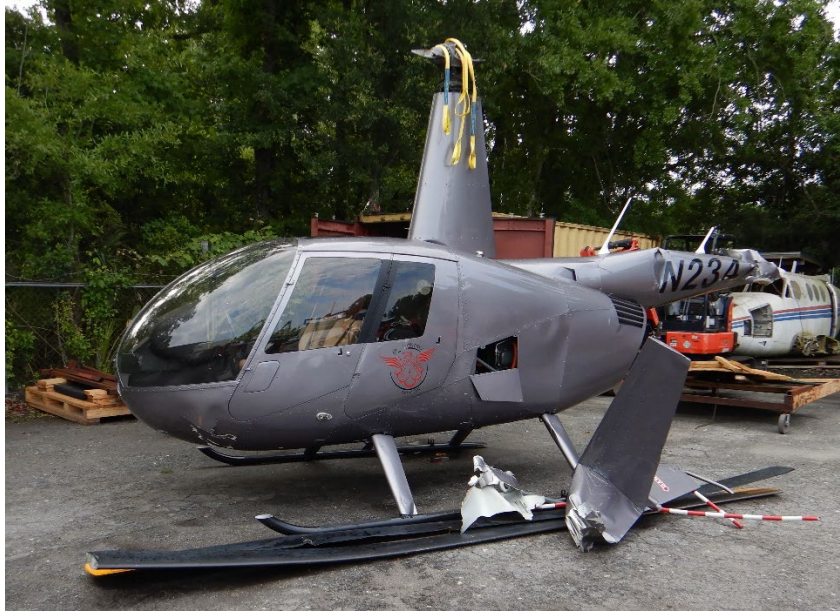
**Photo 2 - View of helicopter from the left.**

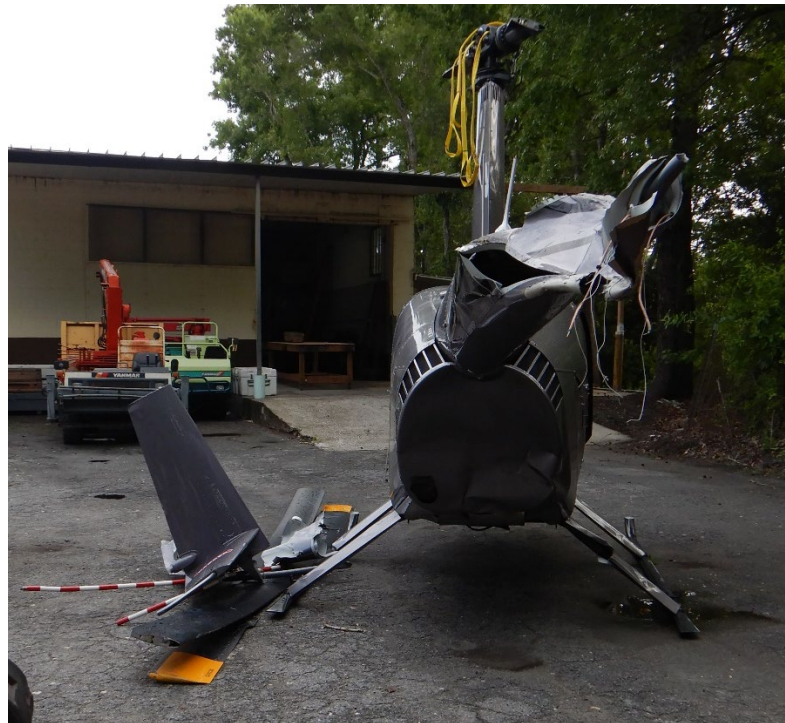
The tailcone was damaged on both sides in the second bay. It was separated in the fourth bay, where there was distortion on the left side with a shape similar to the shape of the main rotor, and some yellow paint transfer. The sixth bay was detached from the rest of the tailcone. The last bay of the tailcone, as well as the tail rotor gearbox, were not present for the examination, but the empennage was. The upper vertical stabilizer had a large dent on the leading edge near the top, and the shape of the dent was similar to the shape of the main rotor, and there was paint smearing evident in the dent. The horizontal stabilizer, lower vertical stabilizer, and tail skid

'stinger' were intact and did not appear to be damaged. The tail rotor visual guard was fractured at the lower stabilizer.

**Photo 3 - View of helicopter from the rear.**

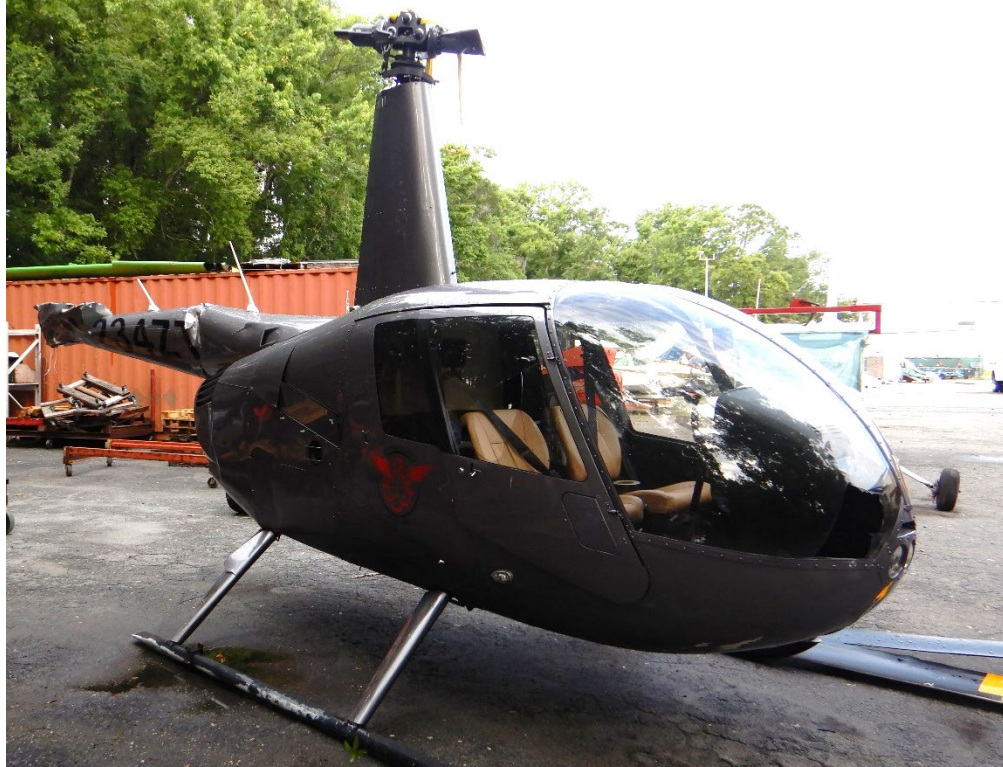
**Photo 4 - View of helicopter from the front right.**

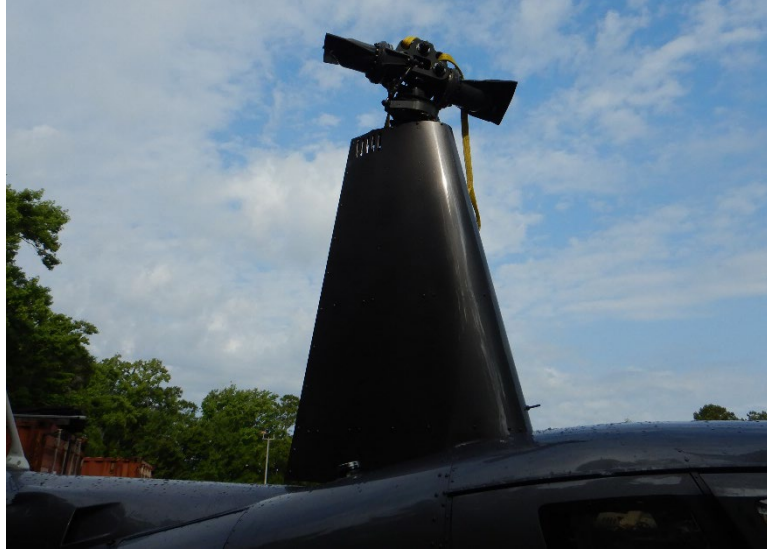
**Photo 10 - View of main rotor mast with rotor blades cut for recovery.**

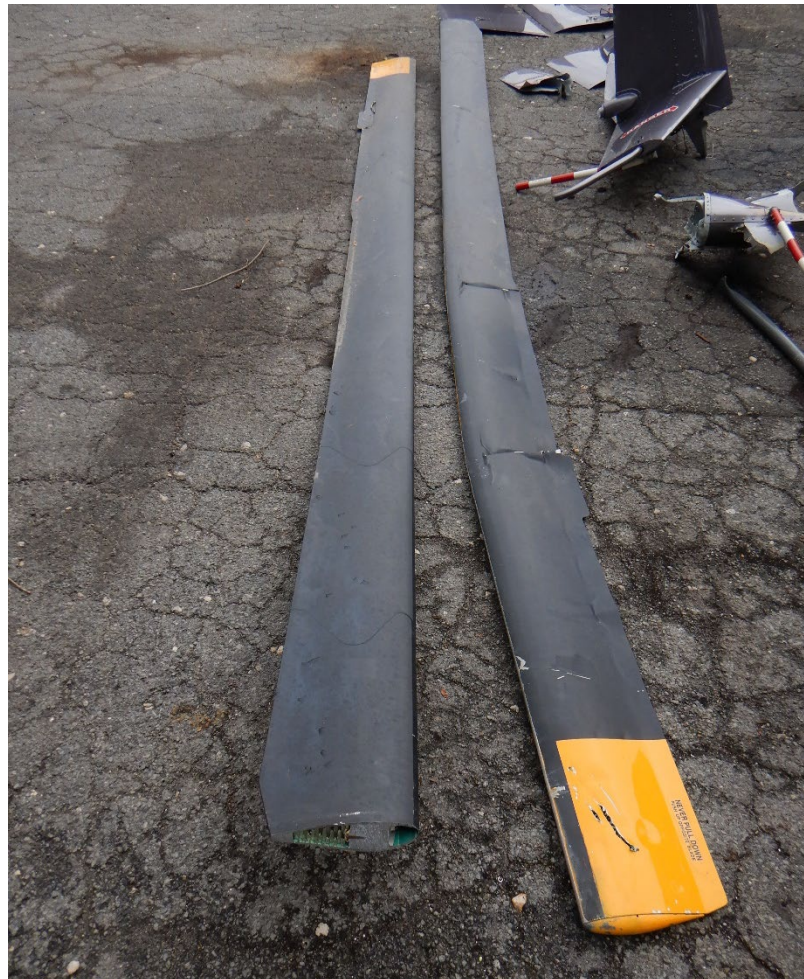
**Photo 11 - View of the main rotor blades cut for recovery.**

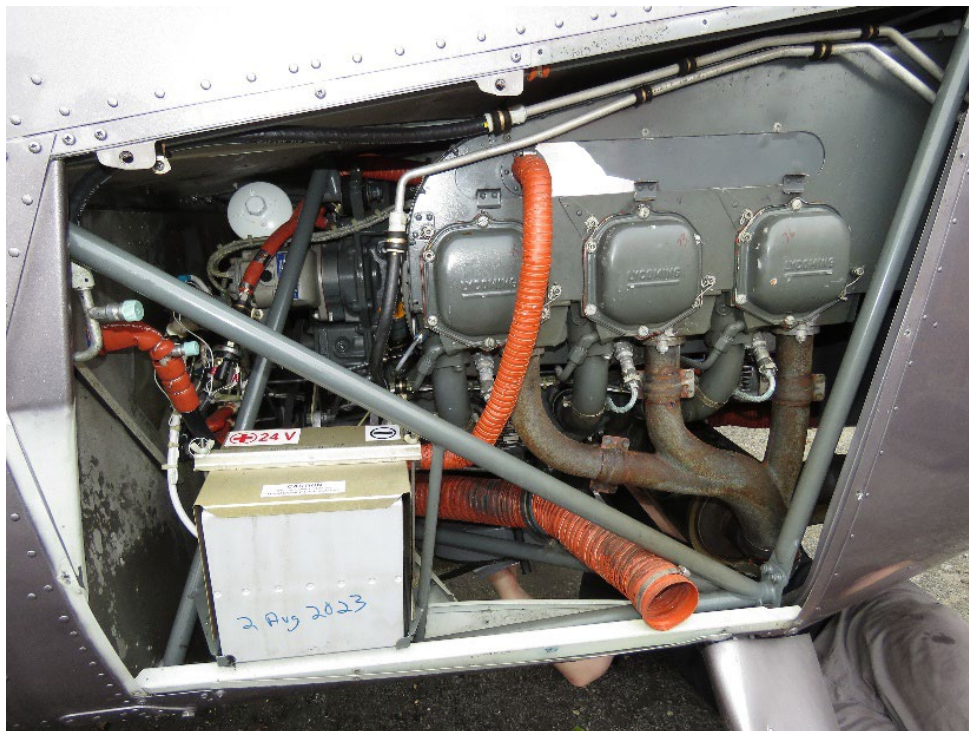
The helicopter was equipped with a Lycoming O-540-F15B engine, S/N L-27702-40E. As first viewed, the engine remained installed in the rotorcraft and remained cowled. There was little external engine damage. There was impact damage to the rear exhaust when it exited the rear cowl, and to the air filter housing. No baffles blocked the exhaust, and no oil was present in the muffler. The crankcase was intact and undamaged. There was no evidence of contact between the oil cooler or the adjacent cooling sheet metal with the starter ring gear, the alternator cooling fan and drive pulley with the starter ring gear, or the engine cooling fan with the scroll or surrounding hardware. The engine cooling fan scroll inlet rings showed no significant scoring adjacent to the cooling fan 'nose.' There was a short (about 30° of arc) circular score on the aft surface of the upper sheave. The belt tension actuator exhibited no scoring on the surface that is adjacent to the upper sheave. There was continuity from the engine attachment points for the mixture, throttle, and carburetor heat to the cockpit controls. There was no obvious physical damage limiting movement of the throttle.

**Photo 21 - Engine before examination.**

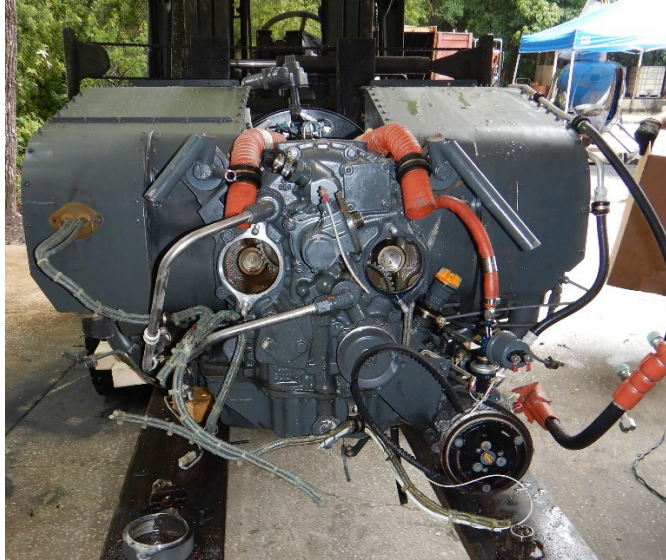
**Photo 22 - Engine removed from airframe.**

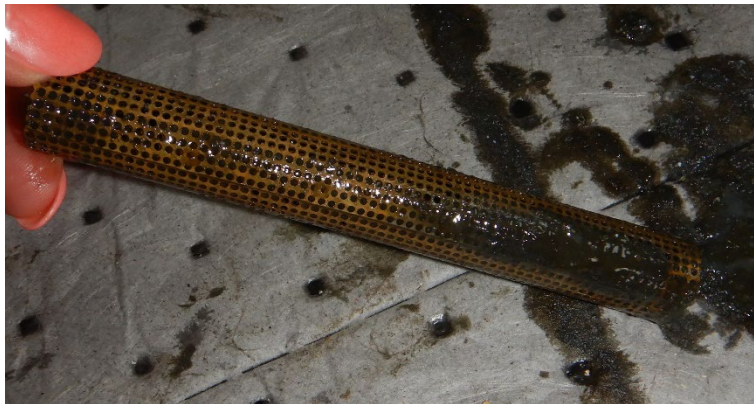
The oil sump was filled with salt water, at the beginning of the exam, the dipstick was removed, and salt water started pouring out of the filler tube. The dipstick was put back in place to prevent water from escaping so the contents could be captured in a container. When the suction screen plug was pulled and the contents drained into a bucket, only a minor amount of oil was present with the salt water. There was a large amount of salt deposits on the bottom of the oil sump, a screwdriver was used to free up the ports that lead to the suction screen plug and the oil contained in the sump was drained into a bucket. The dipstick was reading approximately 11 quarts of oil at the time of examination. The oil suction screen was examined, and some salt deposits and oil sludge noted on the suction screen, no additional contamination was noted. The oil filter remained secured to the oil filter adapter. The oil filter was removed and cut open. The paper element was clean and free of contamination, date and tach time were not recorded on the oil filter body.

**Photo 25 - View of oil suction screen.**

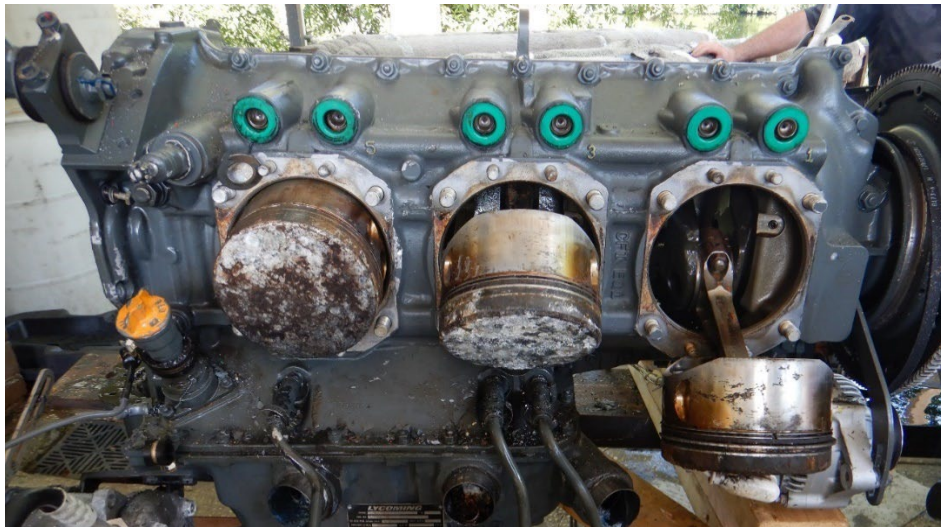
oil. The remaining oil was sufficient for engine operation. All six cylinders were removed. The No. 5 cylinder was difficult to pull free from the piston, and once freed, a large quantity of blackened salt-like deposit was noted between the cylinder and cylinder wall. Once all the cylinders were removed, the crankshaft rotated freely about its axis and was rotated a full 360° multiple times. Each connecting rod moved freely about its journal on the crankshaft. The camshaft rotated when the crankshaft was rotated, no cracks or fractures were noted, and each cam lobe appeared whole and undamaged. The roller tappets appeared undamaged and moved freely against the lobe of the camshaft as it was rotated by the crankshaft. The crankshaft gear was secured and safe tied and the crank gear dowel pin was not sheared. The idler gears remained in position, appeared undamaged, and rotated when the crankshaft was rotated.

**Photo 30 - View of pistons on cylinder Nos. 5, 3 and 1.**

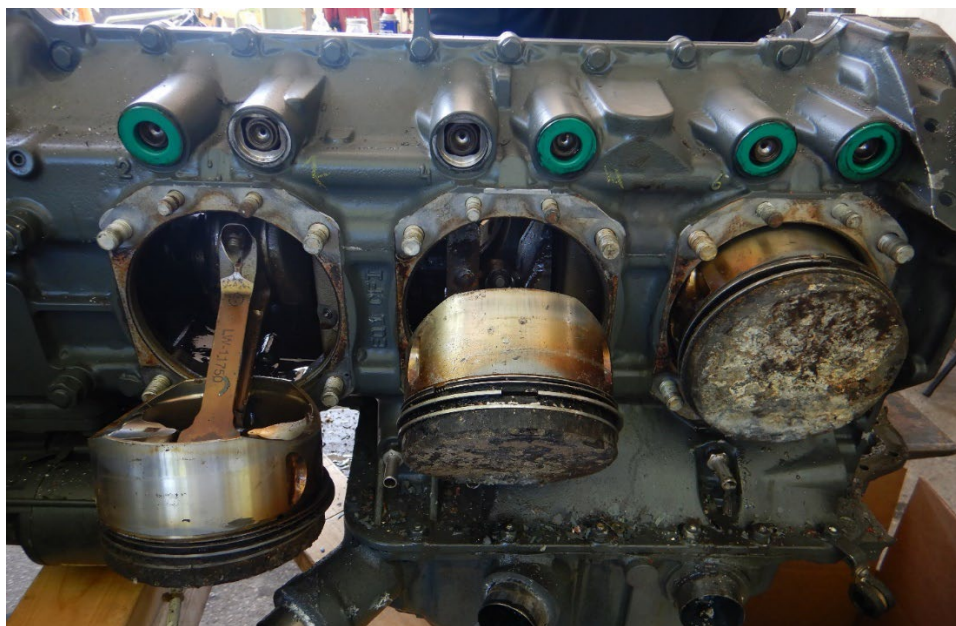
**Photo 31 - View of pistons of cylinder Nos. 2, 4, and 6.**

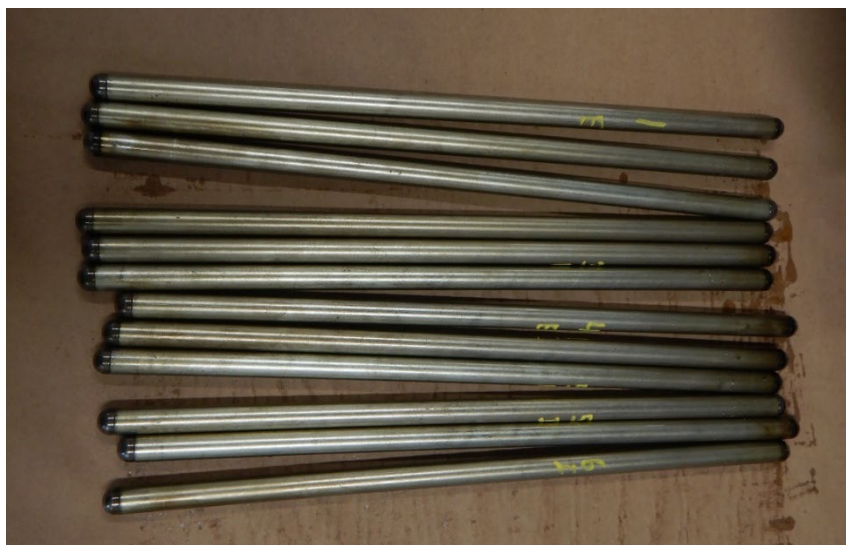
**Photo 32 - View of removed pushrods.**

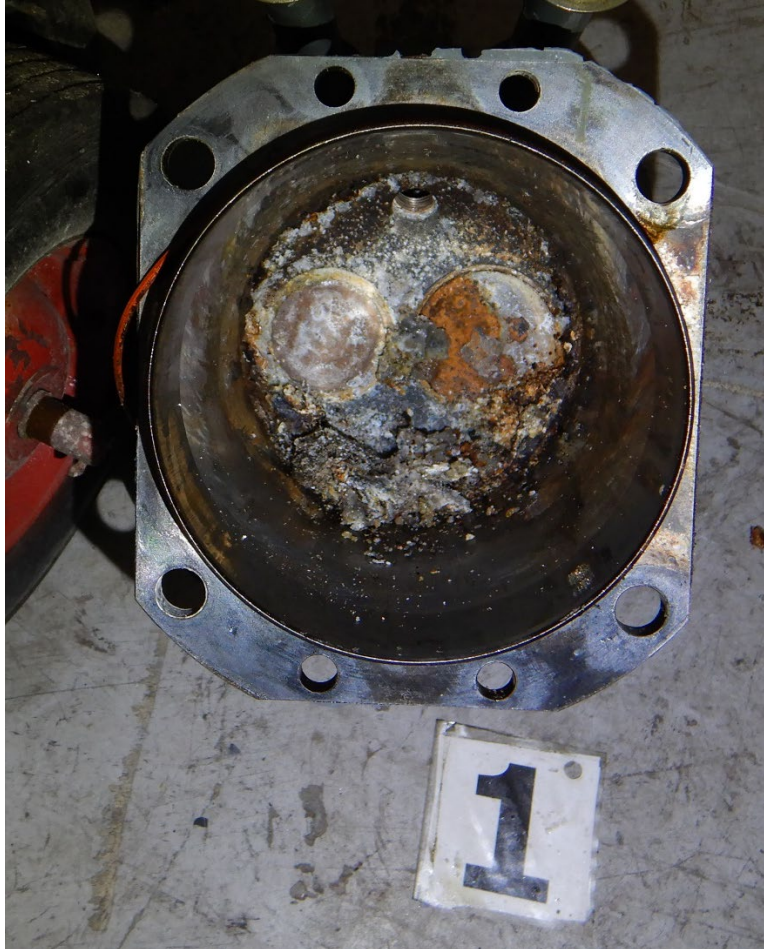
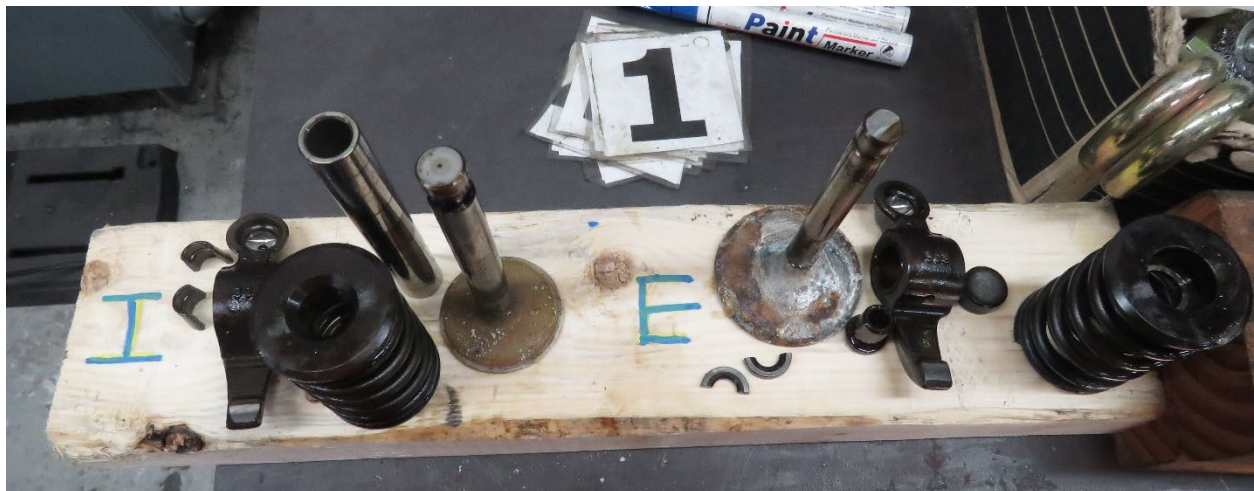
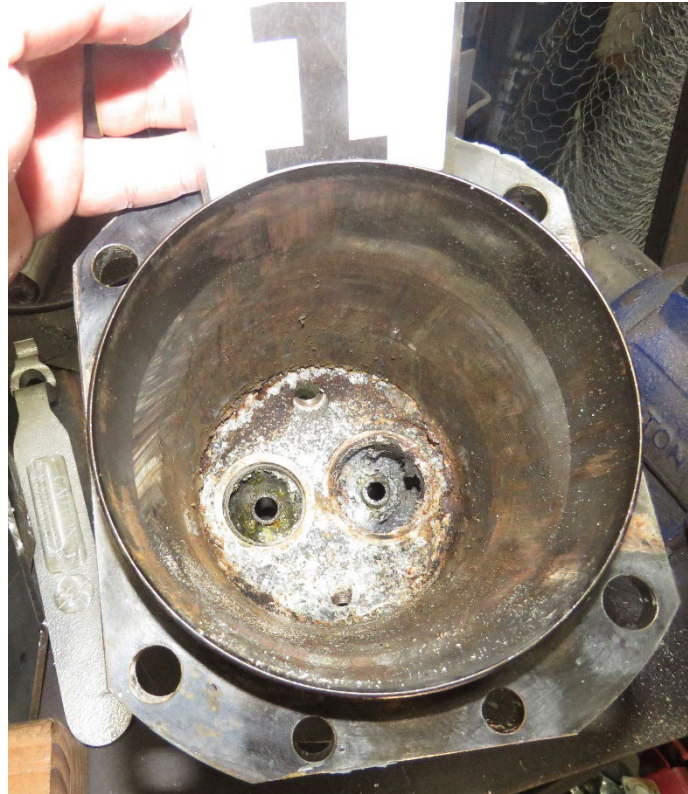
The cylinders had varying amounts of salt deposits and were heavily corroded due to submersion in salt water. Once the valves of each cylinder were released from the binding of the corrosion and deposits, all exhaust and intake valves moved freely in their respective valve guide; no scoring, material transfer, or carbon deposits were noted on the shafts of each valve. Each exhaust valve had its rotator cap installed (this engine does not have rotating intake valves installed). Each pushrod was removed and examined, all pushrods were straight and appeared serviceable. The ball end of each pushrod on the rocker arm side had varying levels of vertical striations, typical of in-service roller tappet engines (Lycoming SA 167A) provides more details about this type of wear. The pistons remained attached to each connecting rod, and no worn piston pin plugs were noted. The faces of each piston and the grooves for the compression and oil control rings were contaminated with salt deposits, and no discrepancies were noted.

**Photo 35 - View of cylinder No. 1 after removal from engine.**

**Photo 36 - View of removed valves and springs.**

**Photo 37 - View of cylinder No. 1 upon removal of valves.**

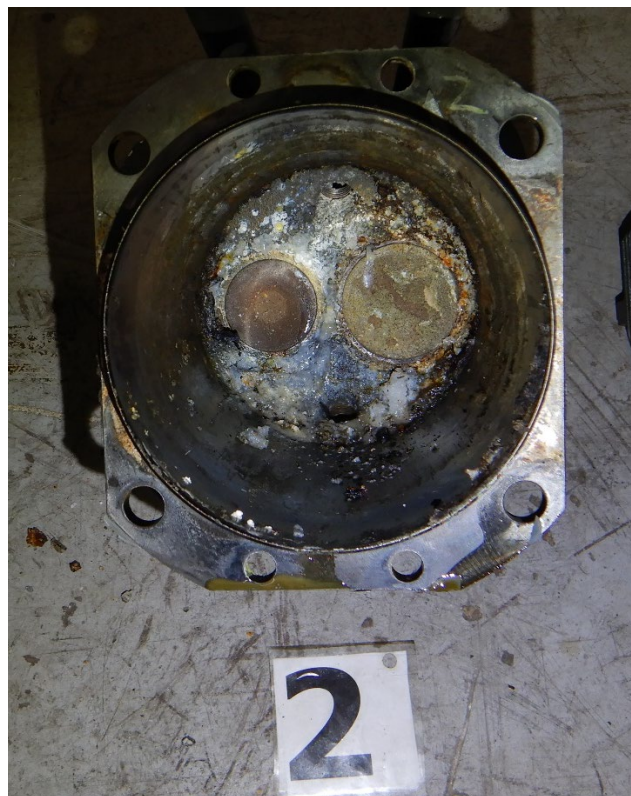
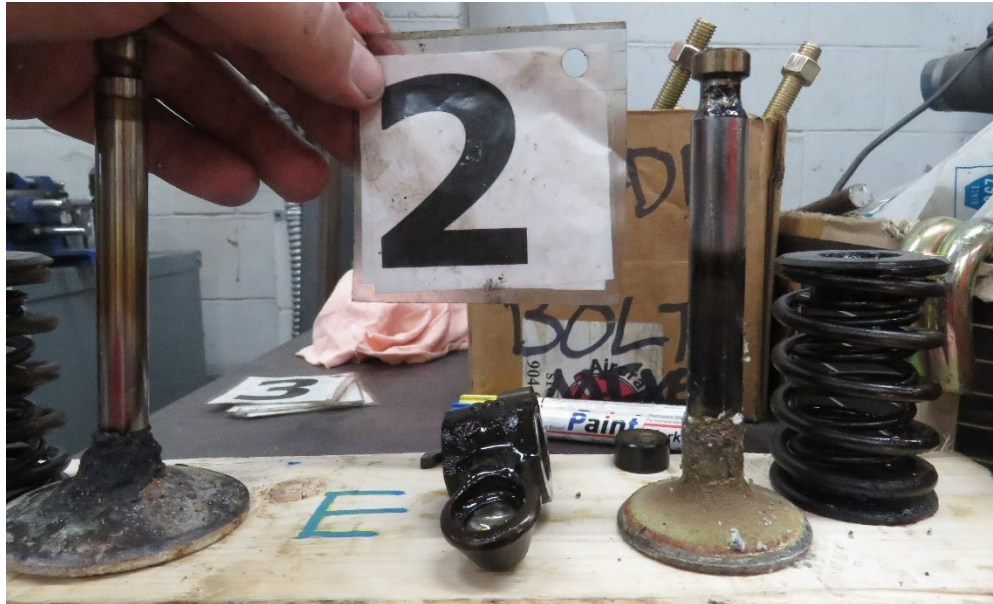
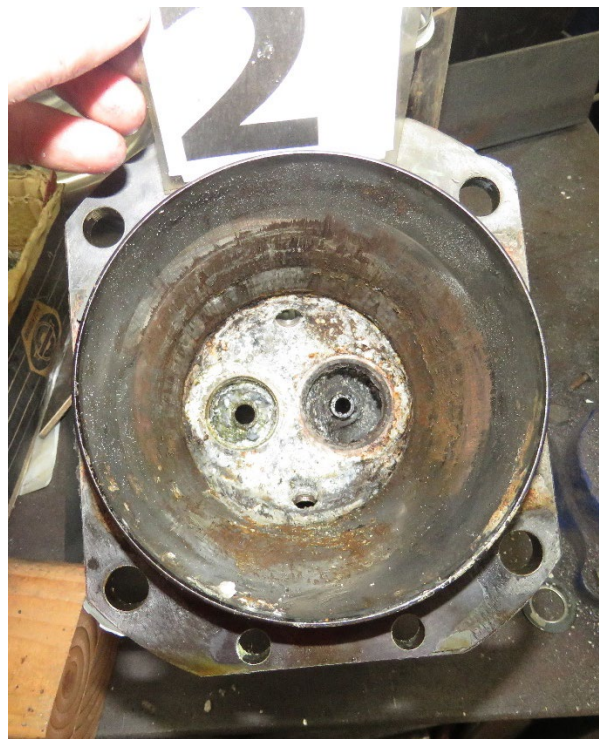
**Photo 38 - View of cylinder No. 2 after removal from engine.**

**Photo 39 - View of removed valves and springs.**

**Photo 40 - View of cylinder No. 2 with valves removed.**

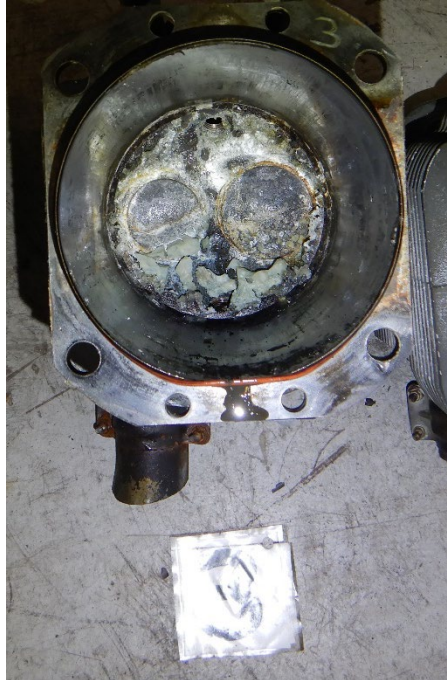
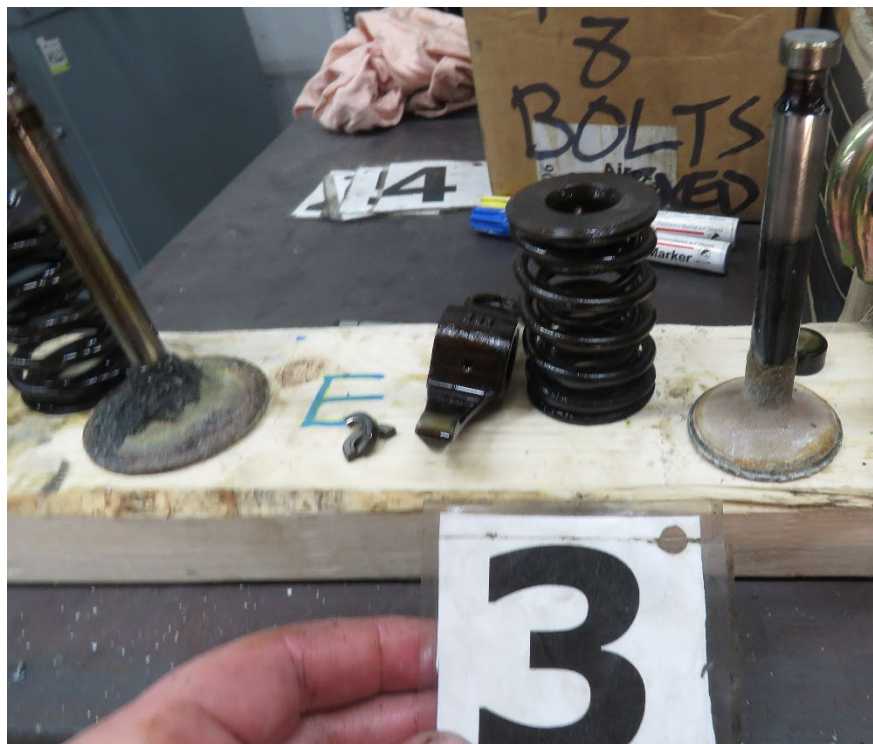
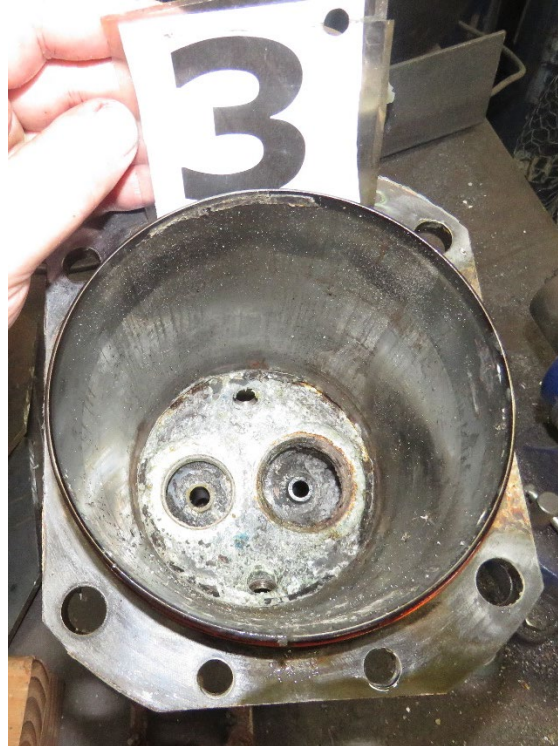
**Photo 41 - View of cylinder No. 3 after removal from engine.**

**Photo 42 - View of removed valves and springs.**

**Photo 43 - View of cylinder with valves removed.**

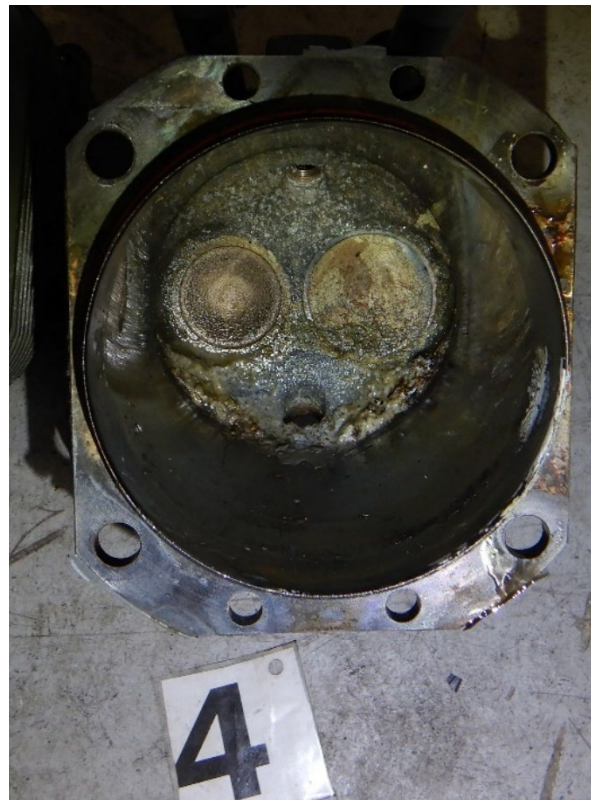
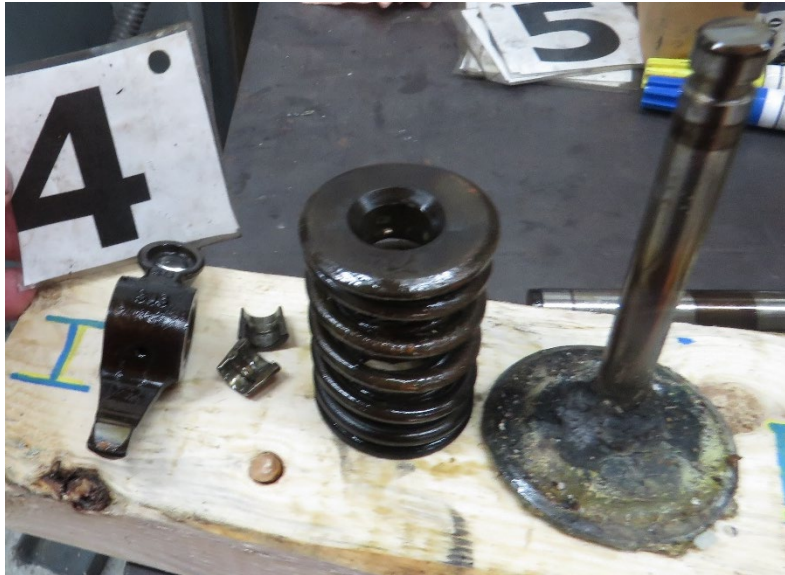
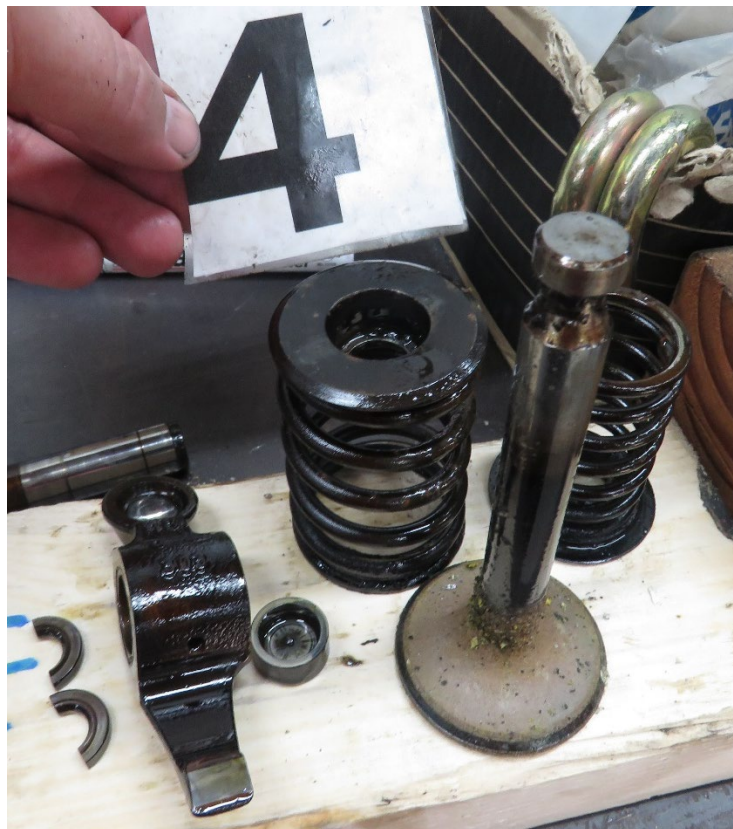
**Photo 44 - View of cylinder No. 4 after removal from engine.**

**Photo 45 - View of intake valve and spring.**

**Photo 46 - View of exhaust valve and spring.**

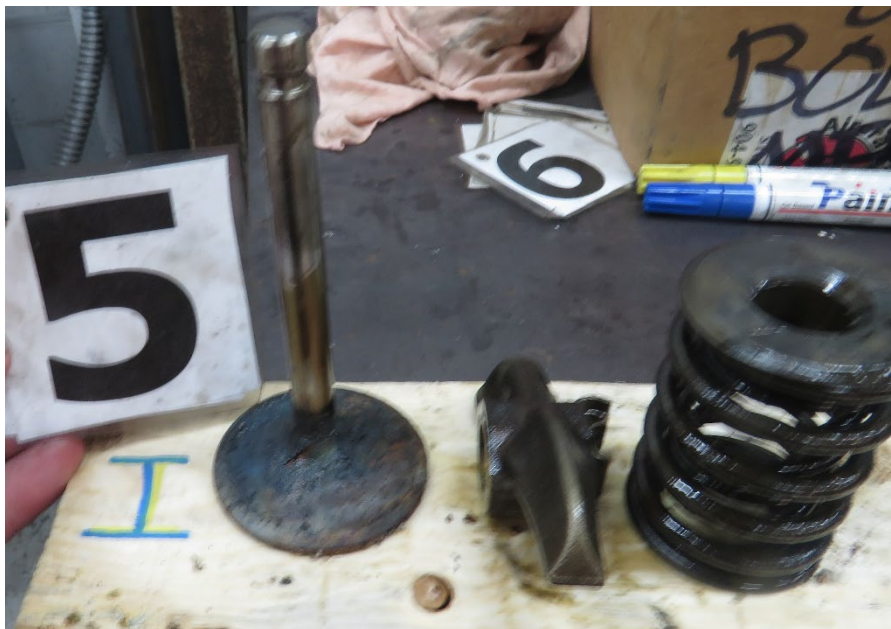
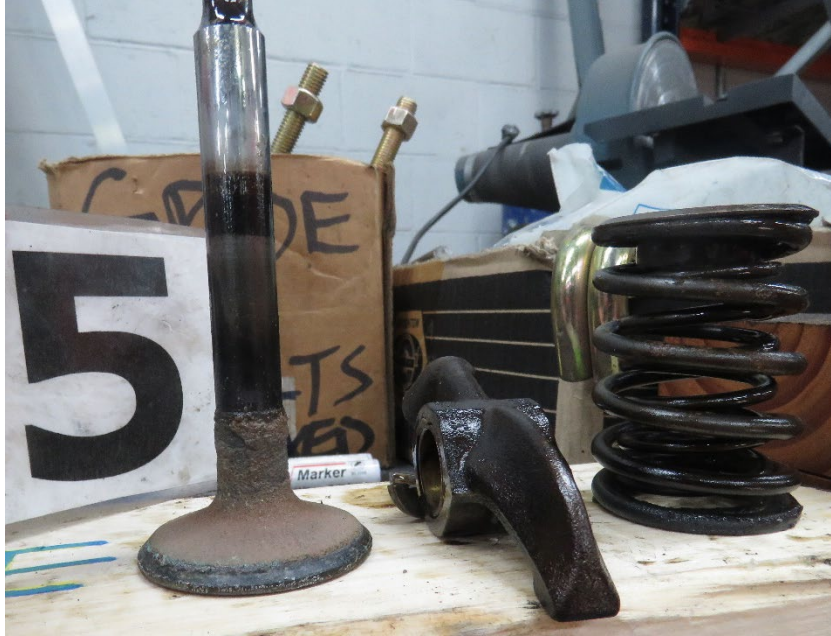
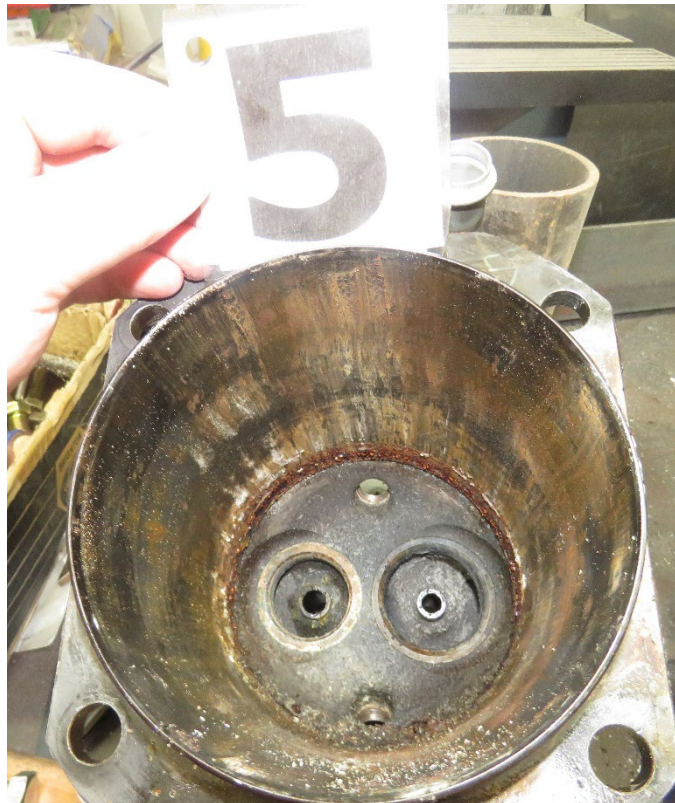
**Photo 48 - View of intake valve and spring.**

**Photo 49 - View of exhaust valve and spring.**

**Photo 50 - View of cylinder with valves removed.**

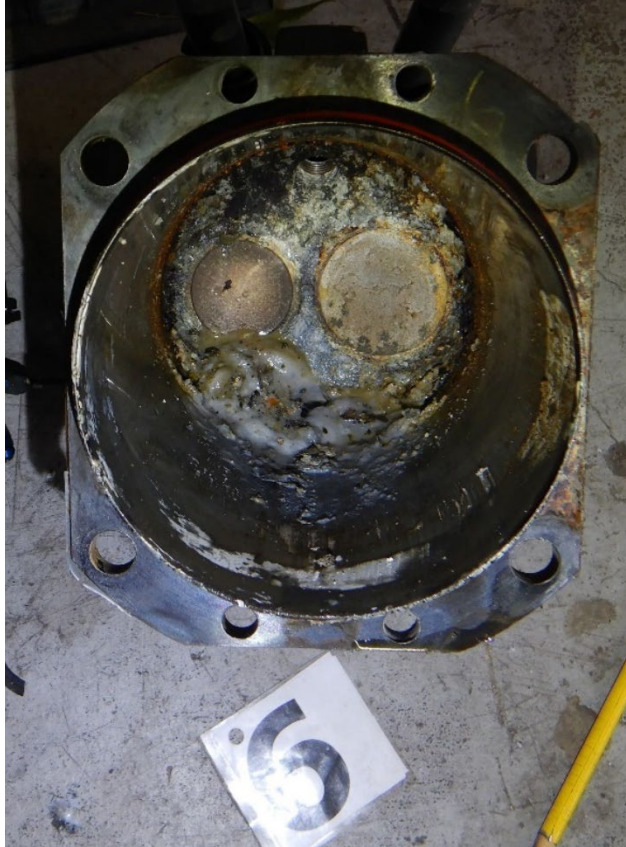
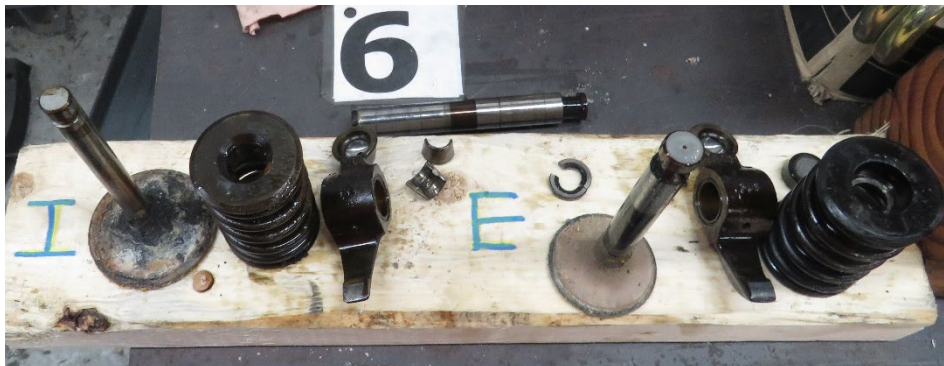
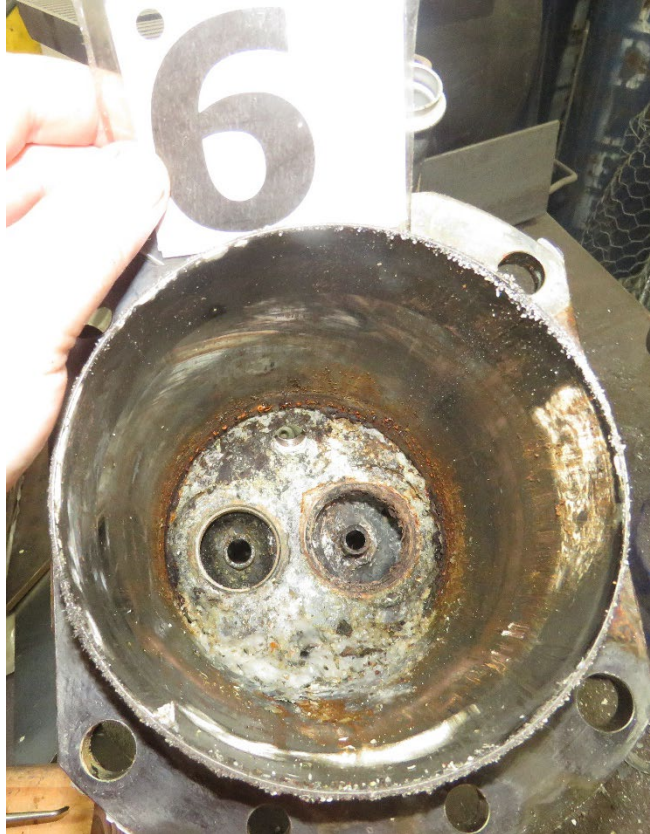
**Photo 51 - View of cylinder No. 6 after removal from engine.**

**Photo 52 - View of intake and exhaust valves and springs.**

**Photo 53 - View of cylinder with valves removed.**
