**Investigation Report**

**VSE MFG010.R0****DETAILS OF REQUEST**

| <b>NTSB Investigation Number</b> | ERA24LA223 |
| <b>Unit Type</b> | Fuel Control Unit |

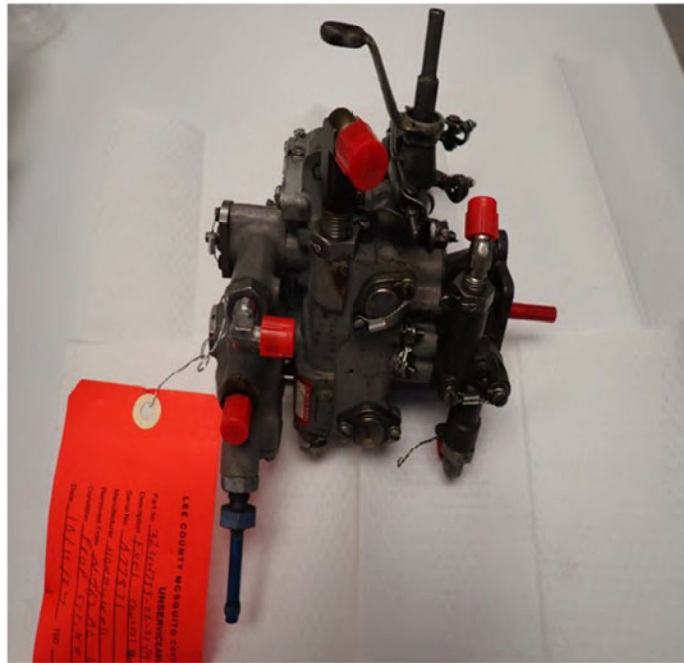
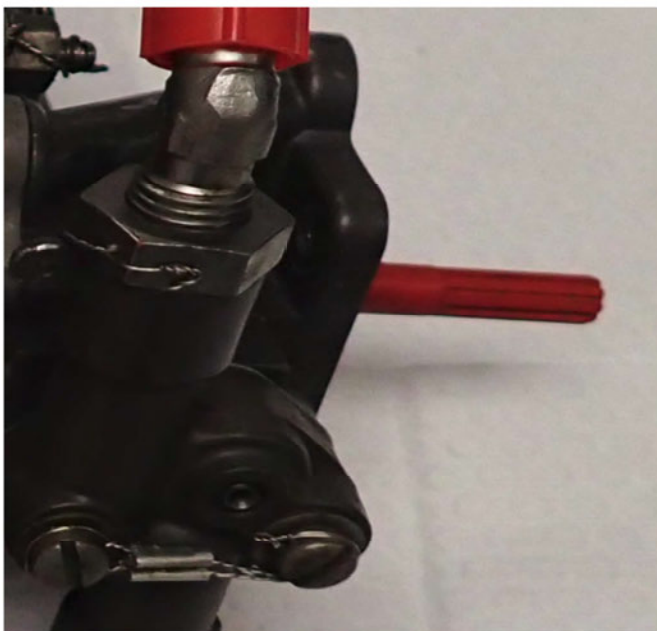
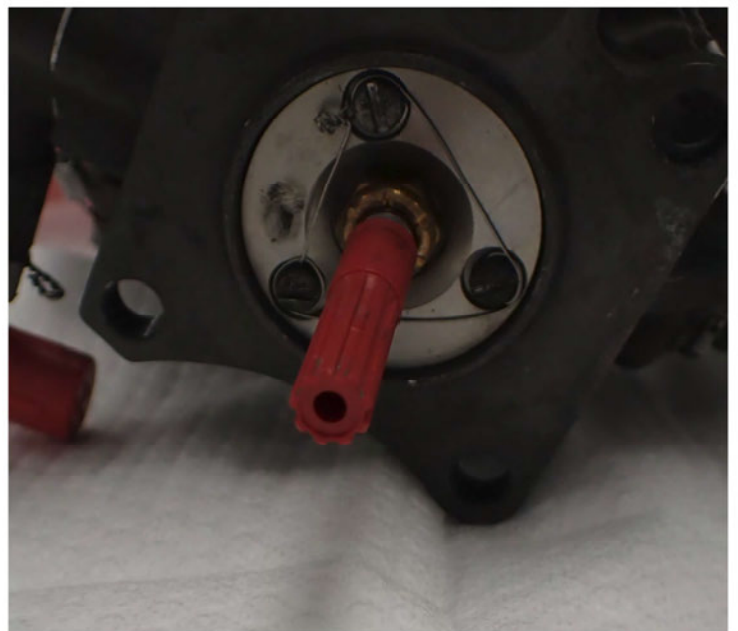
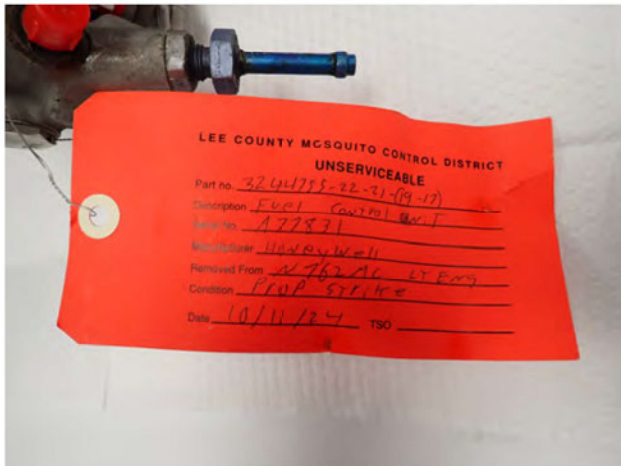
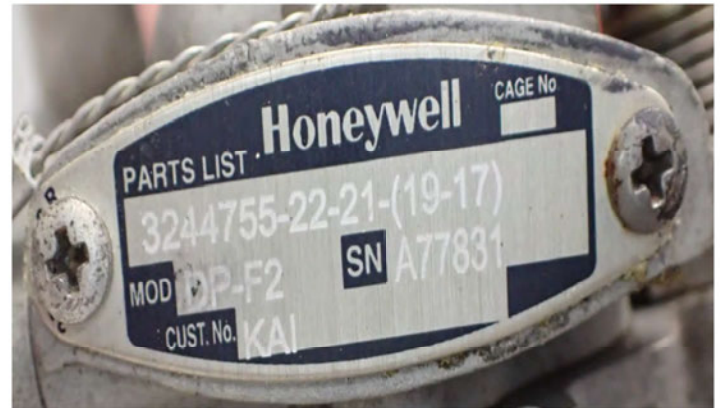
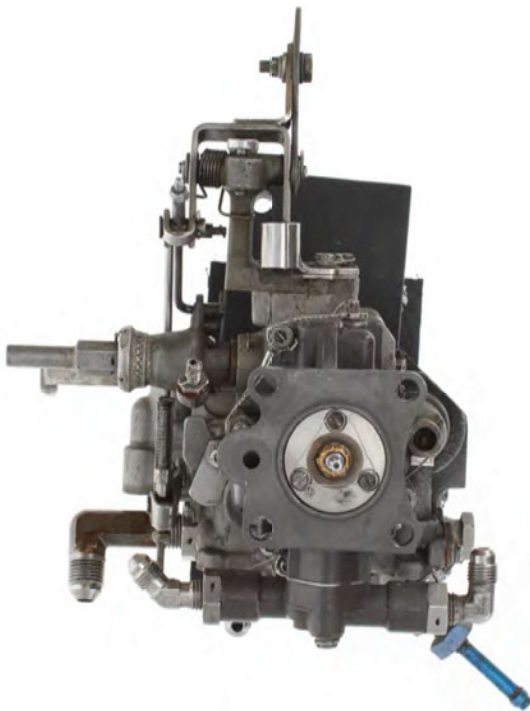
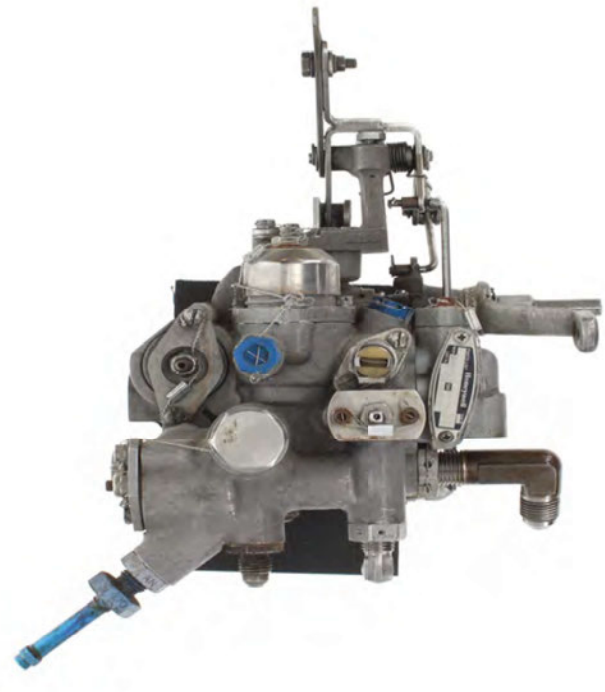
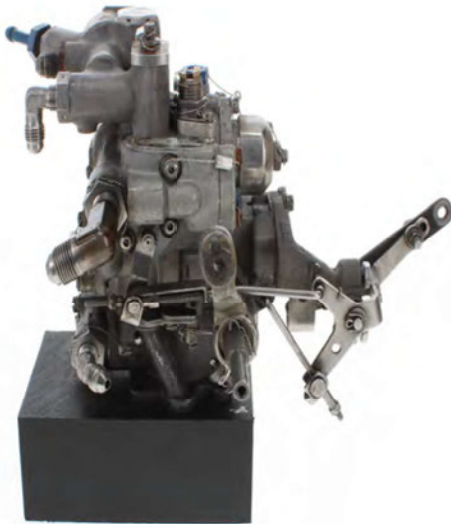
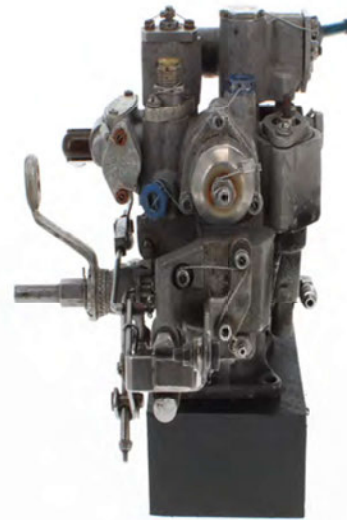
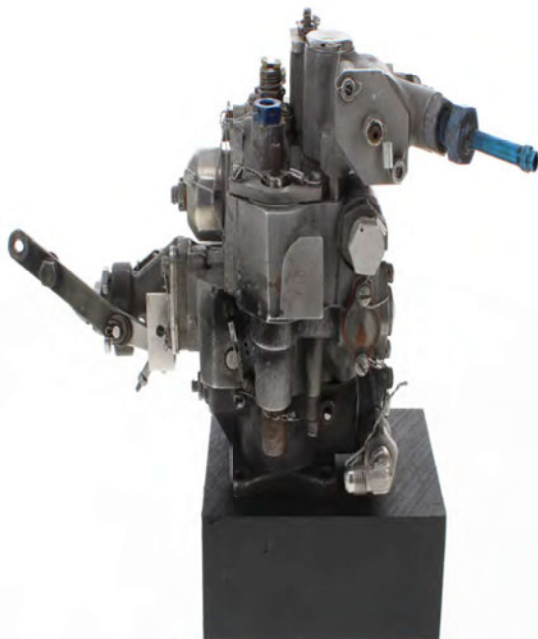
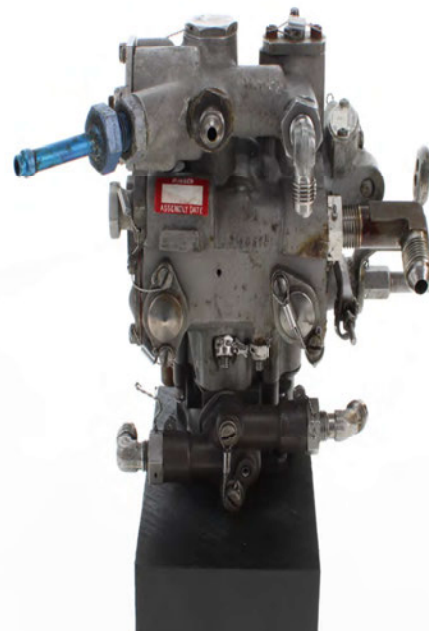
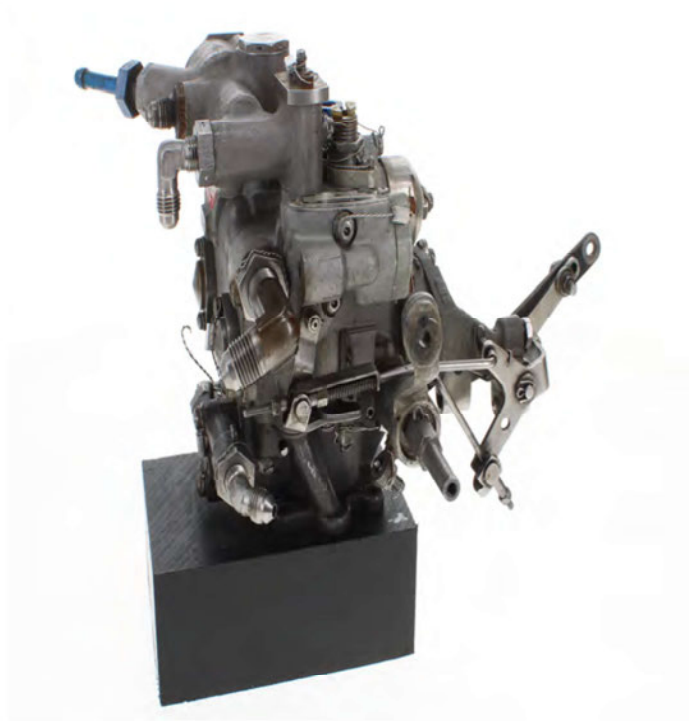
2. Box was opened, packaging material removed. Unit was observed to be in a plastic bag. Reference Images 2A, 2B, 2C, 2D, 2E.
3. Unit was removed from the bag, photographed, Receiving Inspection was performed to include inducing the unit and acquiring pictures of the outside surfaces. Protective caps present on Air/Fuel fittings. No protective cap on drain fitting. Drive Coupling was present on the drive shaft, no damage noted. A Lee County Mosquito Control District Unserviceable Tag was wired to the unit. Data Plate present. Reference Images 3A, 3B, 3C, 3D, 3E, 3F, 3G, 3H, 3I, 3J, 3K, 3L.

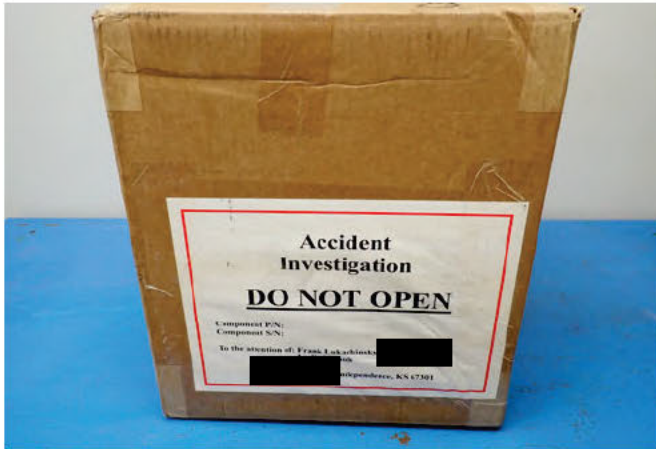
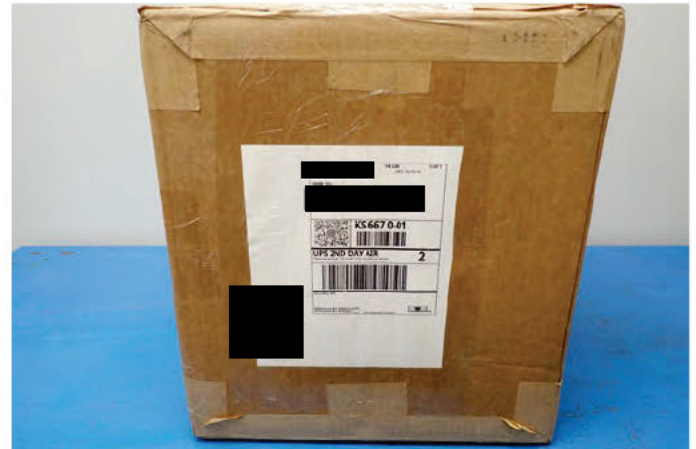
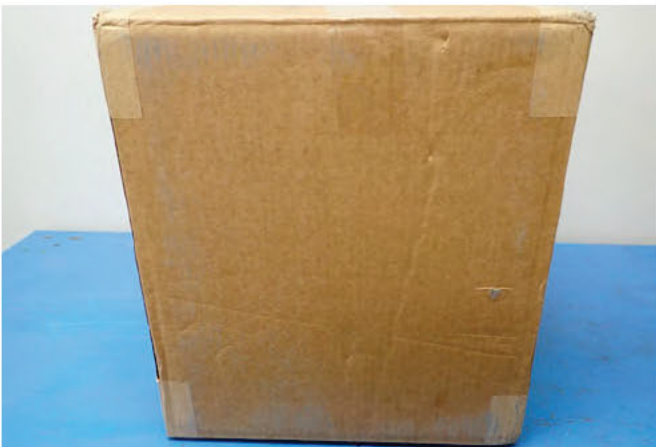
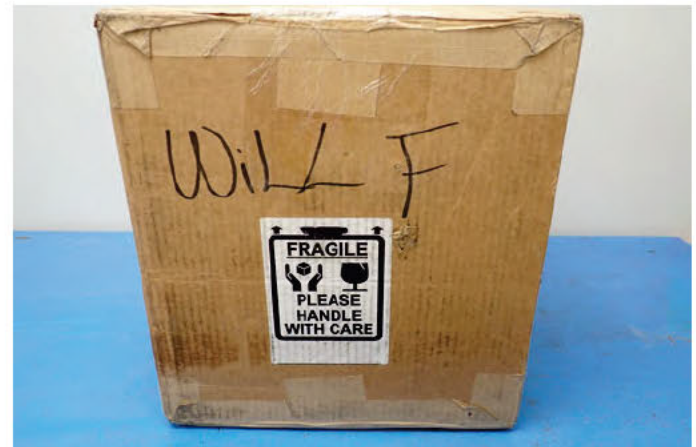
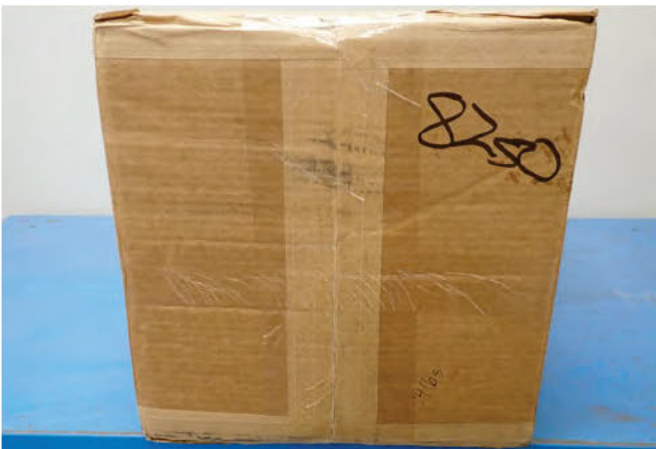
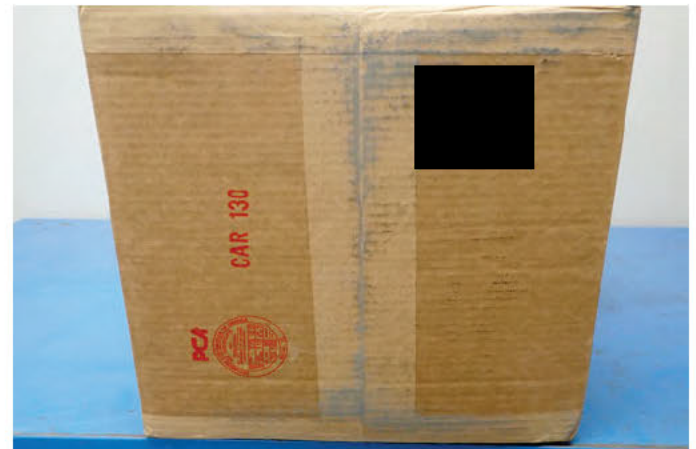
1. Boxed unit was removed from secure cabinet and visually inspected for damage to box prior to opening. No damage noted. Reference Images 1A, 1B, 1C, 1D, 1E, 1F.

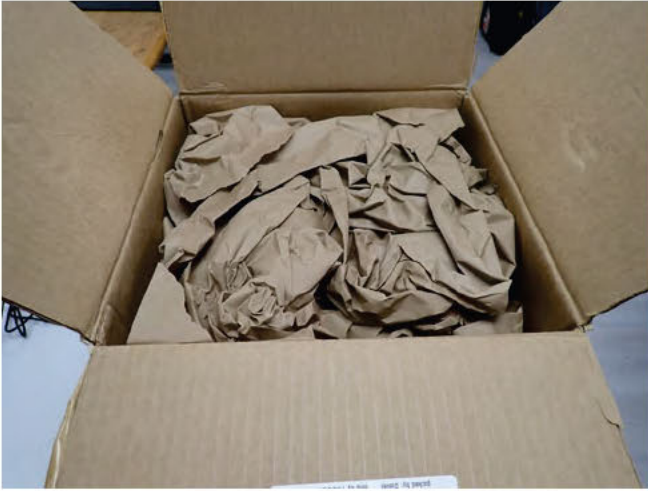
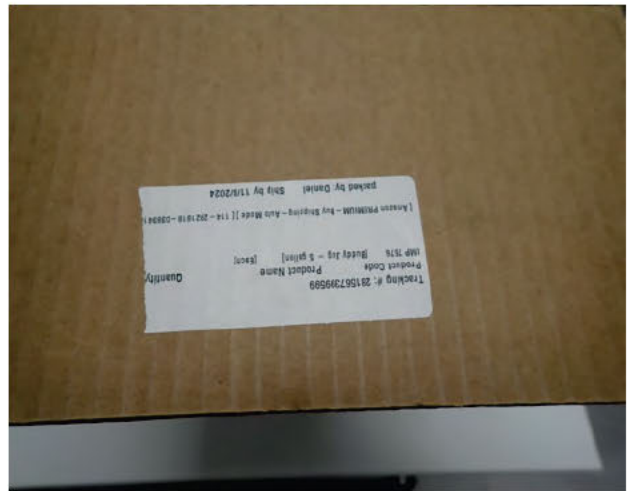
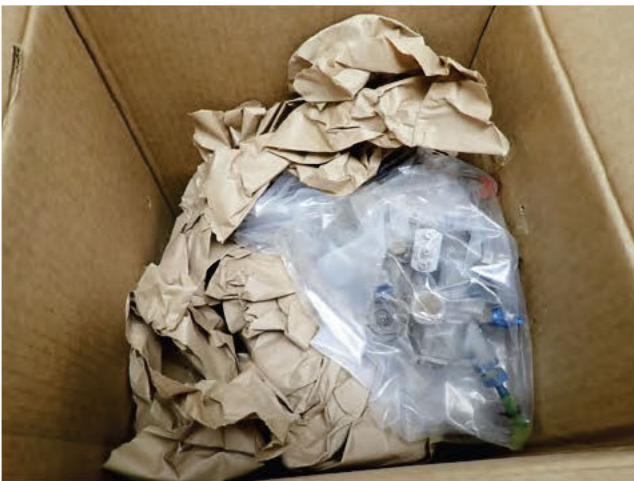
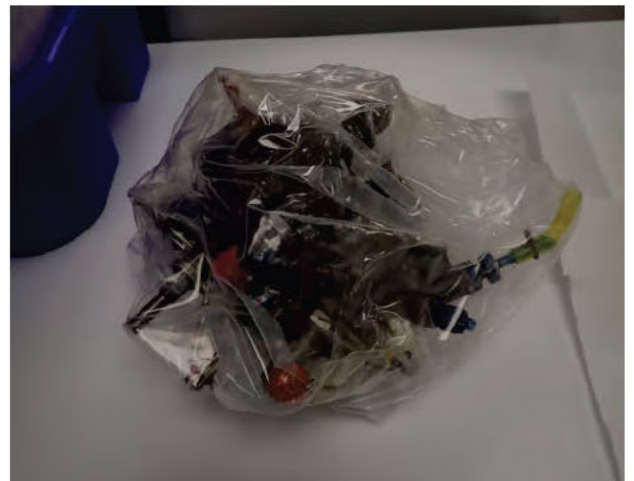
2. Box was opened, packaging material removed. Unit was observed to be in a plastic bag. Reference Images 2A, 2B, 2C, 2D. Unit was removed from the bag, photographed, Receiving Inspection was performed to include inducing the unit and acquiring pictures of the outside surfaces. Protective caps present on Air/Fuel fittings. Section of drain line attached to the drain fitting. Data Plate present. Drive Coupling was present on the drive shaft (appears torsionally broken). Reference Images 3A, 3B, 3C, 3D, 3E, 3F.
