# National Transportation Safety Board

ERA24LA276

## **WRECKAGE EXAMINATION REPORT**

Location: New Ipswich, New Hampshire  
Date: June 25, 2024  
Time: 12:55 EDT  
16:55 UTC  
Airplane: Robert Snyder Searey (N453TS)

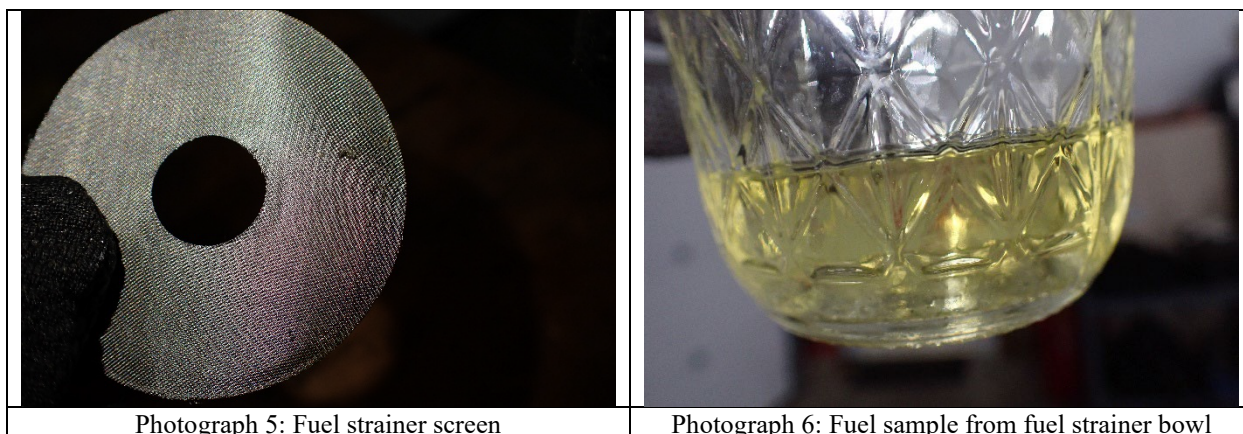
The fuel lines going to the engine were noted to be secure to the engine driven fuel pump and to the carburetors. Low pressure air was blown into the airframe and engine fuel lines, and it was noted that the lines were unobstructed. An inline fuel screen was located near the engine. The fuel screen was disassembled, and the fuel screen was noted to be clear of any contamination and was unobstructed.
