## Exemplar Truss

505 S/N 65573 N945TC

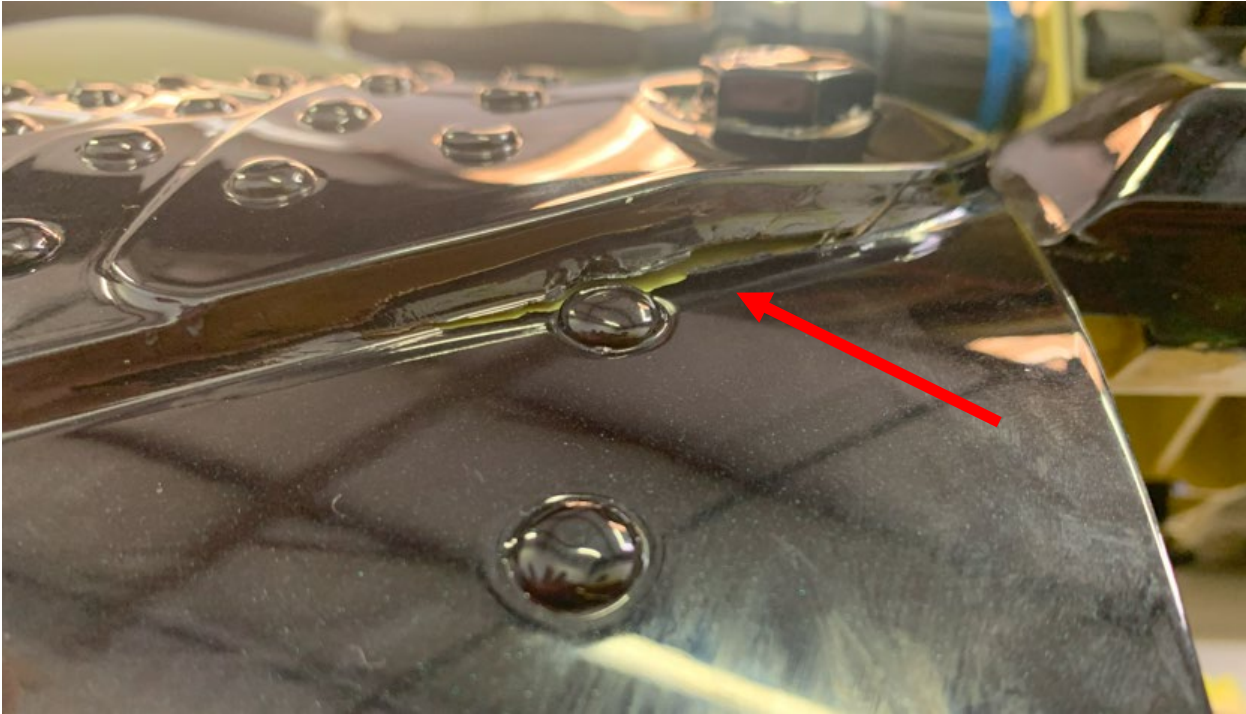
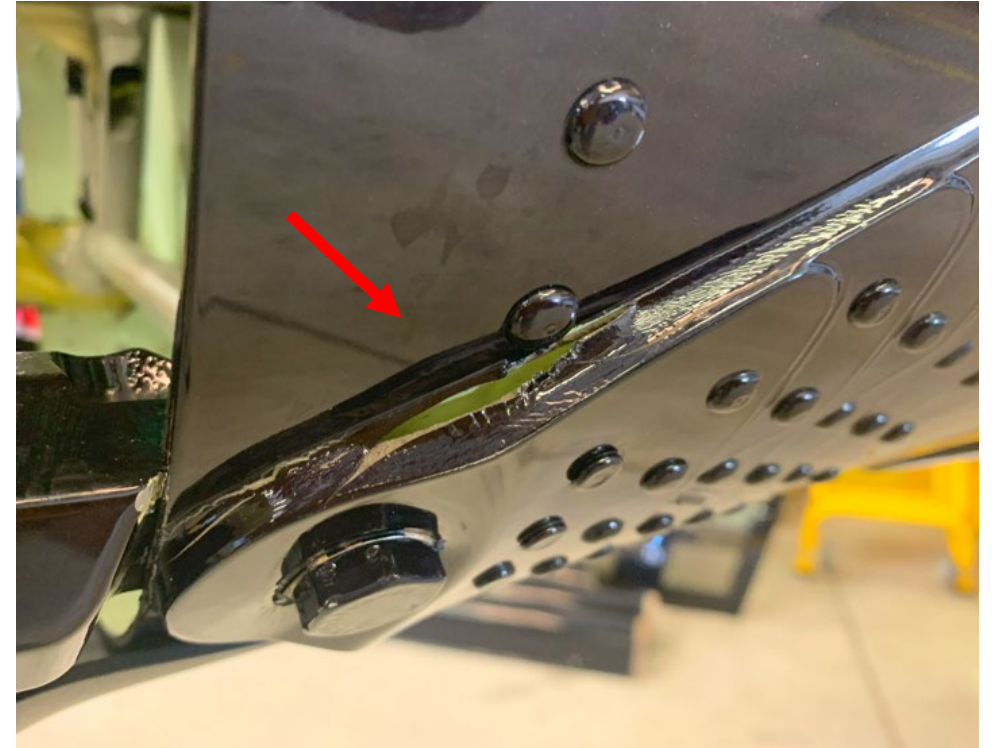
505 S/N 65573 N945TC

## Deformation of the doublers at the attachment point to the truss assembly

Tailboom (tailcone) is being replaced due to the deformation of the doublers at the attachment point to the truss assembly, which is not repairable
