# National Transportation Safety Board

ERA25FA082

## **WRECKAGE EXAMINATION SUMMARY**

Location: Cintrona, Puerto Rico  
Date: December 20, 2024  
Time: 1400 AST  
1800 UTC  
Airplane: N22088; Cessna 172S

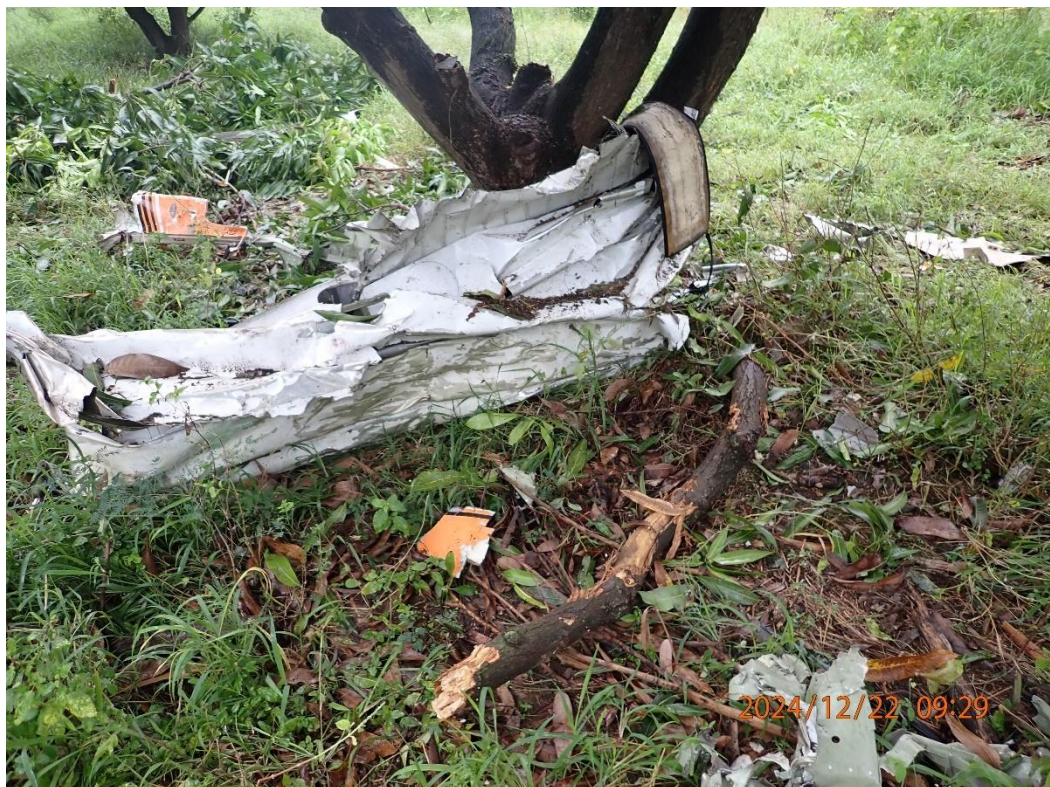
The left wing was impact separated, wrapped around a tree, and exhibited extreme impact damage. The left wing strut remained attached to the wing. The left aileron remained partially attached to the wing with pieces of it impact separated and strewn in the debris path. The inboard aft portion of the left wing including the fuel tank and flap were impact separated and found about 75 ft past the left wing. Left aileron continuity was confirmed from the control surface bellcrank to the flight control in the cockpit through multiple impact overload fractures. The overload fractures exhibited broomstraw appearance and unraveling of the control cable.

**Photo 14: View of the left wing.**

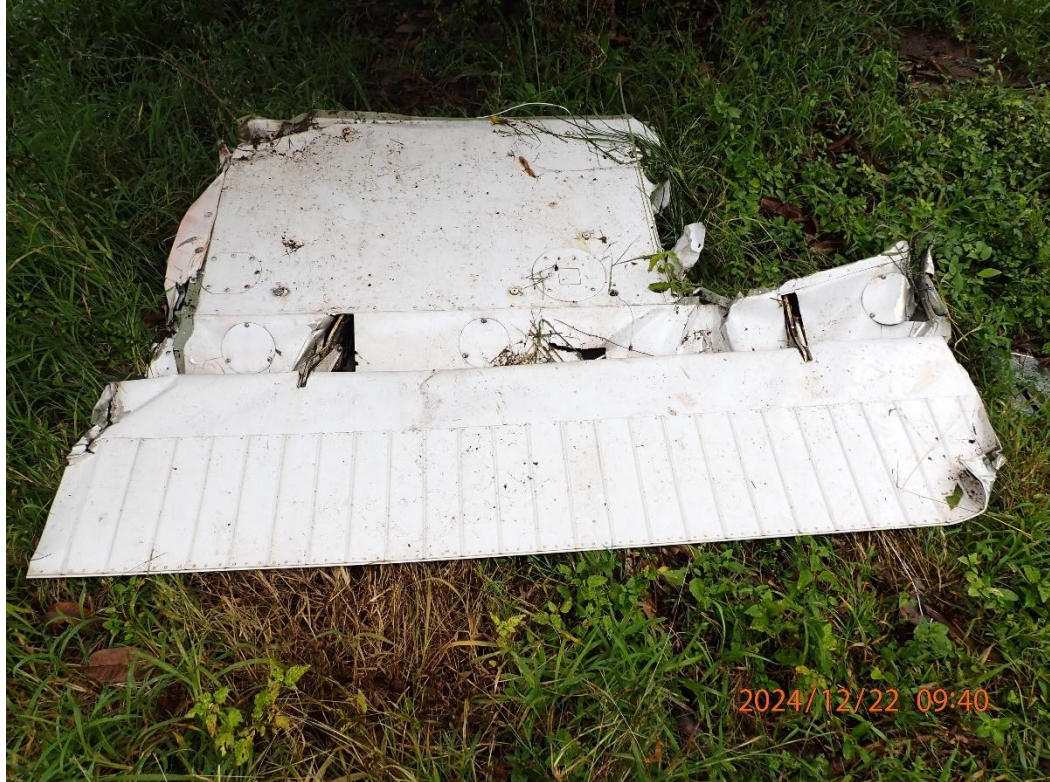
**Photo 15: View of the inboard portion of the left wing and flap.**

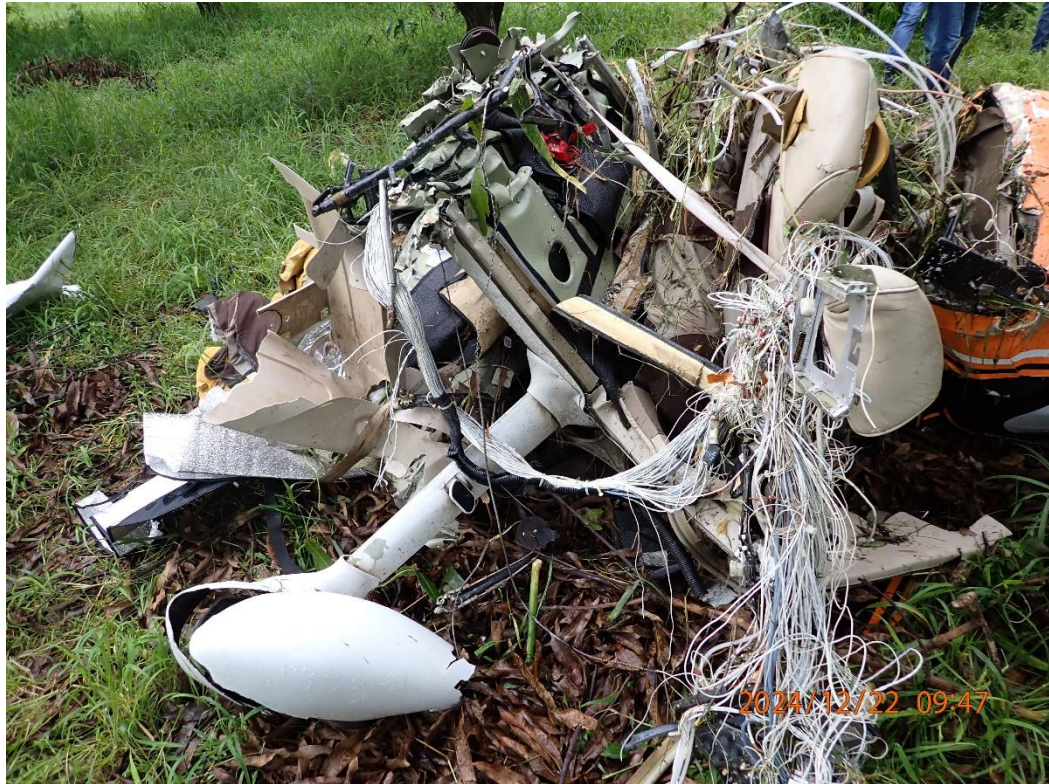
The left main landing gear remained attached to the fuselage. The right main landing gear was impact separated and located in the vicinity of the left wing. The right main landing gear tire was not located. The nose landing gear strut remained attached to the firewall and exhibited impact damage. The nose landing gear tire was located about 30 ft past the main impact crater and had wood wedged between the tire and wheel rim.

**Photo 20: View of the left main landing gear.**

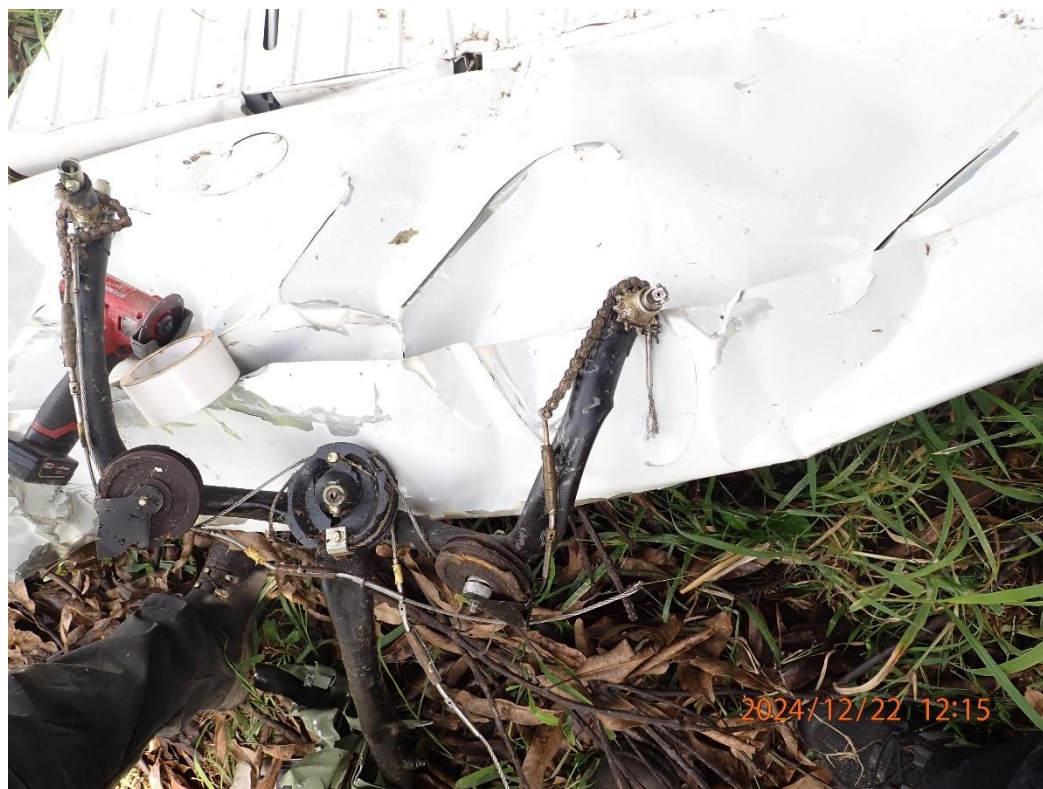
The cockpit was destroyed by impact forces. The control yoke interconnect cable was found separated. The aileron cables were overload separated at the cockpit.

**Photo 22: View of the control yoke.**

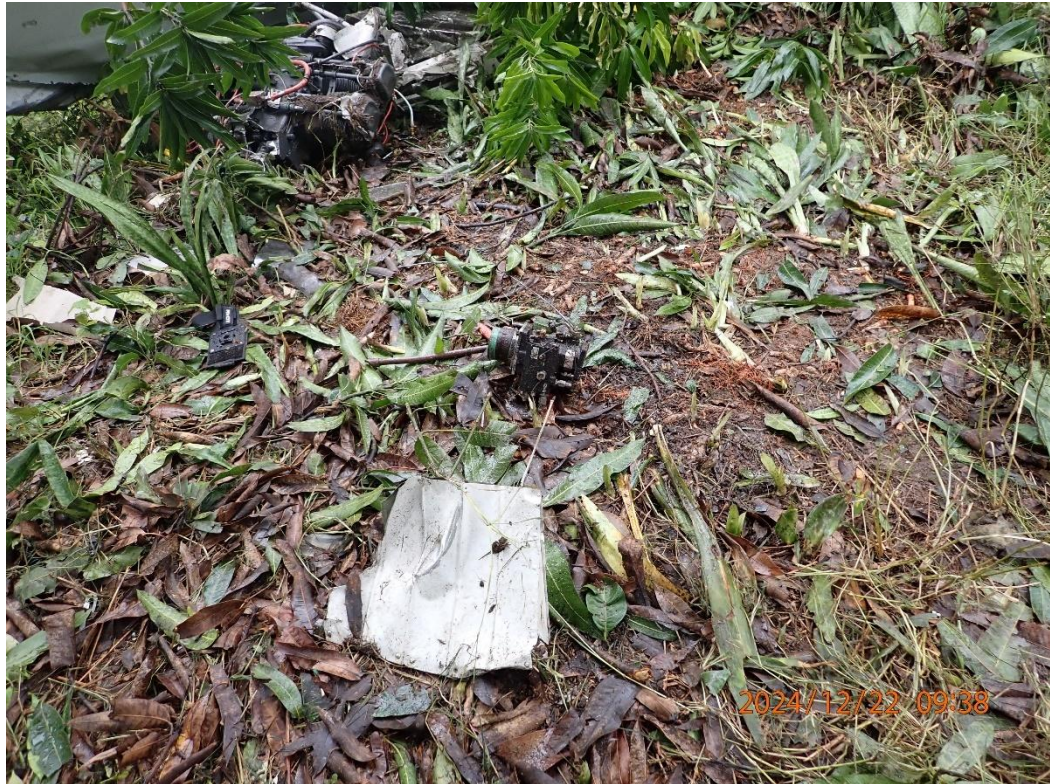
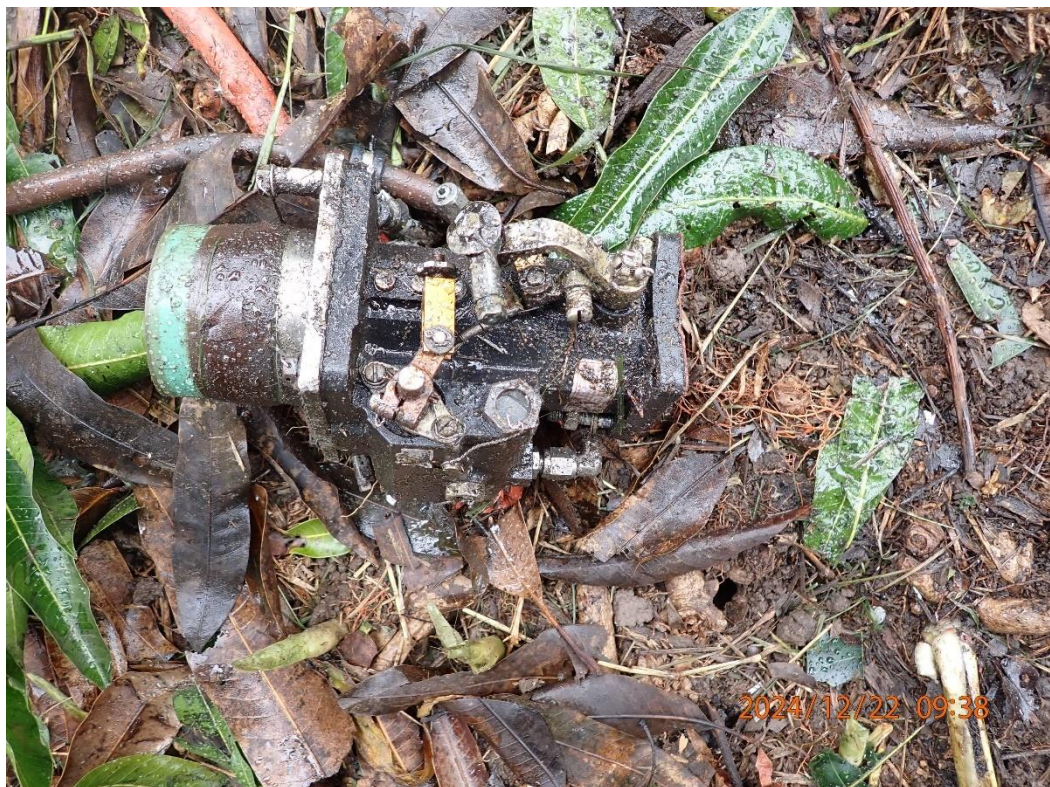
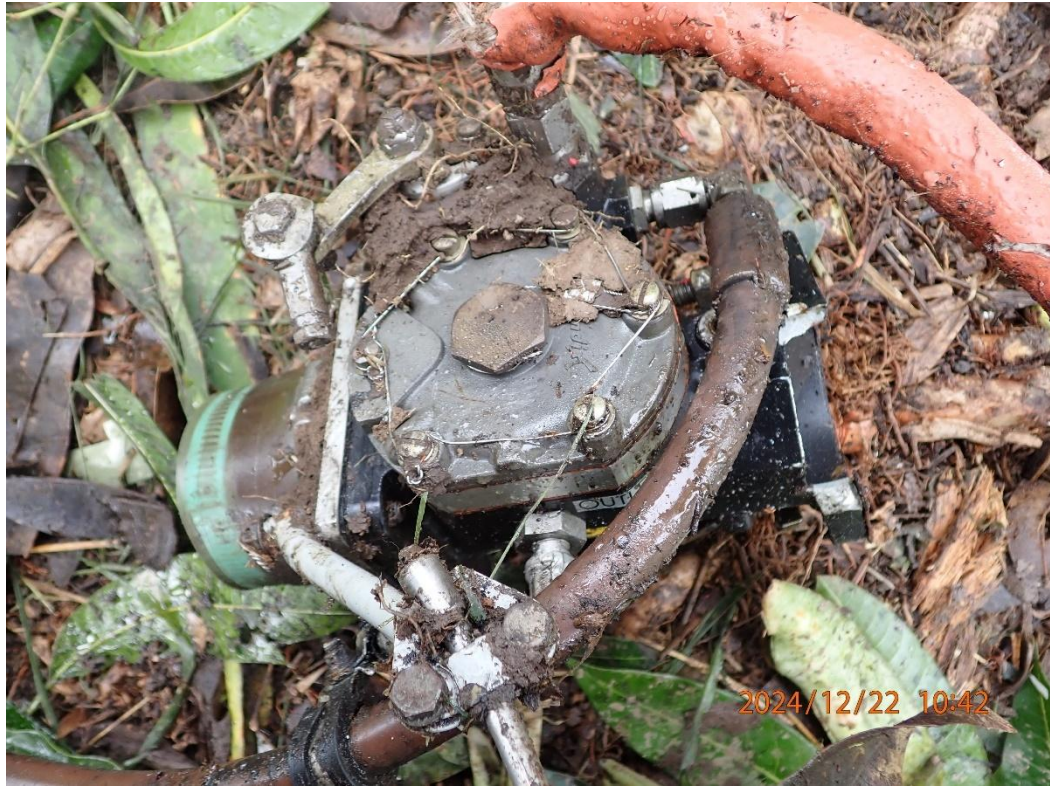
The engine driven fuel pump remained attached to the accessory case and was not removed. The fuel injector assembly was impact separated, the mixture and throttle controls were impact separated at their respective arm heads. The fuel flow divider remained attached to the engine crankcase. All fuel injector nozzles remained in their respective positions and were not removed.

**Photo 34: View of the fuel injector assembly.**

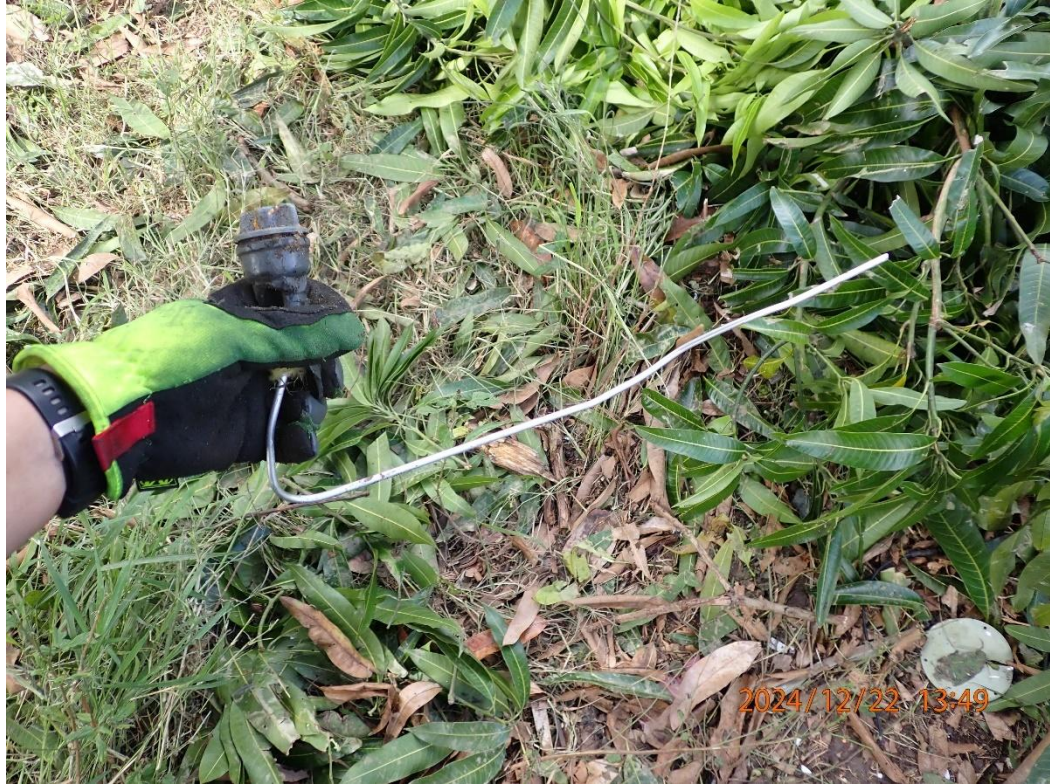
The oil dipstick was impact separated and found near the left wing. The oil cooler bypass valve was impact separated and found in the debris path. The oil filter was impact separated and found about 20 ft past the right wing.

**Photo 37: View of the oil dipstick.**

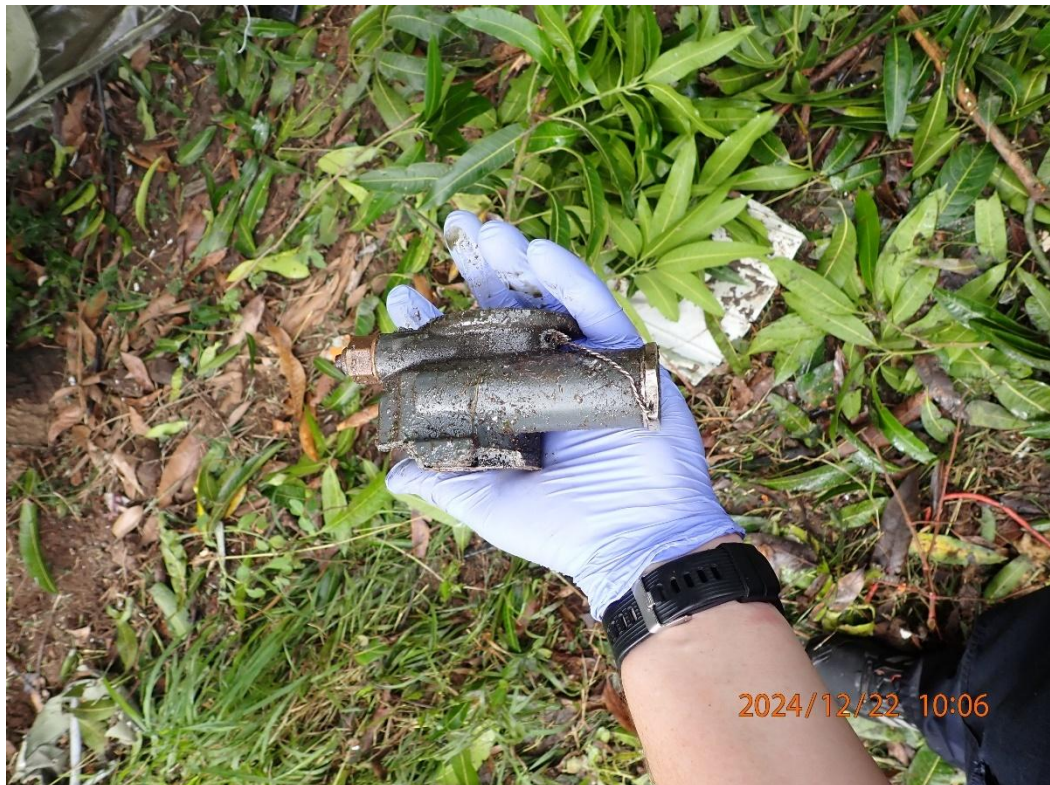
**Photo 38: View of the oil cooler bypass valve.**

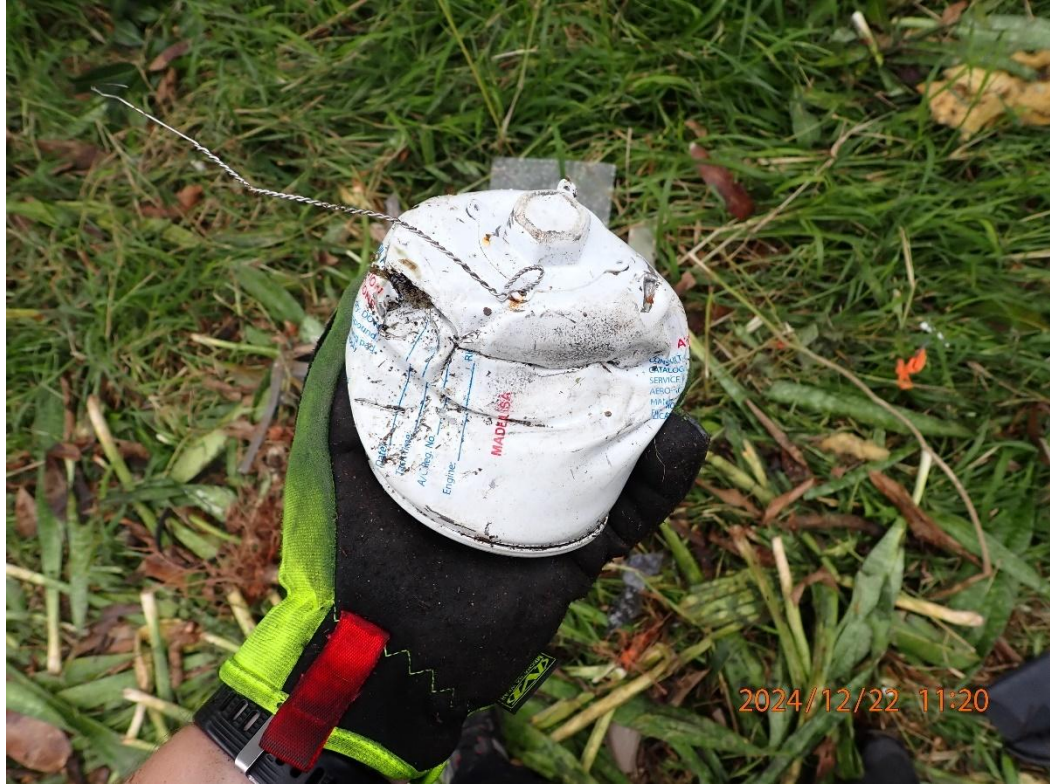
**Photo 39: View of the oil filter.**

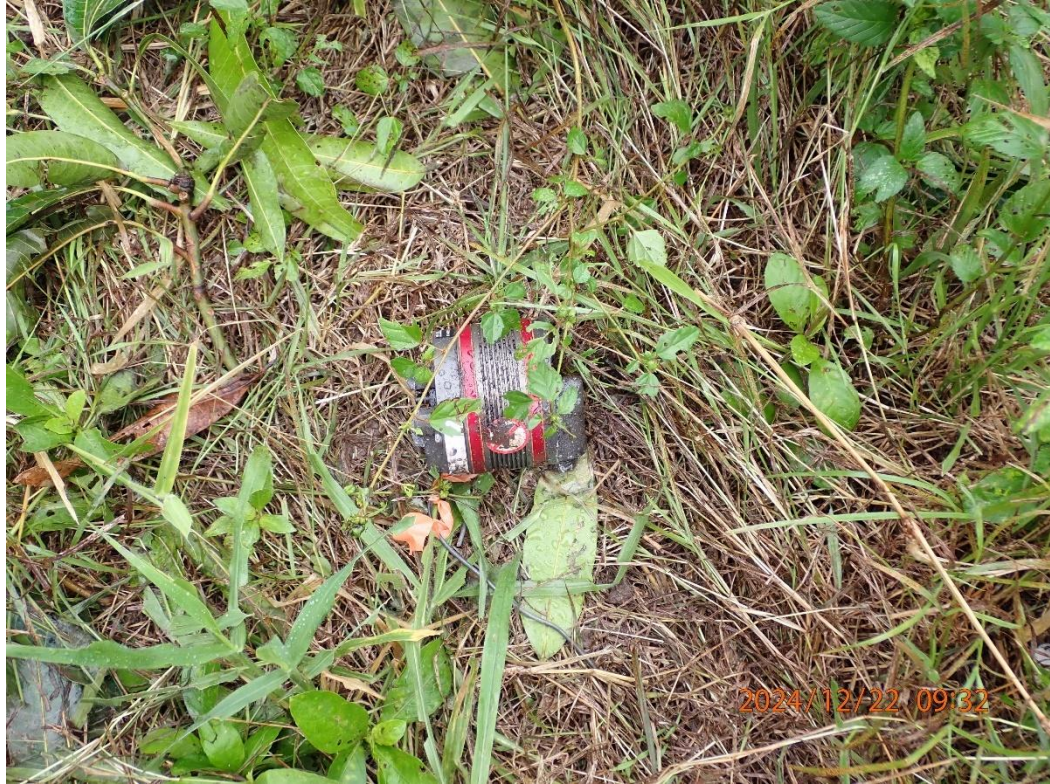
The standby vacuum pump was impact separated and located about 30 ft past the left wing.

**Photo 40: View of the vacuum pump.**

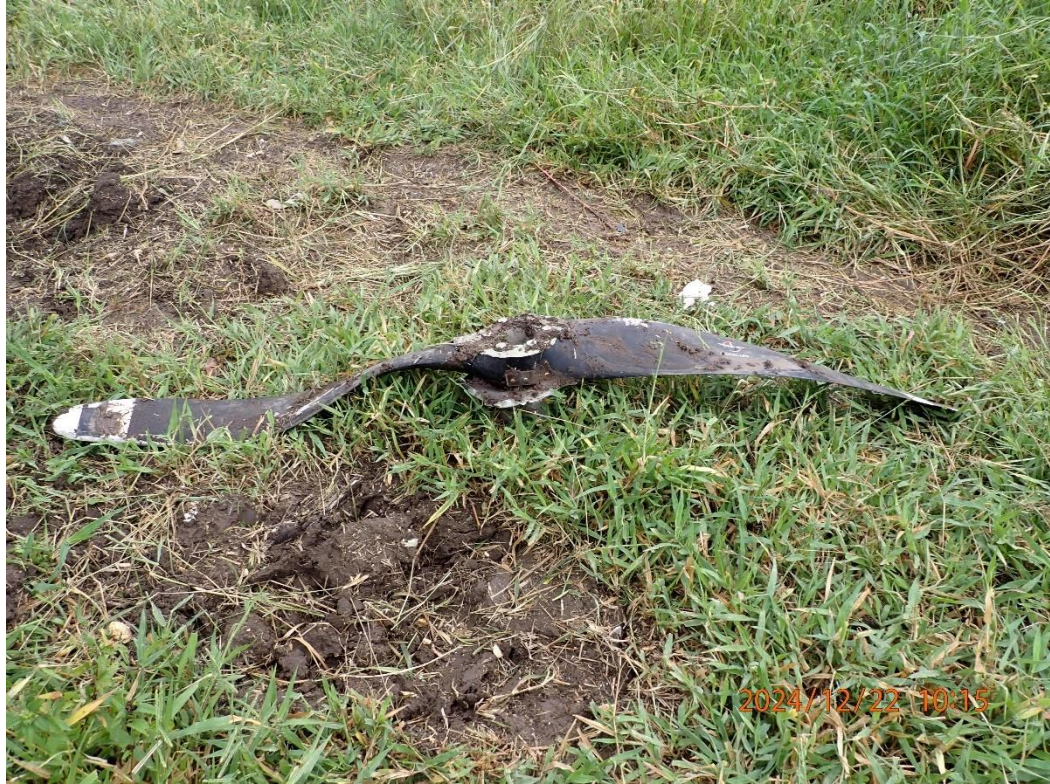
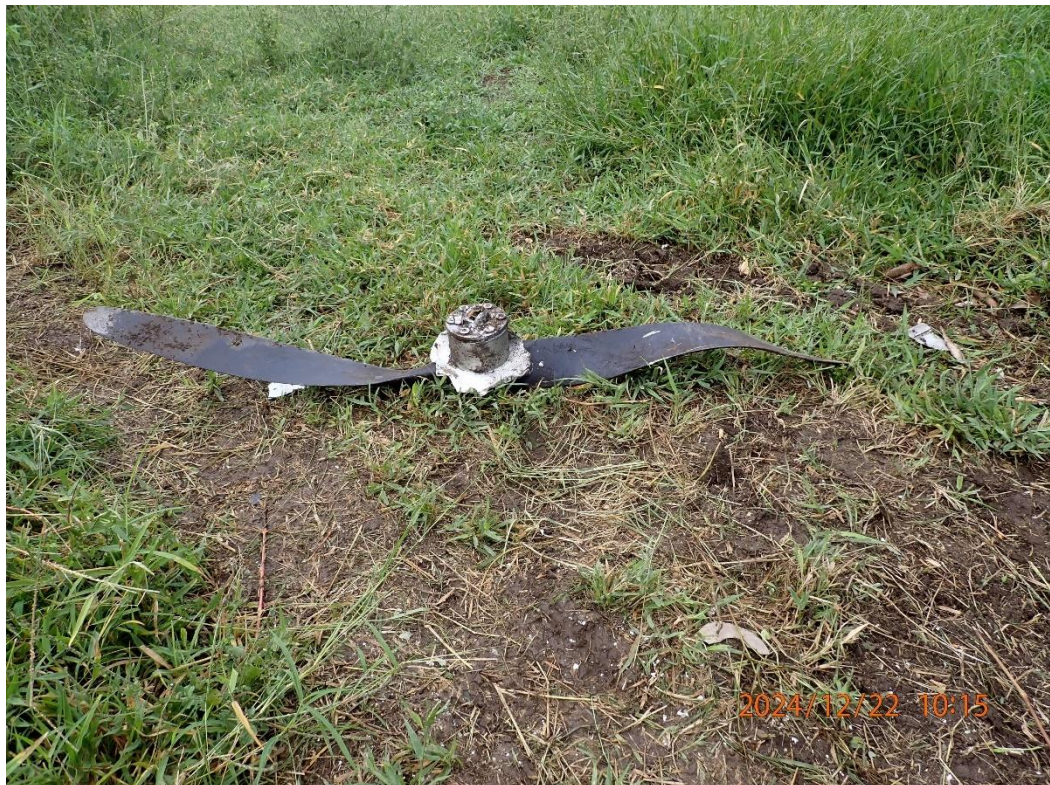
The propeller exhibited S bending, leading edge polishing, and chordwise scratching. The propeller was buried about 8 inches in the dirt in the main impact crater.

**Photo 43: View of the propeller.**

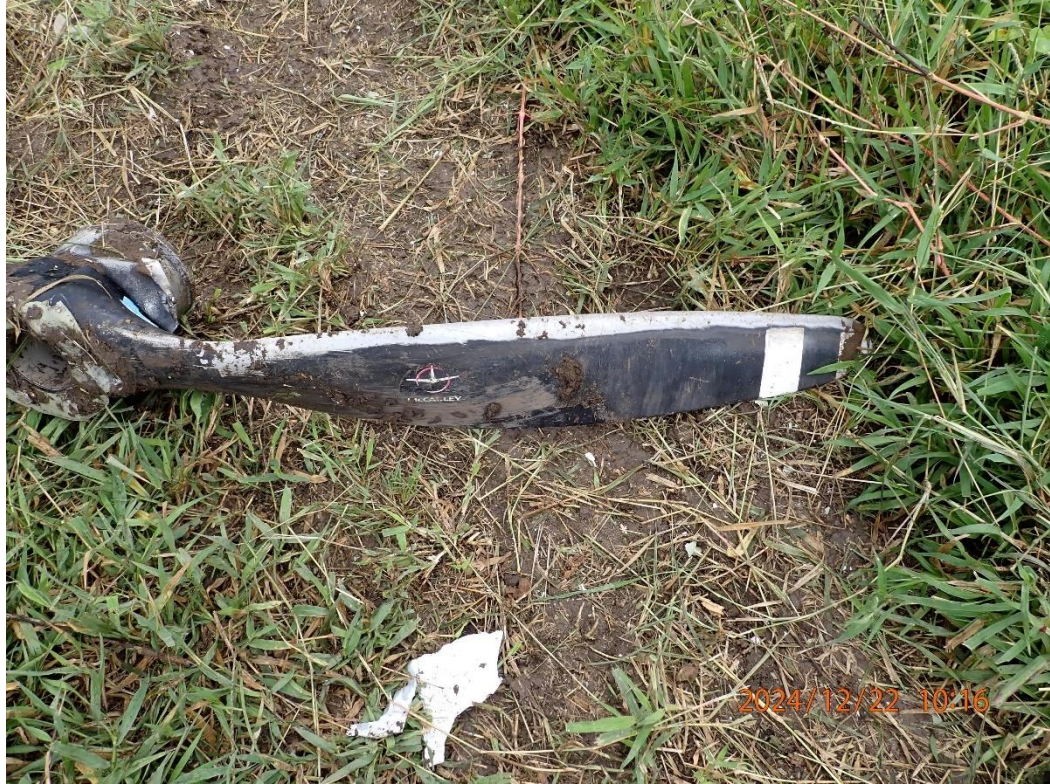
**Photo 45: View of one propeller blade.**

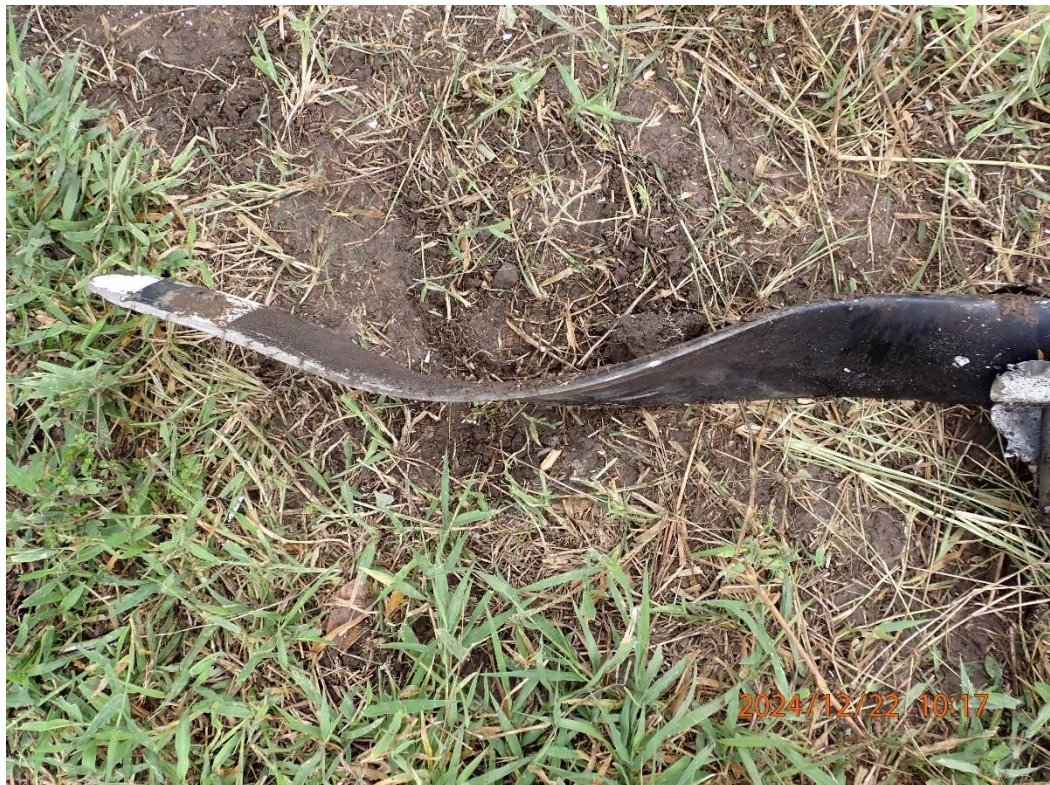
**Photo 48: View of the other propeller blade.**
