# N651CA

SN: 039

During taxi, N651CA was struck by a tug pulling another aircraft. The tug impacted the tail of the aircraft damaging the elevator, horizontal stabilizer, elevator stop block, stop block attaching structure, and cables. This presentation will attempt to detail this damage.

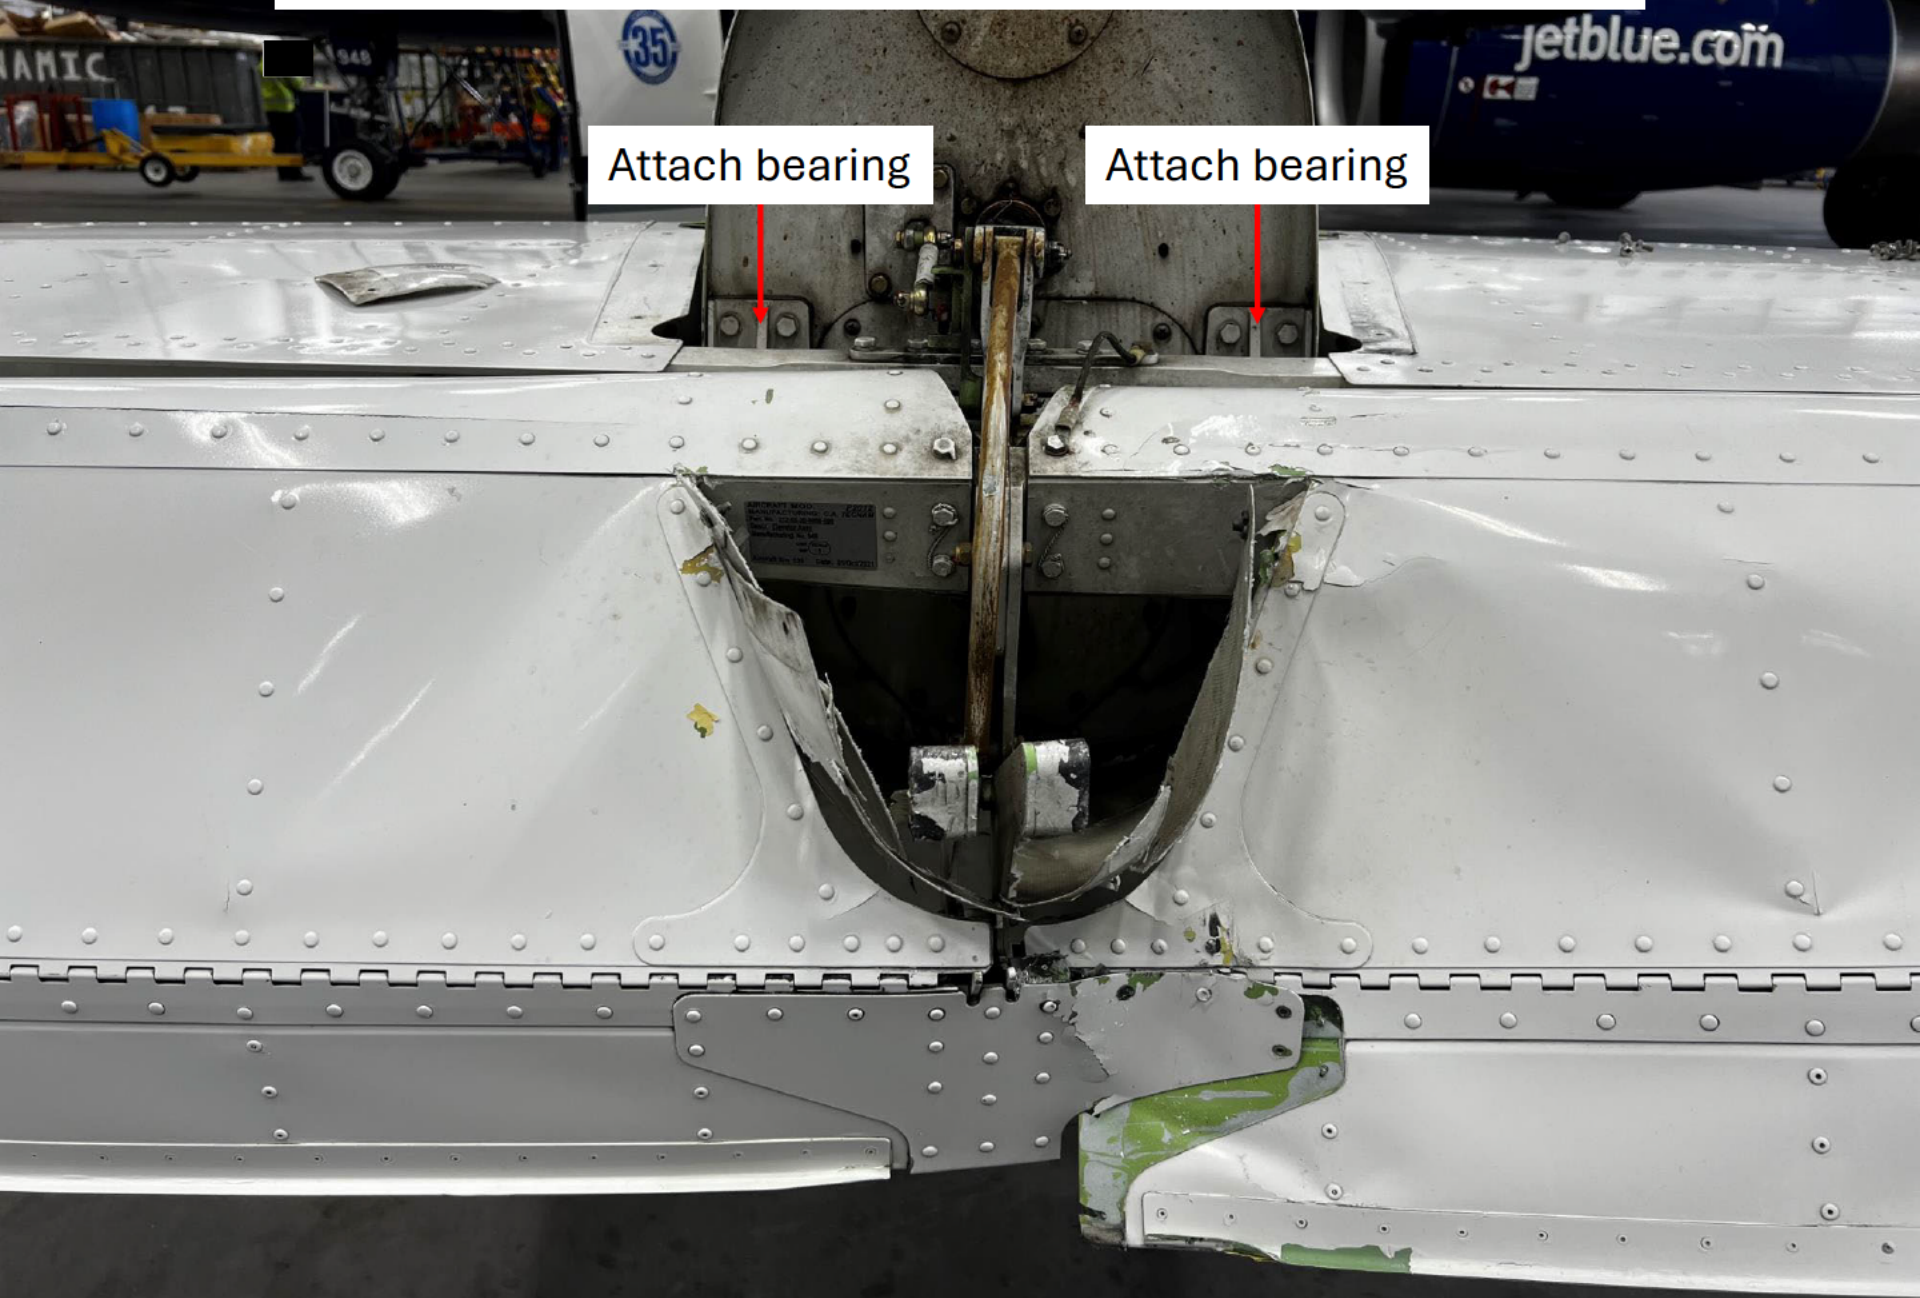
The next two images will look at the aft stabilizer attach bearings.

Attach bearing

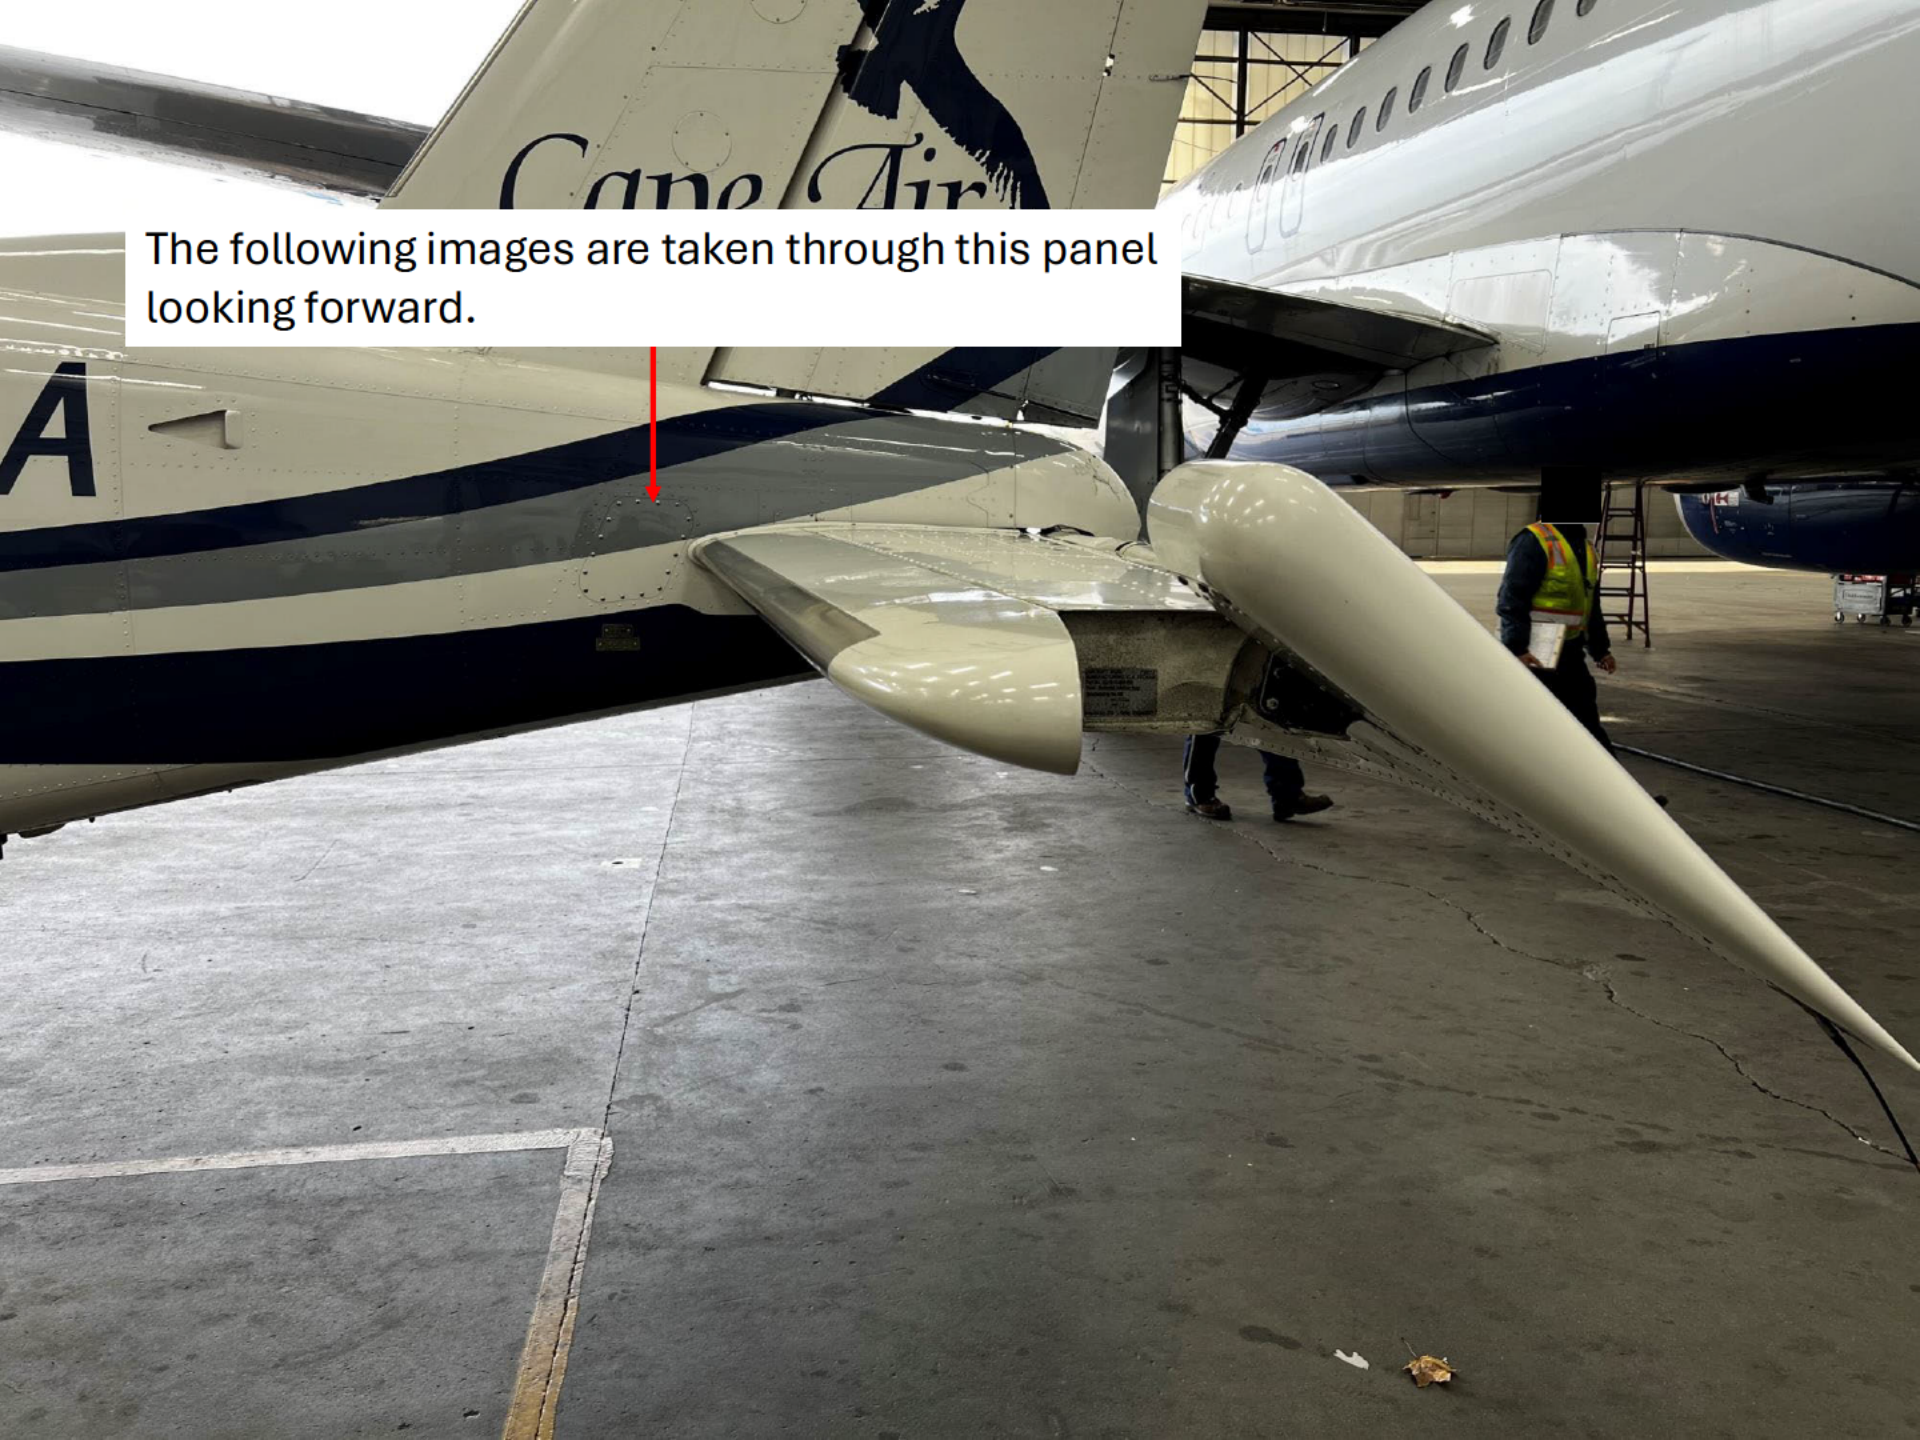
The following images are taken through this panel looking forward.

Image showing the elevator's down stop pushed through its bushing. The lower control rod is also bent, and the elevator cables have been stretched due to over extension.

Damaged structure
