**Date:** December 6, 2024  
**Subject:** ERA25LA067, Record of Conversation/Interview  
**Contact:** Michael T. Howard

Mr. Michael T. Howard contacted the National Transportation Safety Board Response Operation Center (NTSB ROC) on December 5, 2024, to report an aviation accident that occurred on November 7, 2024, involving N6444W, a Cessna P210N, that occurred at KCNI.

N6444W Landing Incident

A Cessna P210N single engine piston airplane was substantially damaged due to a hard bounce landing that resulted in a runway excursion, impact with airport signage, loss of nose gear, and subsequent engine stoppage due to propeller strike.

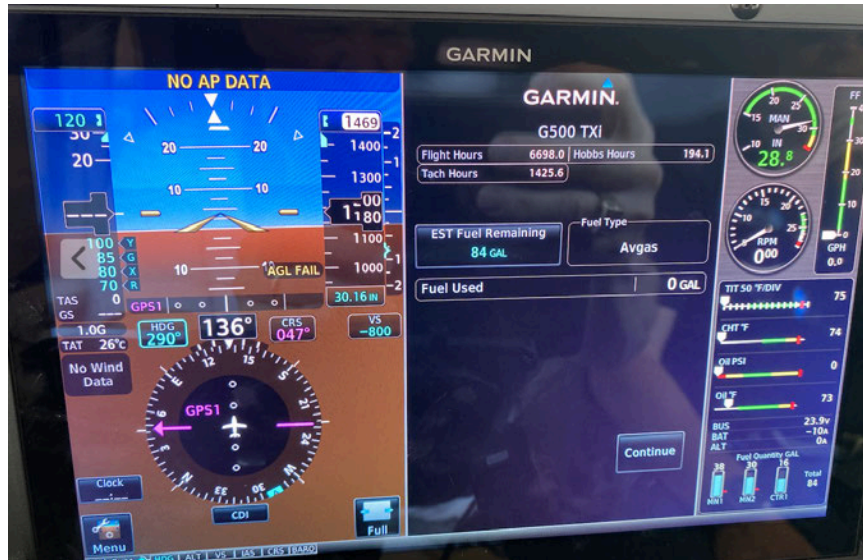
A photo taken by the pilot immediately prior to engine start is timestamped 7 Nov 2024 11:33 EST.

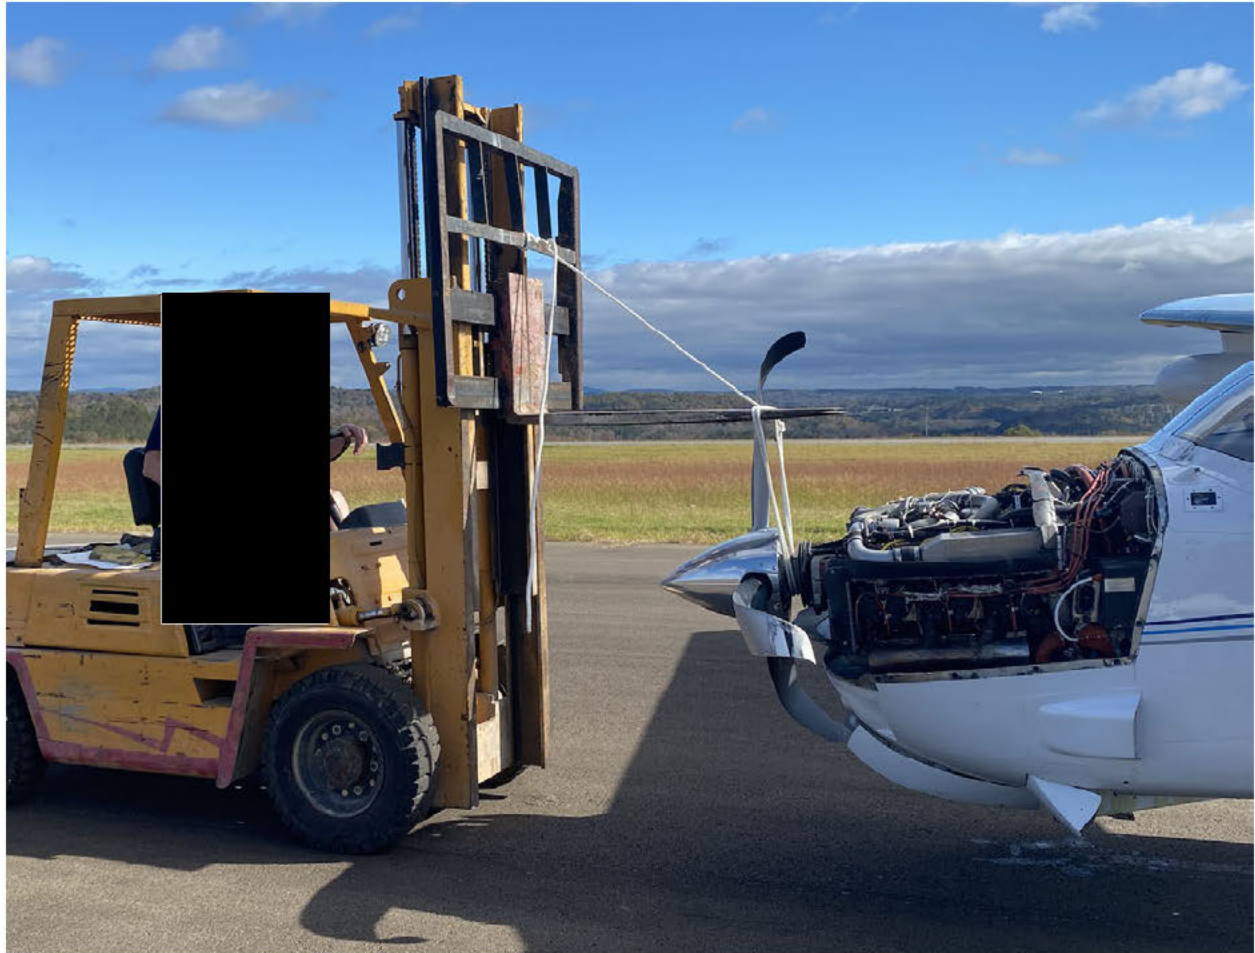
Within 5 minutes the FBO-owner/airport-manager arrived with several crew. They removed the cowling and nose bowl. Approx 10 minutes later their forklift arrived. Under the instruction of the FBO owner, the pilot secured the rope around the crankshaft aft of the spinner in a loop that could be lifted by the forklift. The left tire was deflating so a portable air canister was brought to inflate the tire to protect the left main hub and brakes.

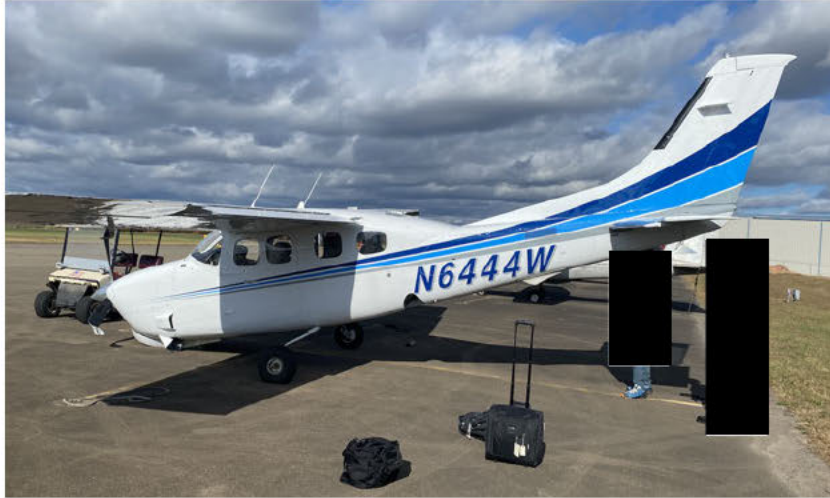
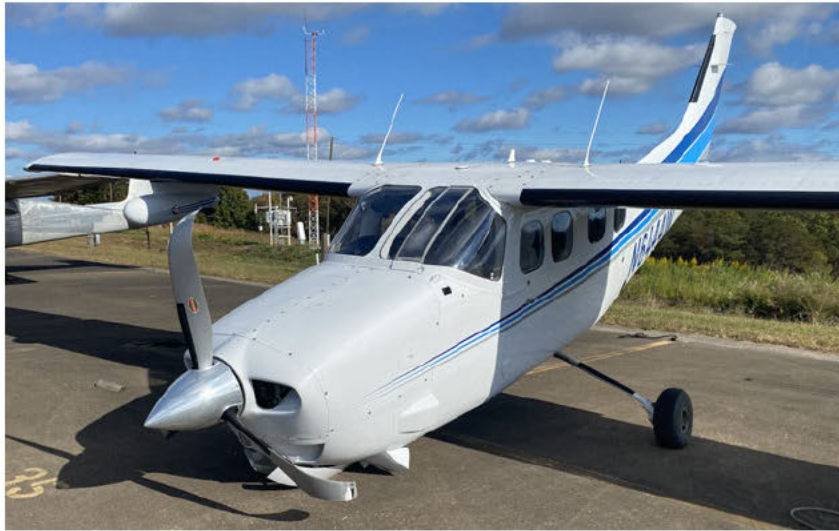
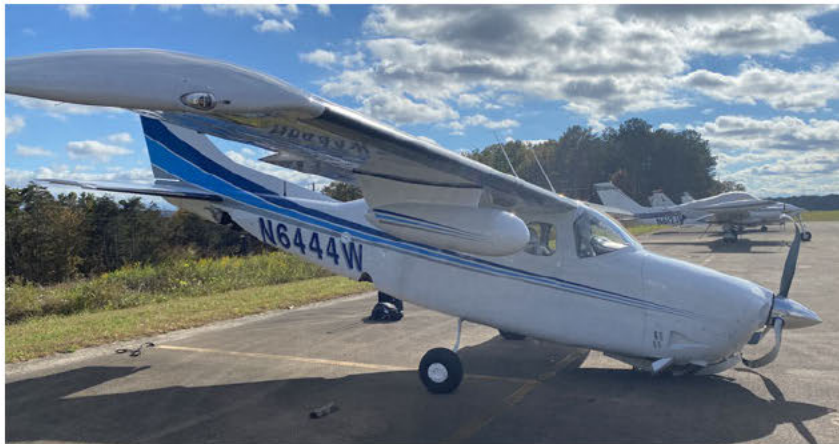
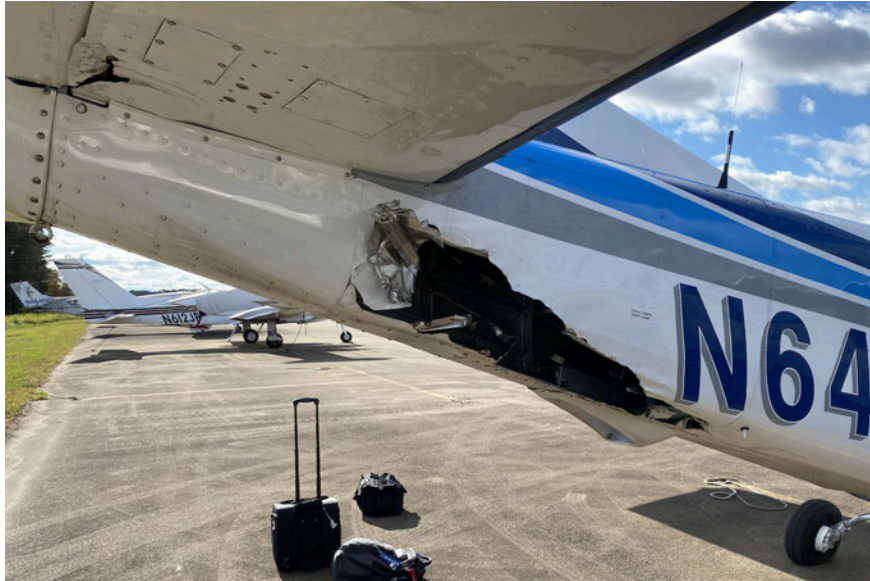
The airplane was slowly removed from the runway with the forklift supporting the nose and pulling, with the main landing gear rolling, with occasional stops to refill the left main tire with air.

The aircraft was moved to a tie-down area on the airport.  
The nose bowl and cowling were reinstalled.
