## Air Safety Investigations Aircraft Incident/Accident Technical Report

| Aircraft Incident/<br>Accident Information | Year: 1977 | Make: Cessna | Model: TU206G |
| | Serial number: U20604105 | | Registration: N27GP |
| Senior Air Safety Investigator: Ernest C. Hall | | Report #: ASI-25-BB-T | Report date: 08-19-25 |

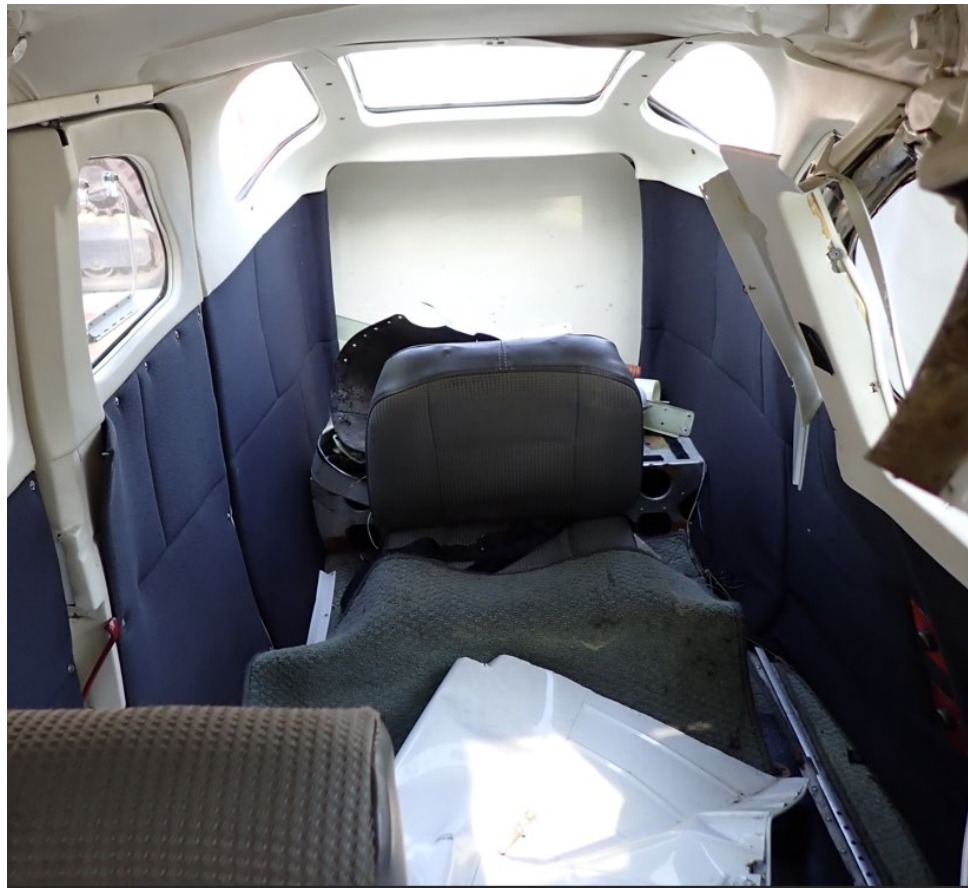
The aircraft was equipped with an STC/337 installed third seat. The seat was in the center of the aft cabin in line with the rear aft baggage door.

Cropped - ASI-25-BB-068 – STC/337 Third Installed Seat

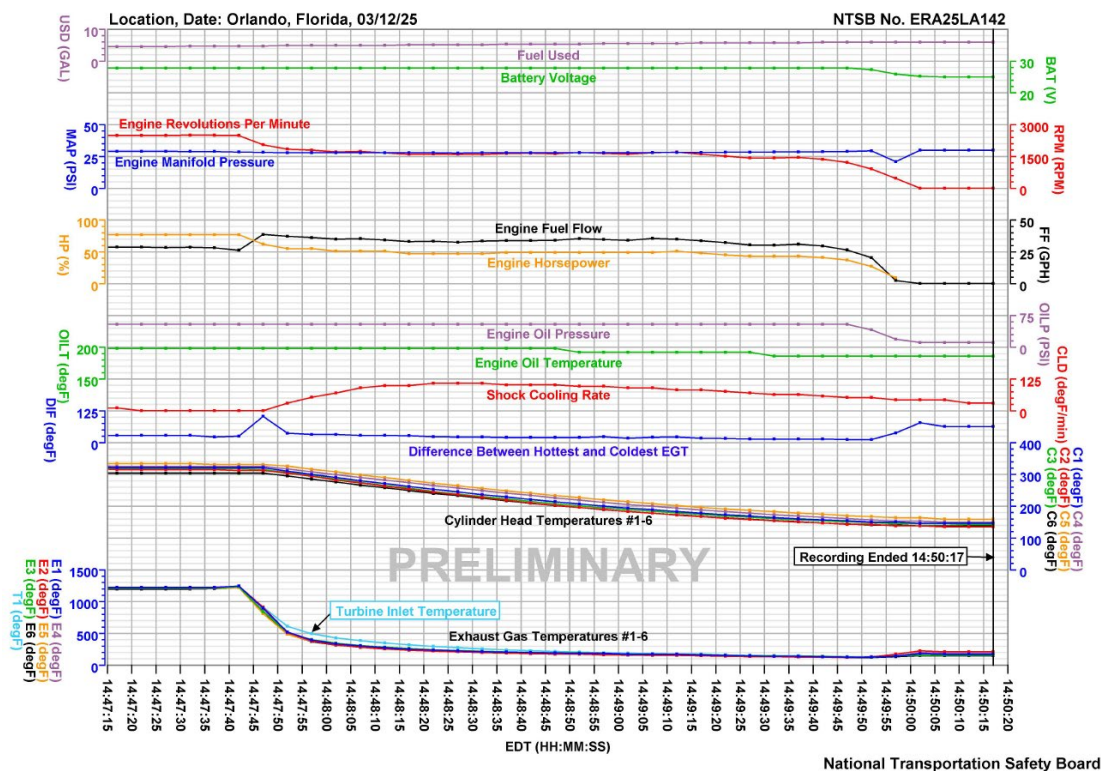
## GPI GEOSPATIAL INC, Cessna TU206G, N27GP

The NTSB retained the JPI EGT-730 and downloaded the memory. The NTSB sent a preliminary plot of the JPI data to the party members.

## NTSB – Preliminary Plots

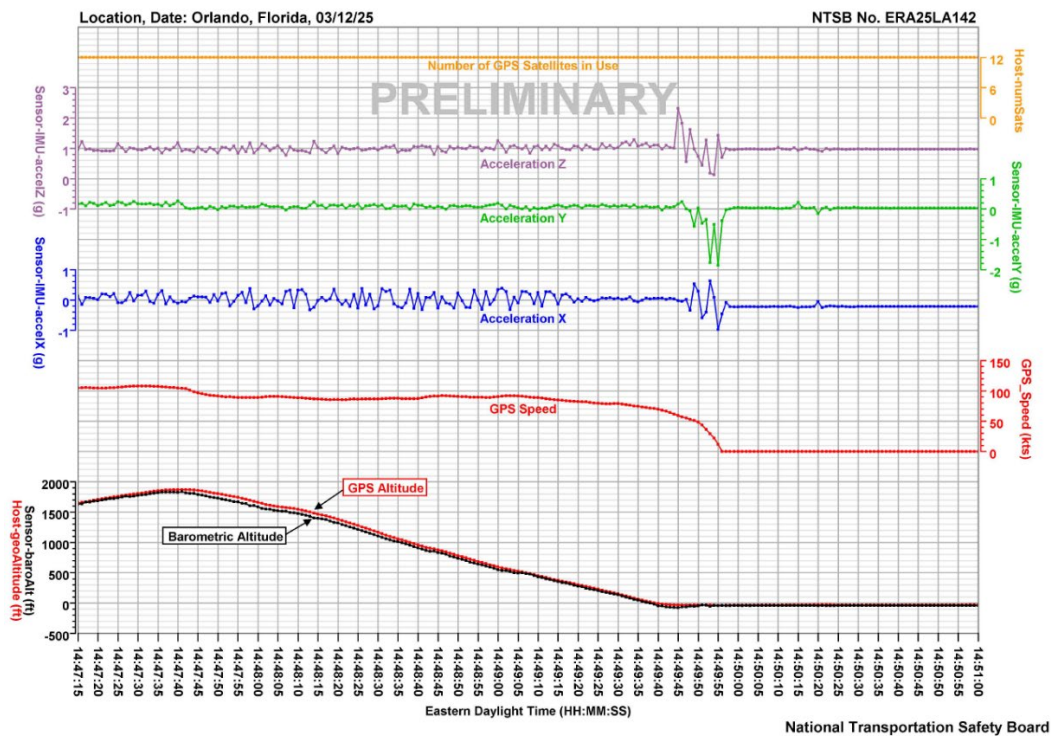
## GPI GEOSPATIAL INC, Cessna TU206G, N27GP

## NTSB – Preliminary Plots
