# National Transportation Safety Board

ERA25LA226

## **WRECKAGE EXAMINATION**

Location: Murfreesboro, Tennessee  
Date: June 10, 2025  
Time: 11:24 CDT  
16:24 UTC  
Airplane: N15PM Beech A36, SN E-1016

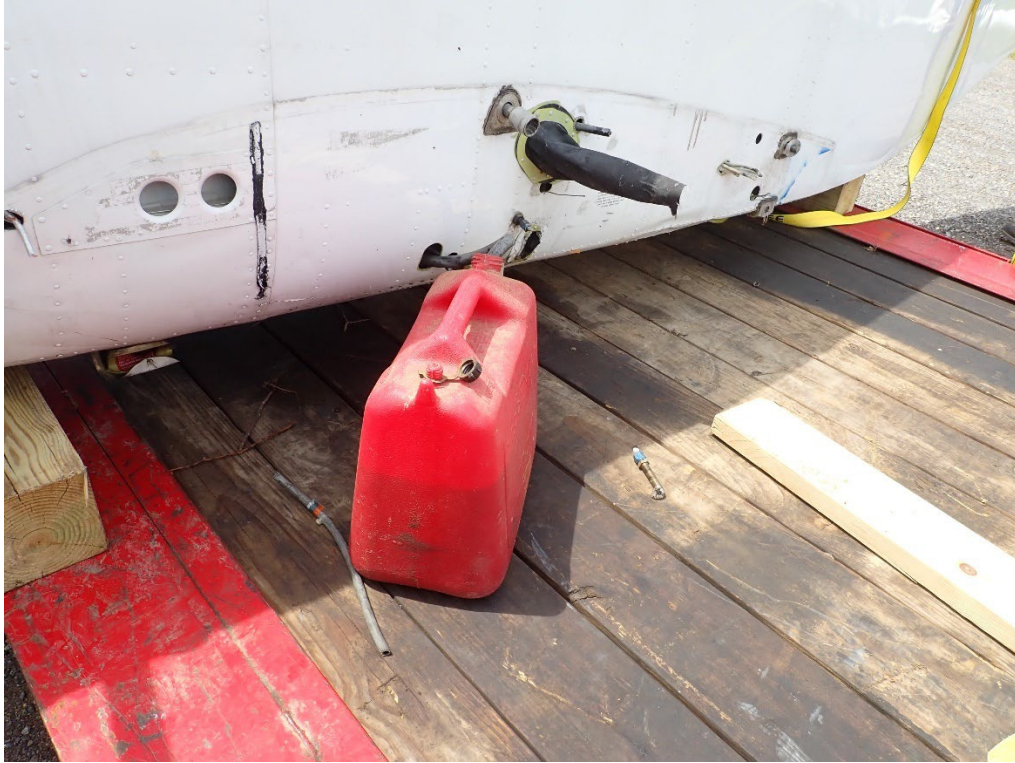
**Figure 12: Fueling Location Example and Setup for Test Run**

The engine ran successfully with no abnormalities observed.
