# National Transportation Safety Board

ERA25MA106

## COCKPIT VOICE RECORDER

Specialist's Factual Report

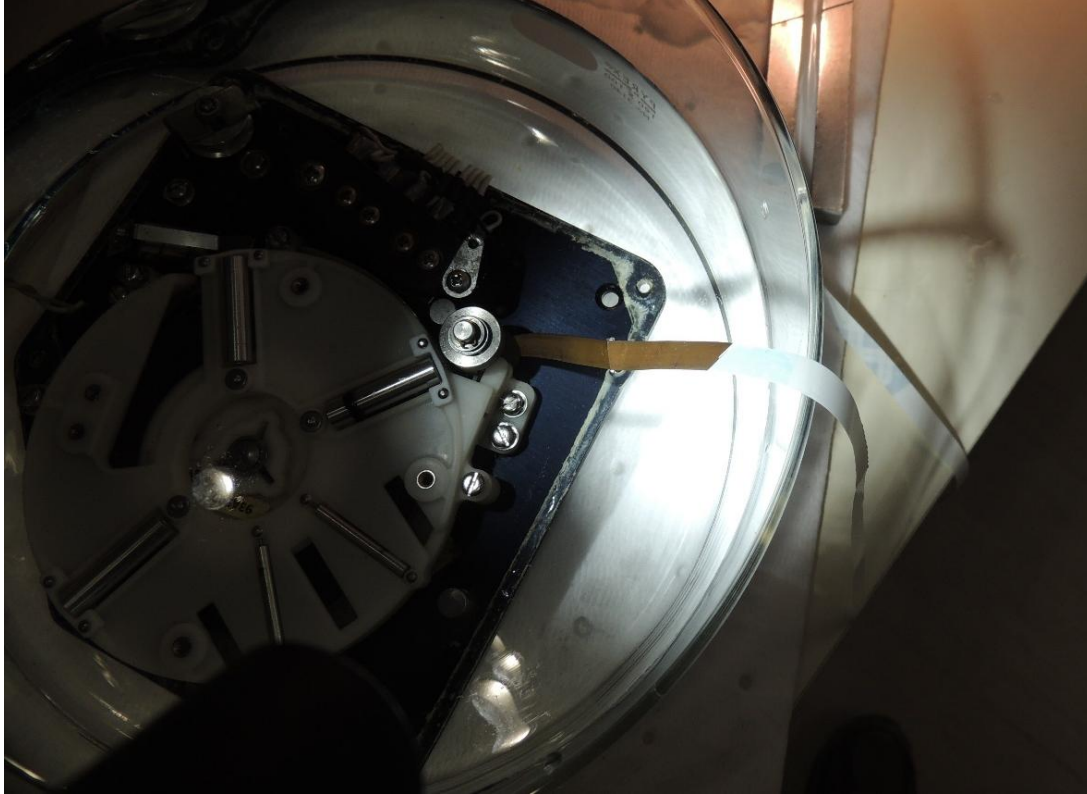
**Figure 12.** Leader tape spliced to outer end CVR tape after initial cutting and splicing.

The transport mechanism was then transferred to a wide Pyrex beaker of RO/DI water and the magnetic tape was cut between the central exit from the Reel and Tape Assembly<sup>12</sup> and the tape recording heads, releasing the tape from the transport mechanism. A leader was spliced to the end threaded past the Bridge Assembly (figure 12) and the opposite end was tucked back into the center of the tape reel. The leader material was then carefully reeled onto the Reel and Tape Assembly while still in the Pyrex beaker (figure 13).

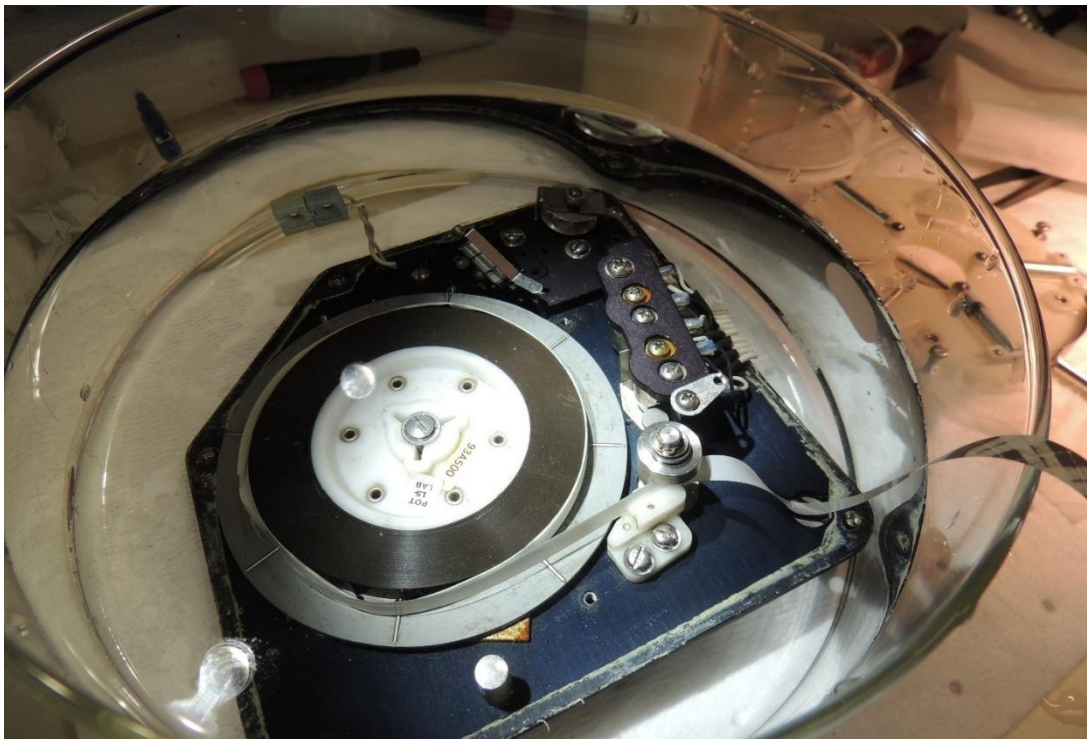
**Figure 13.** Leader tape end of the CVR tape being re-wound onto the transport.

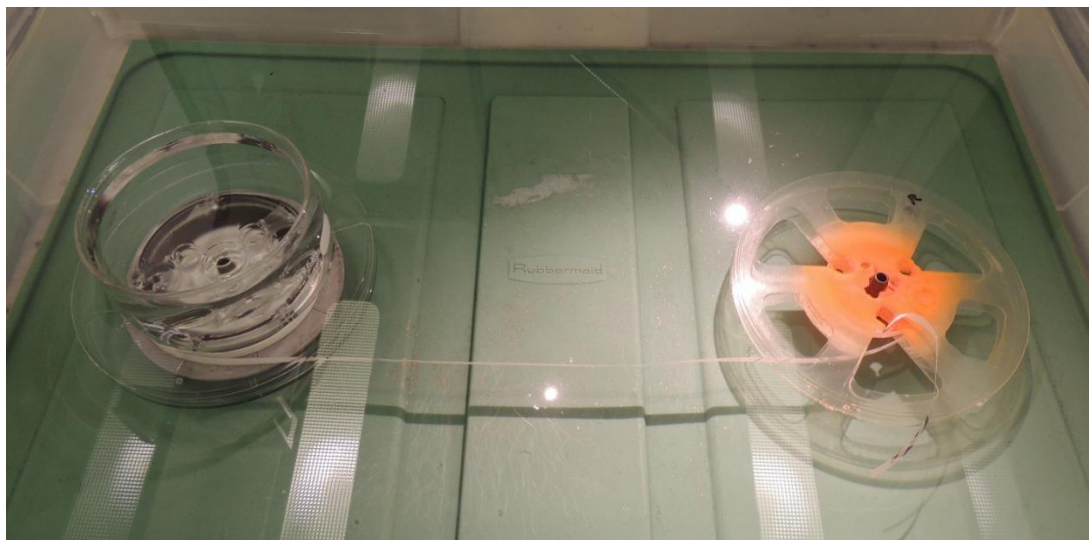
**Figure 14.** Setup for the second stage tape cleaning process.

The Reel and Tape Assembly containing the magnetic tape was then removed from the transport mechanism and placed onto one of a pair of spindles mounted in a large tub filled with RO/DI water using a standard 5-1/2 in plastic take-up reel acting as a top-cover until the tape could be wound onto the first take-up reel (figure 14). The tape medium was soaked for four more days while performing a gentle pass of

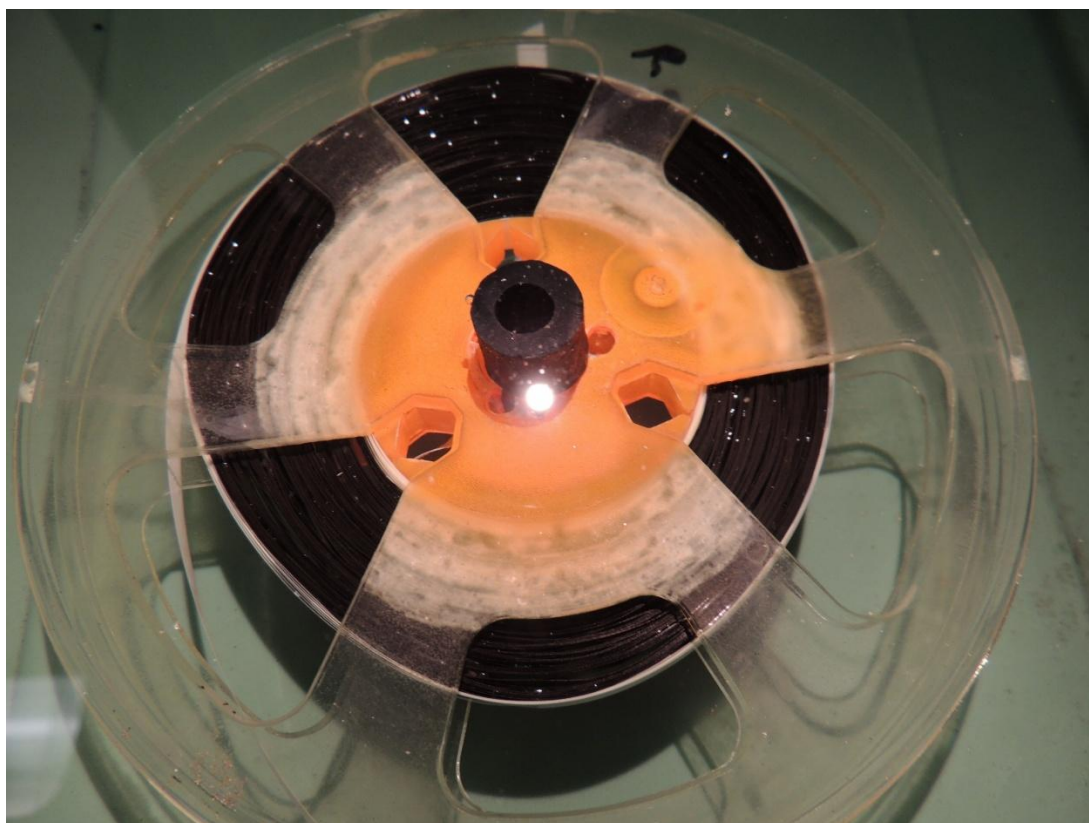
**Figure 15.** Tape loosely wound on take-up reel during the second stage cleaning process.

the tape surface across swatches of 100% cotton batting<sup>13</sup> between water changes as the tape was very slowly wound to another open-style take-up reel while continuously under RO/DI water. A leader was attached to the opposite end of the tape at the end of the first pass. The tape was rewound as loosely as possible during each pass, to maximize the ability for contaminants to diffuse away from the surface of the tape while soaking between turns (figure 15). Evidence of spotty but generally present grey gel-like material smelling of jet fuel appeared on the batting at times emanating from both sides of the tape. This abated very slowly, but not completely, before transitioning to the drying phase.

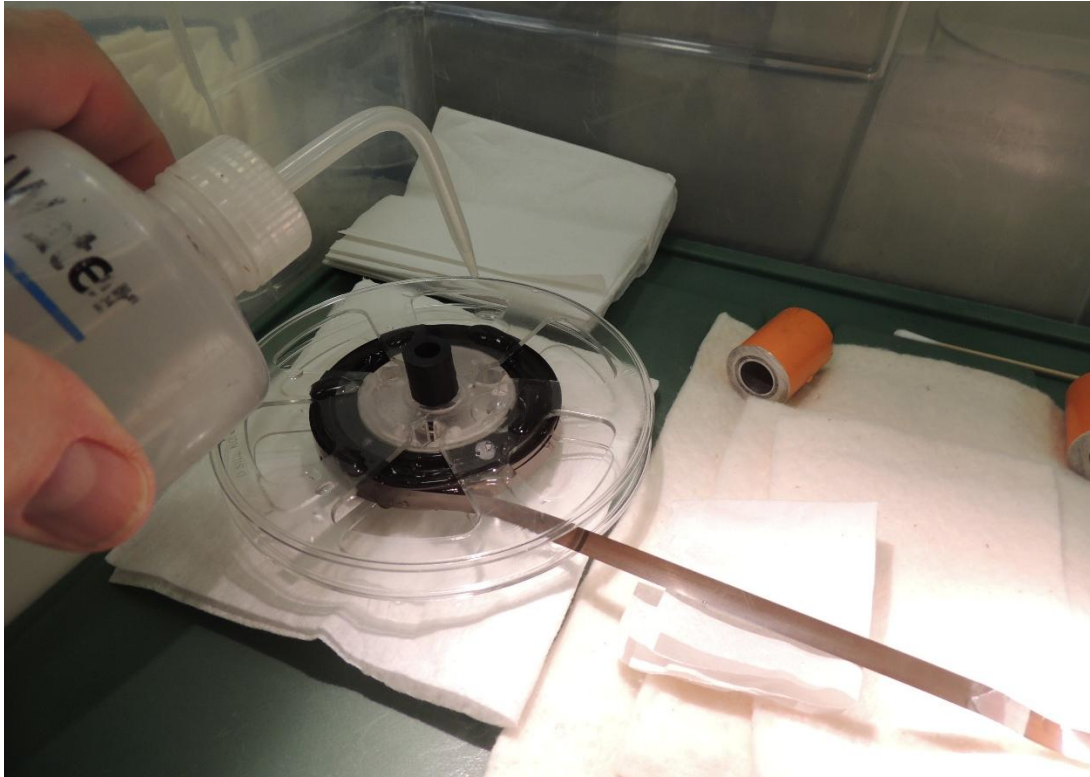
**Figure 16.** Tape being wound onto a dry take-up reel after the second stage cleaning process.

For the drying phase, the tape was rewound extremely loosely<sup>14</sup> onto a new dry open-style take-up reel (figure 16). The tape was then baked out in stages:

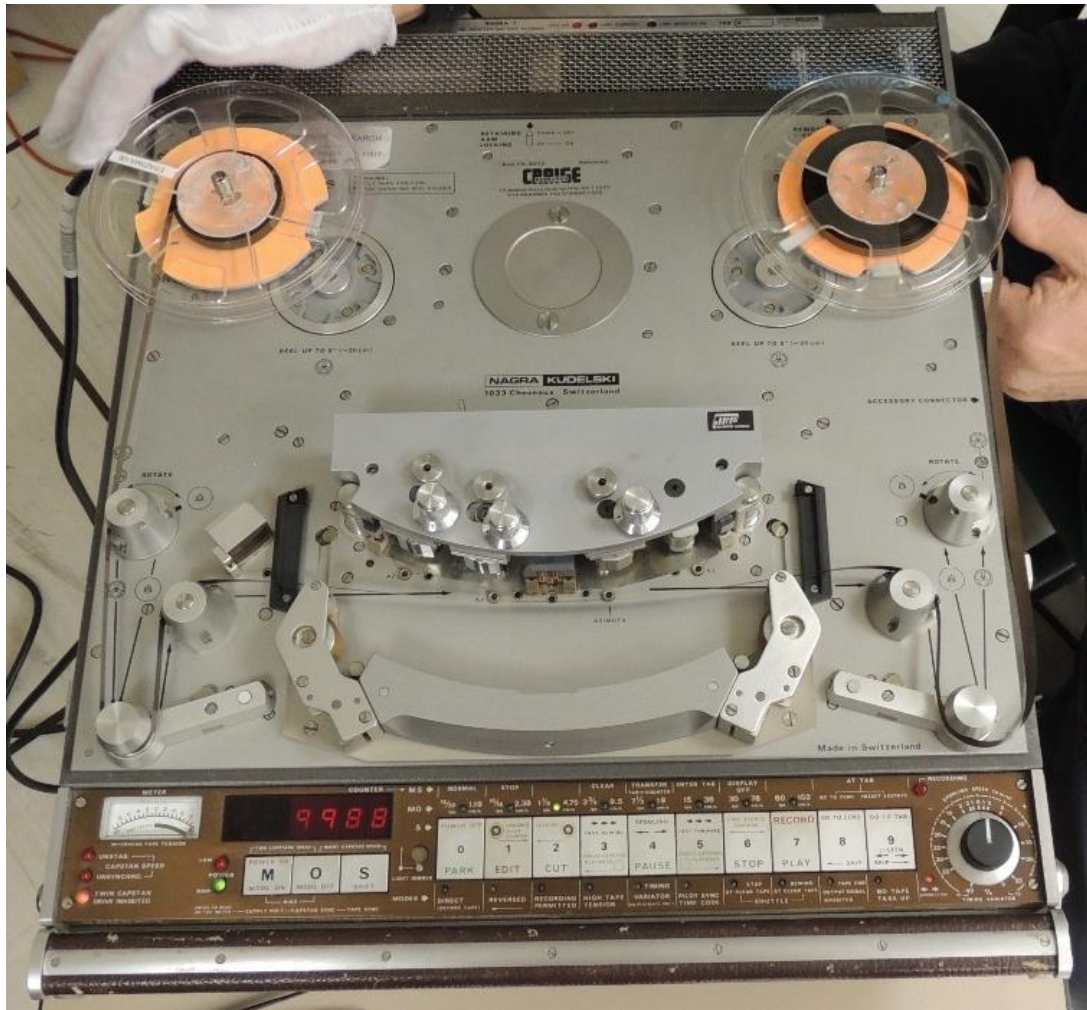
**Figure 17.** Tape being hand-wound in free-spooling mode after drying to take up slack.

The smell of jet fuel was still evident after this procedure as the tape was inspected for any remaining visible deposits while very, very slowly rewinding it onto another open-style take-up reel. The tape was then allowed to dry further in a commercial portable fume hood running 24/7 for 3 days. The odor of jet fuel was significantly reduced by the end of this procedure. The tape was then slowly rewound by hand to another take-up reel and inspected. The second as-found splice (observed on the tape prior to NTSB re-work) was repaired to eliminate overlap observed on magnetic tape medium. This take-up reel was moved to a NAGRA<sup>15</sup> set in free-spooling mode and hand re-wound onto another take-up reel using tension just high enough to keep the NAGRA tension gauge arms activated during the respooling procedure (figure 17). The tape was then very carefully cycled again on the NAGRA in dual reel playback mode to even out the tape tension throughout the reel prior to attempting a normal playback for digitization of the recording.
