# National Transportation Safety Board

ERA25MA106 (KEYS# 199630)

## COMPUTED TOMOGRAPHY

Specialist's Factual Report

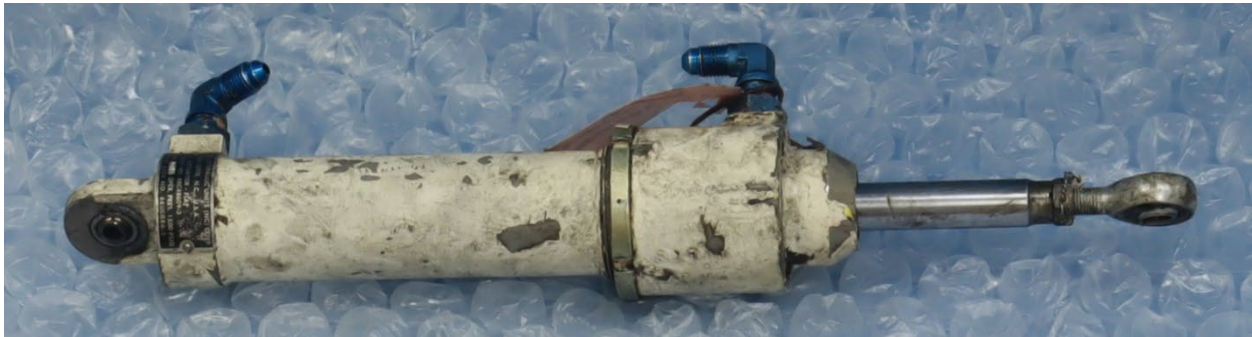
The righthand (RH) flap actuator has SN 0915 (Figure 7). According to the Airworthiness Group Chairman, it was removed from the wing, but during the removal the actuator piston was pulled and extended about 1 to 1-½ inches. The RH flap actuator measurement afterward this movement was 19 inches equating to full extension. Prior to the movement, it would have been about 17-½ to 18 inches. 17-½ inches corresponds to 30° of flap, which is not a standard position; however, when hydraulic pressure is not maintained, the piston rod is free to move.

**Figure 7.** RH flap actuator as received at the NTSB Materials Laboratory.

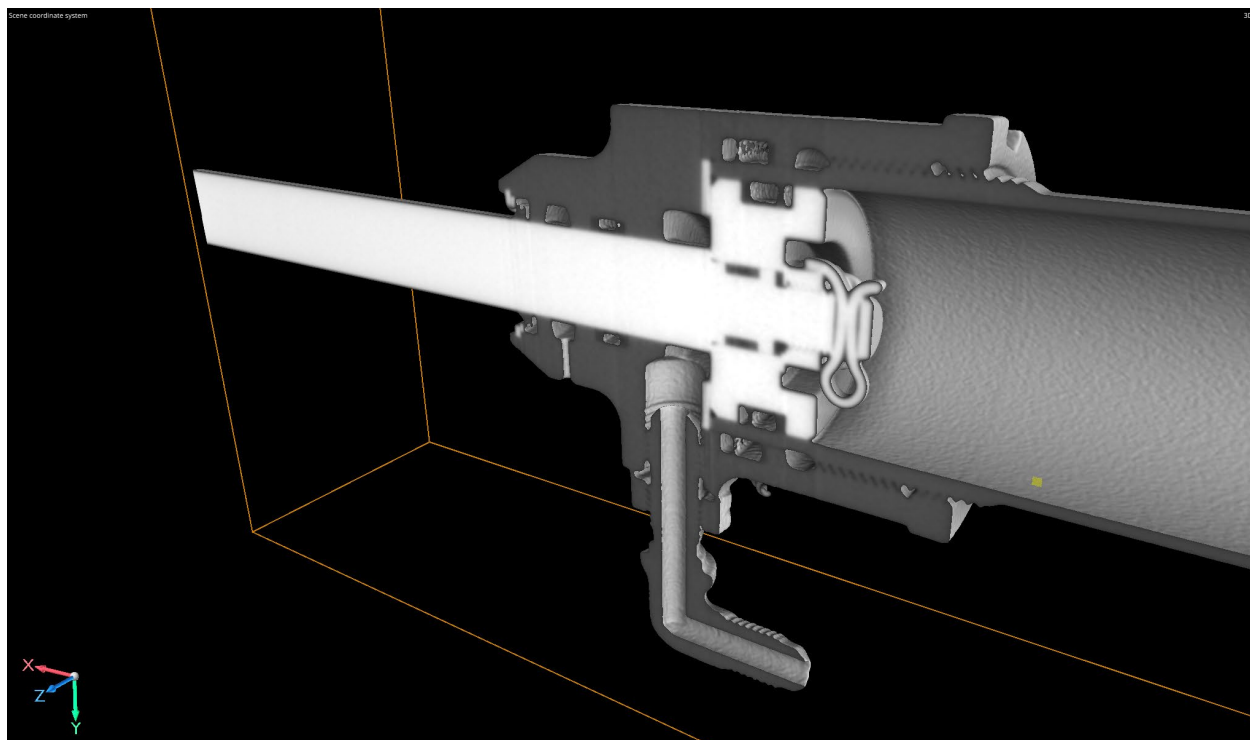
All components were present and in their correct locations. No debris was identified within the actuator. The internal components appear to move as expected. No anomalies were identified.

**Figure 10.** Sectioned and shaded isosurface view of the RH flap actuator in the extended position near the piston and retraction port.

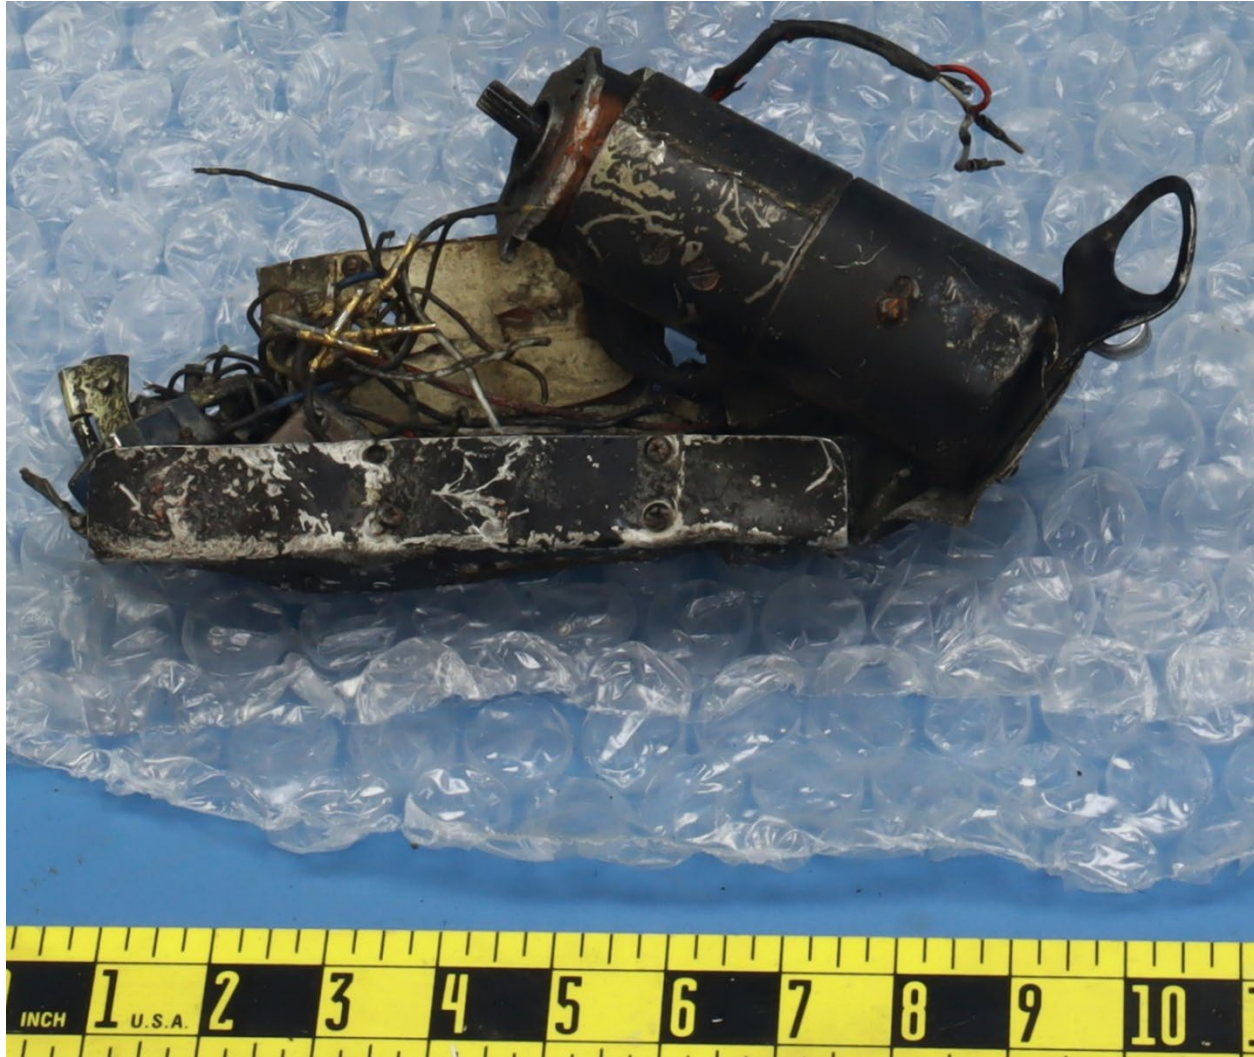
**Figure 11.** Pitch trim motor as received at the NTSB Materials Laboratory.

The drive shaft was permanently deformed. The end cap was dislodged and rotated. The outer bearing race remained with the end cap, but the ball bearings and inner race remained on the drive shaft. The housing beyond the commutator and rotor bearings was deformed radially inwards. The commutator and brushes appeared in good condition. No other anomalies were identified.

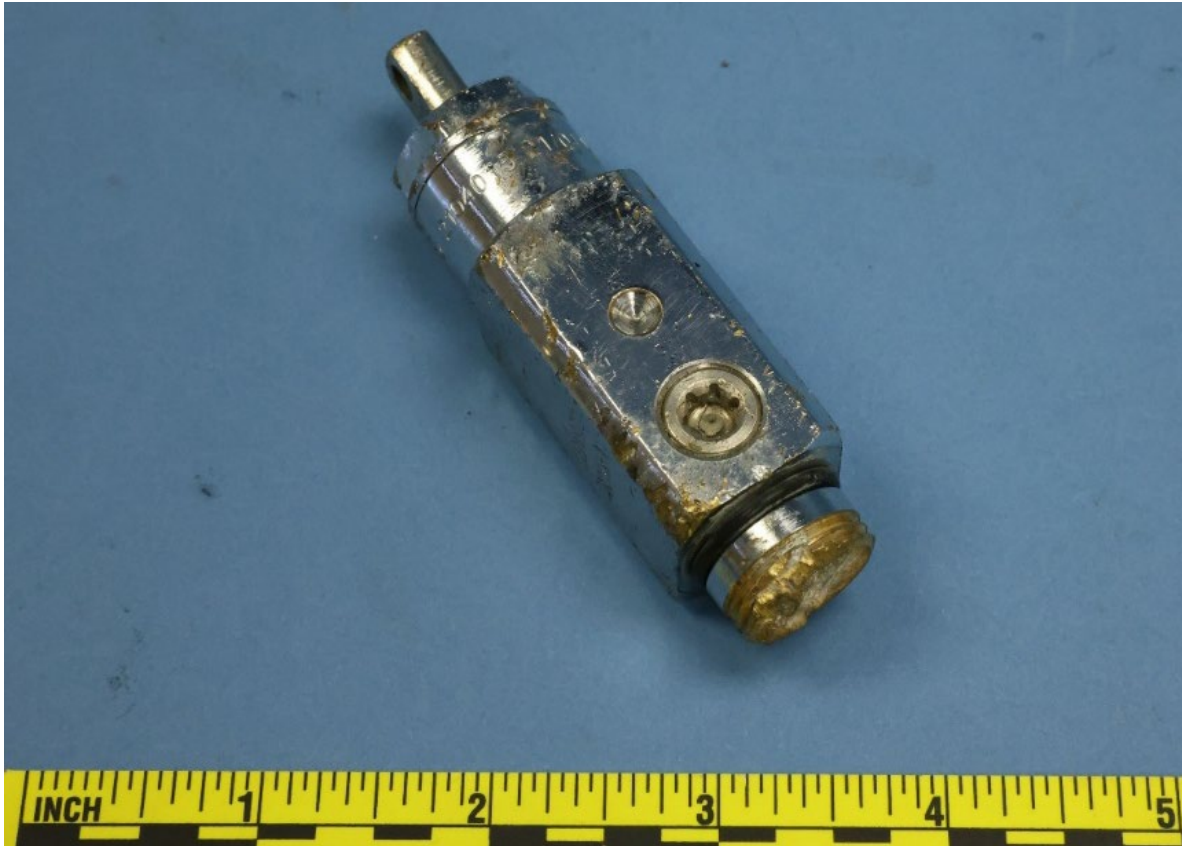
**Figure 14.** Oxygen medical pin index valve as received at the NTSB Materials Laboratory.

The inlet threads were broken. The stem exhibited permanent deformation.

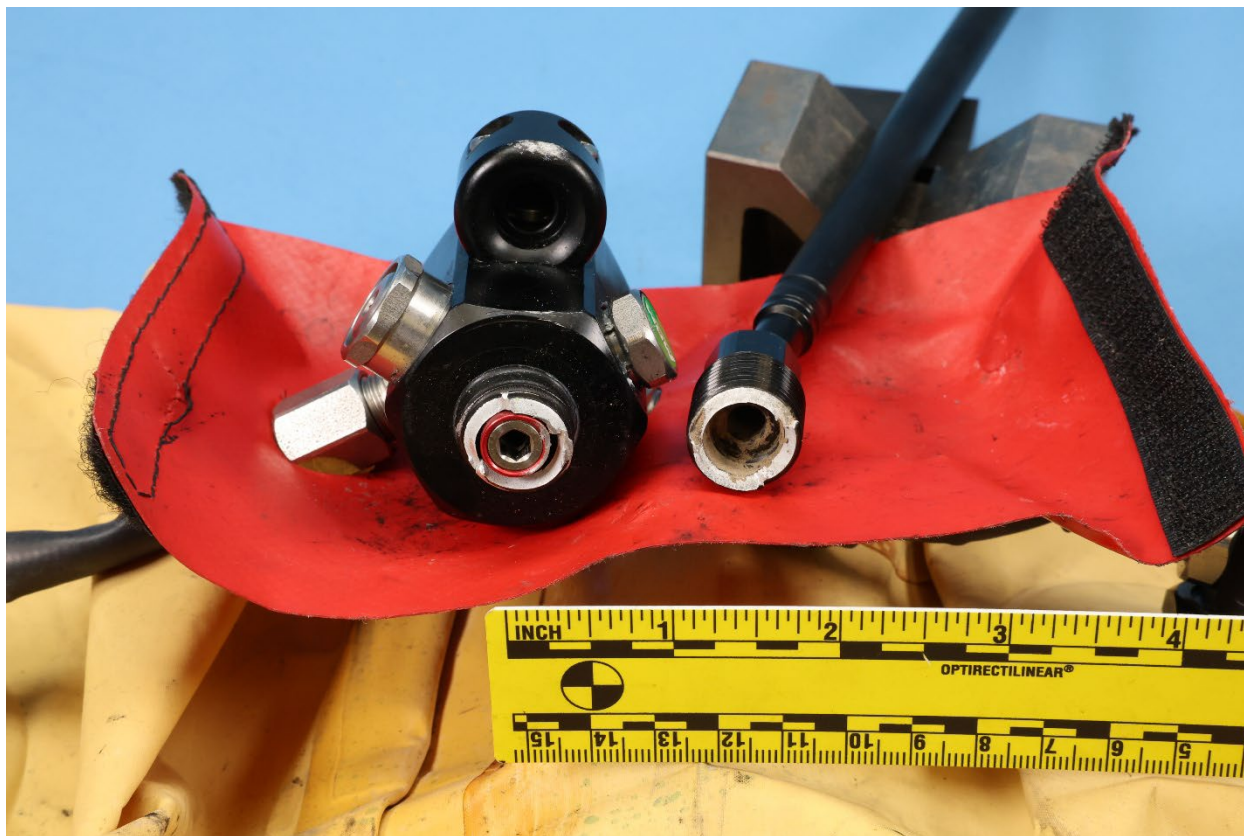
An inflation valve for an emergency raft was also submitted to the CT specialist (Figure 18). The field investigator wanted to determine the status of the pressure relief mechanism to determine if the valve or mechanism activated.

**Figure 18.** Emergency life raft inflation valve as received at the NTSB Materials Laboratory.

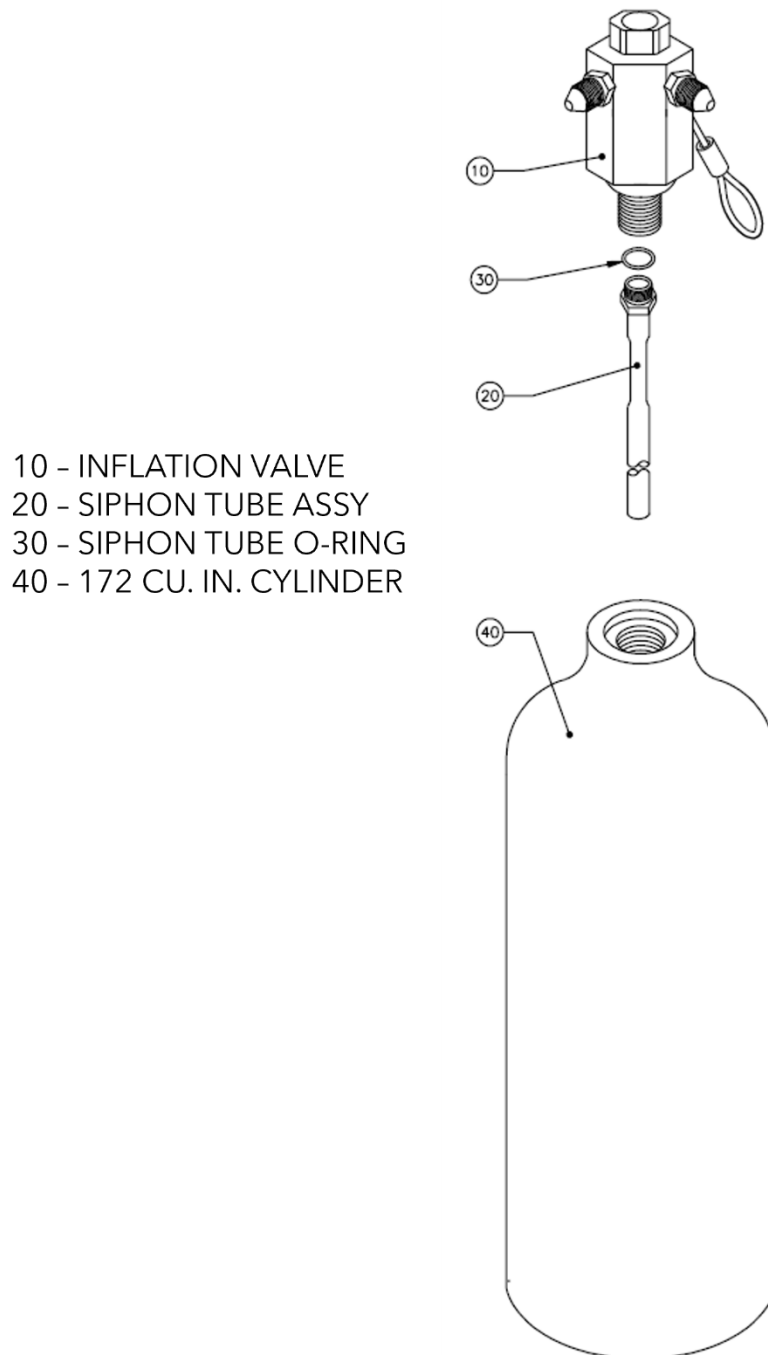
**Figure 19.** Inflation cylinder and valve assembly illustrated parts breakdown with critical components labeled (Source: AVI Survival Products, modified for clarity).

The following additional observations were made. The inlet area appears to have sustained damage including a broken siphon tube (Figure 19, item 20) and broken threads where the valve body (Figure 20, item 10) mates with the carbon dioxide cylinder. The green safety disk (item 80) appears to be intact (see Figure 23). No other anomalies were identified.
