# National Transportation Safety Board

ERA25MA106

## **AIRWORTHINESS FACTUAL REPORT- ON-SCENE**

Location: Philadelphia, Pennsylvania  
Date: January 31, 2025  
Time: 1807 eastern standard time  
Airplane: Learjet 55, registration XA-UCI

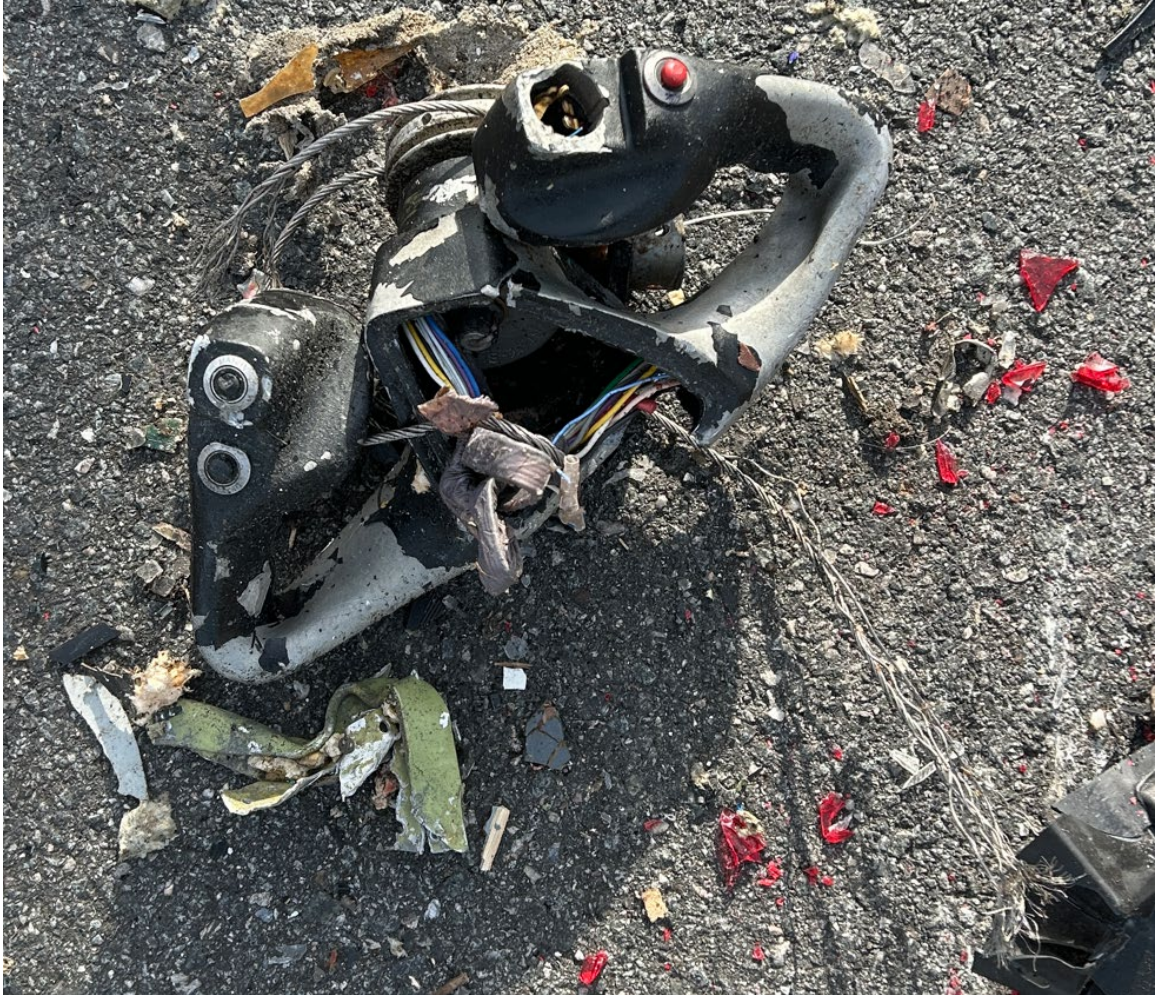
- Engine exhaust
- Co-pilot side control wheel (Appendix A Figure 13)
- Lower portion of control column
- Portion of tailcone skin
- A section of center fuselage structure, normally located just above the center wing box

*Figure 15: Co-pilot Control Wheel*

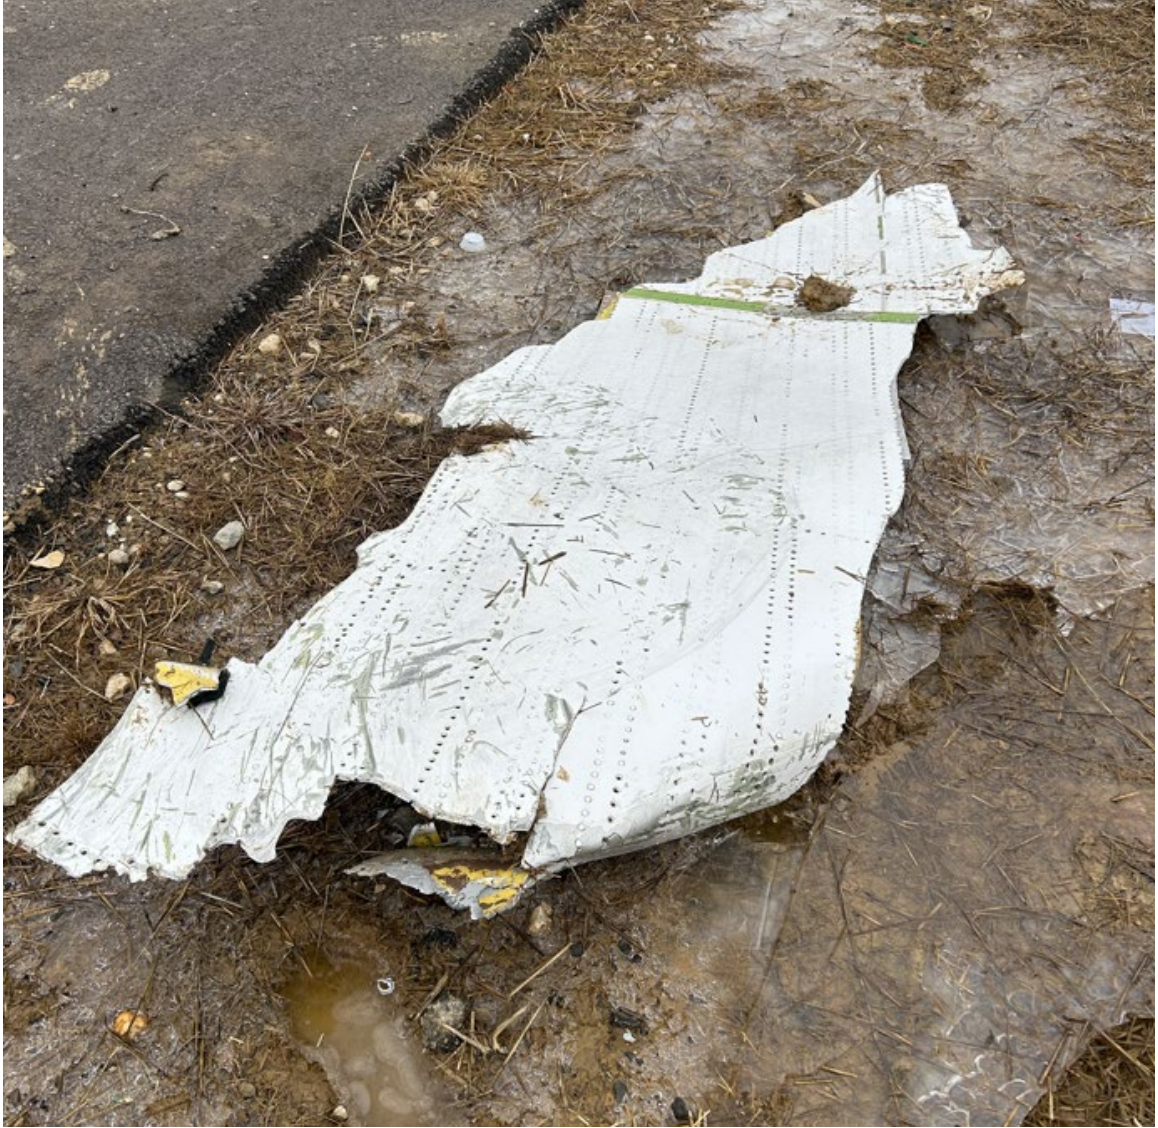
- Portions of upper wing skin (Appendix A Figure 16)
- Pilot control wheel (Appendix A Figure 14)
- Portion of horizontal stabilizer leading edge (Appendix A Figure 15)

*Figure 16: Upper Wing Skin*

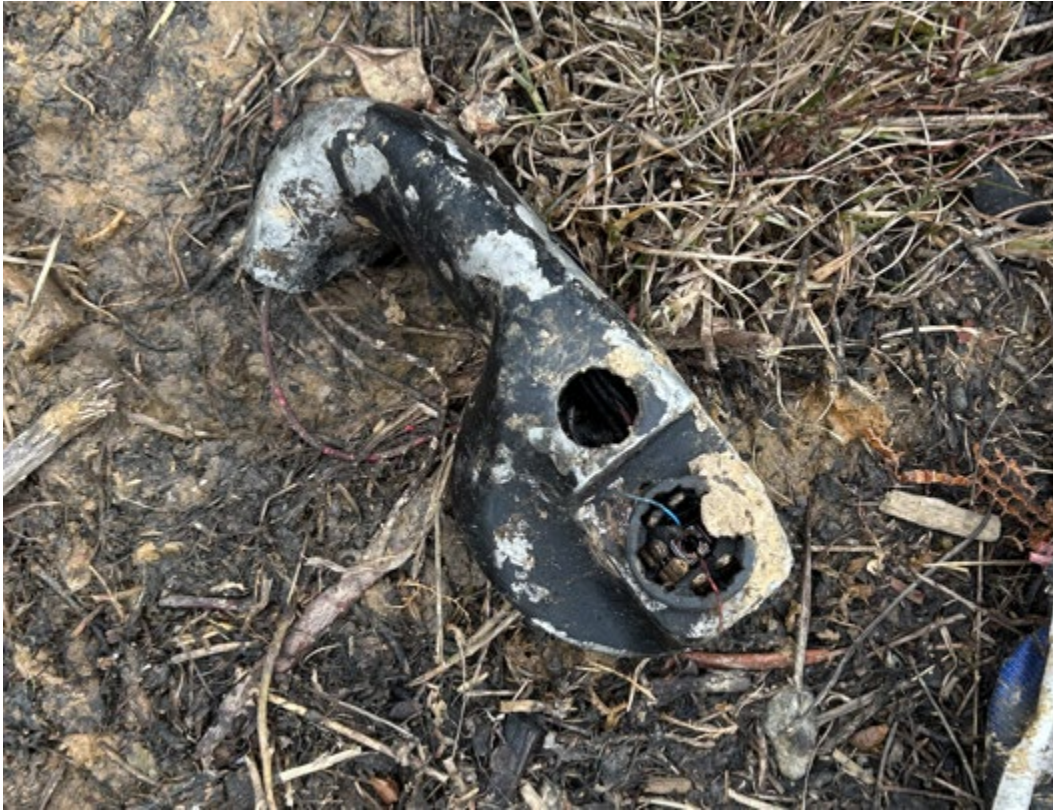
*Figure 17: Pilot Control Wheel*

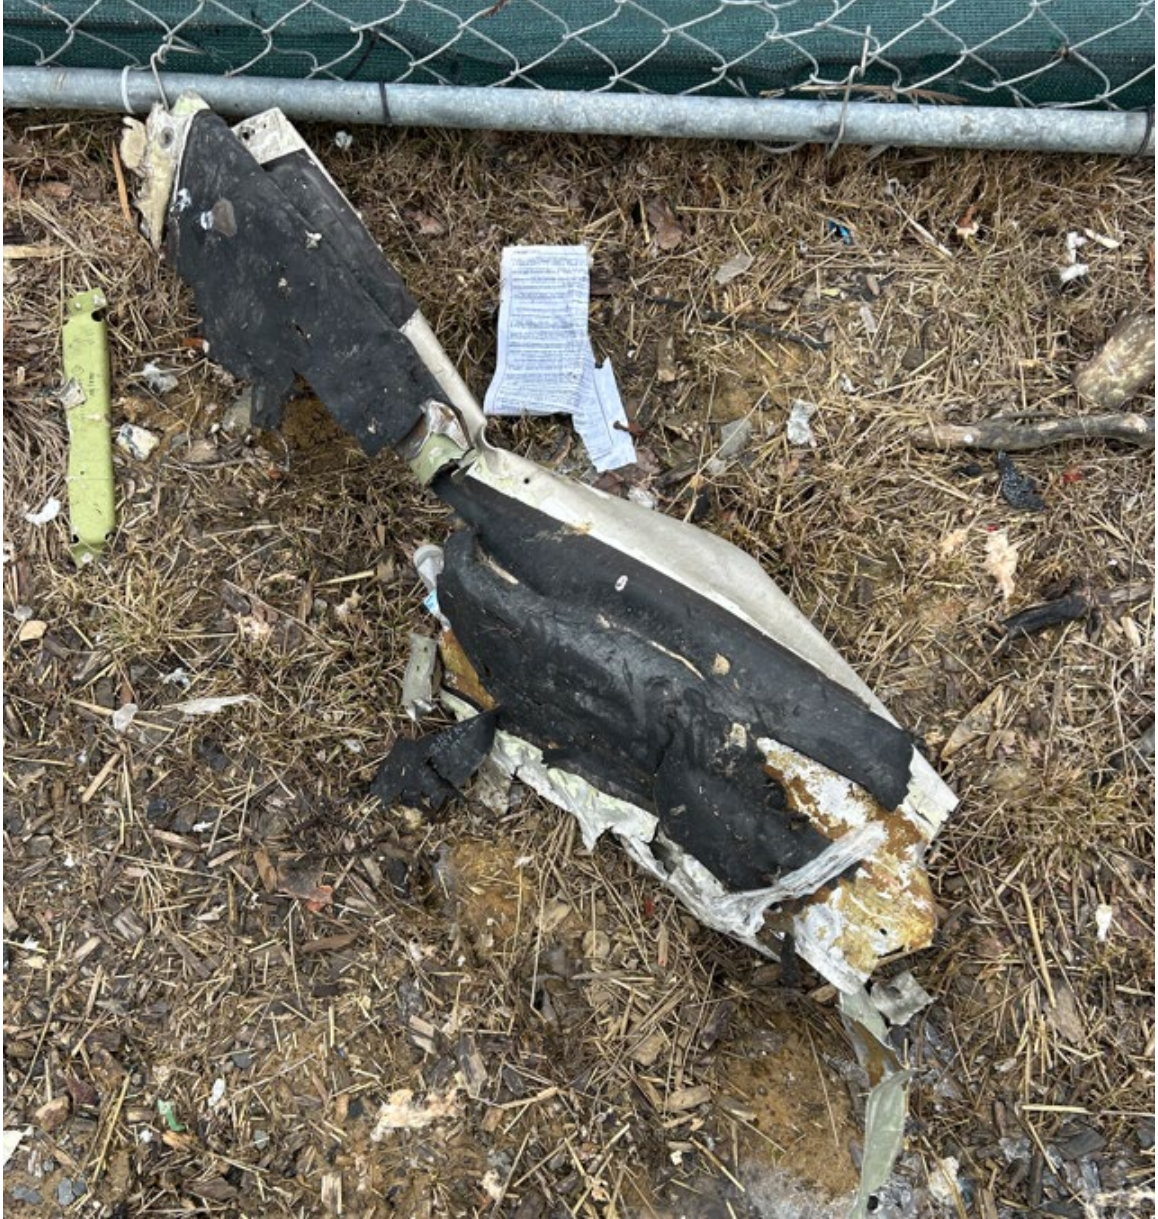
*Figure 18: Portion of Horizontal Stabilizer Leading Edge*

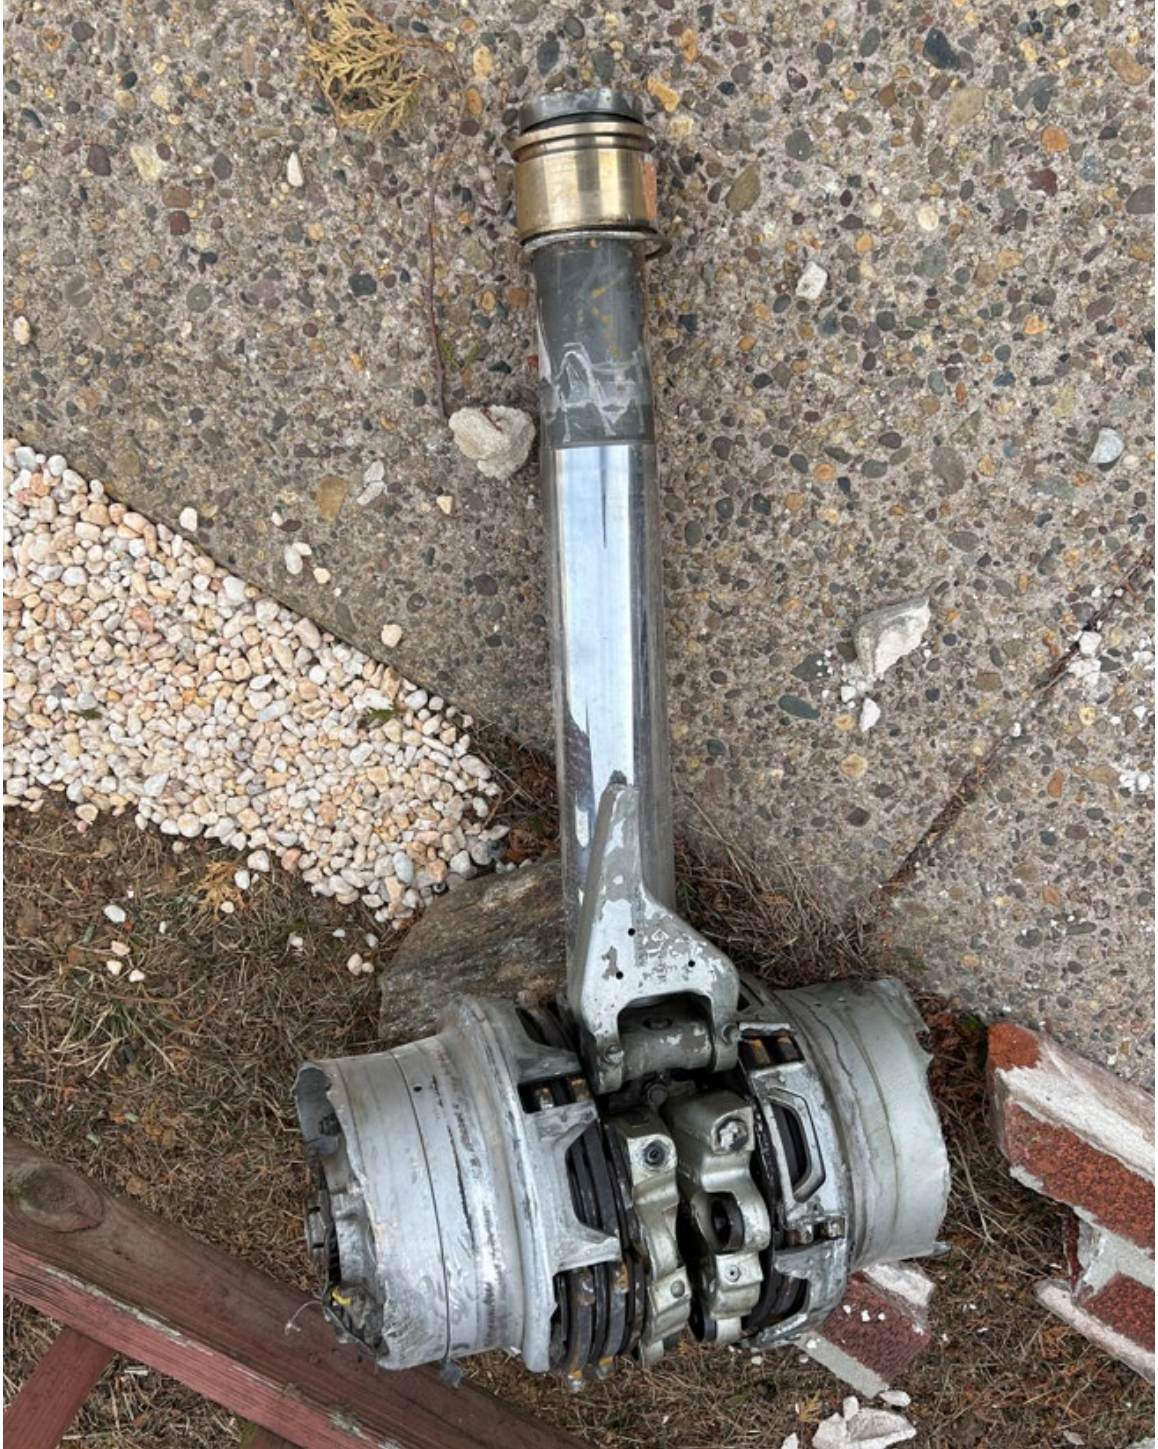
- Engine oil tank
- Right-hand main landing gear strut piston, axle, brake assemblies and portions of wheels (Appendix A Figure 17)
- Main landing gear tire

*Figure 20: Right-hand Main Landing Gear Strut Piston*

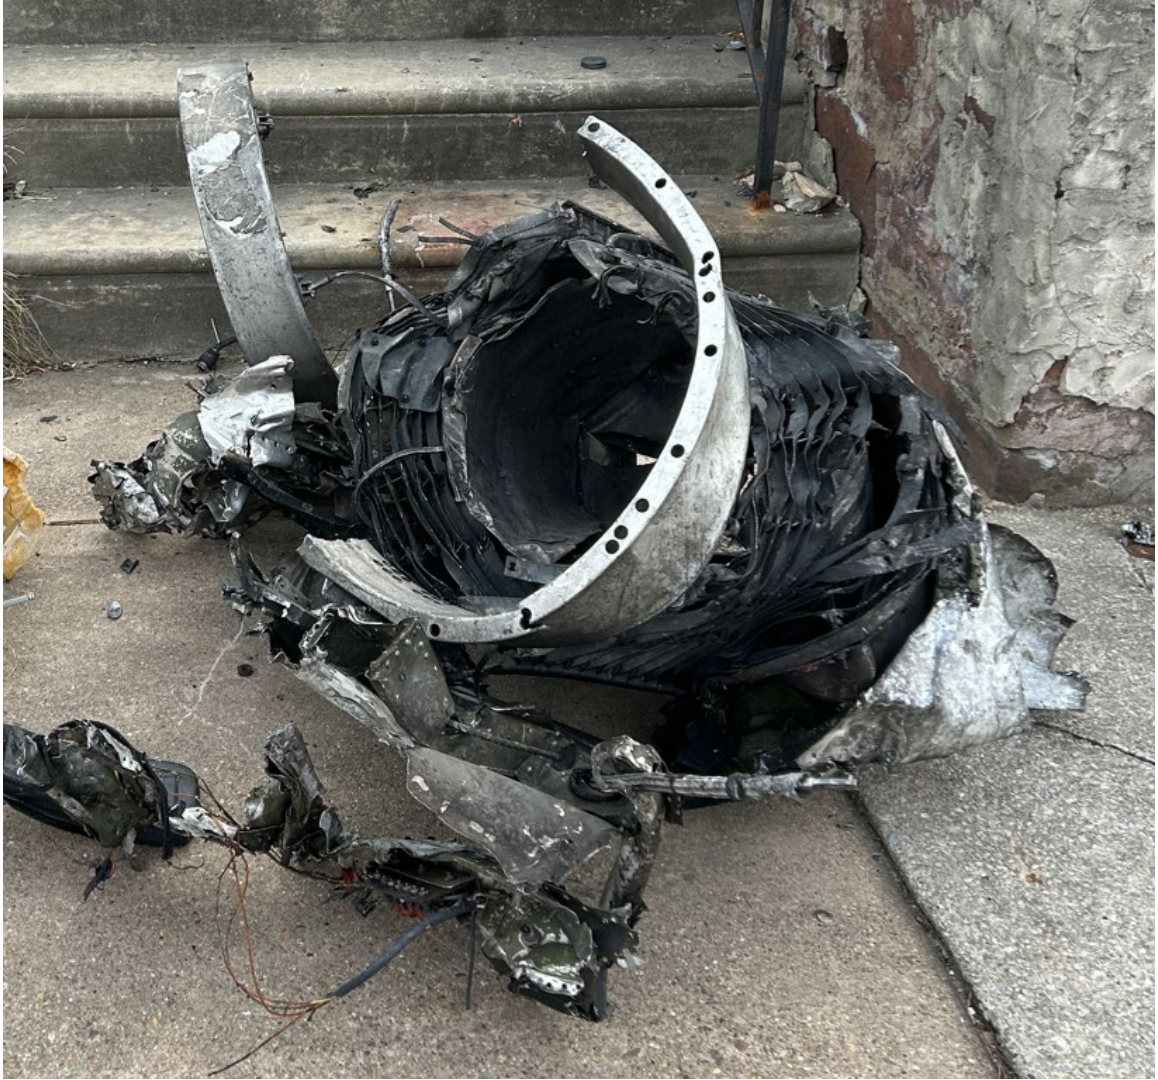
- Portion of cockpit with wiring and pitot tube mount
- Engine cowling with part of thrust reverser and switch
- Right-hand forward engine mount (Appendix A Figure 18)
- Altimeter
- Portion of cockpit seat structure
- Portion of right-hand thrust reverser assembly (Appendix A Figure 18)
- Attitude direction indicator (ADI)
- Single Point Pressure Refueling (SPPR) door and fuselage skin
- Portion of autopilot servo
- Portion of main wheel (S/N AUG86-2789) and brake assembly
- Engine fire bottle
- Parts of brake assembly
- Engine fan assembly and planetary gear
- Portion of main wheel, S/N JUL84-239, S/N JUL10-3974

*Figure 22: Portion of Right-hand Thrust Reverser*

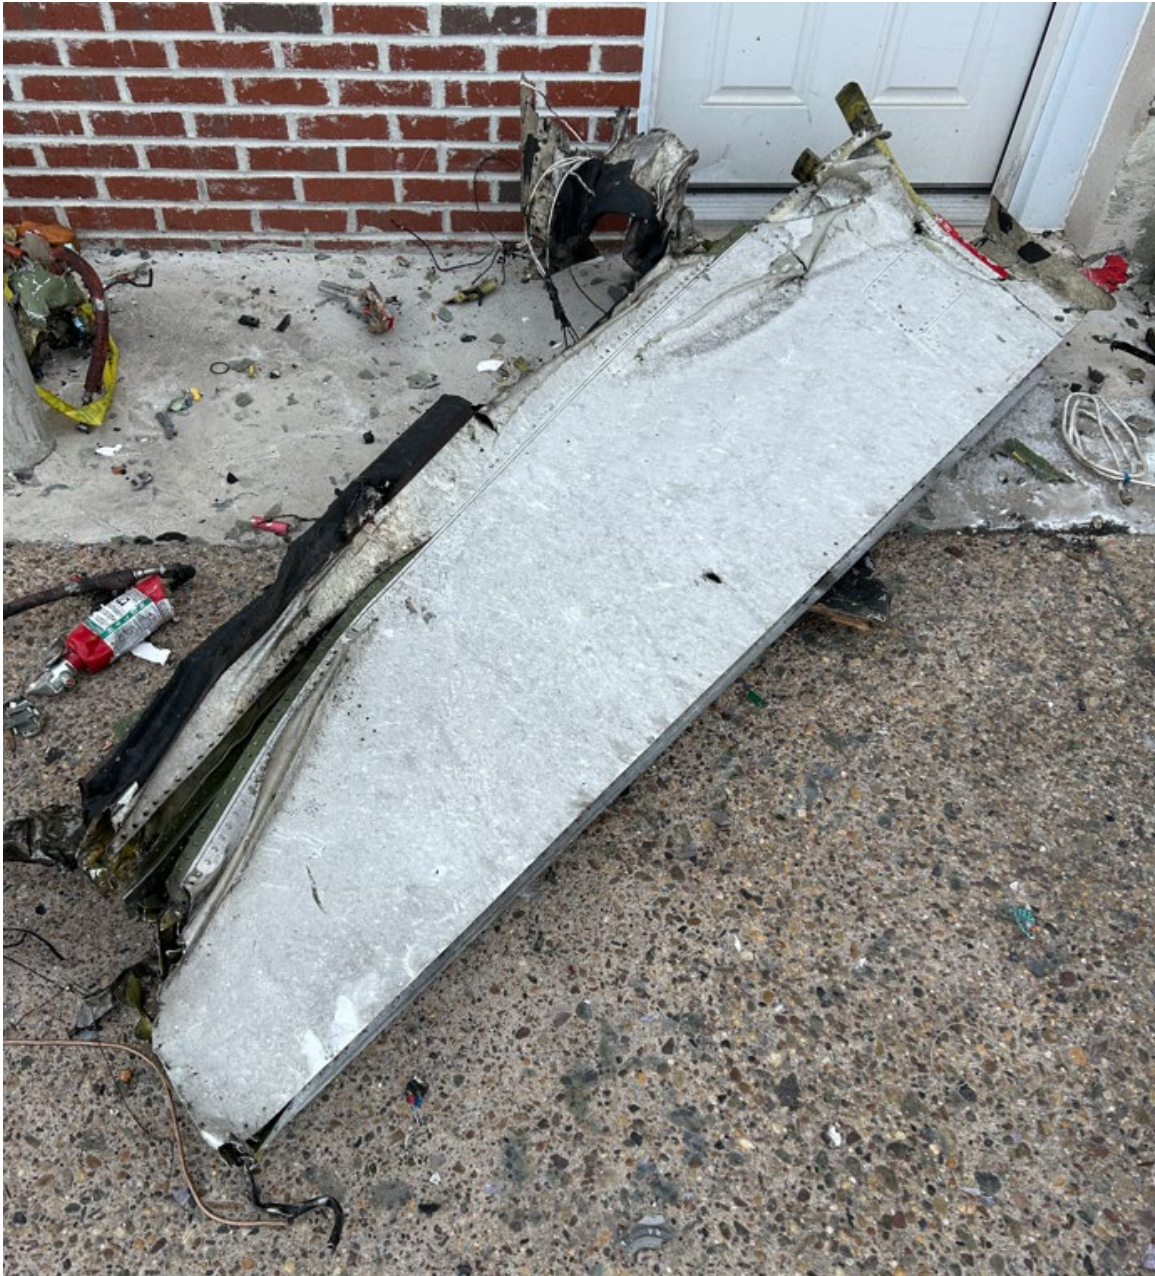
- Portion of control column
- Portion of right-hand horizontal stabilizer (Appendix A Figure 20)
- Portion of right-hand forward fuselage
- Right-hand winglet (Appendix A Figure 21)
- EGPWS (Appendix A Figure 22)
- Engine fire bottle
- pitch trim actuator motor (Appendix A Figure 23)

*Figure 23: Portion of Right-hand Horizontal Stabilizer*

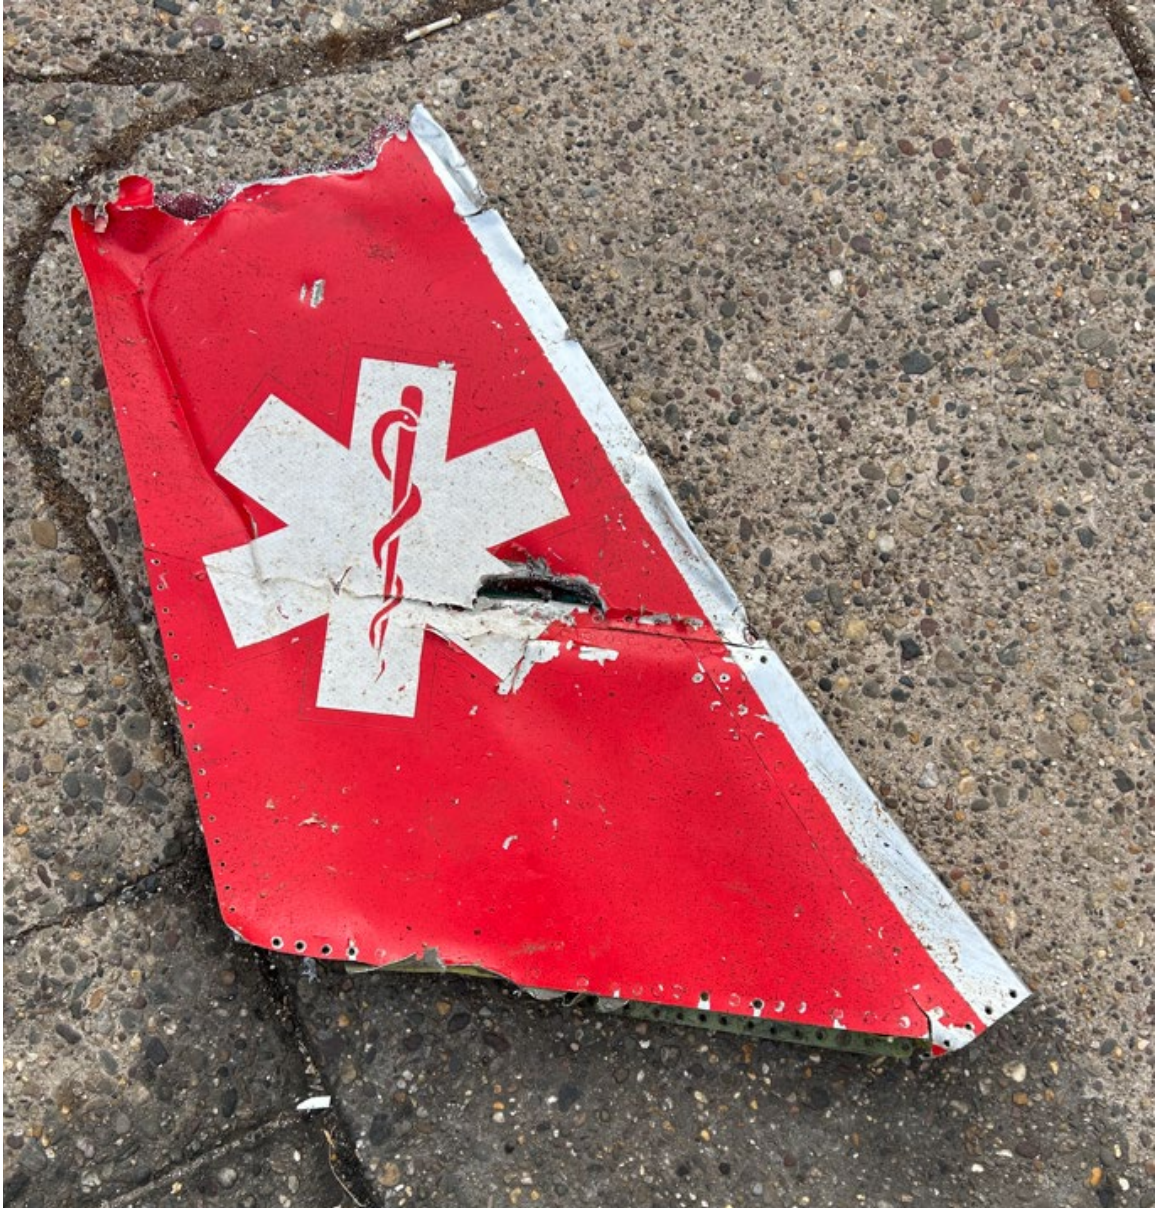
*Figure 24: Right-hand Winglet*

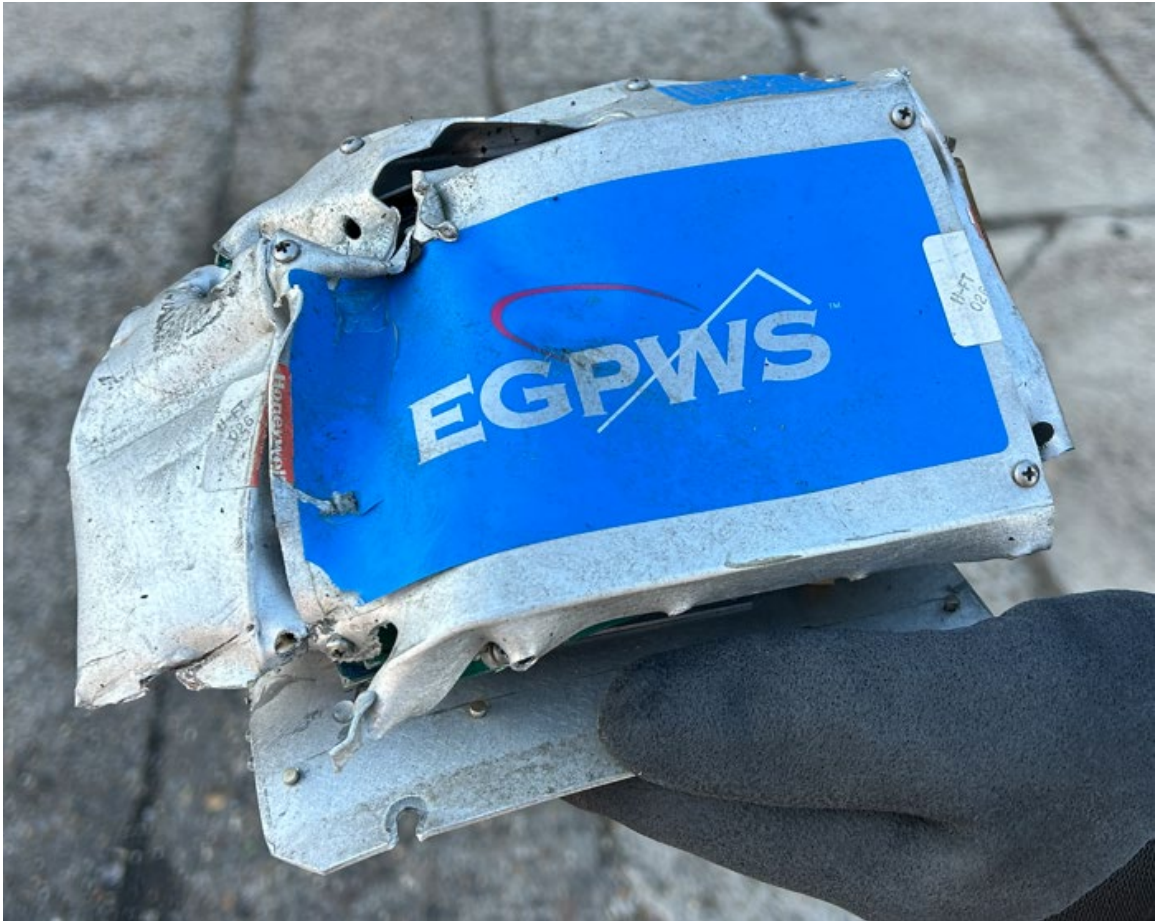
Figure 25: EGPWS

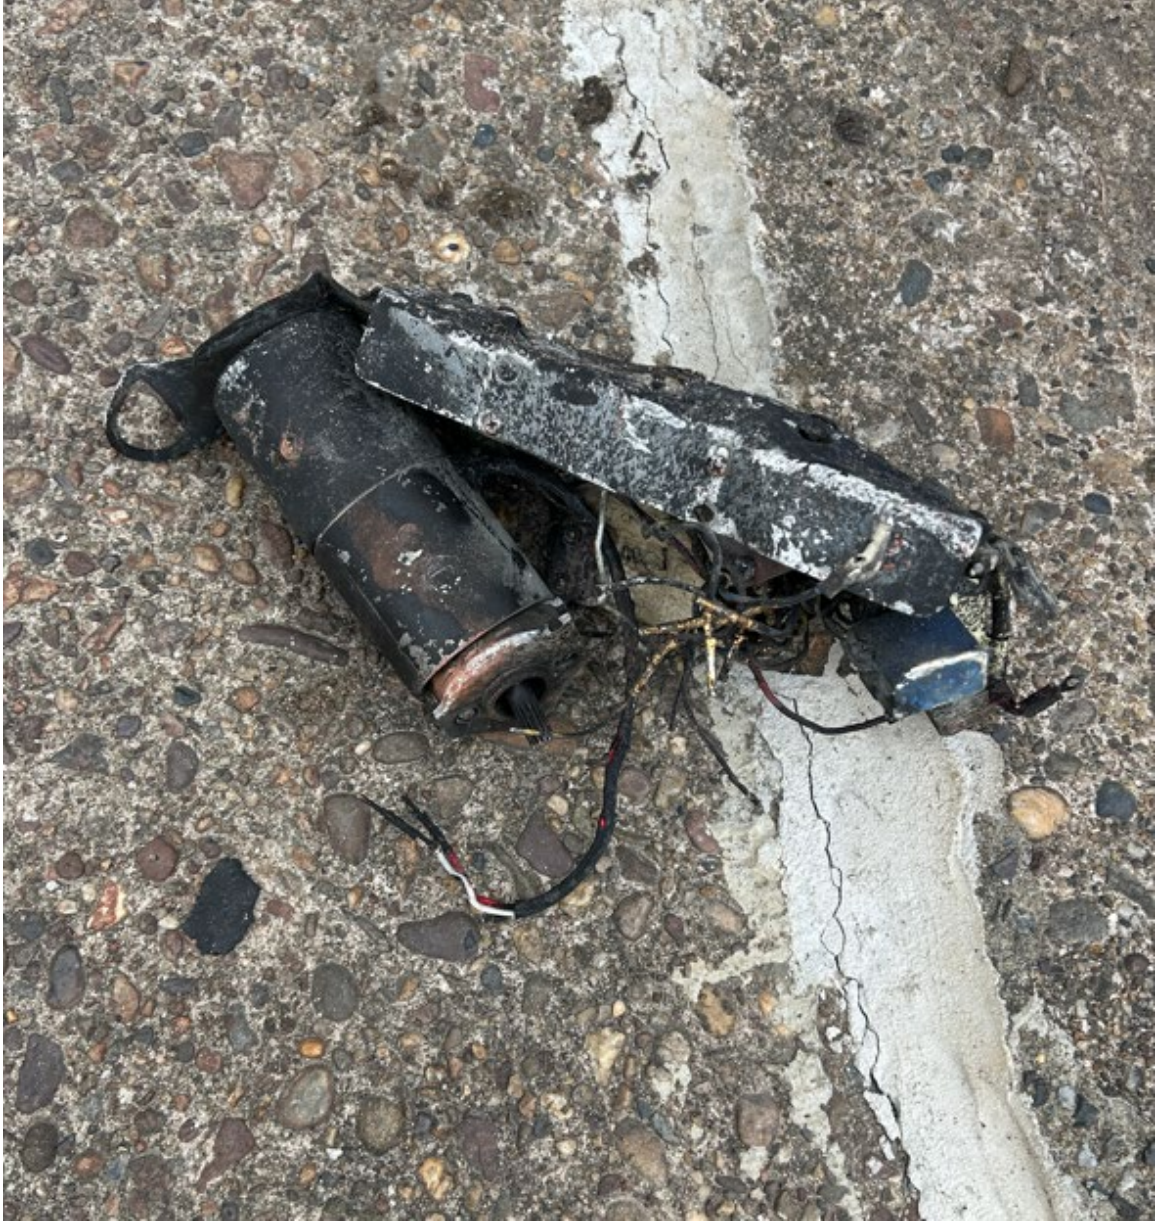
*Figure 26: Pitch Trim Actuator Motor*

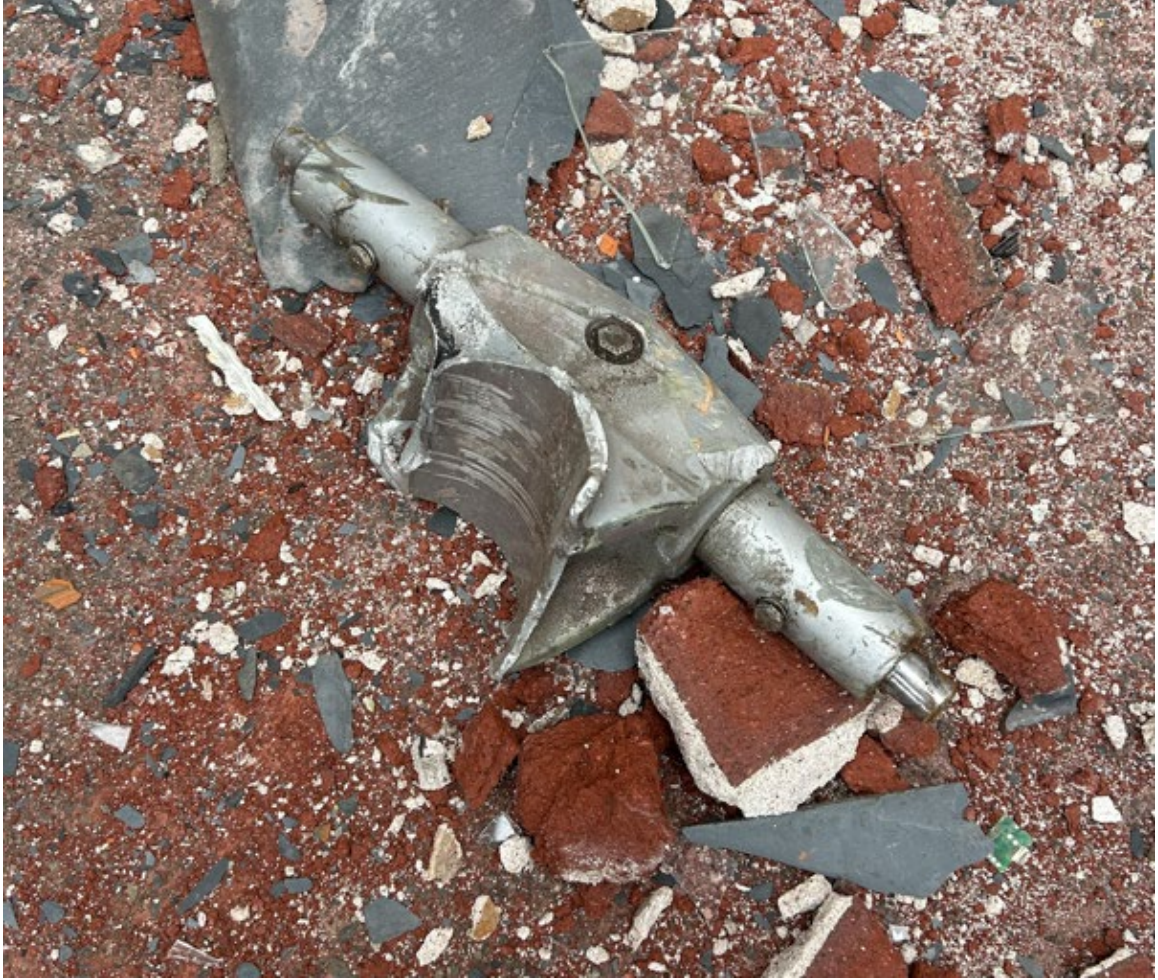
- Ram air duct
- Portion of right-hand lower engine cowling
- Right-hand thrust reverser and aft cowl, S/N 5154
- Portion of cabin floorboard structure with portion of wing structure
- Top piece of nose landing gear strut (Appendix A Figure 26)
- Aircraft oxygen bottle
- Main landing gear actuator, likely right-hand (Appendix A Figure 27)
- Portion of aileron control cable
- Fuel boost pump with portion of throttle control cable

*Figure 27: Top Piece of Nose Landing Gear Strut*

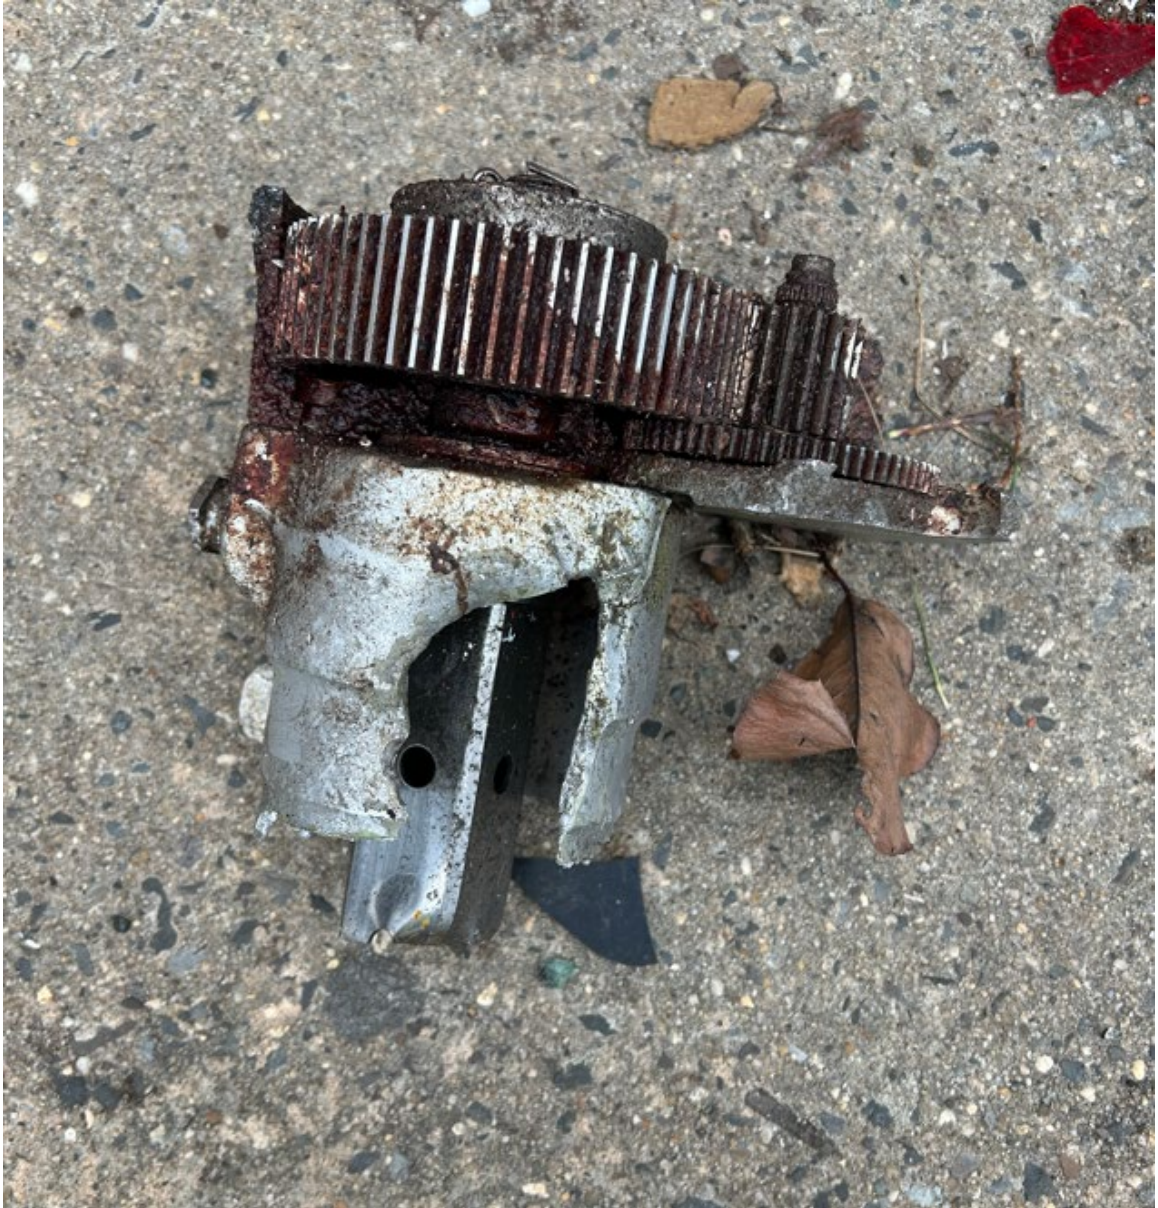
- Pieces of engine fan blades
- Portion of main landing gear actuator attachment point
- Nose wheel steering servo (Appendix A Figure 28)

*Figure 29: Nose Wheel Steering Servo*

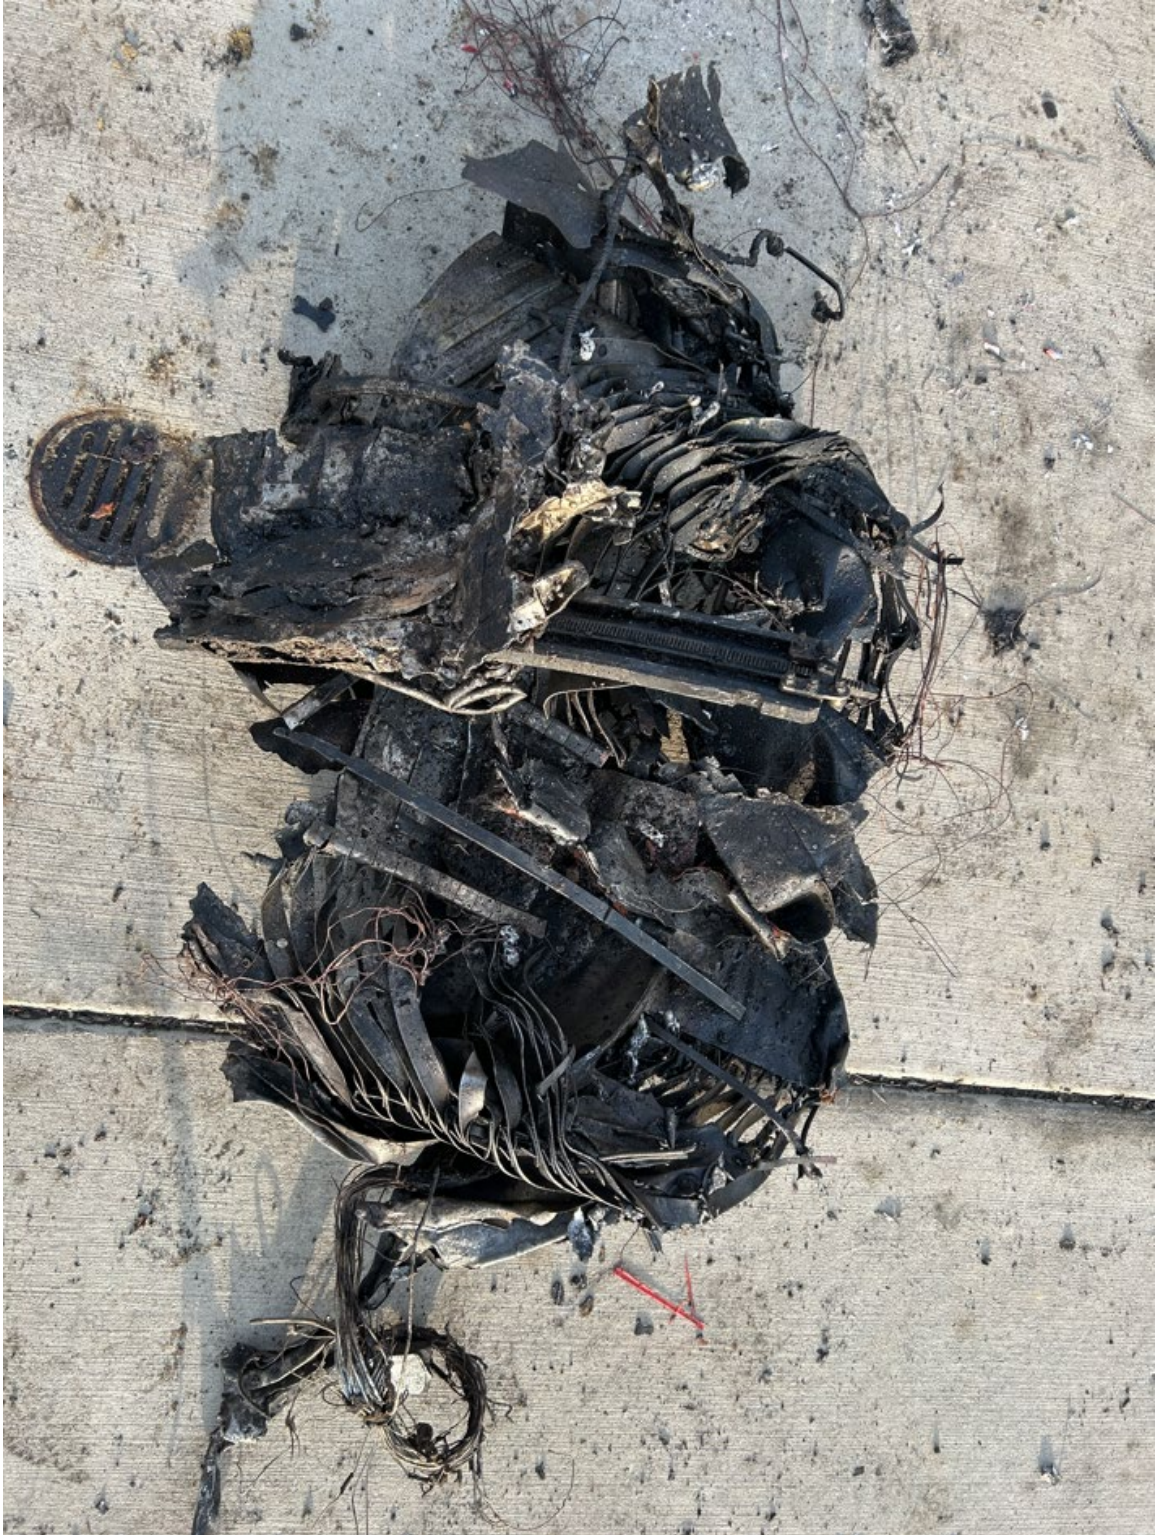
- Cockpit voice recorder
- Portion of left-hand thrust reverser assembly (Appendix A Figure 1), S/N 5015; one of the thrust reversers racks was in the recovered assembly; the other rack was found separately, but also in the crater (Appendix A Figure 2); this rack appeared to have witness marks on it (Appendix A Figure 32)

*Figure 30: Thrust Reverser Assembly Recovered from Crater*

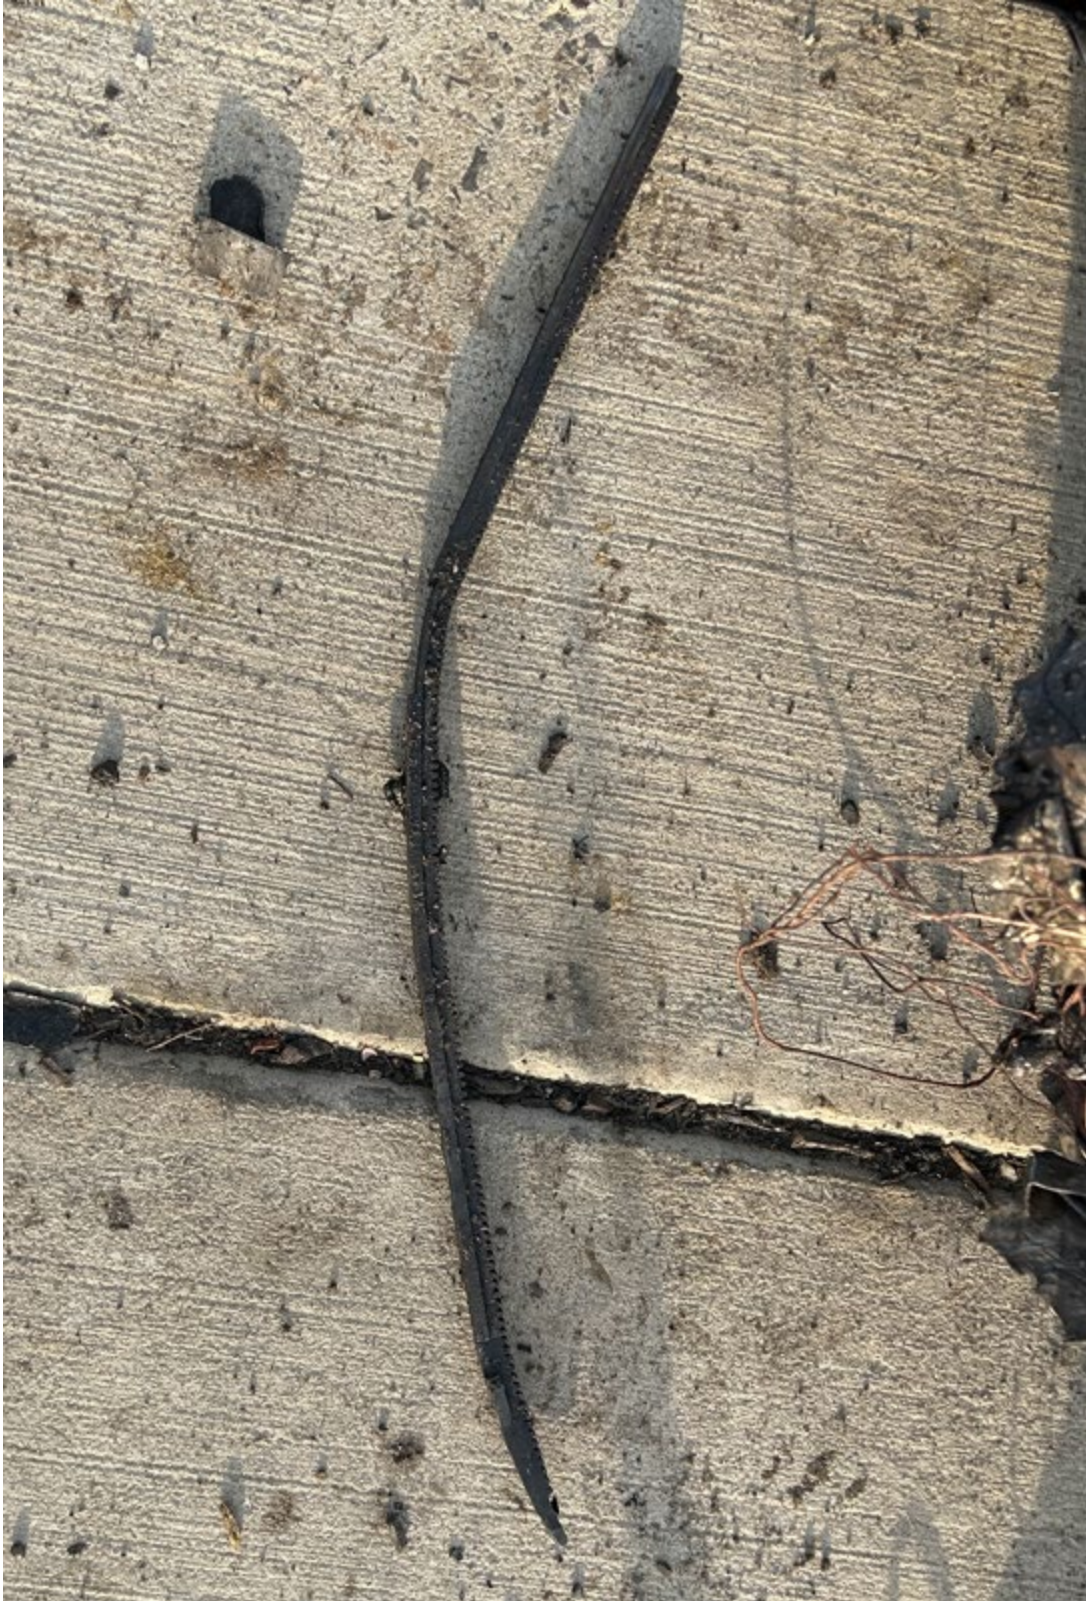
*Figure 31: Thrust Reverser Rack Found in Crater*

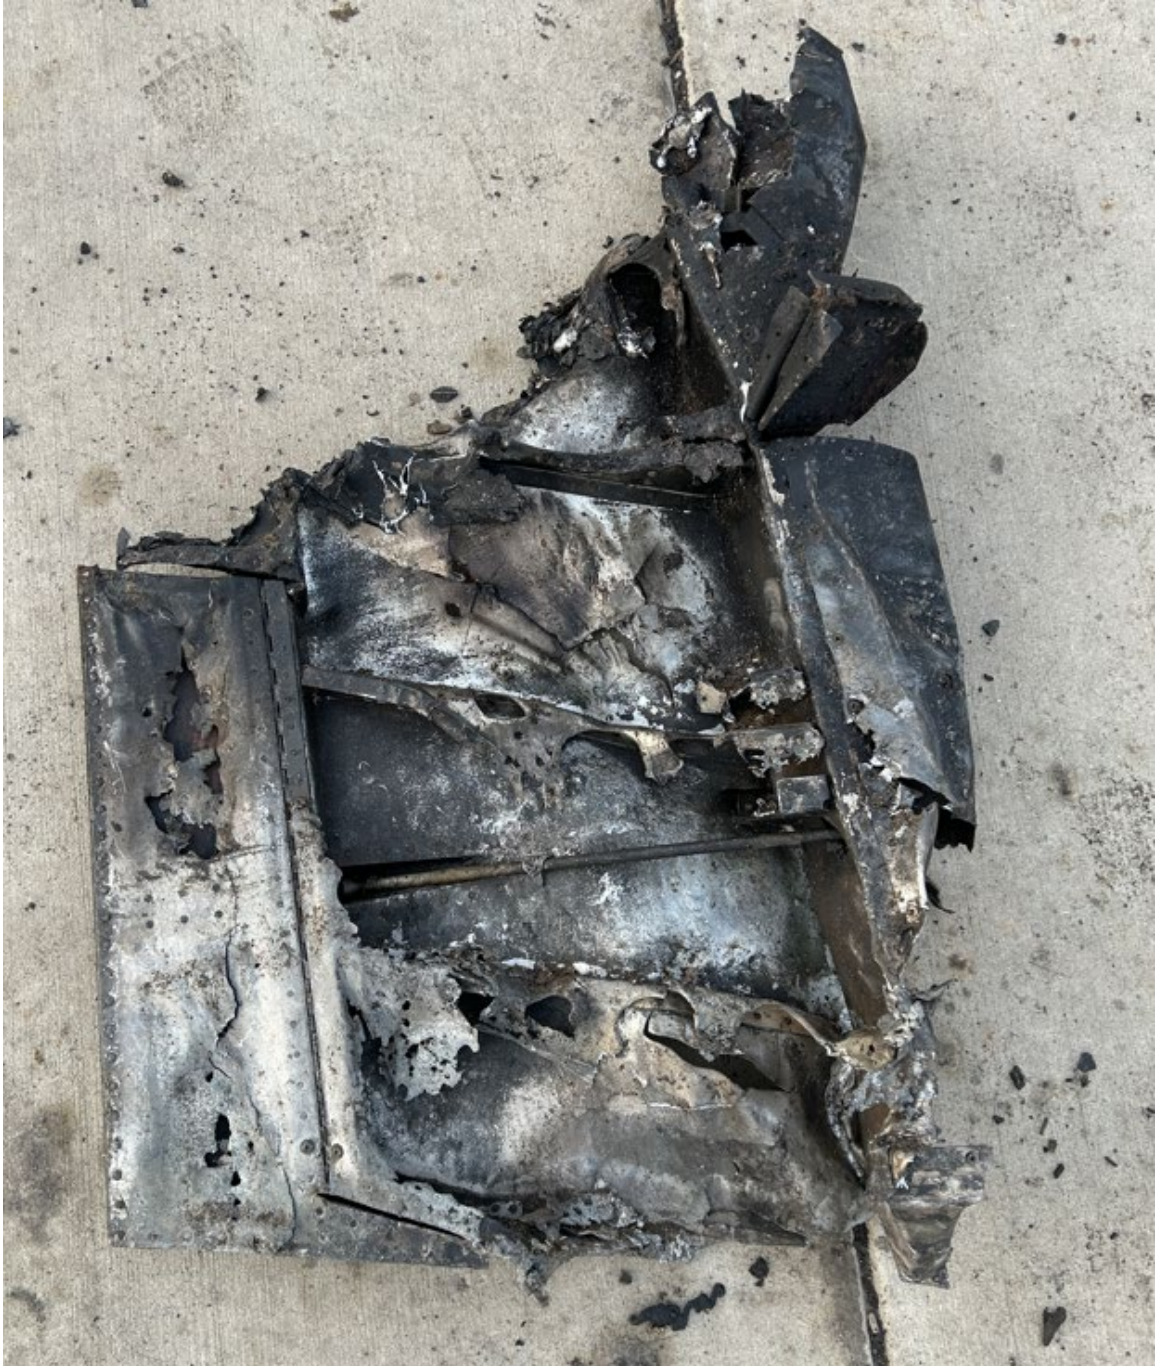
- Generator control panel (located in aft equipment bay)
- Faceplates for engine EECs
- Portion of rudder with trim tab, trim tab control rod still connected at both ends (Appendix A Figure 32)

*Figure 33: Rudder*

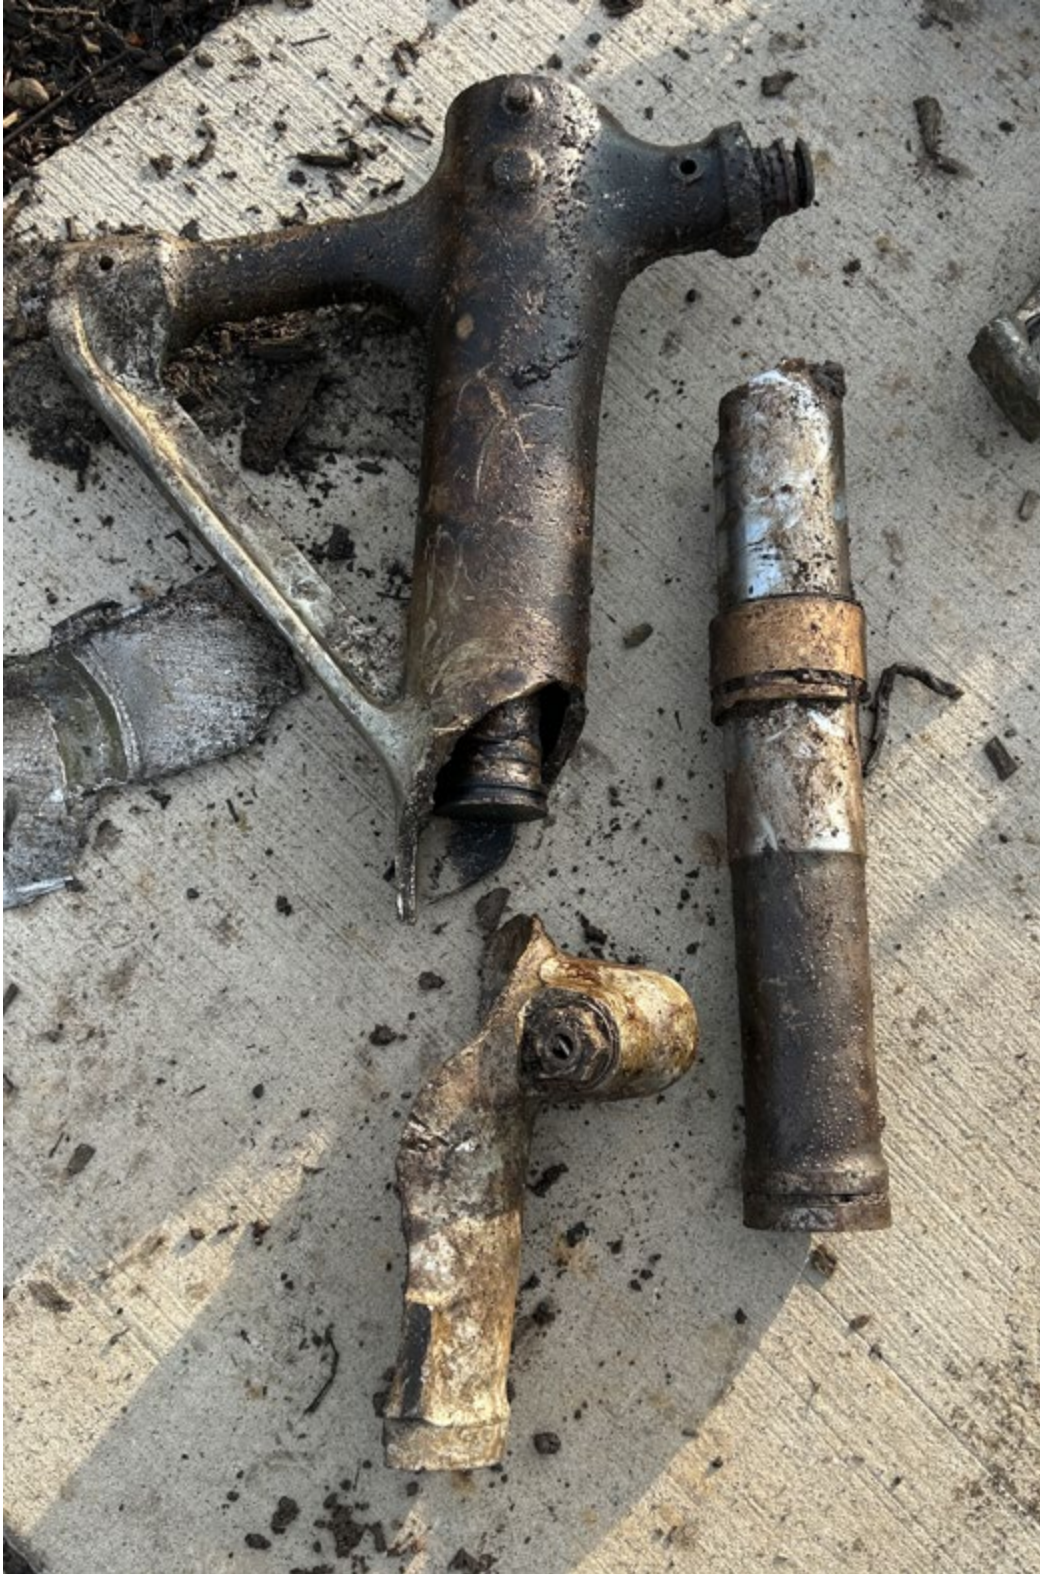
- Engine fuel control assembly
- Autopilot roll servo
- Engine oil reservoir
- Air conditioning motor
- Left main landing gear fitting, piston, pieces of strut with actuator attachment point (Appendix A Figure 34)

*Figure 34: Left-hand Main Landing Gear*
