# National Transportation Safety Board

ERA25MA106

## **AIRWORTHINESS FACTUAL REPORT- ON-SCENE**

Location: Philadelphia, Pennsylvania  
Date: January 31, 2025  
Time: 1807 eastern standard time  
Airplane: Learjet 55, registration XA-UCI

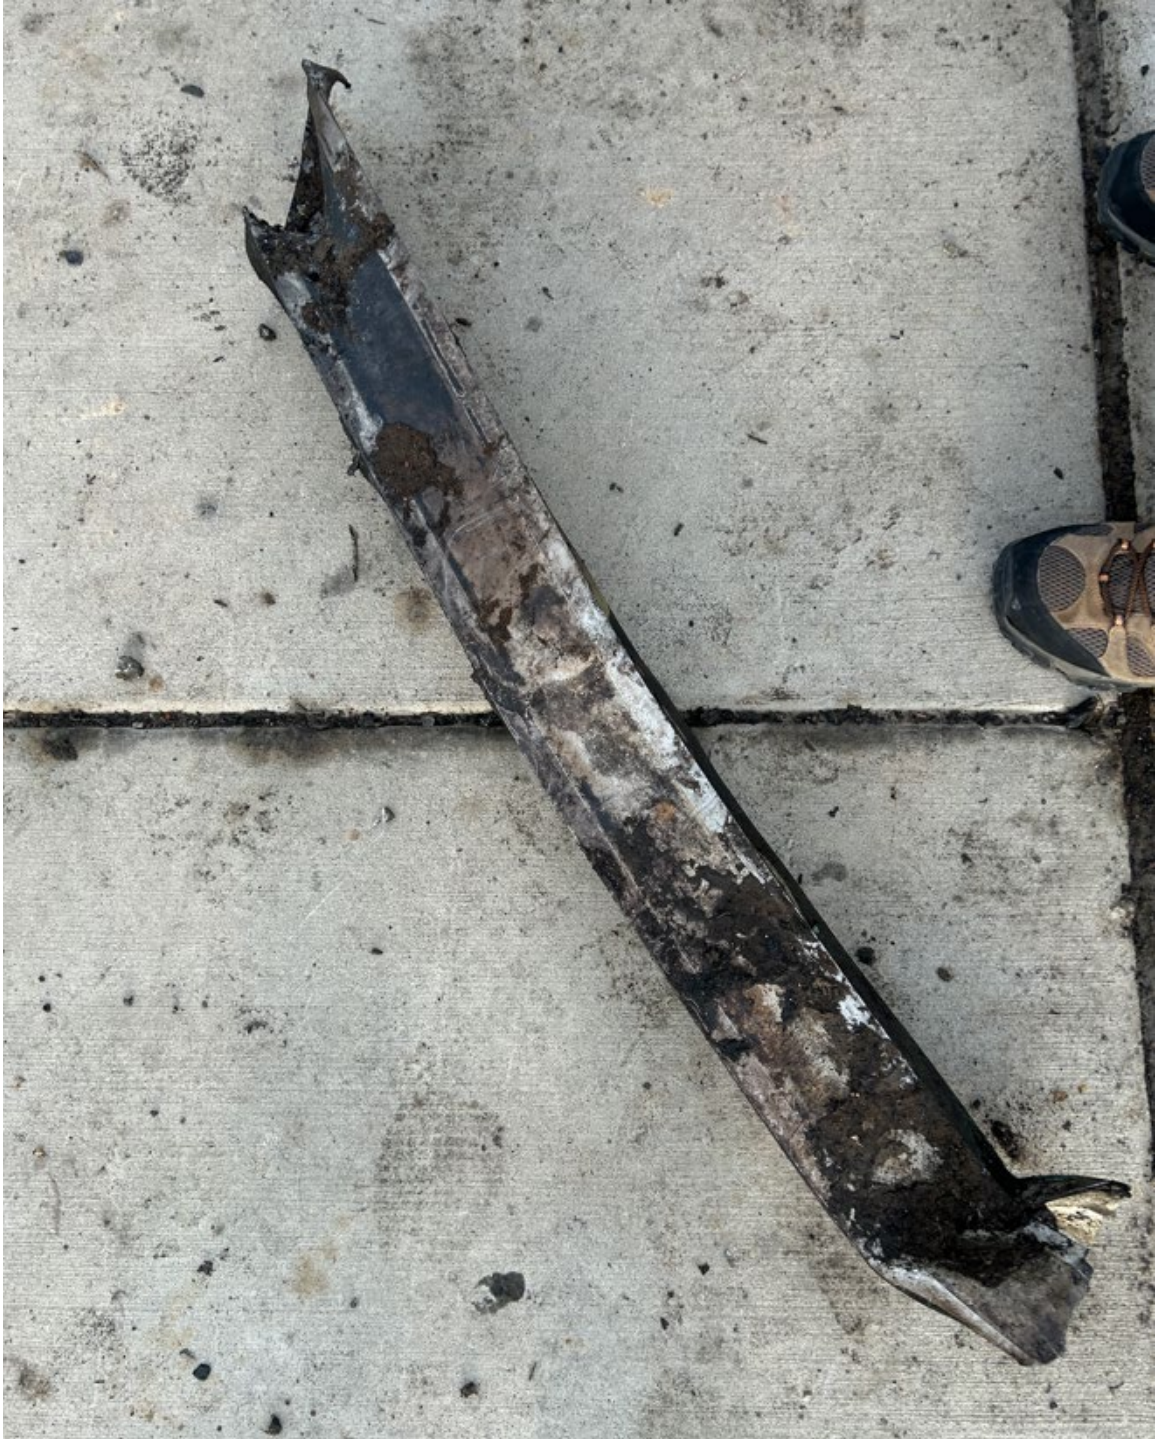
- Generator
- Portion of keel beam (Appendix A Figure 36)
- Freon heat exchanger
- Flap track
- GNS-500 internal loop antenna
- Ram air heat exchanger

*Figure 36: Keel Beam*

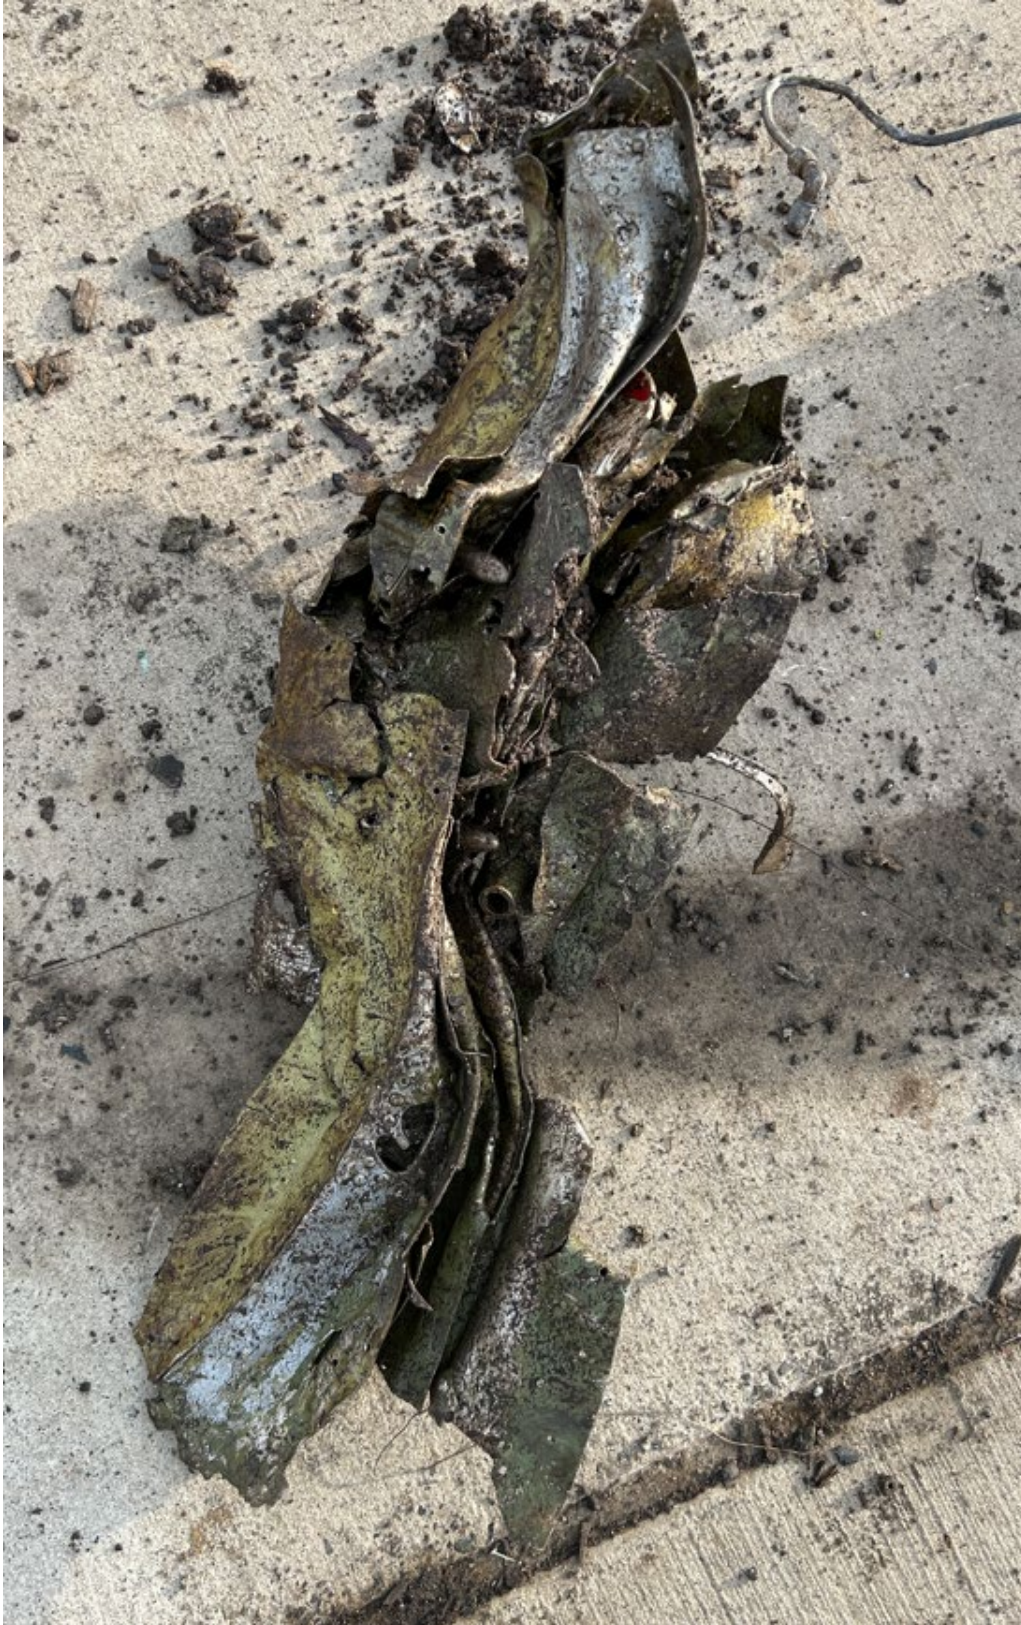
- Section of main entry door frame with pins and receptacles (Appendix A Figure 37)
- Underwater Locator Beacon (ULB)
- Piece of flap sector with portion of flap cable (Appendix A Figure 38)
- Aileron hinge access panel

*Figure 37: Main Entry Door Frame*

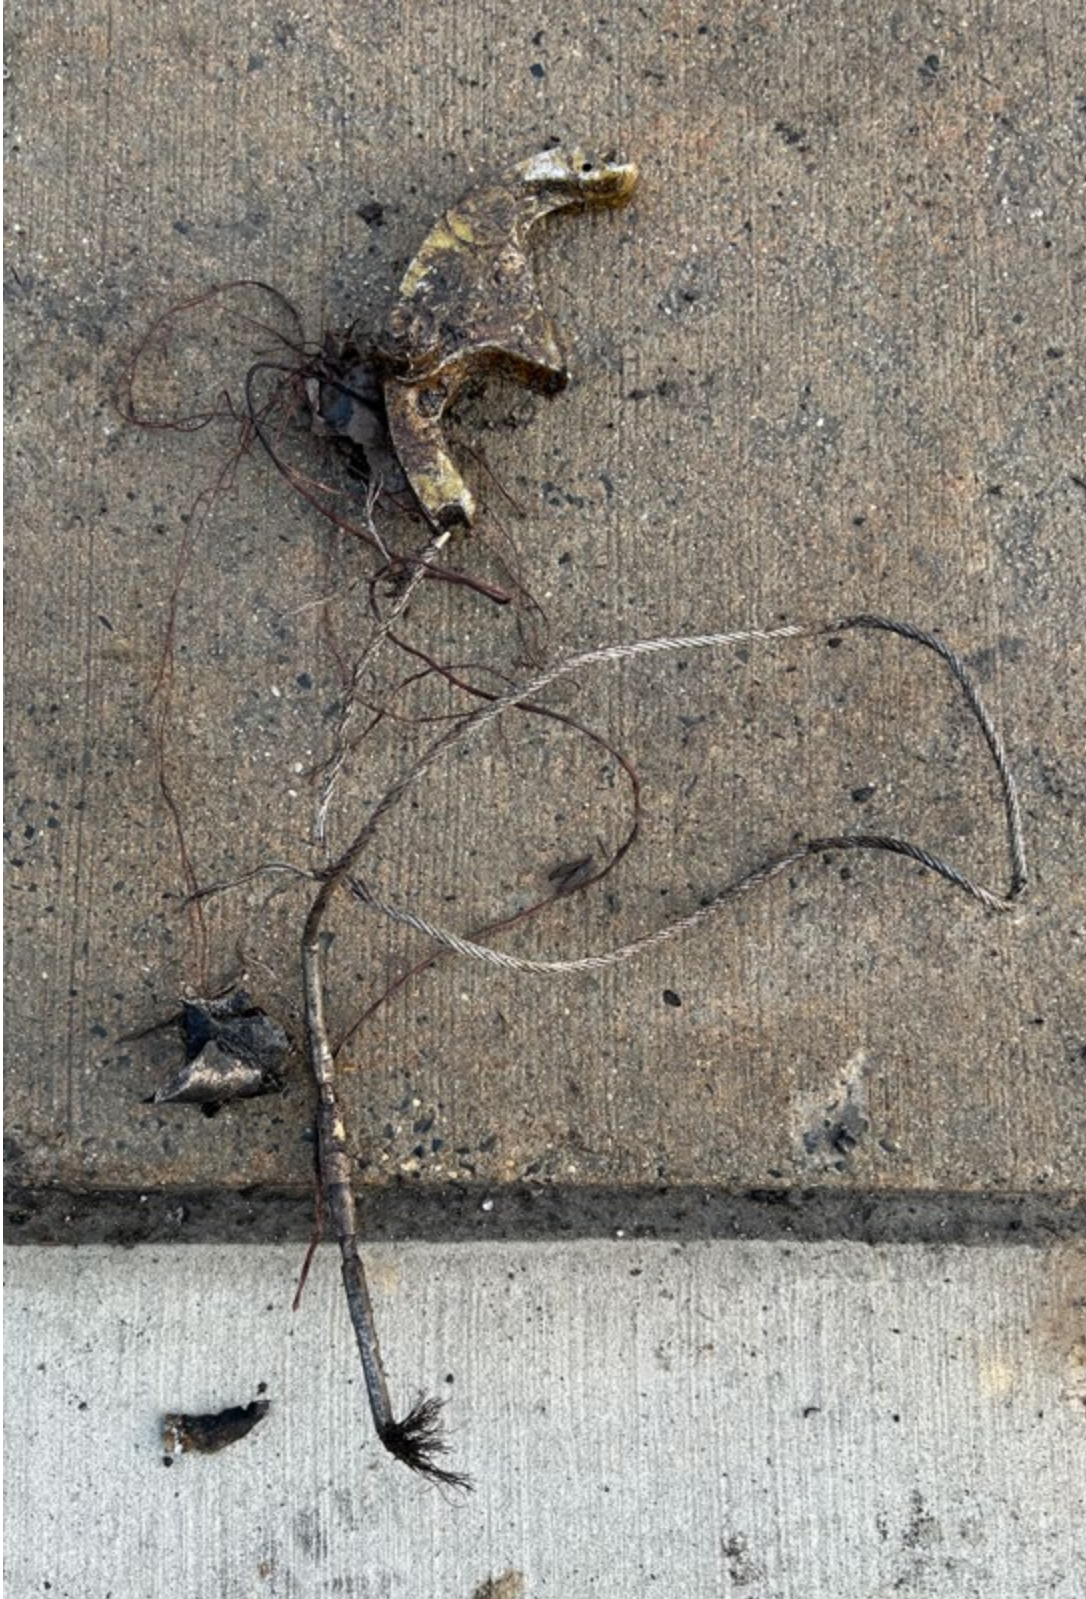
*Figure 38: Flap Sector*

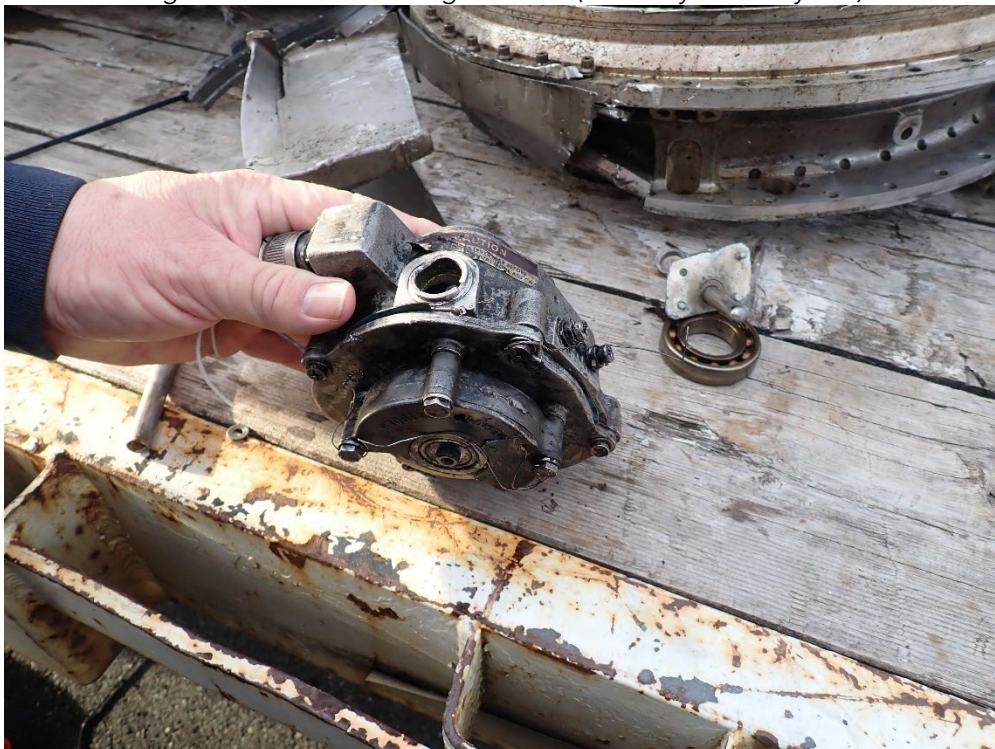
Part of a detached fuel control (Appendix B Figure 61).

*Figure 61: A Portion of an Engine Fuel Control (Courtesy of Honeywell)*
