# National Transportation Safety Board

ERA25MA106

## **AIRWORTHINESS**

Location: Philadelphia, Pennsylvania  
Date: January 31, 2025  
Time: 1807 eastern standard time  
Airplane: Learjet 55, registration XA-UCI

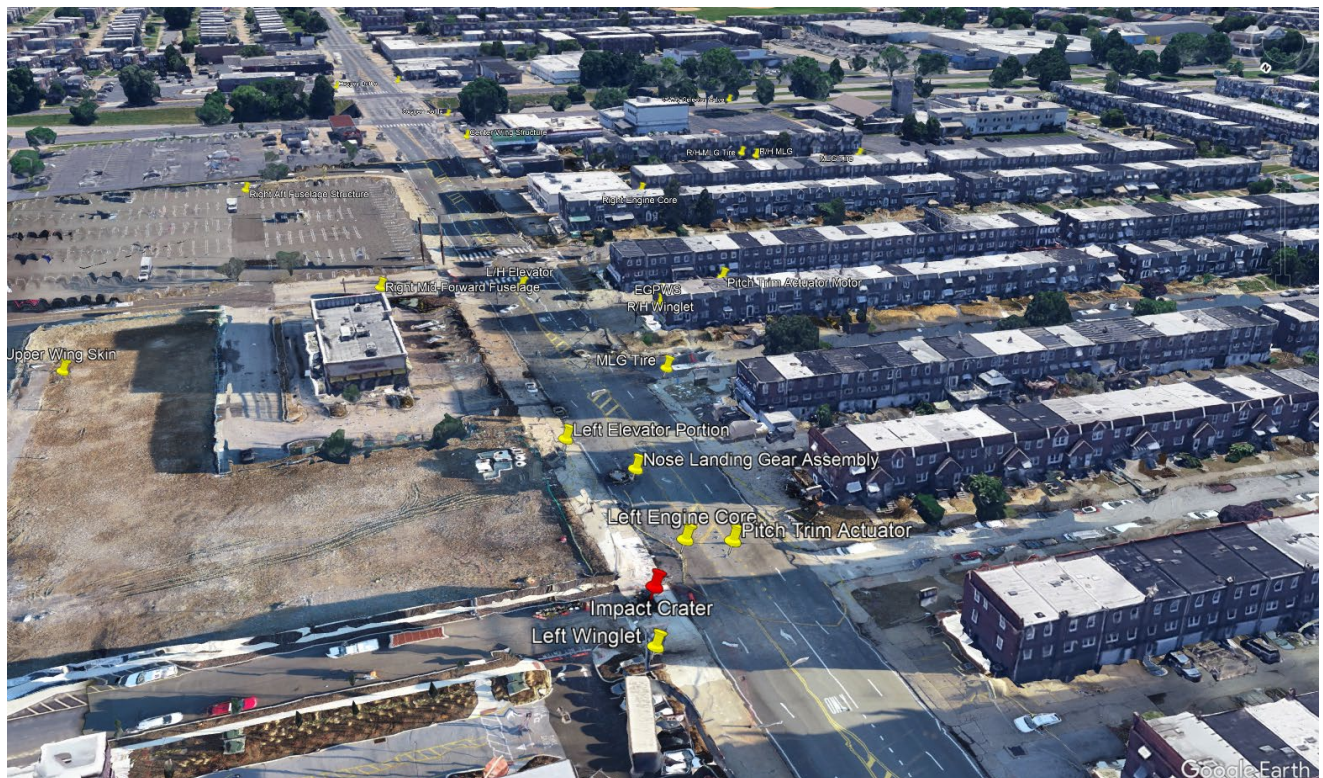
The main wreckage debris field was located between the intersections of Hanford St. at Cottman Ave. and Roosevelt Blvd. and the wreckage debris field was about 1,410 ft in length and 840 ft wide, oriented on a magnetic heading of about 150°. The airplane horizontal stabilizer contacted a business sign beside the main impact crater and the calculated descent angle based on the height of the observed damage to the sign was about 22°. White paint transfer was evident at the point of contact with the sign.

**Figure 2: A View of the Debris Path on the 150° Heading with Larger Components Marked. Aerial Imagery of the Accident Site is Overlaid**

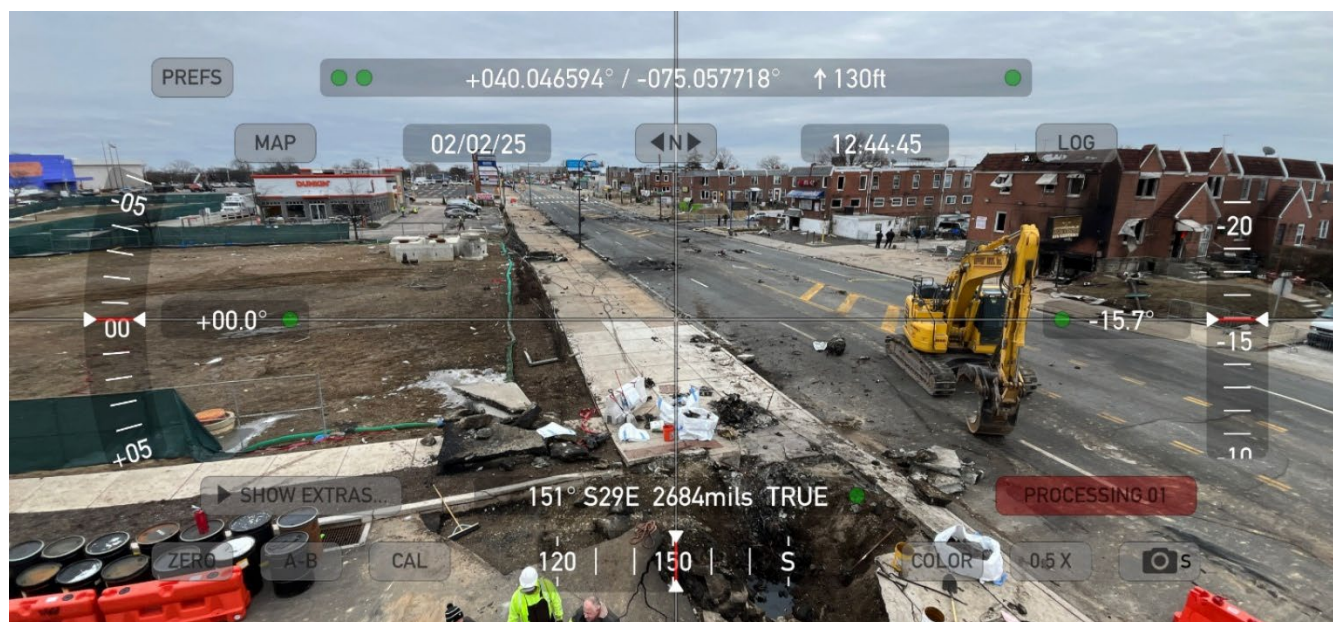
**Figure 4: View of the Debris Path as Viewed from the First Point of Impact**

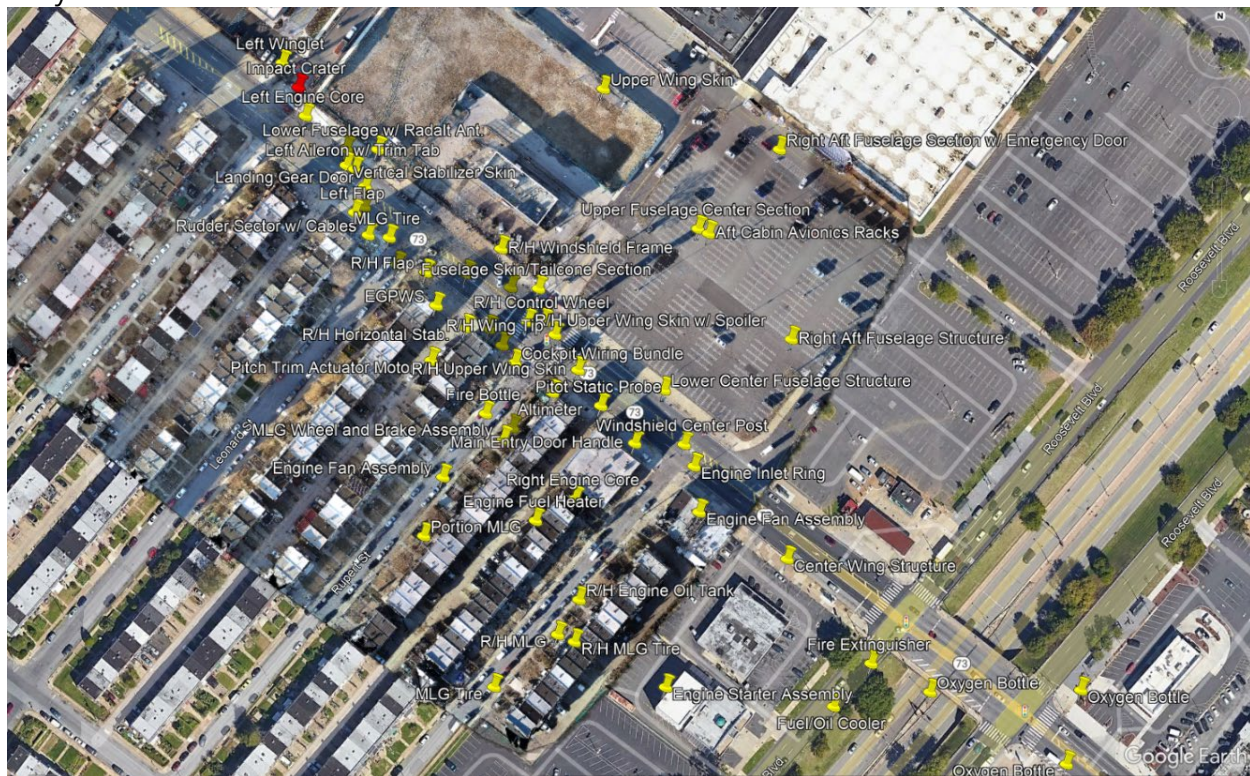
Both engines were separated from the empennage and located within the main debris field. Four major sections of the engine hardware were located within the debris field. The left engine core was located and identified 30 ft from the impact crater. The right engine core was located and identified 665 ft from the impact crater in a second-floor residential bedroom. The left fan assembly was located 560 ft from the impact crater under a car on Rupert St. and the right fan assembly was located 785 ft from the impact crater at the base of an overhead billboard on top of a single-story commercial structure. Numerous other pieces of both engines were located throughout the debris field.

**Figure 6: Impact Point and Debris Location with Aerial Photography Overlay. The Debris Path was 1410 ft in Length and 840 ft in Width**

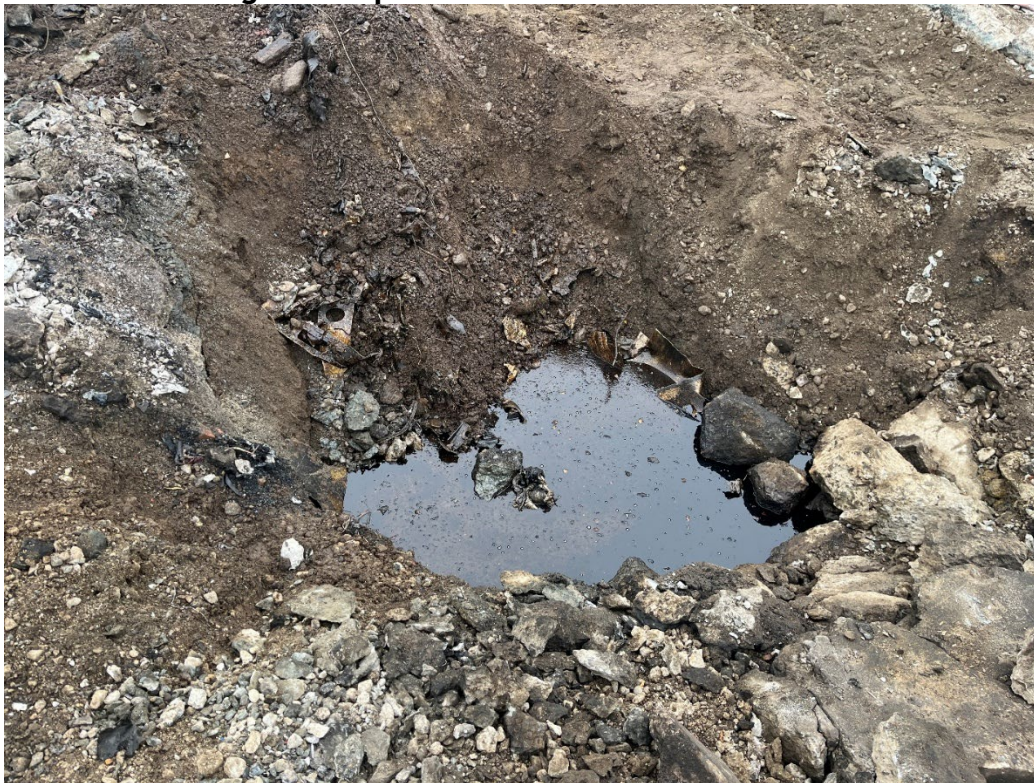
The initial impact crater, measuring about 8 ft deep and 10 ft in diameter, was located centered in a commercial driveway along Cottman Ave., on the northeast sidewalk, between Roosevelt Blvd. and Bustleton Ave. The sidewalk was displaced upwards 3 ft surrounding the impact crater.

**Figure 8: Impact Crater with Most Debris Removed**

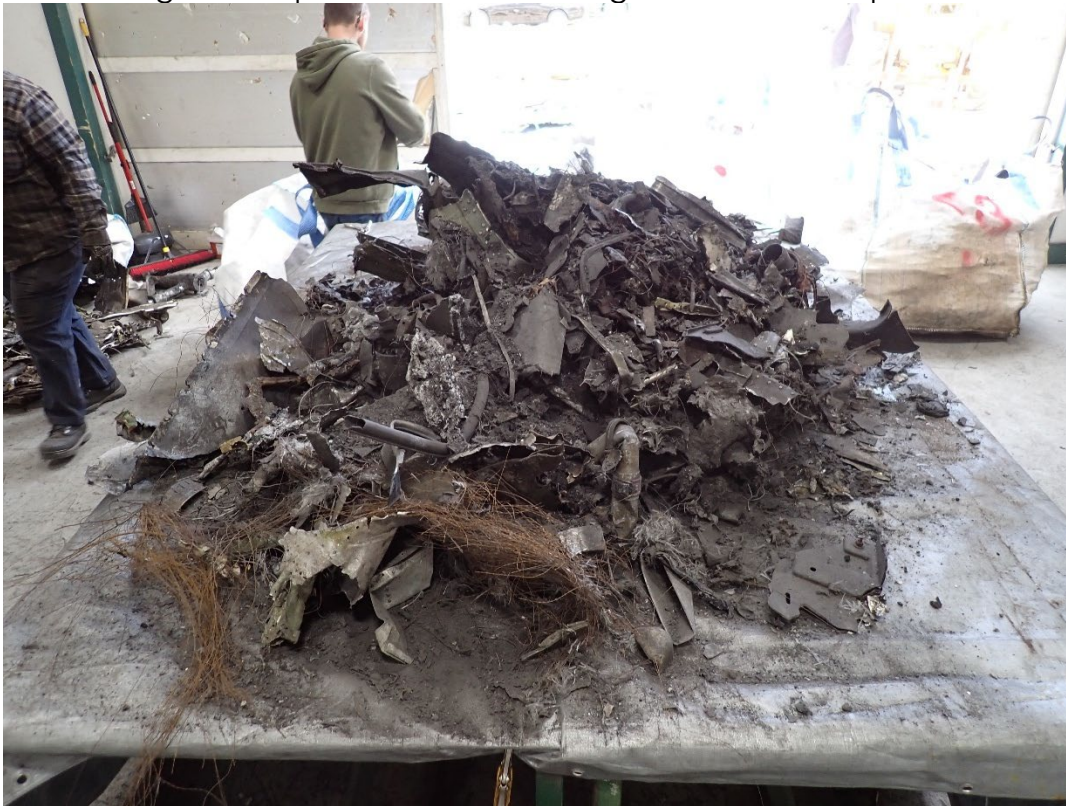
The collected bags of wreckage debris were evaluated individually and their large components contained within them were documented.<sup>7</sup> During the wreckage examination, there was no evidence of preaccident mechanical malfunctions or failures with the airplane that would have precluded normal operation.

**Figure 9: Bag 23 Contents as an Example of Wreckage Debris Collection. The Bag Photographs and a List of Contents Can be Found in the Airworthiness Chairman's Factual Report - Attachment 2**

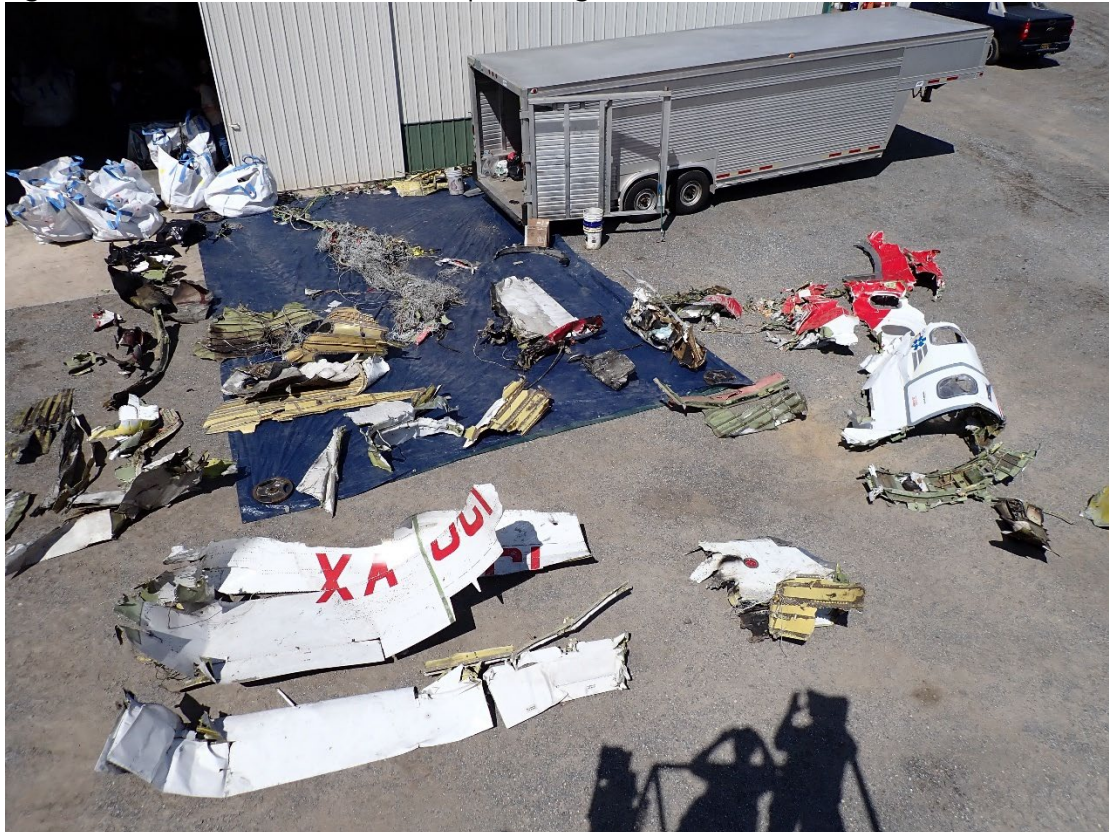
Portions of the fuselage were found throughout the recovery bags. Larger portions of the fuselage structure included a portion of the right fuselage, a section with the emergency egress door, a section with three cabin windows, the right hand pilot side window and windshield, a portion of the top fuselage corresponding to the three cabin window fragment, a section of the left side forward cabin window, and other various portions of fuselage exterior structure. The larger portions of the fuselage were laid out in their corresponding locations and documented.

**Figure 12: Layout of the Largest Fuselage Structure Components and Remaining Wing Fragments**

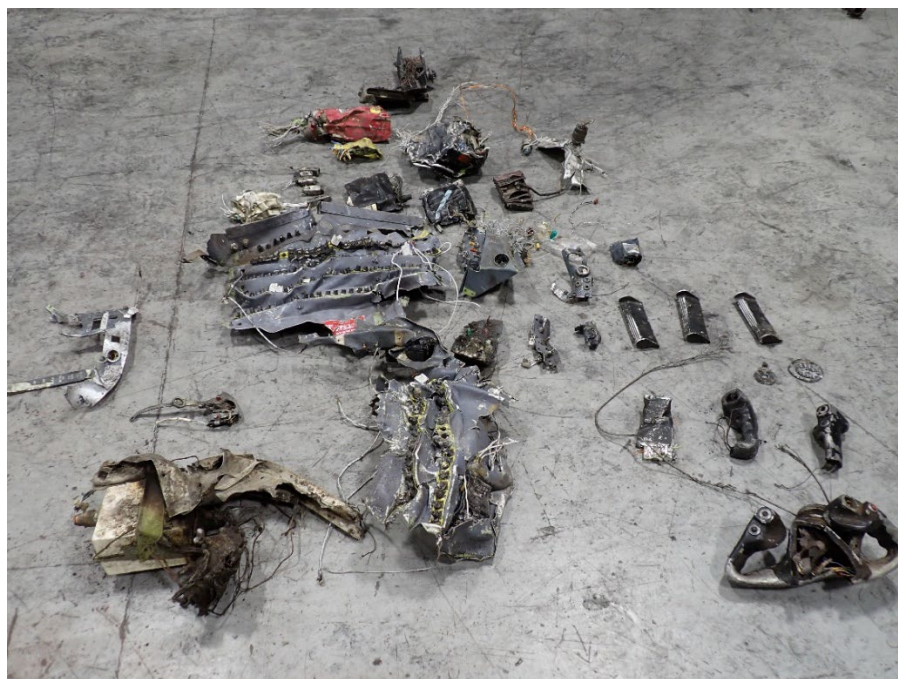
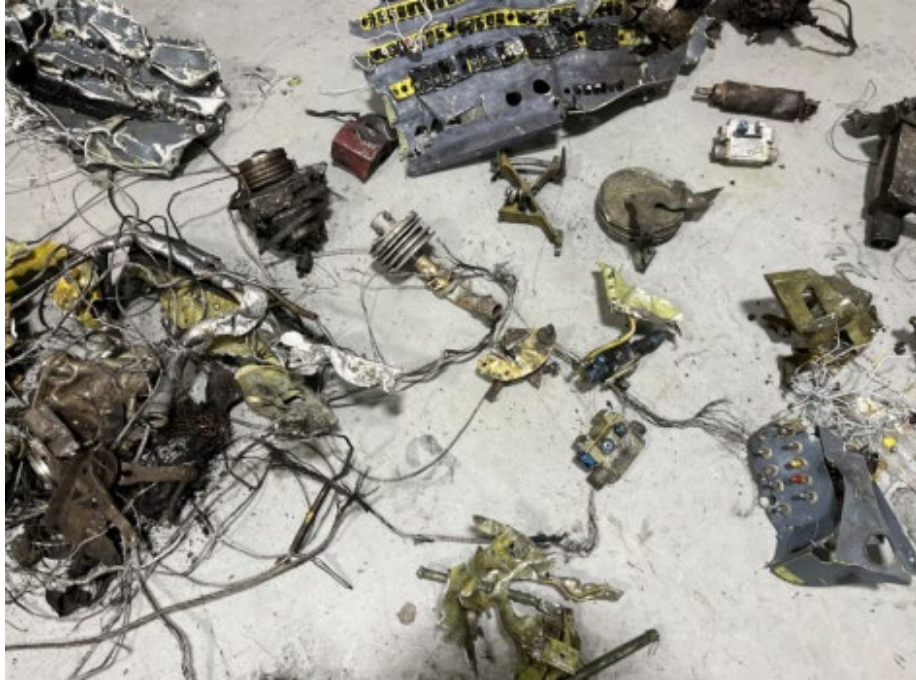
primarily in the center of the debris field along the debris heading. The cockpit instrumentation and controls that were found were isolated and photographed collectively. Avionics and other electronic equipment were also isolated and evaluated. Of the evaluated electronics, no data was recovered from the accident flight.

**Figure 15: Cockpit Instrumentation, Circuit Breakers, and Controls**

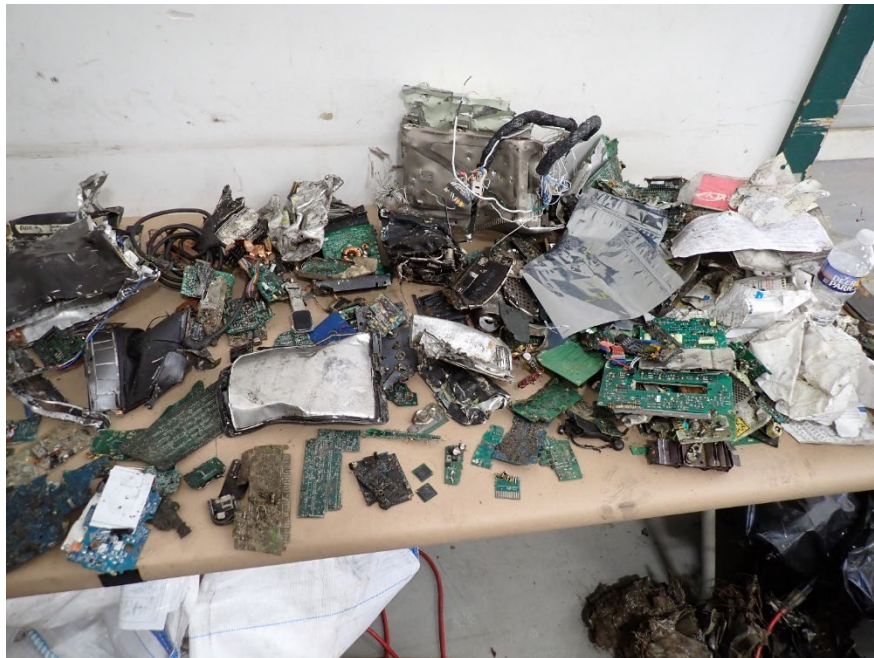
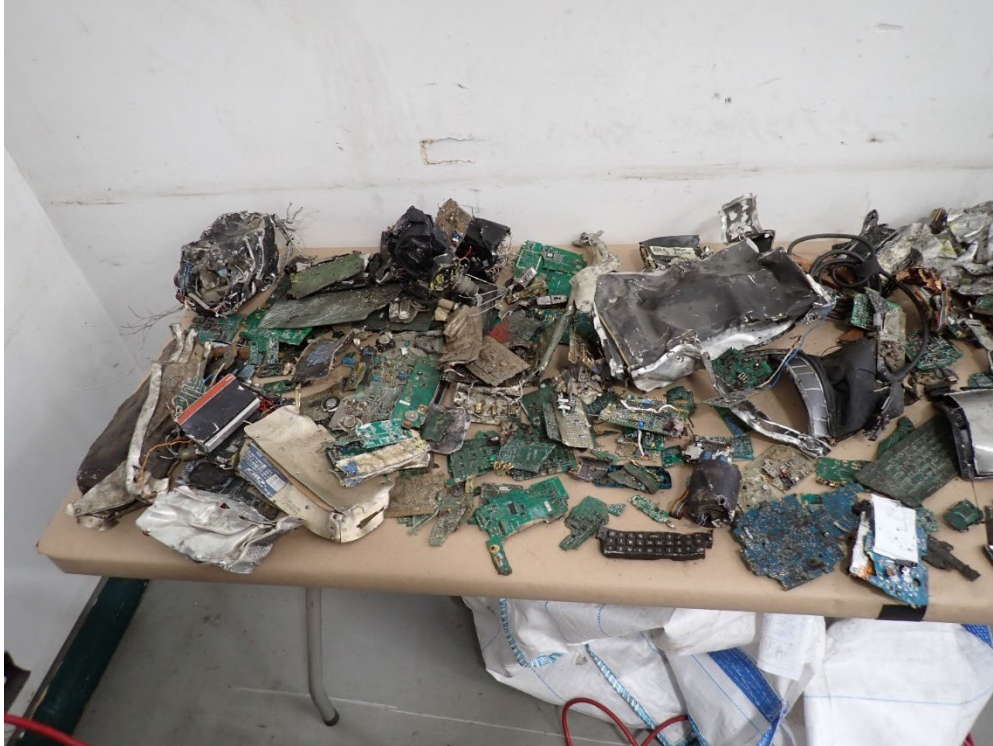
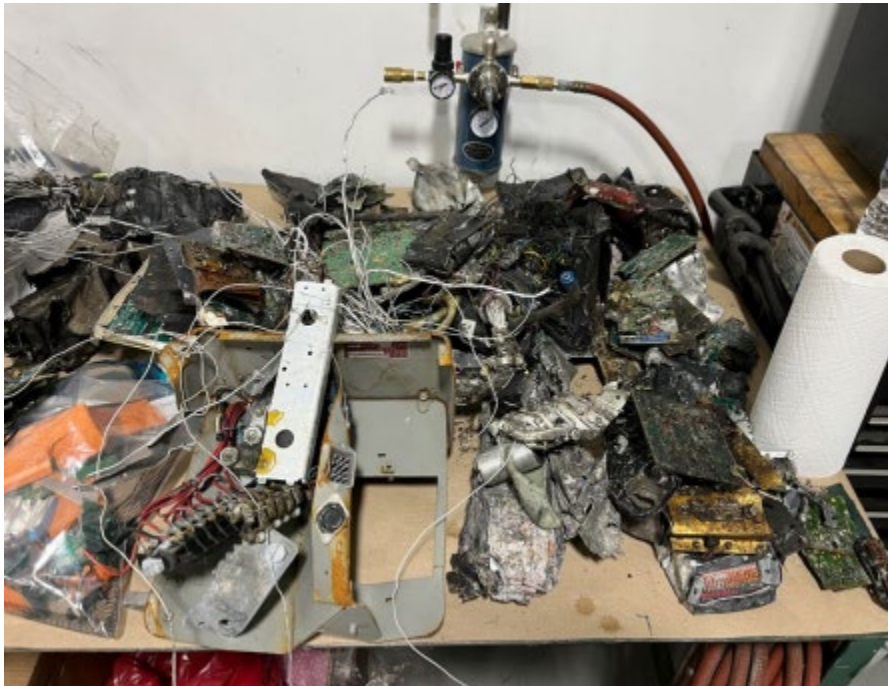
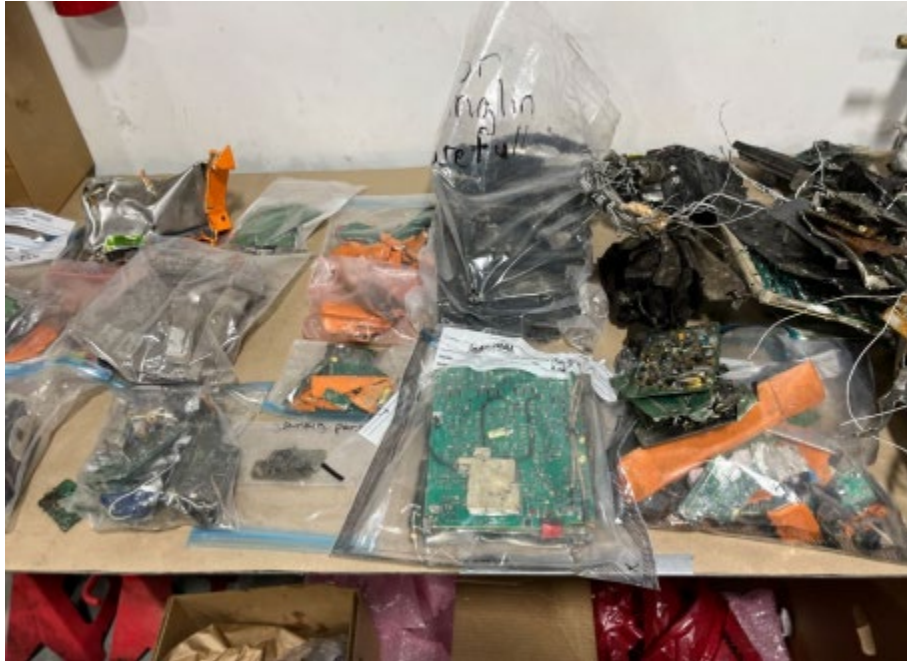
**Figure 17: Collection of Miscellaneous Electronic Equipment Recovered**

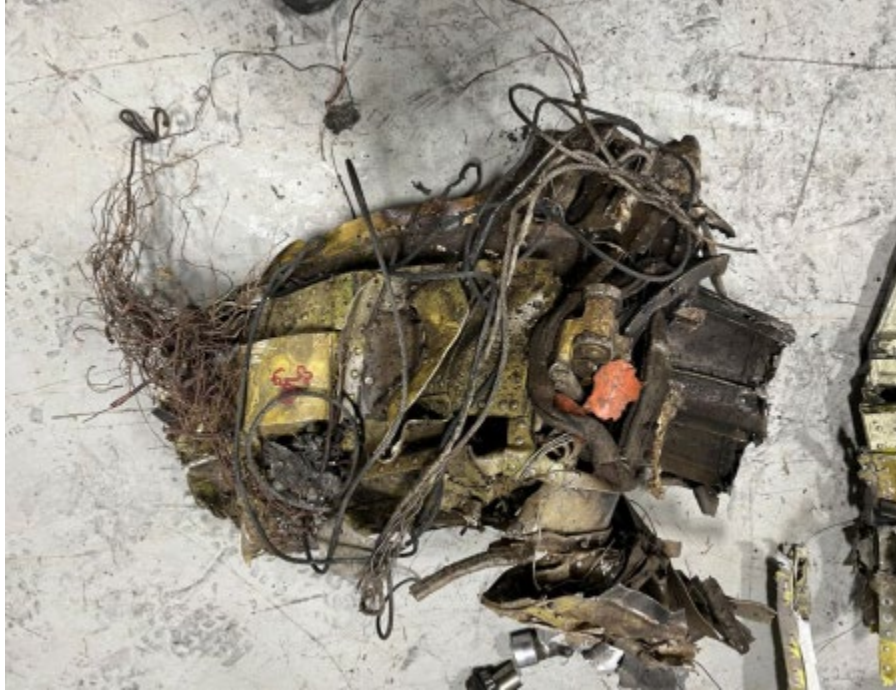
**Figure 23: Lower Tail Section with Attached Control Cables**

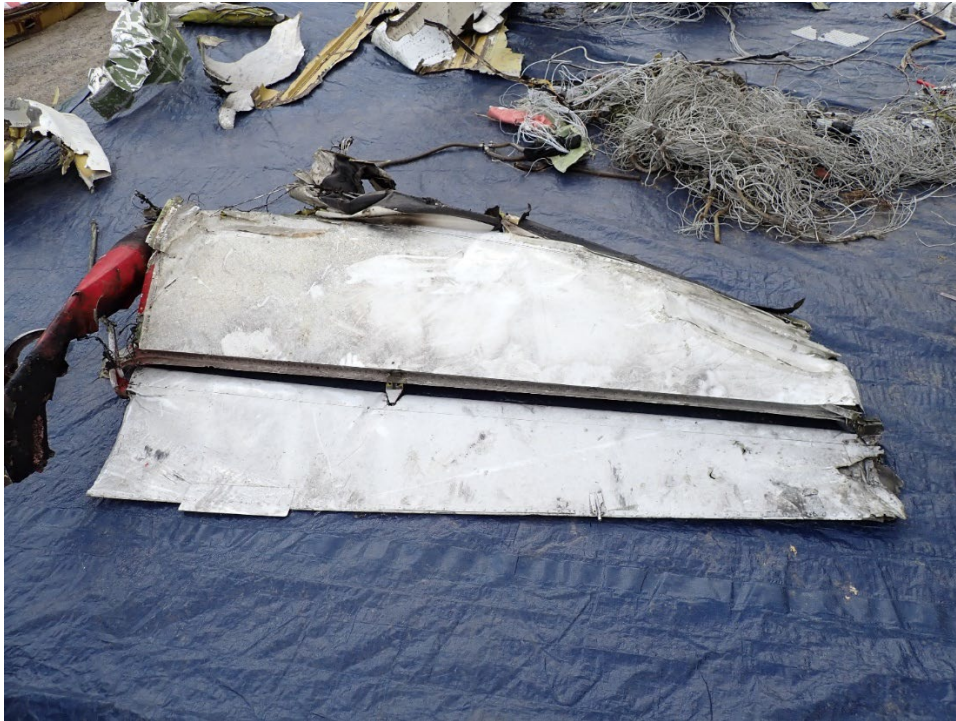
**Figure 24: Portion of the Left Horizontal Stabilizer and Elevator**

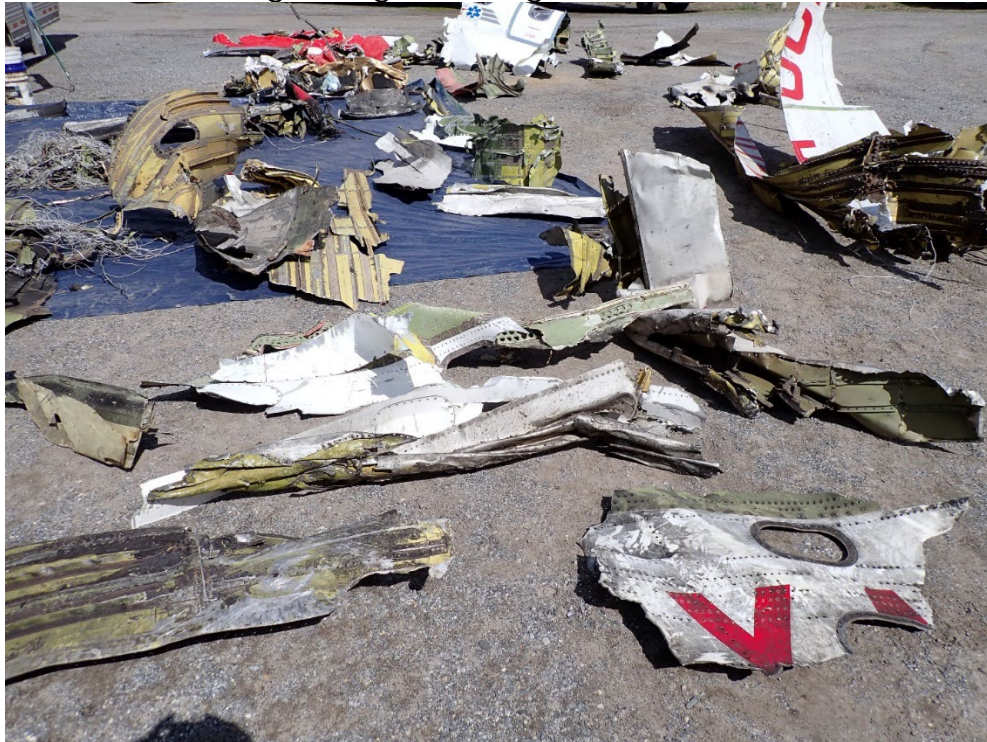
**Figure 25: Fragments of the Left Wing Structure**

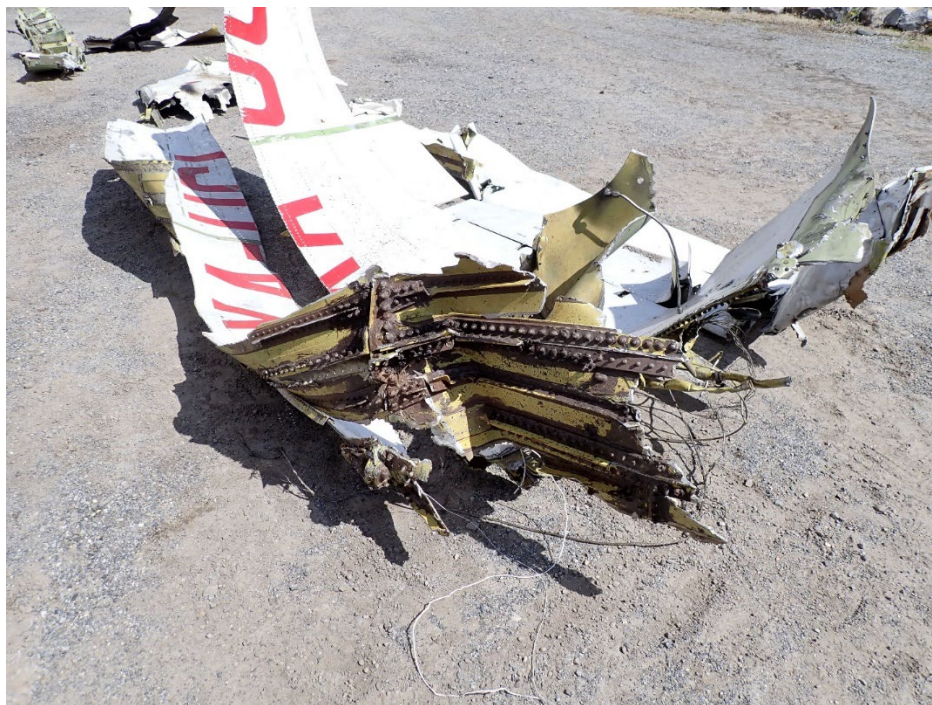
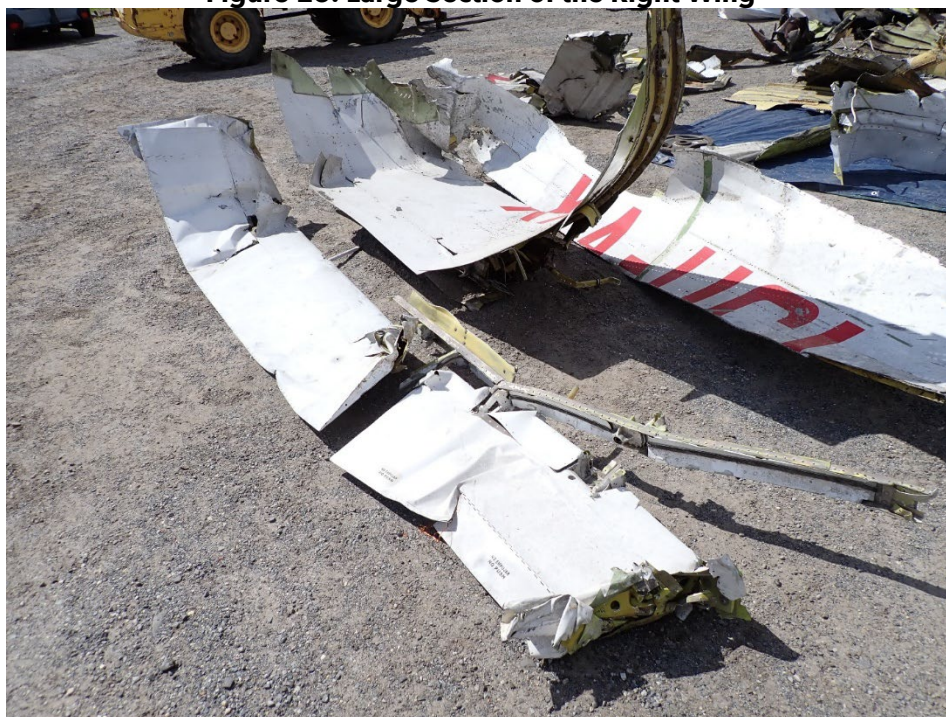
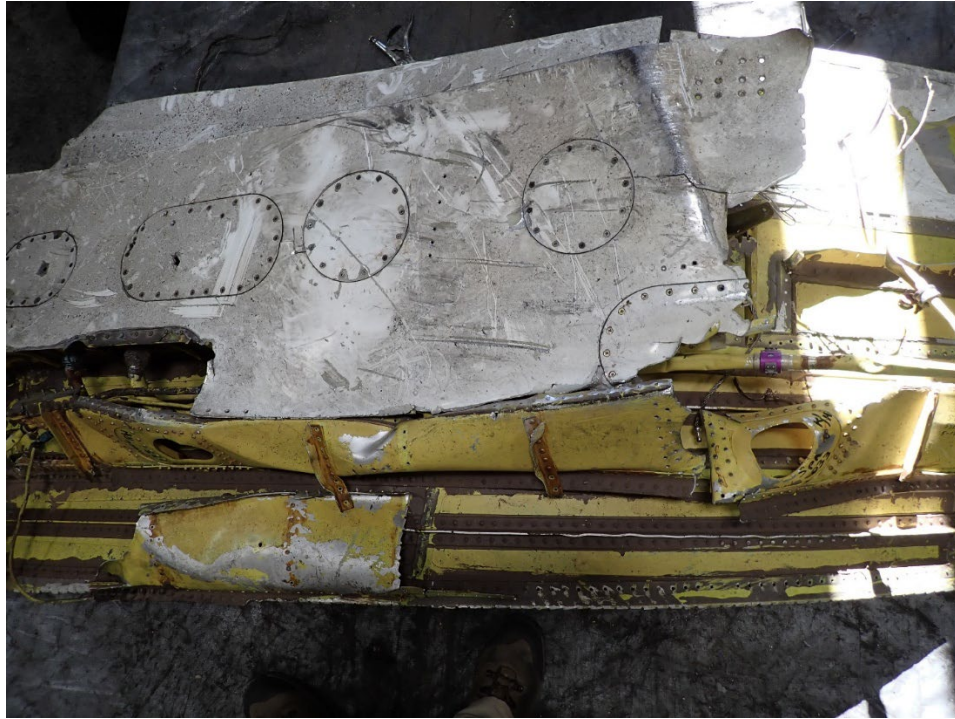
A large portion of the right wing was recovered. Post recovery, the right-hand wing was placed on a table upside down. The access panels for the right-hand flap actuator were removed. The actuator was verified to be connected at the sector and the mounting lug. The flap interconnect cable was still attached to the flap sector. The hydraulic lines were still attached to the actuator. The spoiler actuator remained in place and undamaged and remained connected to the spoiler. An aileron control cable was observed running through the wing.

**Figure 26: Large Section of the Right Wing**

**Figure 27: Right Wing and Right Flap**

**Figure 28: Right Wing Spar**

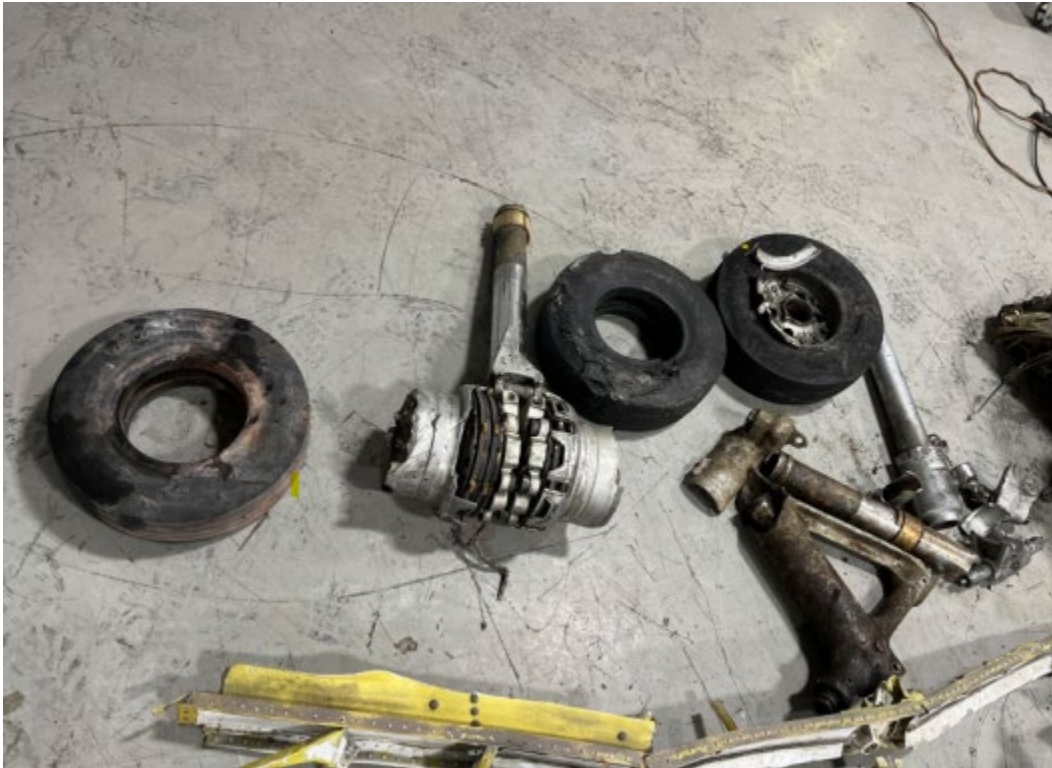
On-scene, the right main landing gear assembly and tire were found about 830ft beyond the impact crater. The tire had punctured the second floor structure of a residential property and came to rest within that bedroom. The remainder of the landing gear assembly was outside of that residential property near the street. The left main landing gear was found about 550 ft away from the impact crater on a sidewalk adjacent to Rupert St. The nose landing gear and tires were found near the impact crater and were wedged underneath a vehicle on the northern travel lane of Cottman Ave. Post recovery, the landing gear components were organized with all major components accounted for. Based on video surveillance of the accident, all

three landing gears (nose, left and right main gears) were in the “up” position at the time of the accident.

**Figure 29: Pieces of the Landing Gear**

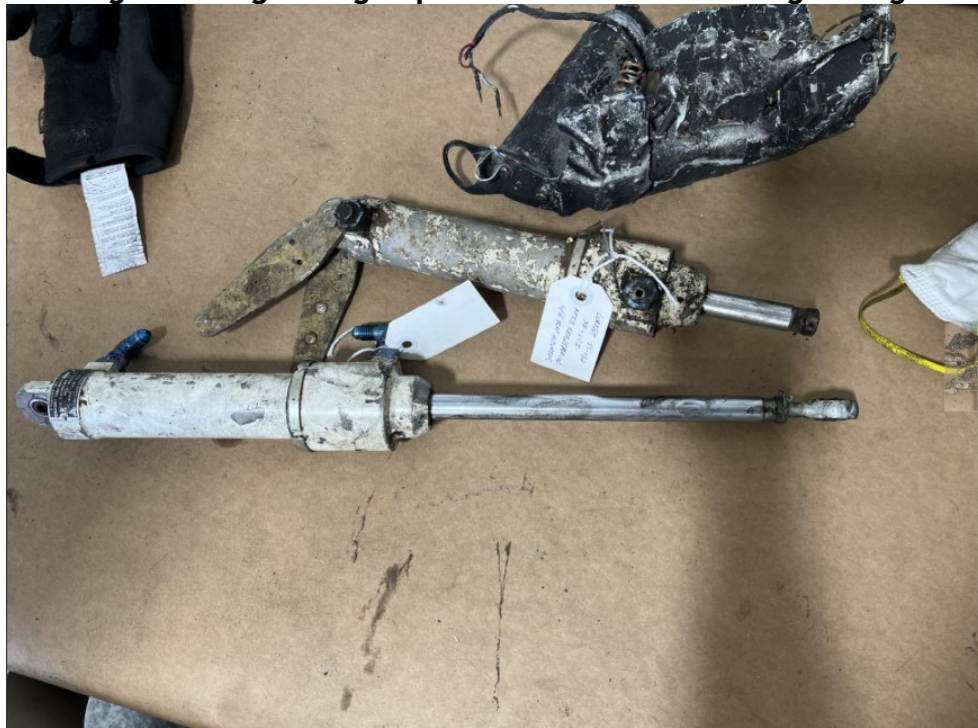
The right flap actuator remained contained within the right wing and the access panel was opened to access it. The right actuator was verified to be connected at the sector and the mounting lug. The hydraulic lines were still attached to the actuator. The flap actuator was removed from the wing but during the removal the actuator piston was pulled/extended about 1-1 1/2 ". The righthand flap actuator measurement, post pull, was 19" equating to full extension. Prior to the movement, it would have been about 17 1/2 - 18". 17 1/2 corresponds to 30 degrees of flap, which was determined to not be a standard flap setting position. The left-hand flap actuator was impact separated and found within a recovery bag during a wreckage examination. The left-hand flap actuator was measured at about 13 1/4" corresponding to about 2 degrees of flap (retracted). The piston was jammed and could not be moved by hand and indicated, per the Learjet standard flap settings for takeoff, this was likely the flap setting at the time of the accident. The right and left flap actuators were scanned using computed tomography (CT) to document the position and condition of the internal components. Reference the Computed Tomography Specialists factual report.

**Figure 35: Left and Right Flap Actuators**

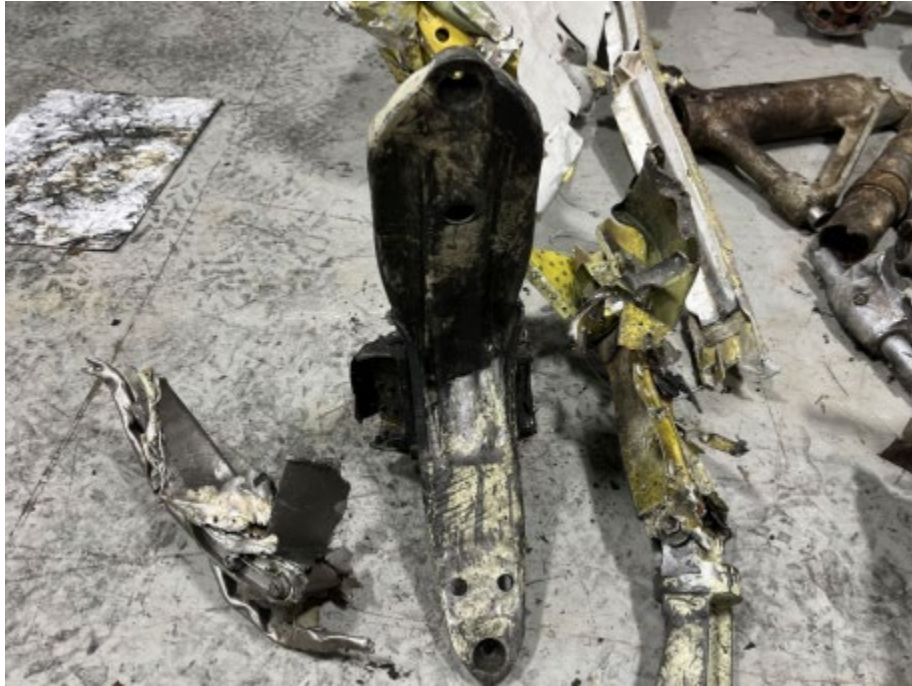
Both engines were examined to confirm their respective locations on the airplane. The engines were identified based on the physical damage to the aft engine mounts and the serial numbers of a fan disk and a first stage compressor disk. A borescope inspection was completed on both engines showing that the 1st stage of the low pressure (LP) turbine was present. Visual inspection of both engine cores did not reveal any preimpact mechanical malfunctions or failures that would have precluded normal engine operation.

**Figure 39: One of the Engine Mounts**
