# National Transportation Safety Board

ERA25MA171

## **MATERIALS LABORATORY**

Factual Report 25-077

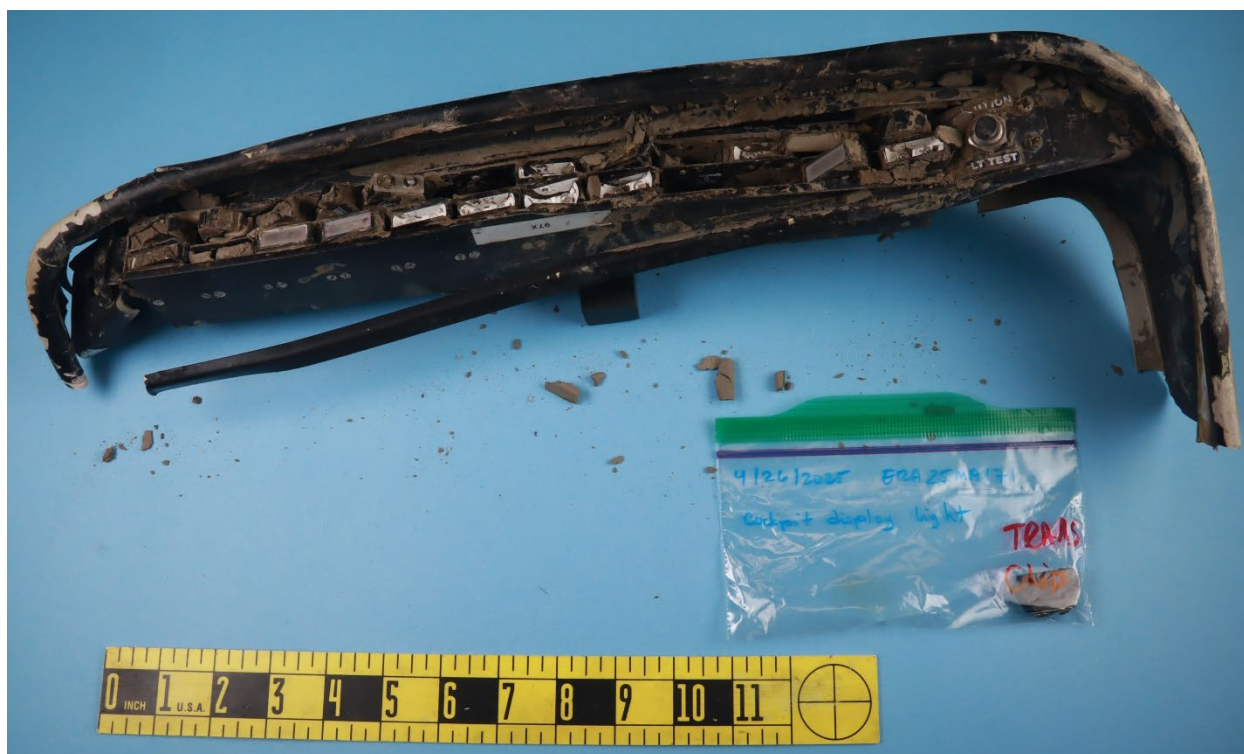
**Figure 2.** Photograph of as-received annunciator panel. The TRANS CHIP annunciator (in the plastic bag) was found separated from the panel.
