# National Transportation Safety Board

ERA25MA171

Group Chair's Factual Report

Location:     Jersey City, New Jersey  
Date:          April 10, 2025  
Time:          1515 eastern daylight time  
Helicopter:   Bell 206L-4, registration N216MH

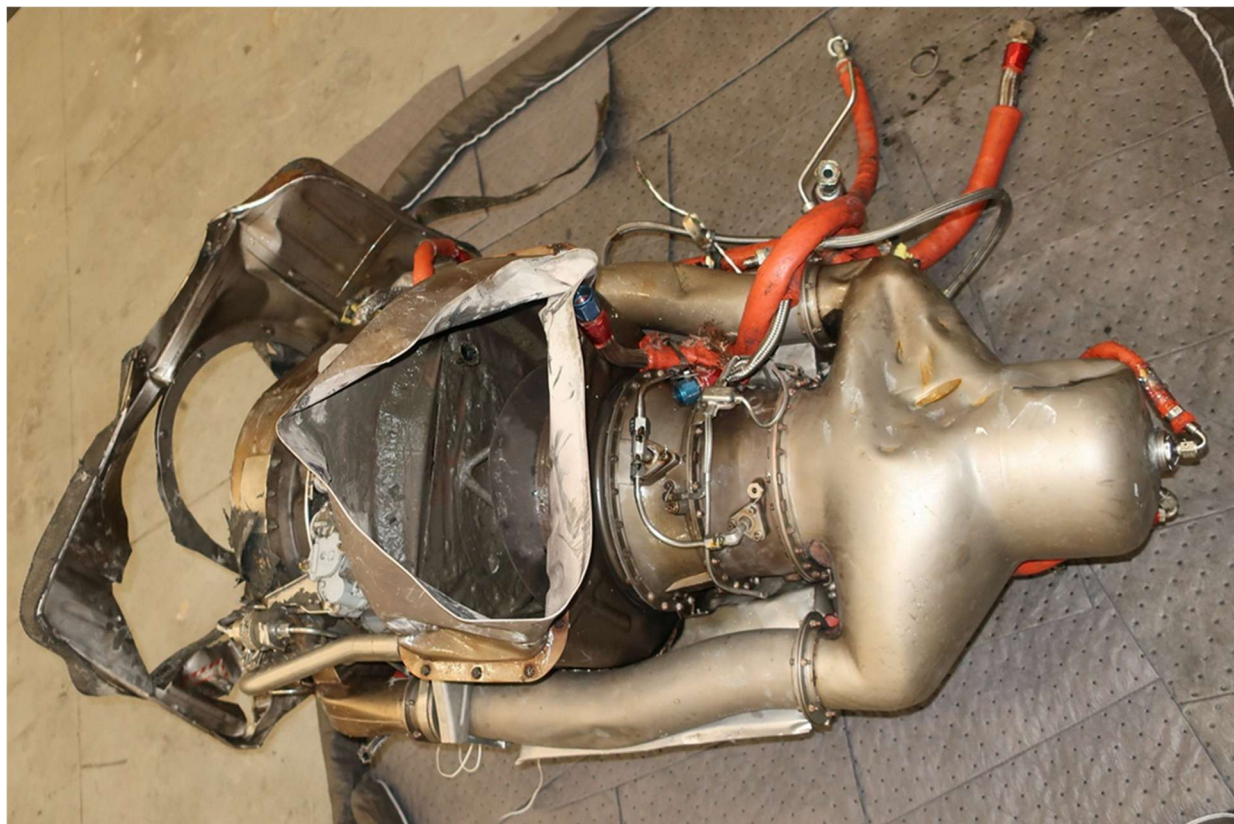
The two compressor discharge tubes remained installed between the compressor section and the combustor section and exhibited indentations. Wrinkling was observed on the right top portion of the outer combustion case (**figure 30**). The compressor bleed air manifold was dented inward at the 5 and 7 o'clock positions and the compressor scroll was dented at the 7 o'clock position.

**Figure 30.** The recovered engine after it was separated from the wreckage.

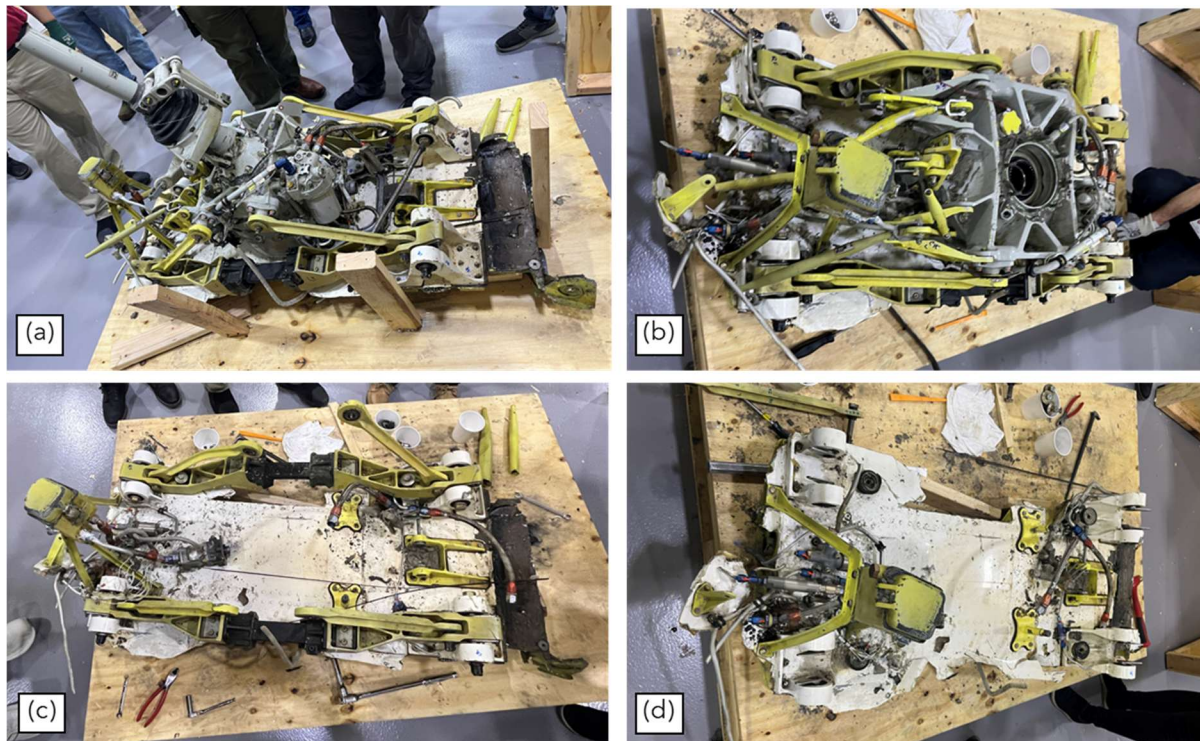
The mast and swashplate support assembly fasteners were removed and the mast assembly was separated from the main transmission (**figure 31**). The lower stem of the mast, mast bearing, and the internal surfaces of the main transmission housing exhibited corrosion. The mast bearing was able to be rotated by hand, and the bearing rotated with minimal roughness without evidence of seizure. The lift link bolts that attach to the main transmission, the hydraulic pump fasteners, and the drag pin nuts were removed and the main transmission was separated from the roof assembly with the use of a hoist and a hoist plate that was bolted to the main transmission at the swashplate fastener holes. The lower lift link bolts were removed and the lift links

**Figure 31.** Sequential photos of removing the transmission and mounts from the roof structure.

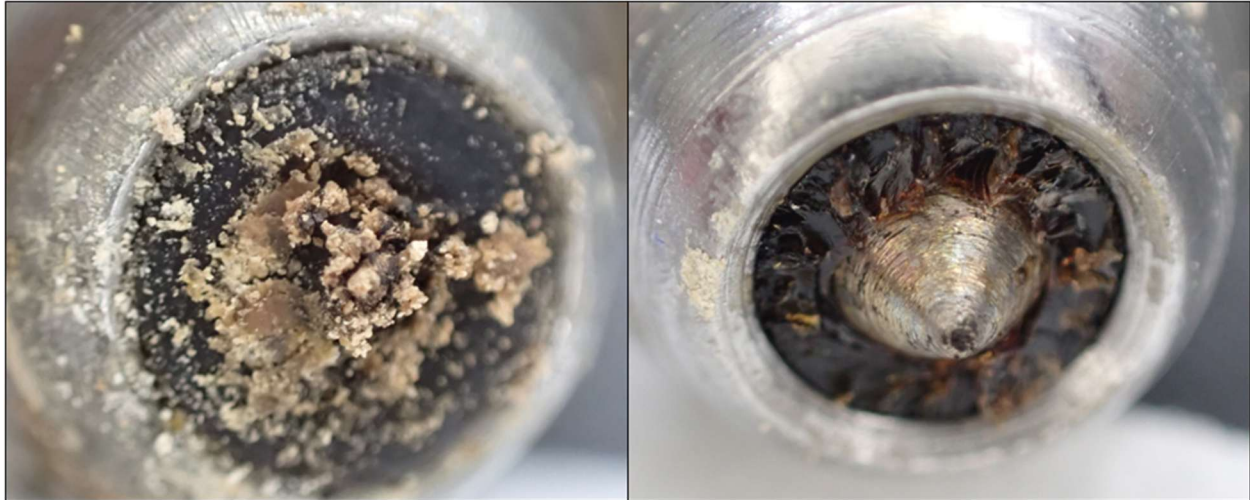
Two magnetic chip detectors monitor oil flow within the system. An upper detector samples oil flow from all the scavenge pumps flowing out of the engine to the oil cooler while a lower detector samples oil only from within the gearbox. Both chip detectors were found dry. The upper detector had dirt adhered to the tip, while the lower detector had small debris (**figure 38**). The oil filter element appeared undamaged and the filter pleats were free of debris.

**Figure 38.** Upper (left) and lower (right) chip detectors

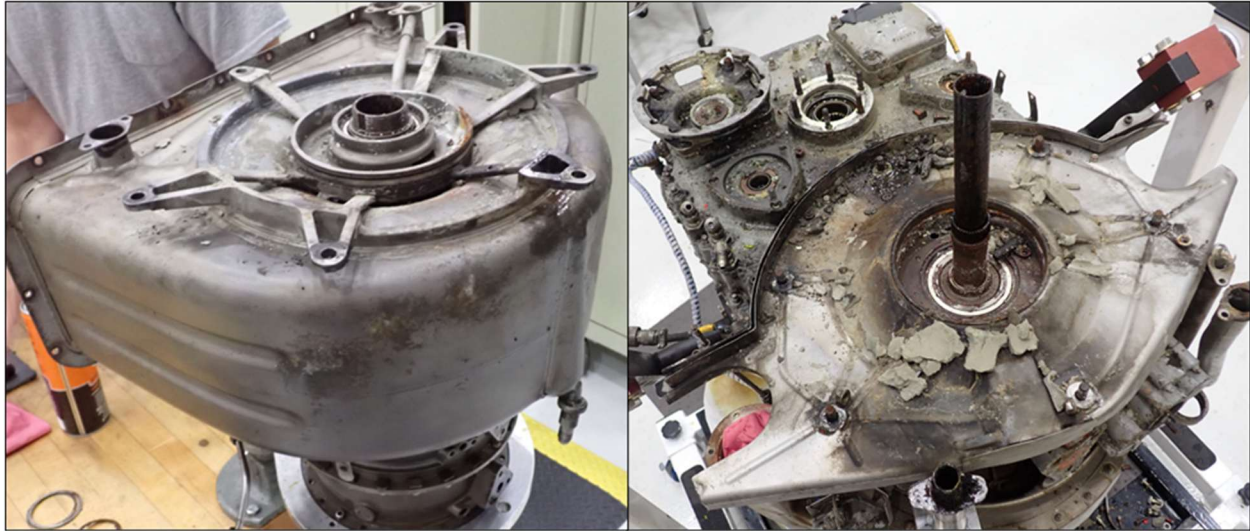
The turbine assembly, consisting of the exhaust collector, PT, and GP, was removed from the gearbox. Earthen debris was lodged between the assembly and the gearbox heatshield. The turbine-to-compressor coupling shaft was still connected to the spur adapter gear (SAG) shaft sticking out from the gearbox. Surfaces around the SAG were corroded. The SAG's two o-rings and forward retaining ring were in-place and appeared in good condition. The PT-to-pinion gear coupling was intact with corrosion on its outer surfaces. Aft splines of the PT shaft-to-pinion gear coupling appeared intact. PT rotation was achieved by attaching a wrench to the inner splines of the PT outer shaft. Rotation was smooth but had some resistance (**figure 39**).

**Figure 39.** Turbine assembly (left) removed from gearbox and heatshield (right)

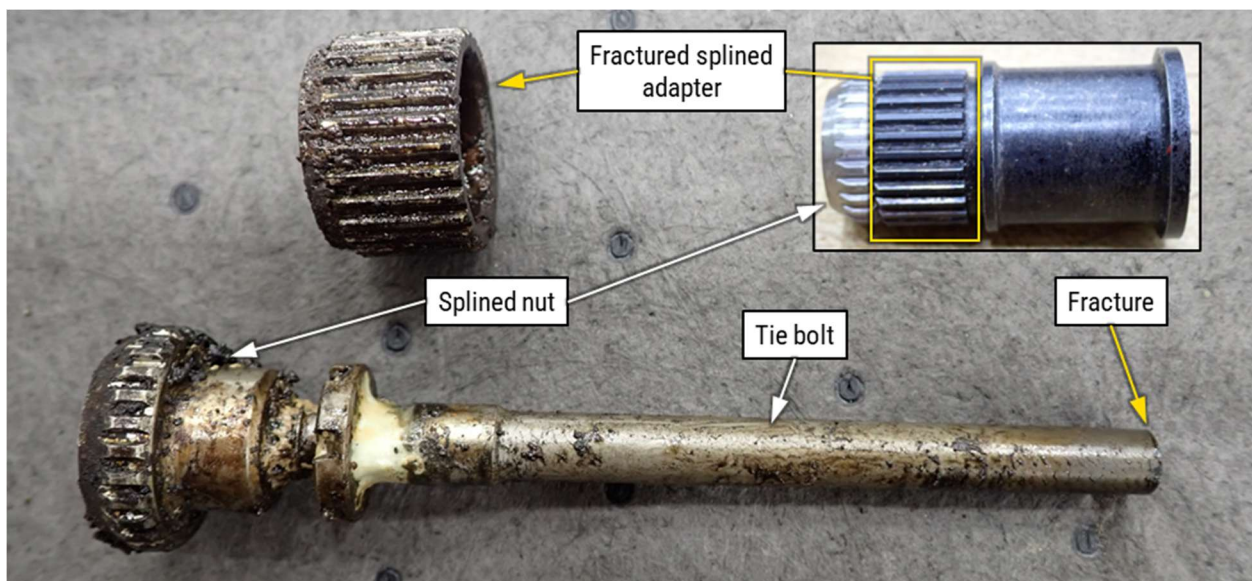
A splined adapter is held onto the front of the stage 2 rotor by a splined lock nut, and the GP stage 1 and 2 rotors are retained together by the adapter, a tie bolt, and a rear tie bolt nut. The forward four inches of the tie bolt was found fracture separated inside the turbine-to-compressor coupling shaft. The front splined nut was still screwed onto the tie bolt and the front end of the splined adapter was fracture and separated. All parts were covered in dirt and oil (**figure 40**). The remainder of the tie bolt and rear nut were recovered when the GP turbine was disassembled.

**Figure 40.** Recovered tie bolt and splined adapter (inset shows exemplar splined nut and adapter)

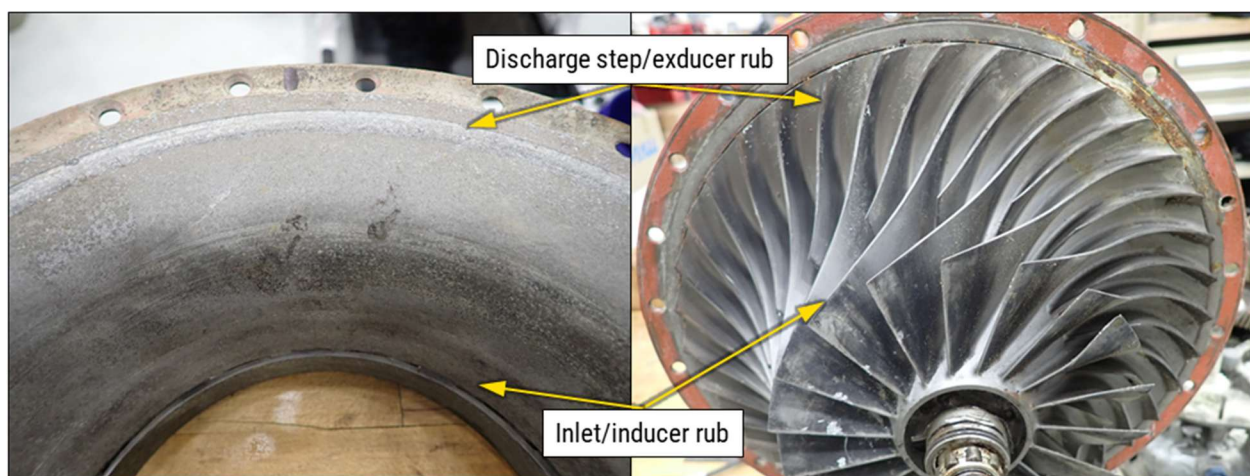
The deformed shroud-bleed air manifold had to be cut from the shroud housing for removal. The contoured inner shroud surface was cleaned with a brush and soapy water. The shroud surface had a machined step near the shroud discharge. The shroud also had light rubs near the inlet. Corresponding rubbing was found on the impeller vanes near the inducer and exducer (**figure 41**).

**Figure 41.** Inner shroud surface (left) and impeller (right)
