# National Transportation Safety Board

ERA25MA171

## VIDEO STUDY

Description: Rotorcraft Inflight Breakup  
Location: Hudson River, Adjacent to Jersey City, NJ  
Date: April 10, 2025  
Time: 1515 Eastern Daylight Time (EDT)  
Operator: New York Helicopters Charter, Inc.  
Aircraft: Bell 206L-4, N216MH, Serial Number 52296

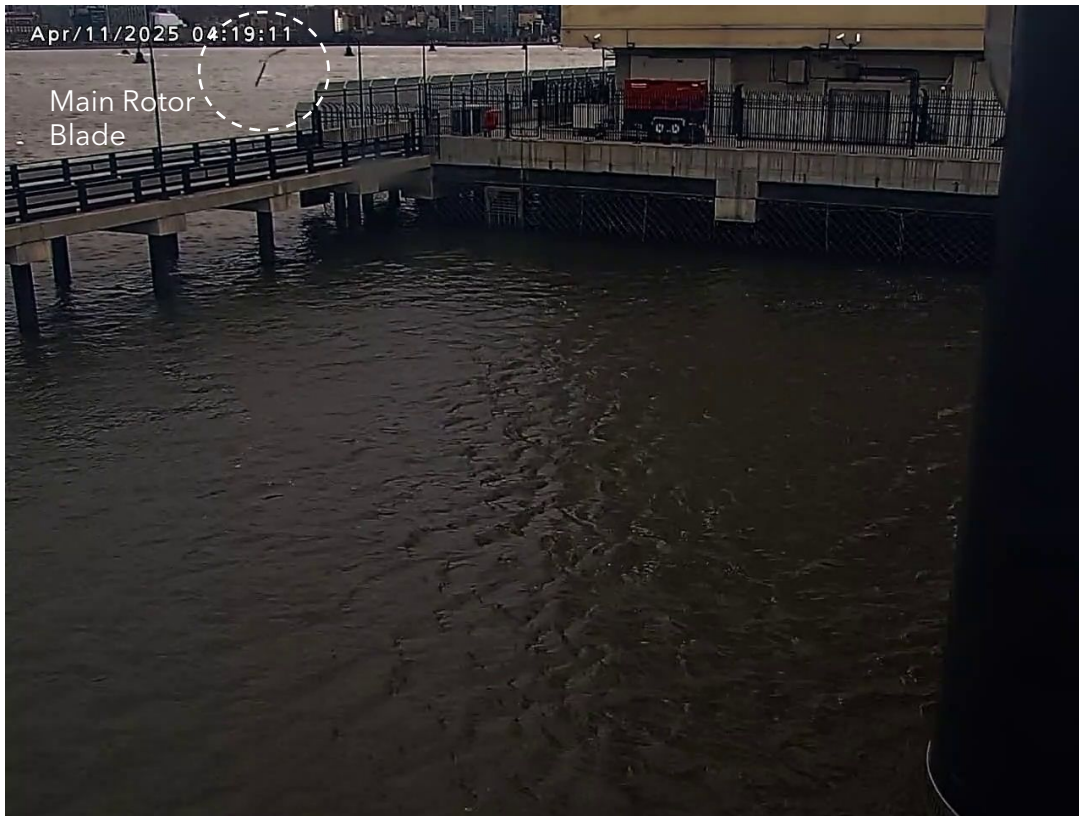
Figure 2: Exemplar N216MH main rotor blade image (1280x960 pixels, encoded date and time, 29.97 fps) extracted from source video Export\_\_F6 - NJRB South Pier PTZ Camera-1\_Thursday April 10 2025225649 613bdf6.avi. The same source video was used to construct the cropped and zoomed image sequence content shown in Attachment 4.

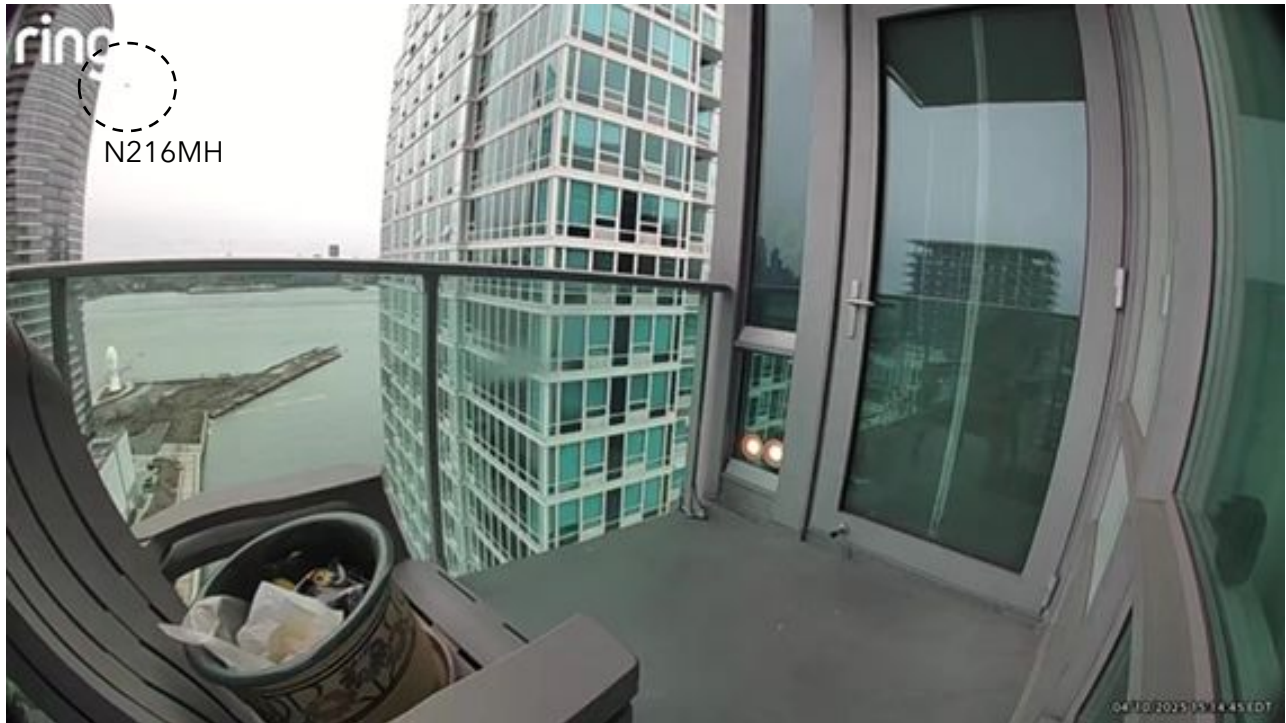
Figure 4: Exemplar N216MH image (568x320 pixels, as recorded distortion, 24 fps) extracted from source video RingVideo\_20250412\_092418.mov. Helicopter direction of travel is left to right. The same source video was used to construct the cropped and zoomed image sequence content shown in Attachment 7.

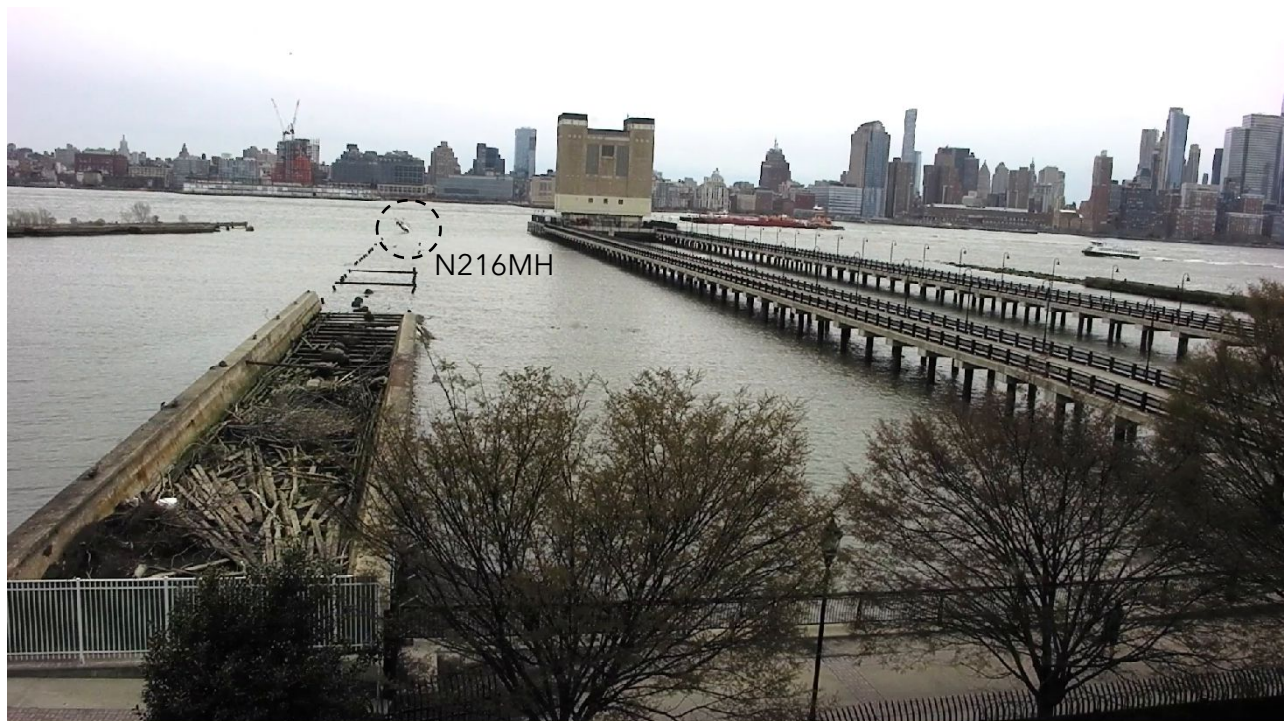
Figure 5: Exemplar N216MH image (1920x1080 pixels, 15 fps) extracted from source video Export\_205 NJLB NE PTZ\_ Thursday April 10 2025230457 4fe20b7.avi. This image frame was used to define the helicopter fuselage longitudinal position at water impact relative to Hudson River shoreline infrastructure.
