# National Transportation Safety Board

ERA25MA171

## **STRUCTURES**

Group Chair's Factual Report

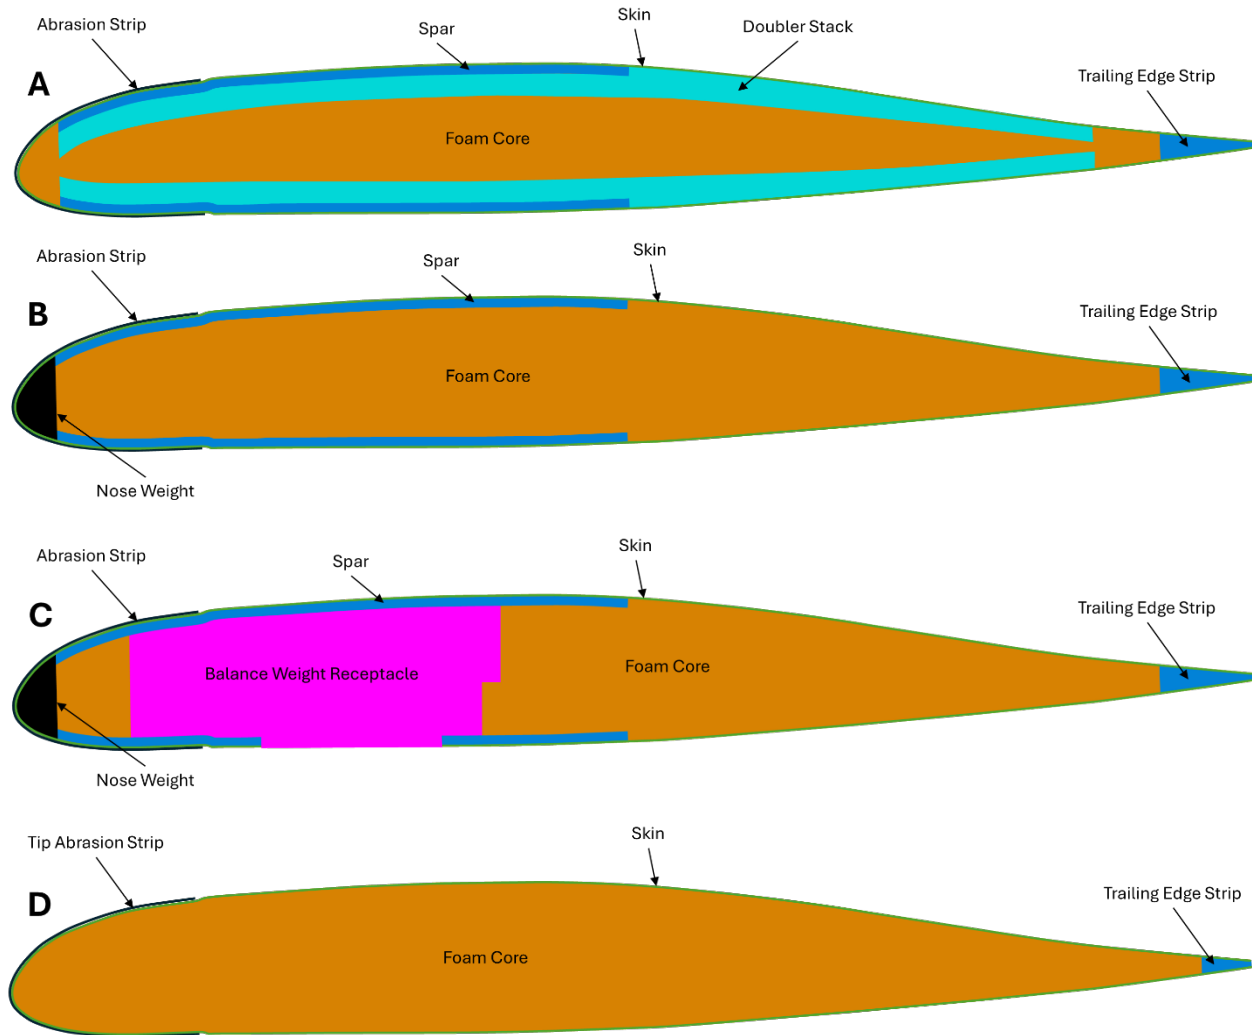
The composite structure of the Van Horn Aviation (VHA) Bell 206L main rotor blades are constructed using a combination of plane-weave (PW) pre-impregnated (prepreg) carbon-fiber with an epoxy resin, unidirectional (UD) prepreg carbon-fiber with an epoxy resin, G10 fiberglass epoxy laminate sheets, and structural foam core (Figure 1). The blade also incorporates tungsten tip balance weights, an internal fiberglass and tungsten balance weight receptacle in the outboard portion of the blade, and Inconel and nickel abrasion strips on the blade leading edge (Figure 2).

**Figure 2.** Main rotor blade section cuts at doubler stack region (A), mid-span (B), balance weight receptacle (C), and blade tip (D) (modified VHA diagrams)

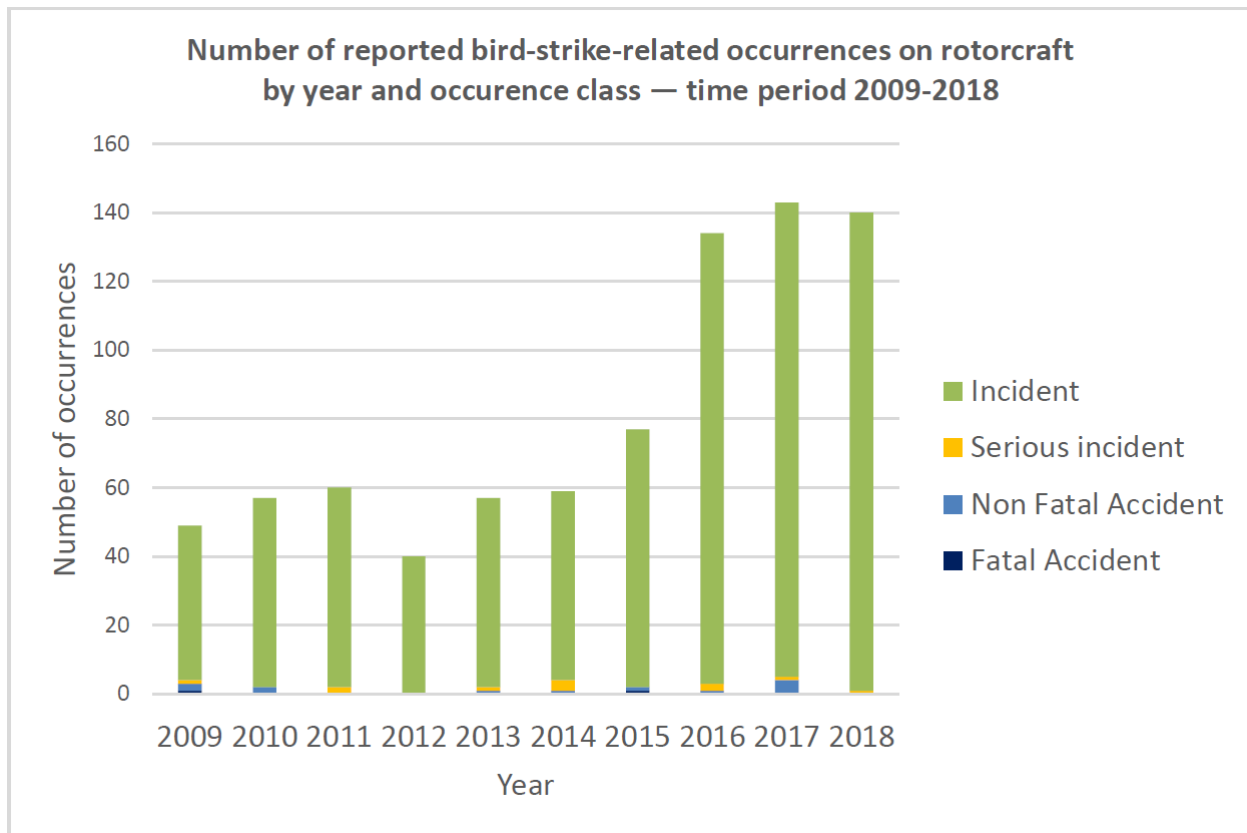
CS 27.631 'Bird Strike' was developed in response to an observed upward trend in bird strikes to rotorcraft that resulted in bird penetration into the cockpit. The upward trend in rotorcraft bird strike occurrences since 2009 was confirmed by EASA's occurrence database (Figure 6). Additionally, EASA cited the following reports and studies to support their safety risk assessment:

**Figure 6.** Rotorcraft bird strike occurrences in EASA's occurrence database 2009-2018 (Figure from NPA 2021-02 - Rotorcraft occupant safety in the event of a bird strike)

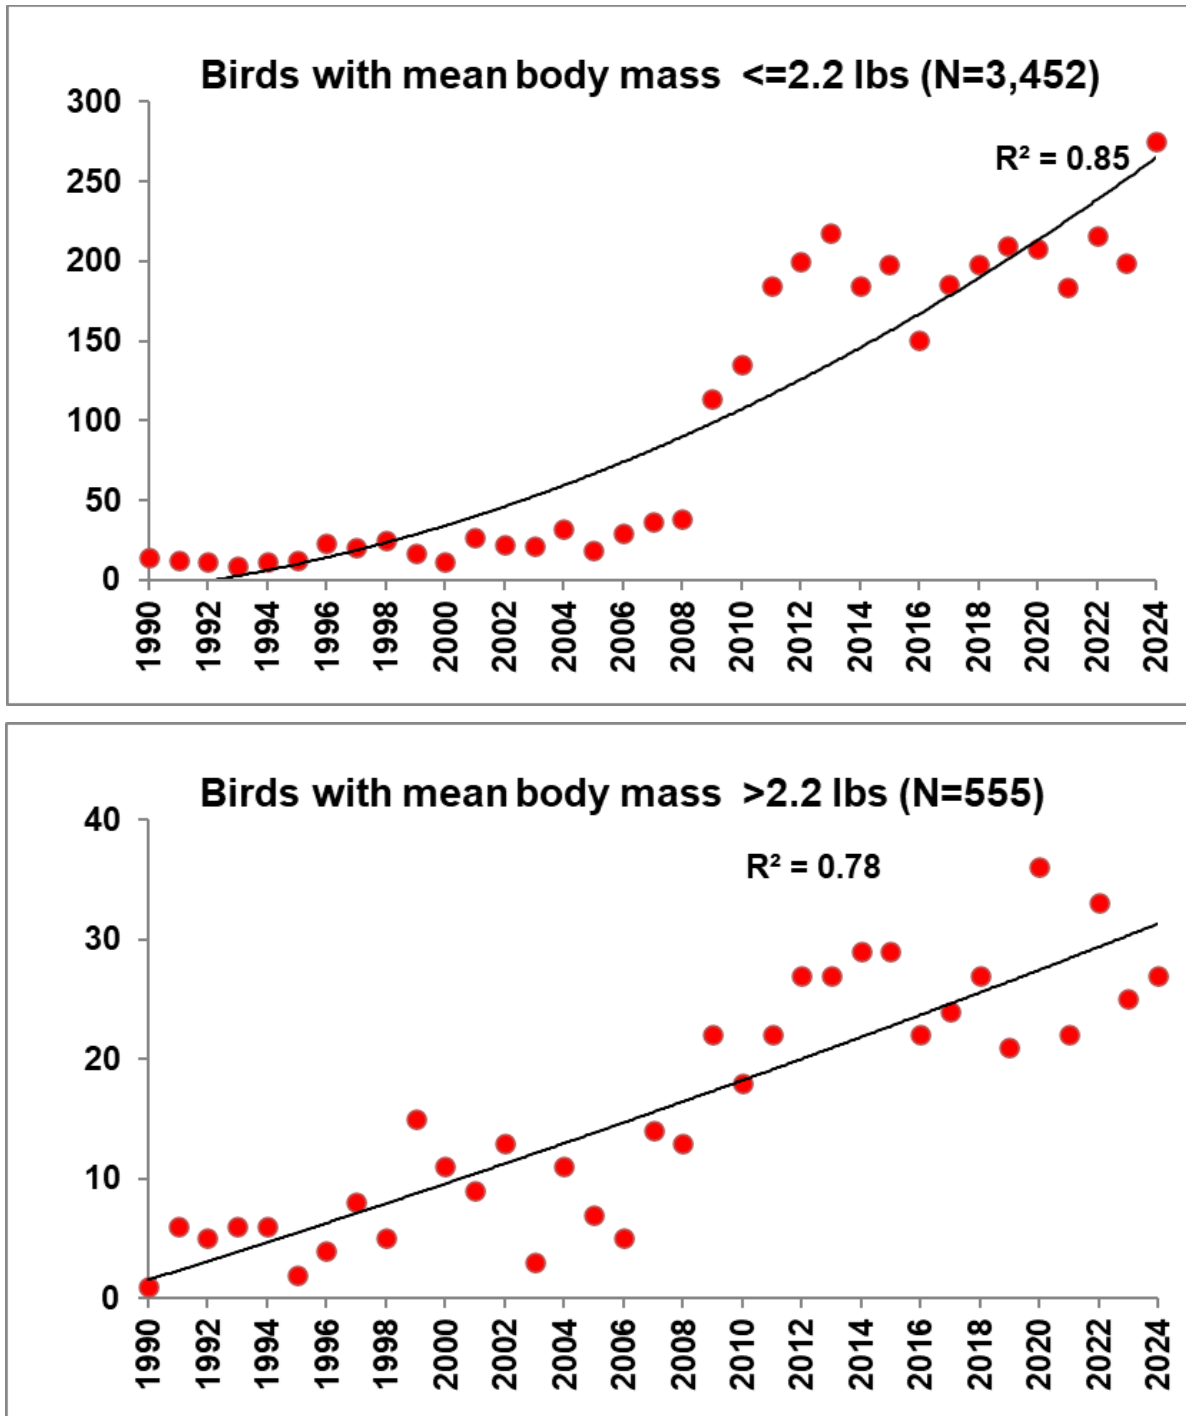
The data was broken down year over year starting in 1990 to 2024 and by body mass of the birds (Figure 7). The data shows a significant trend of increased reports of bird strike events with rotorcraft. The increase is significantly larger for birds identified as having a mean body mass  $\leq 2.2$  lbs. For this category, reports remained constant, under 50, from 1990 to 2008, spiked to about 100 in 2009 and to about 200 in 2011 where they remained until 2024 when they increased to over 250. Reporting of strikes with birds identified as having a mean body mass  $> 2.2$  lbs also increased year over year at steady rate going from less than 5 in 1990 to less than 30 in 2024 with a maximum of about 35 in 2020.

**Figure 7.** Reported strikes involving civil rotorcraft and birds with mean body mass  $\leq 2.2$  lbs (top graph) and  $> 2.2$  lbs (bottom graph), USA, 1990-2024. Provided by USDA Airport Wildlife Hazards Program Wildlife Services.

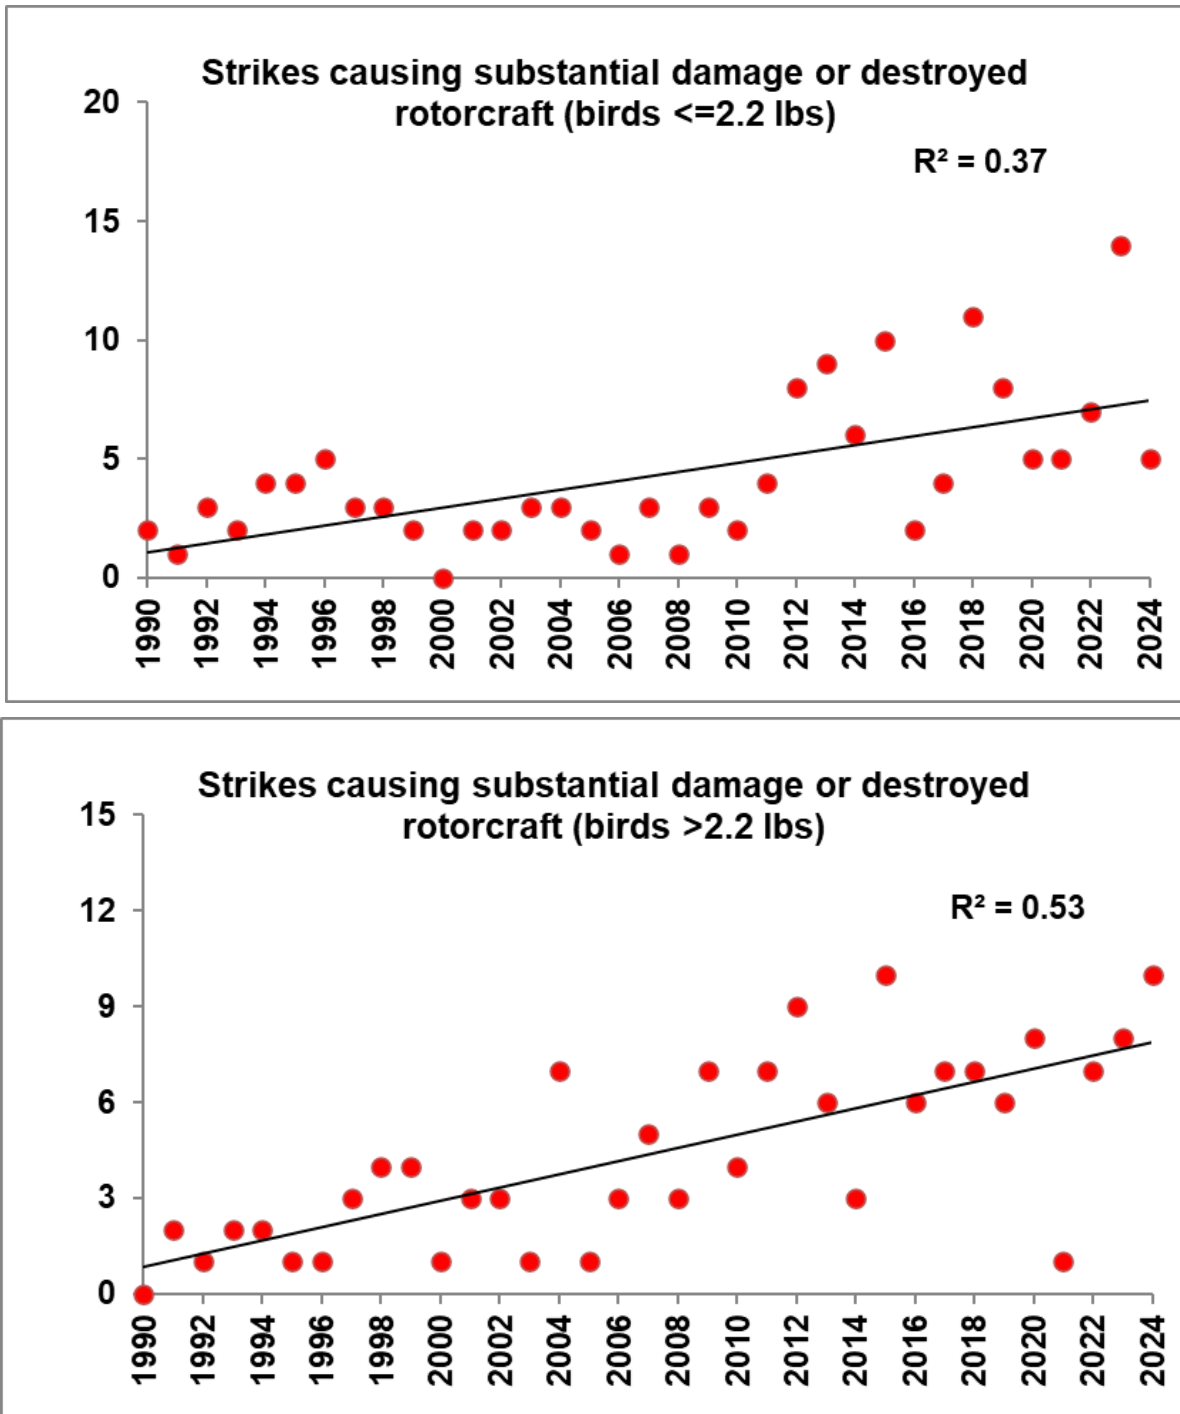
Figure 8 shows the same data but limited to events that resulted in substantial damage or destruction of the rotorcraft. Both graphs show year over year increase in reported strikes that resulted in substantial damage or destroyed rotorcraft for birds  $\leq 2.2$  lbs and birds  $> 2.2$  lbs for the period of 1990-2024.

**Figure 8.** Civil rotorcraft destroyed or substantial damaged after striking birds with mean body mass  $\leq 2.2$  lbs (top graph) and  $>2.2$  lbs (bottom graph), USA, 1990-2024. Provided by United States Department of Agriculture Airport Wildlife Hazards Program Wildlife Services.

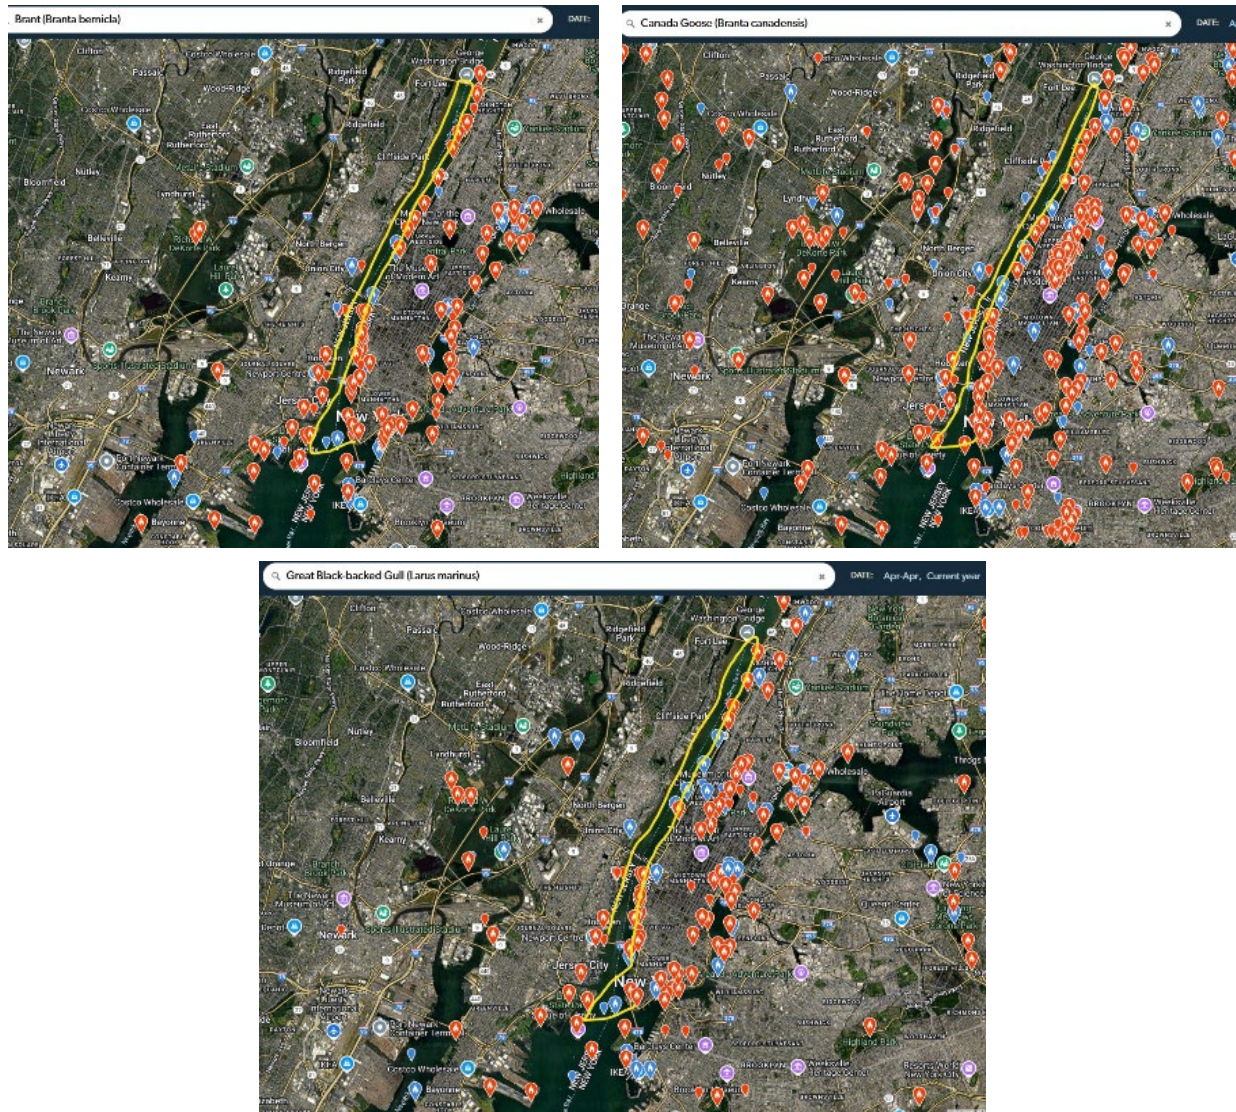
The population density of these bird species in the NYC area is also confirmed by the sightings reported for April 2025 on eBird.org<sup>12</sup> (Figure 9). The sighting maps show the population density of these birds around the Hudson River in the same area as the sightseeing helicopter flight paths.

**Figure 9.** eBird.org data of sightings<sup>13</sup> of Brant Geese (top left), Canada Geese (top right), and Great Black-backed Gull (bottom) in the NYC around the flight path of the accident helicopter (yellow) (provided by Smithsonian Institution's Feather Identification Lab)

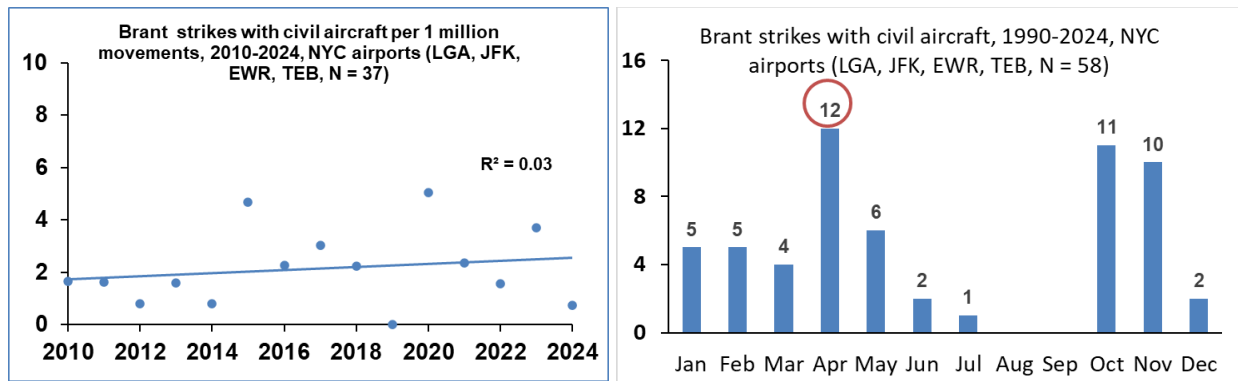
According to FAA NWSD, historically the annual number of bird strike events of Brant Geese with civilian aircraft (data includes fixed wing and rotorcraft) was approximately constant with significant year over year (2010-2024) variability. The month of April (accident month) represented the highest number of reported bird strikes (Figure 10).

**Figure 10.** Brant Geese bird strikes with civilian aircraft year over year (left) and by month (right) (source: FAA NWSD provided by Smithsonian Institution’s Feather Identification Lab)

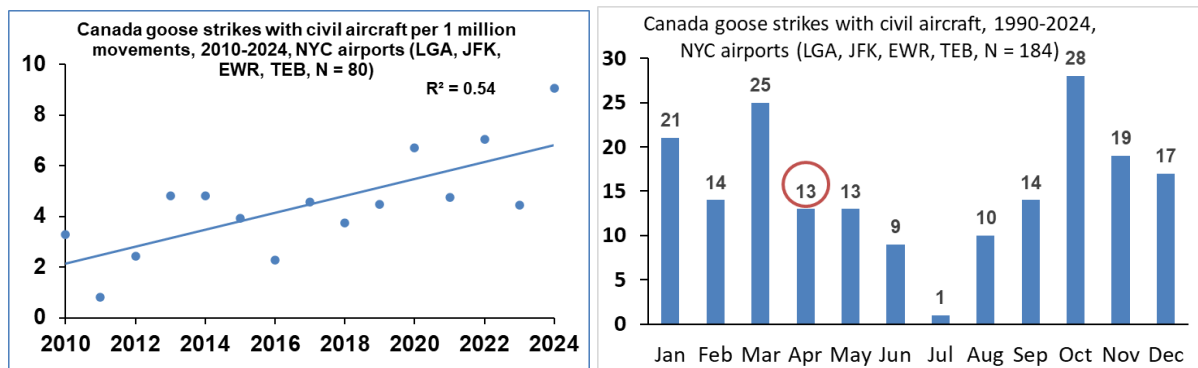
There has been a year over year (2010-2024) increase of bird strike events of Canada Geese with civilian aircraft with the month of October representing the highest number of reported bird strikes (Figure 11). The month of April (accident month) reported an average number of bird strikes.

**Figure 11.** Canada Geese bird strikes with civilian aircraft year over year (left) and by month (right) (source: FAA NWSD provided by Smithsonian Institution’s Feather Identification Lab)

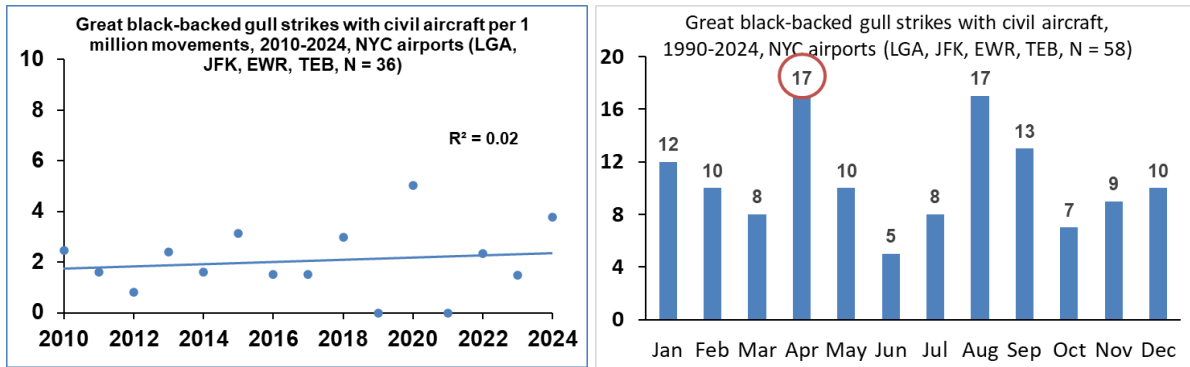
Similar to the Brant Geese, the annual number of bird strike events of Great Black-backed Gull with civilian aircraft was approximately constant with significant year over year (2010-2024) variability and with the month of April (accident month) representing the highest number of reported bird strikes (Figure 12).

**Figure 12.** Great Black-backed Gull bird strikes with civilian aircraft year over year (left) and by month (right) (source: FAA NWSD provided by Smithsonian Institution’s Feather Identification Lab)
