# National Transportation Safety Board

ERA25MA171

## **OPERATIONS**

Group Chair's Factual Report

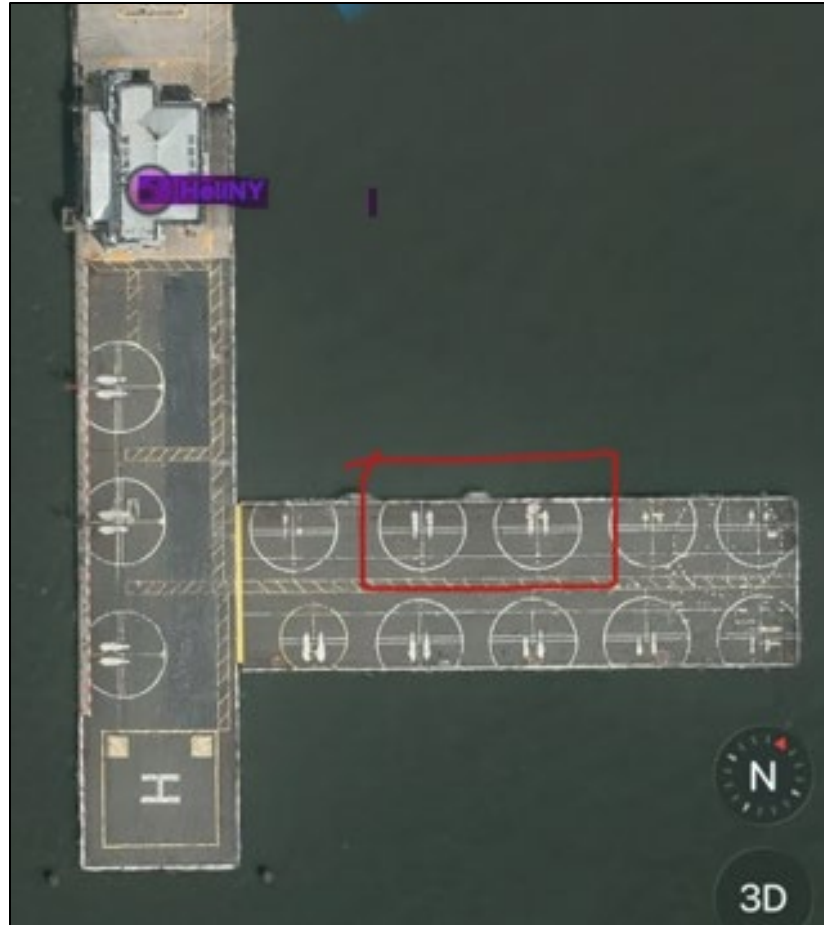
The facility includes Helipad H1, which measured 62 by 62 feet and was constructed of concrete in good condition, with a single-wheel weight-bearing capacity of 50,000 pounds. The helipad was equipped with perimeter runway edge lighting, left traffic patterns, and basic markings described as being in fair condition. Helipad elevation was 7 feet, consistent with the overall heliport elevation. The JRB heliport had 14 parking spots for helicopters. Two primary spots for refueling were identified as spots 5 and 6 in the red outline of the photo. (see figure 6)

Figure 6. JRB helipad

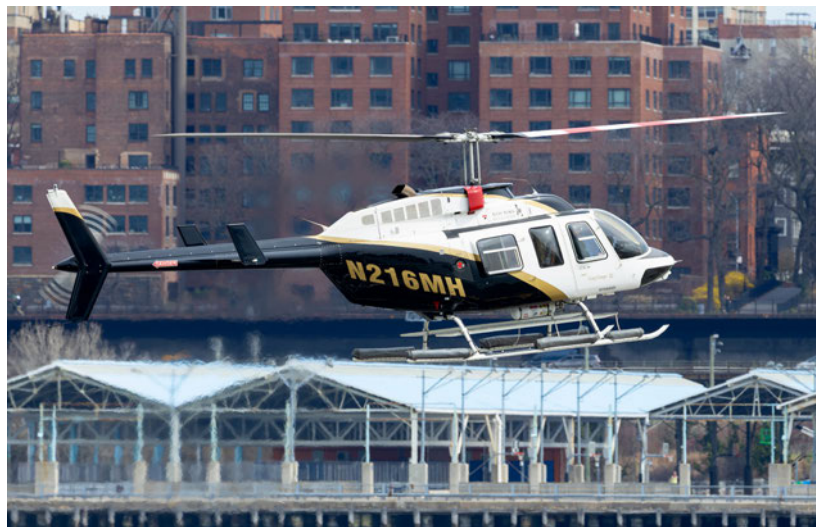
The accident helicopter, a Bell 206L-4 Long Ranger IV (registration N216MH, serial No. 52296) was built in 2004 and issued its most recent airworthiness certificate on February 11, 2005. (see figure 8) The 206L-4 had a two-blade semi-rigid (teetering) main rotor system that provides helicopter lift and thrust. A two-blade teetering tail rotor system provided thrust for helicopter directional control. A Rolls-Royce 250-C30P turboshaft engine was installed on the accident helicopter. The helicopter was equipped with light weight pneumatic floats, Van Horne composite main and tail rotor blades, and a Precise Flight Pulselite<sup>7</sup> system.

Figure 8. Photograph of helicopter prior to the accident. Photo by Dan Smith

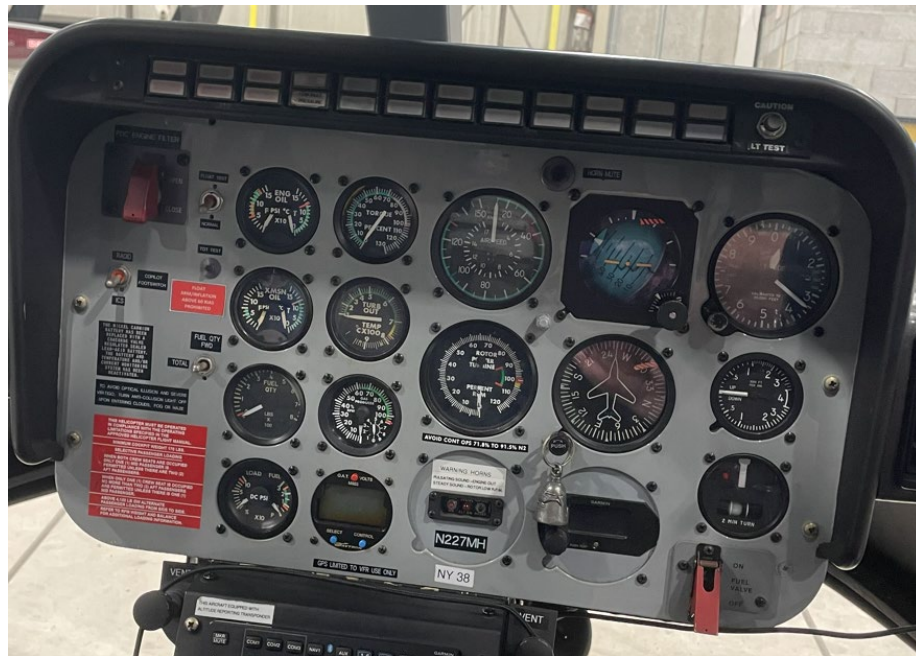
The cockpit flight control system was composed of cyclic, collective, and directional (pedal) controls. The helicopter was configured for the pilot to fly in the right seat and for single-pilot operations. The instrument position on the right forward seat was equipped with a HSI (Horizontal Situation Indicator), airspeed, attitude, vertical speed indicator, and altimeter as the primary instrumentation. (See figure 9) Above the flight instruments, below the glareshield contained the panel with caution and warning indications. (see figure 10)

Figure 10. Exemplar (N227MH) instrument panel with caution and warning panel.
